State of Nevada
Department of Corrections
Nevada State Prison
Facility Condition Analysis

Site Number: 9989
STATE OF NEVADA PUBLIC WORKS BOARD
FACILITY CONDITION ANALYSIS

Report Printed in February 2009

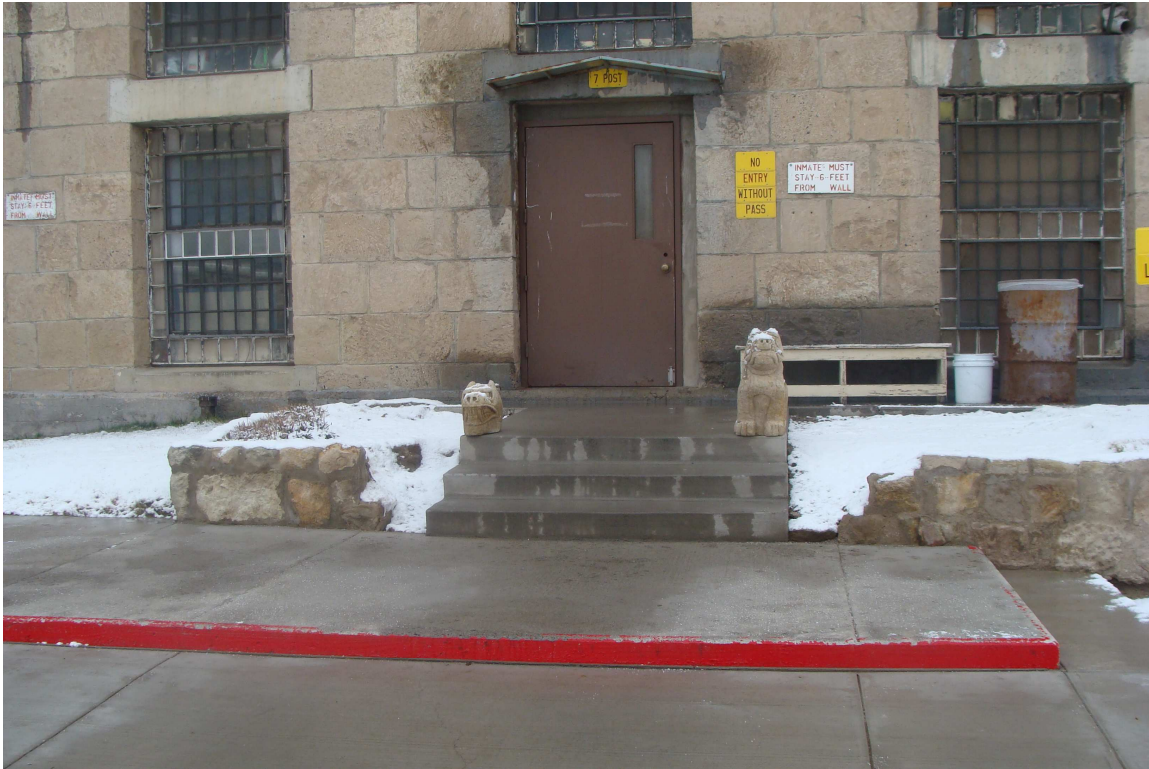
Nevada State Prison - Site #9989
Description: Existing stairs in need of handrails.

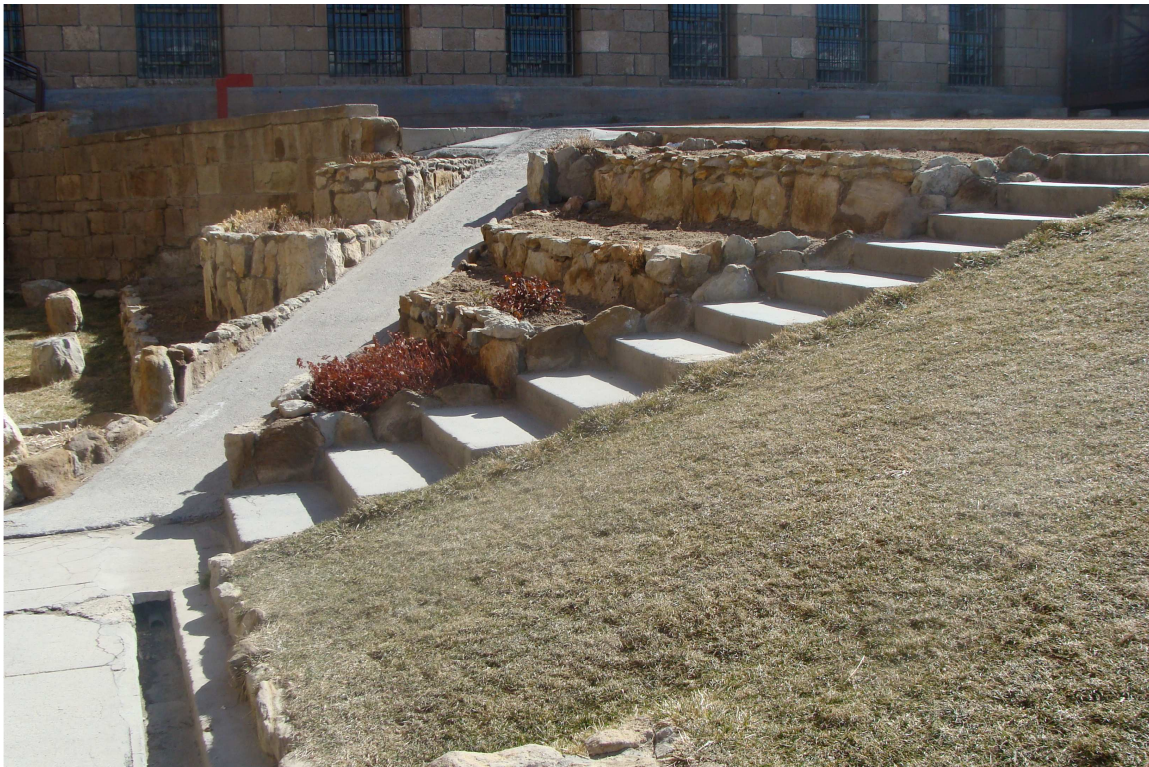
Nevada State Prison - Site #9989
Description: Lower yard stairs in need of handrails.

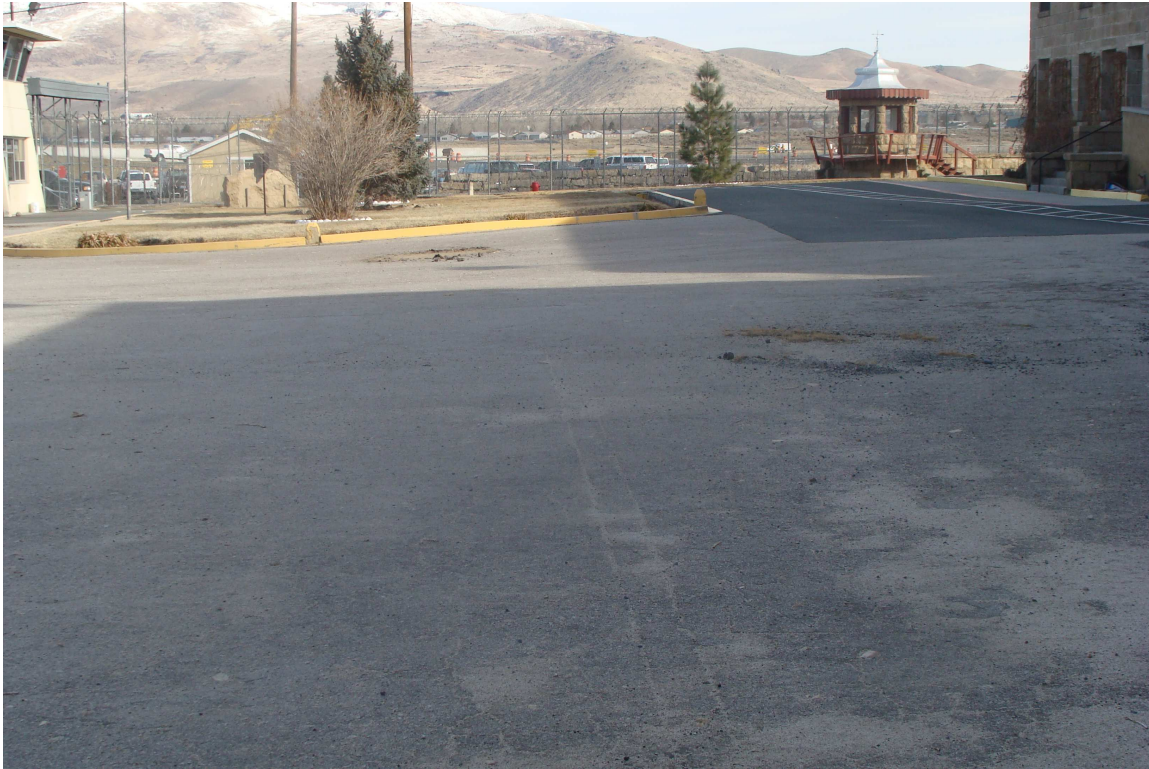
Asphalt walkways have been constructed to many of the facilities, including the guard towers; most of these walkways are in fair condition. Some of the driveways and parking areas throughout the site have damage. Numerous cracks, potholes, and general deterioration are present. Snow accumulations, frost and rain, etc. are contributing factors. This is typical wear over time. It was noted that under the main parking lot a geothermal area exists. This is the main cause of accelerated deterioration from heat rising through the road surface. The areas for replacement are all non-foot traffic areas. The asphalt leading to the housing units will only need to be sealed. 145,233 square feet was used to generate this estimate.

Nevada State Prison - Site #9989
Description: Asphalt in need of repair and sealing.

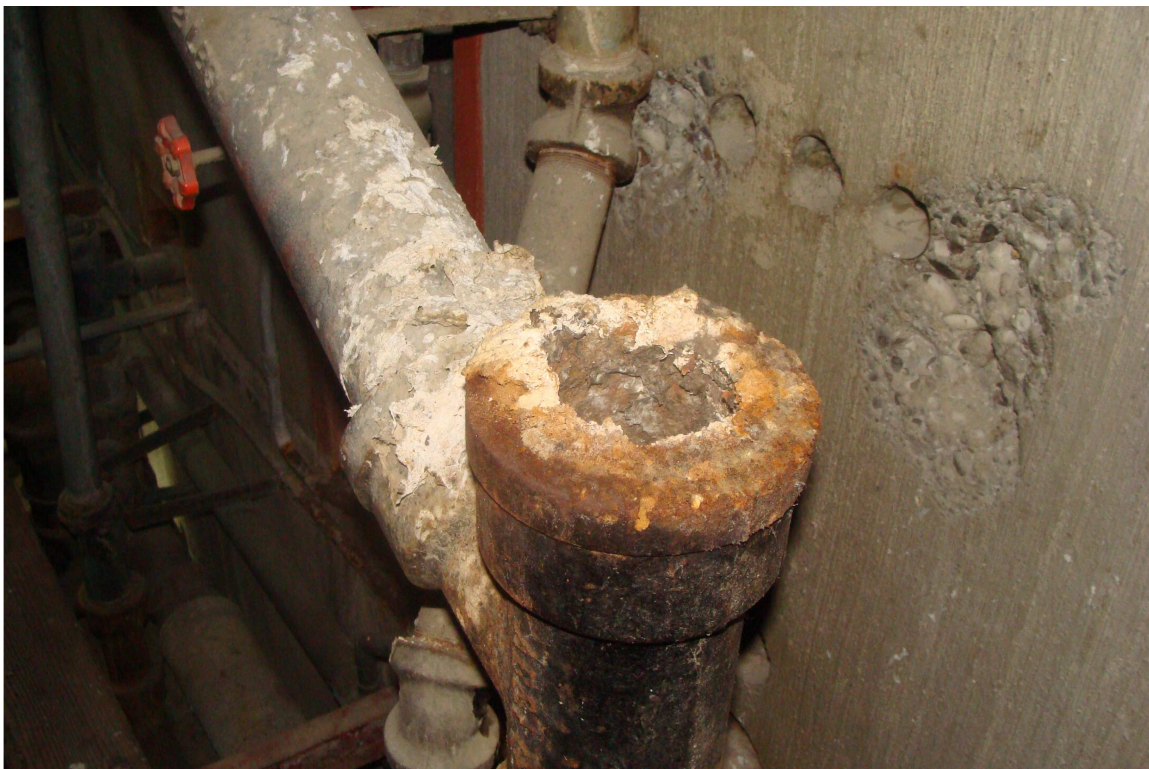
Administration/ Cell Blocks - Building #0094
Description: Example of sewer waste line in Cell Block 5.

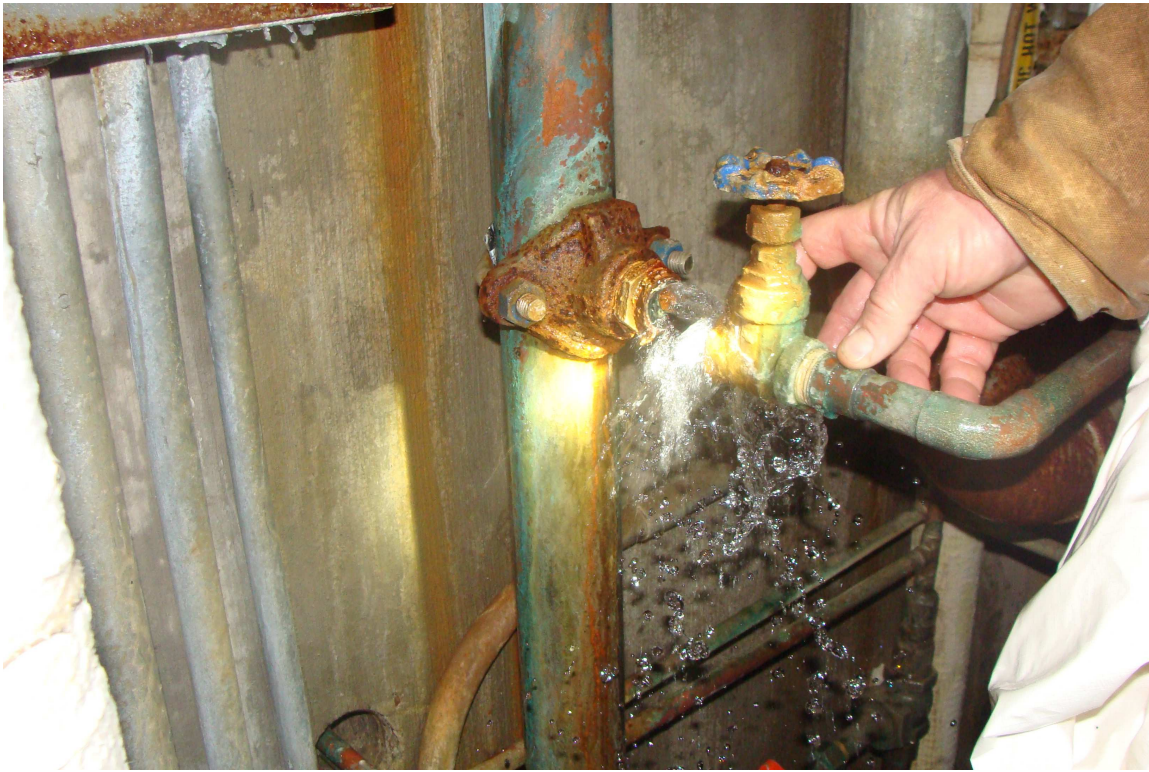
Administration/ Cell Blocks - Building #0094
Description: Example of broken domestic water line in Cell Block Unit 5.

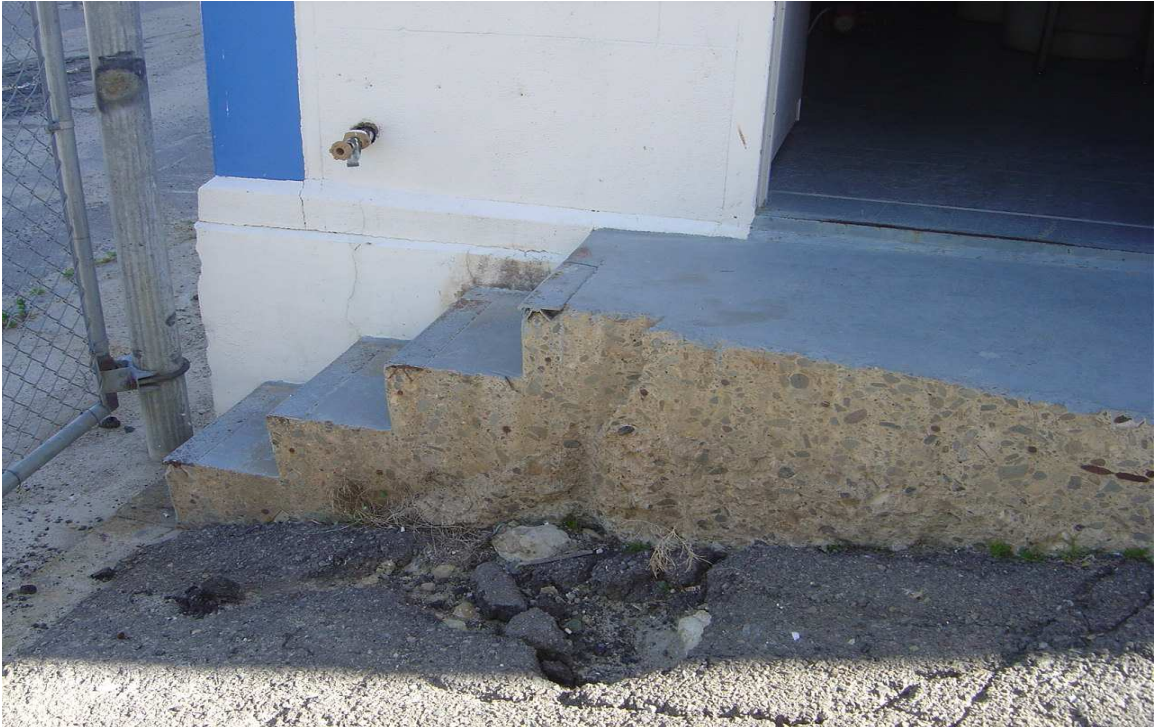
Boiler Plant - Building #0099
Description: Exterior stairs in need of replacement.

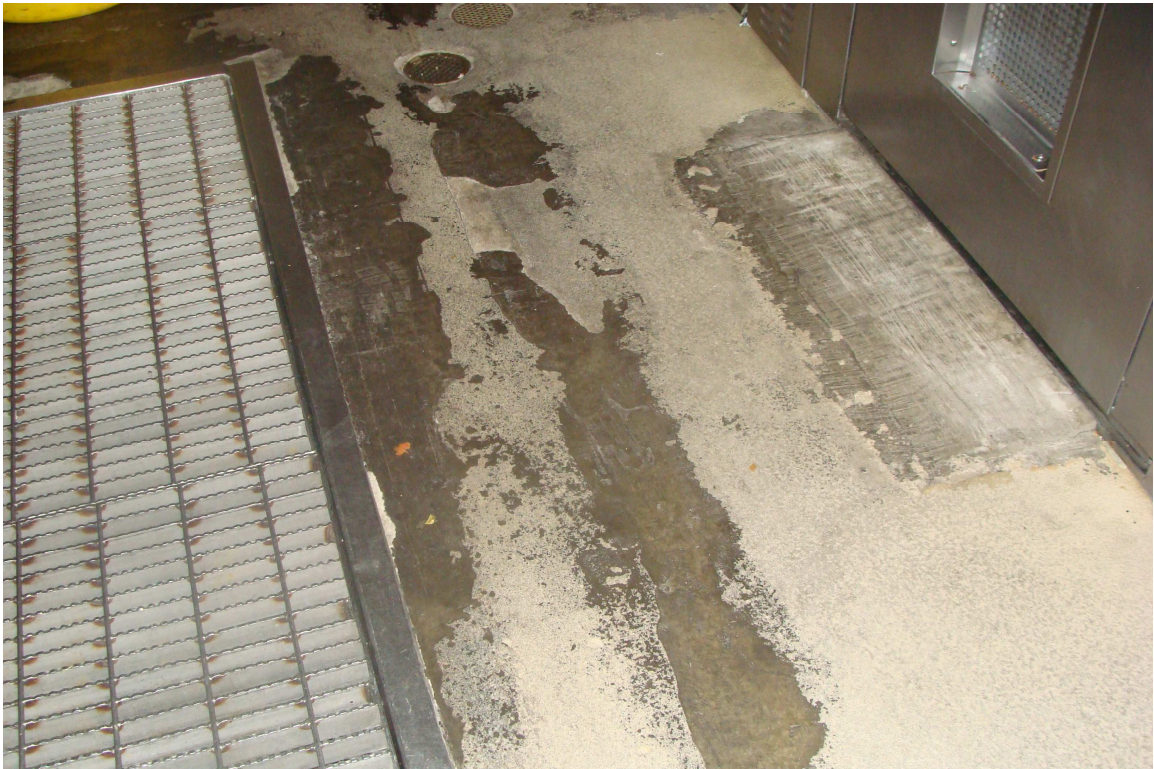
Culinary/ Dining Hall - Building #0103
Description: Floor damage in Kitchen.

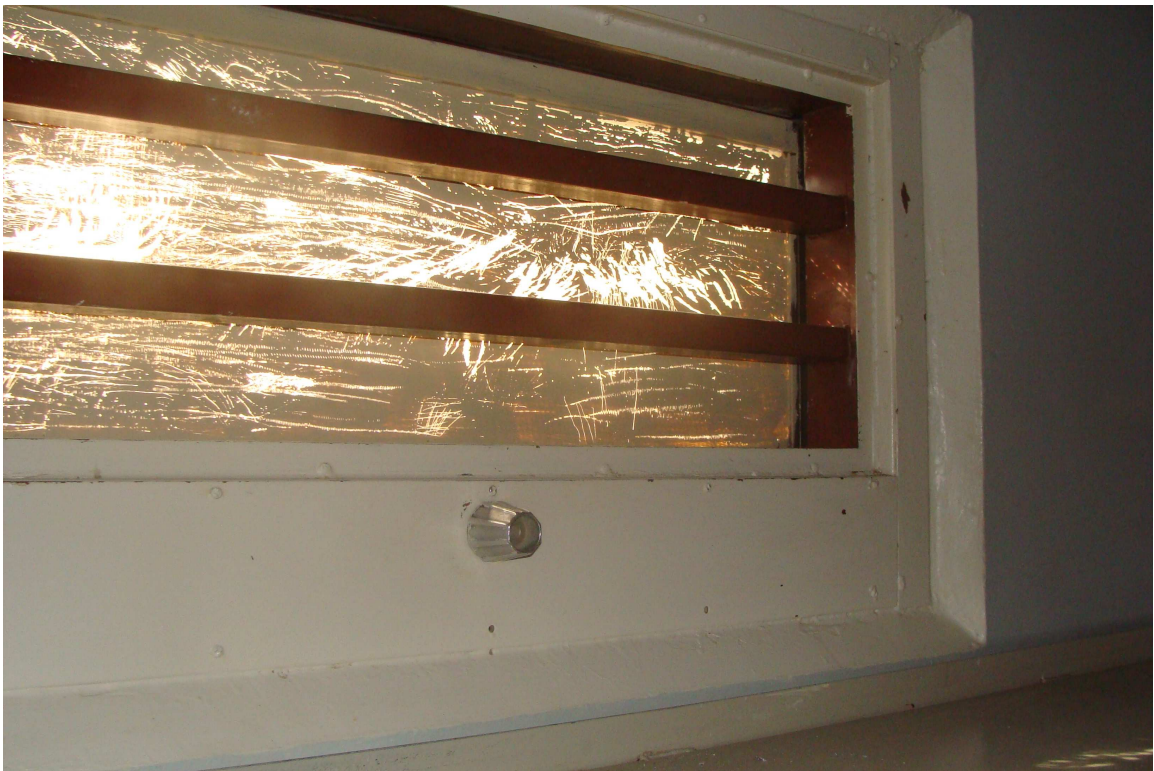
Housing Unit 8 - Building #0108 (Housing Units 6, 7, 9, 10 & 11 similar)
Description: Window in need of replacement.
