DEPARTMENT OF ADMINISTRATION  
STATE PUBLIC WORKS DIVISION  
FACILITY CONDITION ASSESSMENT

### PROPERTY PORTFOLIO REVIEW PROJECT ADDENDUM

NORTHWEST REGION  
NORTHERN NEVADA CORRECTIONAL CENTER COMPLEX  
9990 - NORTHERN NEVADA CORRECTIONAL CENTER SITE  
1721 E SNYDER AVE  
CARSON CITY, NV 89701-7812  
CARSON CITY COUNTY

SURVEY DATE: 06/12/2024

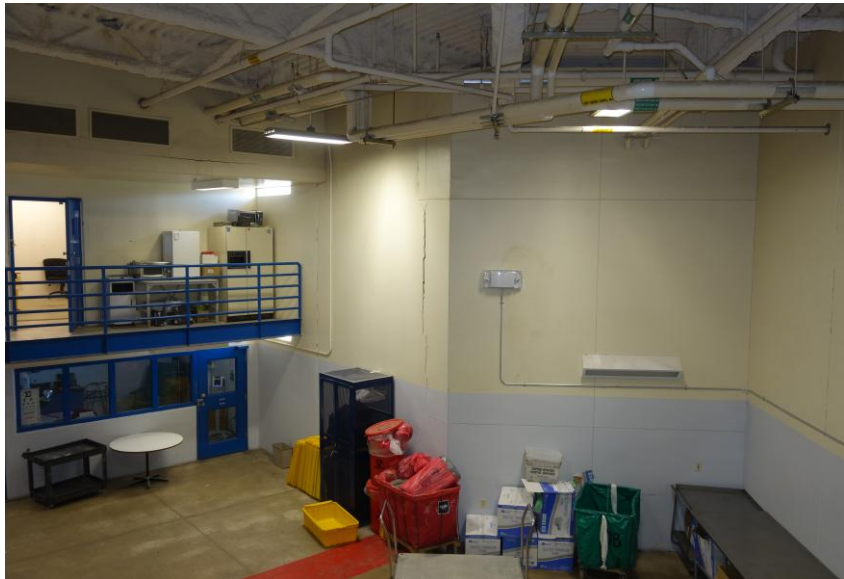
A significant crack has developed in the exterior wall panel, with visible lateral displacement on one side, indicating potential compromise of the wall's structural integrity. This project recommends a full structural analysis to assess the extent of the damage and determine whether repairs are necessary. The cost of any required repair work is not included in this recommendation.

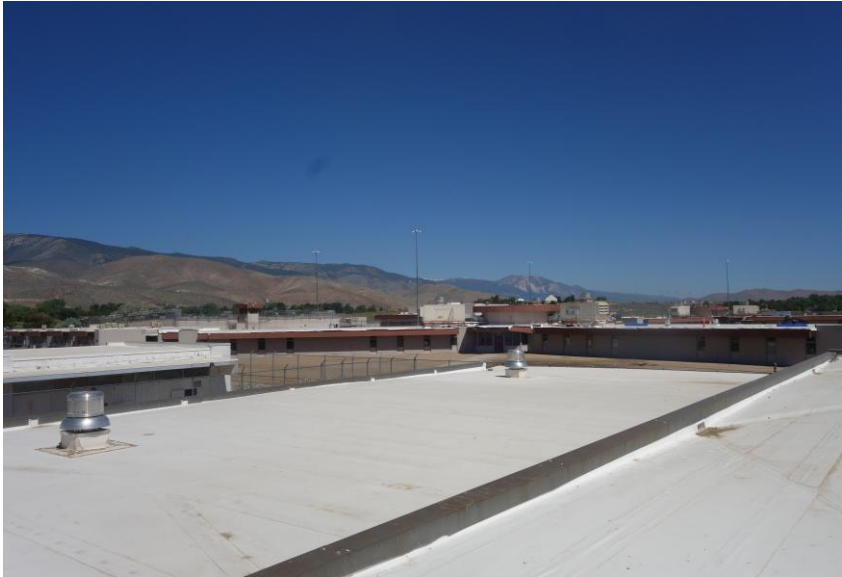
At the time of the survey, the building's roof was found to be in fair condition. Installed in 1994, the current roofing system has exceeded its typical 20–25-year useful life, and the original warranty has expired. Harsh environmental conditions—such as temperature fluctuations, windborne sand and debris, and prolonged sun exposure—have accelerated deterioration. Re-roofing is recommended within the next 2 – 3 years to align with the statewide roofing program and address the aging system.

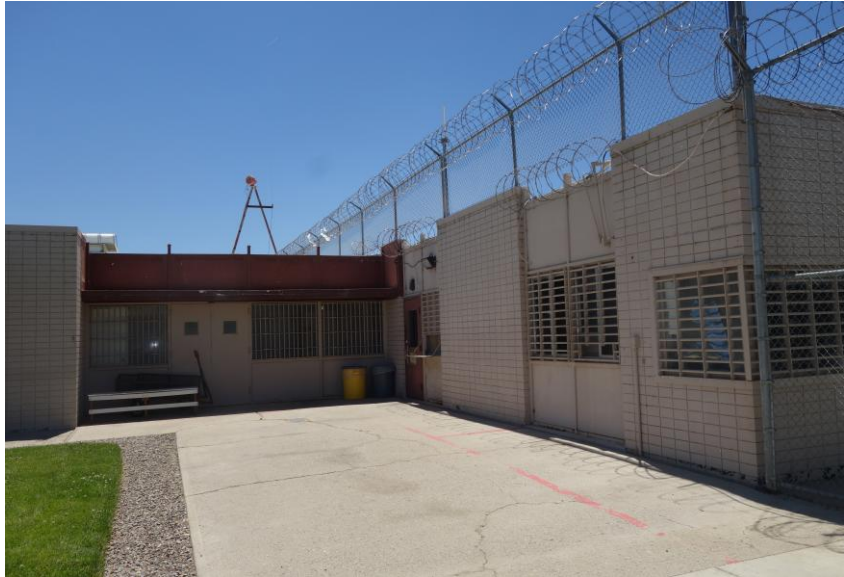
The existing windows in this building are single-pane wire mesh construction, with some units broken and all lacking energy efficiency. This project will fund the removal and replacement of these windows with new dual-pane, security-rated window systems that comply with all applicable NDOC standards, improving both safety and energy performance.

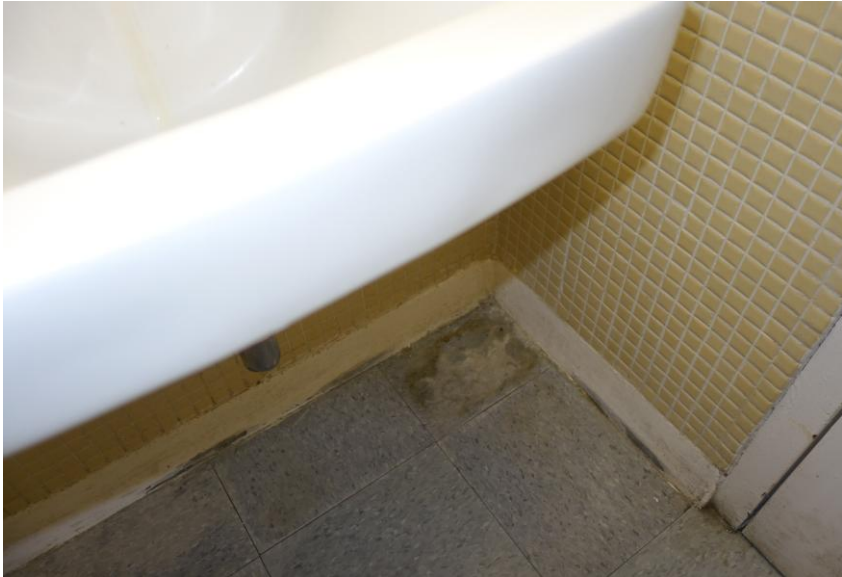
The vinyl composite tile (VCT) and carpet in the building are damaged and nearing the end of their useful life. There is a possibility that asbestos-containing materials (ACM) may be present in the existing floor tile and mastic; testing by a licensed abatement professional will be required. This project will fund the removal and disposal of the existing flooring and the installation of new 12" x 12" VCT with a 6" base and heavy-duty commercial-grade carpet within the next 2 to 3 years. Any costs related to ACM testing or abatement are not included in this project.
