State of Nevada
Department of Corrections
Northern Nevada Correctional Center
Facility Condition Analysis

NORTHERN NEVADA CORRECTIONAL CENTER

Site Number: 9990
STATE OF NEVADA PUBLIC WORKS DIVISION
FACILITY CONDITION ANALYSIS

Report Printed in June 2015

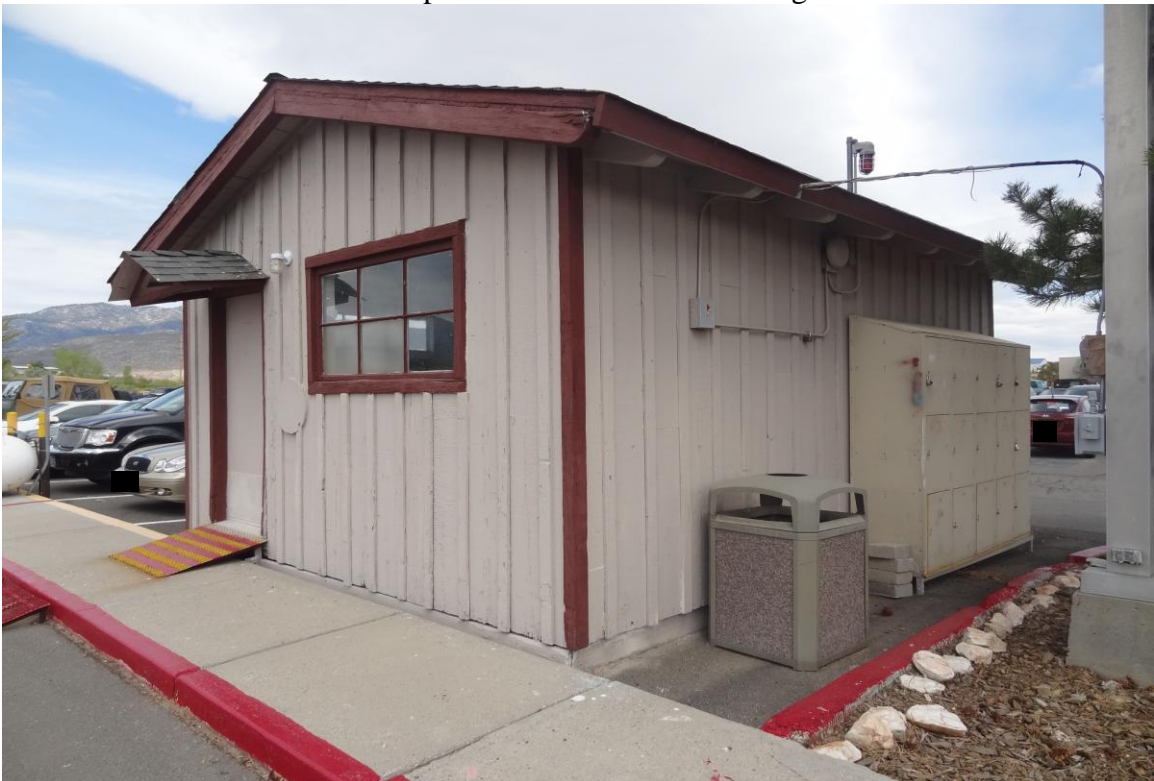
Inmate Clothing Store – FCA Building #2005
Description: Exterior of the building.

The 2 exterior wood man doors appear to be original to the building. They are damaged from age and general wear and tear. This project would provide for the replacement of the wood doors with new metal doors, frames and hardware. Removal and disposal of the existing doors and painting of the new doors is included in this estimate.

The asphalt composition shingle roof on this building was in poor condition at the time of the survey. It is recommended that this building be re-roofed in the next 2-3 years with a new 50 year asphalt composition roofing shingle and new underlayments. This estimate includes removal and disposal of the old roofing.

The windows are original, single pane construction in a wooden frame. These older windows are drafty, not energy efficient and the wooden frames have deteriorated significantly. This project recommends replacing the windows with dual pane, higher efficiency units. This estimate is for the replacement of 2 units including wooden frames. Removal and disposal of the existing windows is included in this estimate.

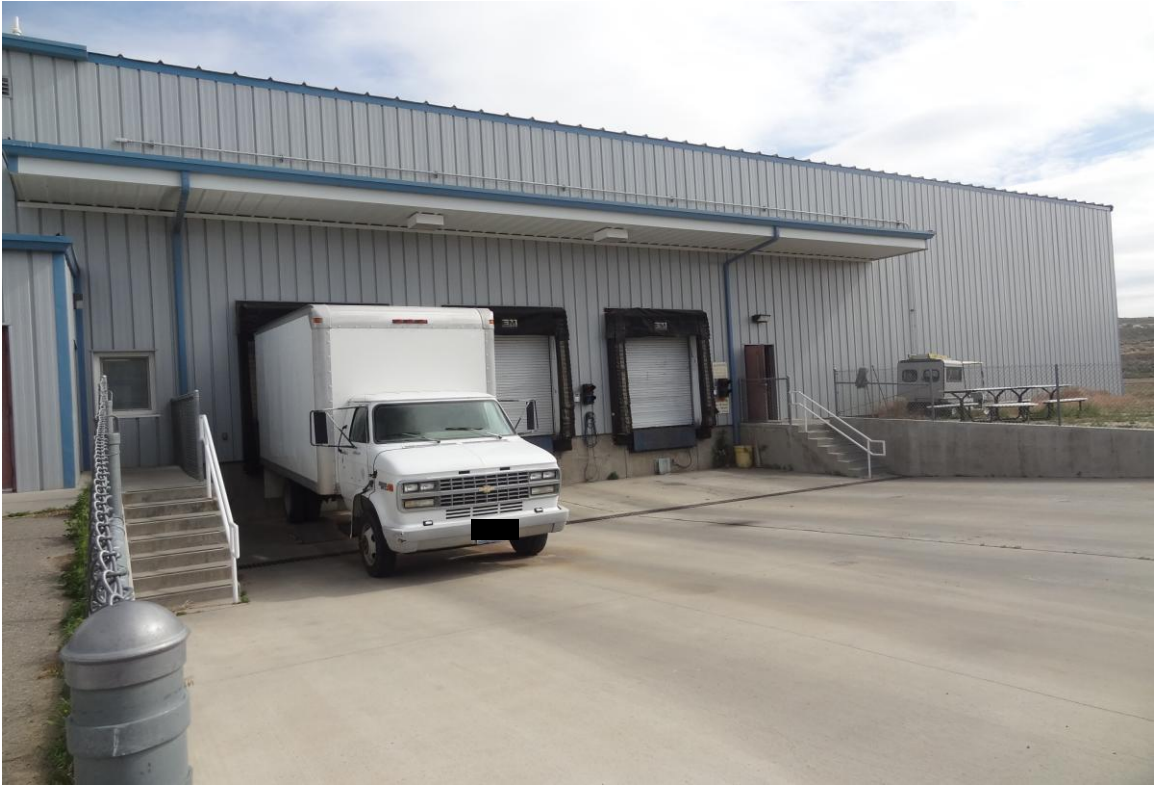
Central Warehouse – FCA Building #2004
Description: Exterior of the building / loading dock.

The wood stairs and handrails in the north side of the original warehouse do not meet the requirements in the 2012 International Building Code sections 1009 and 1012. The landing at the top is not large enough and the handrails are not structurally adequate. This project would provide funding to remove and replace the stairway and handrail.

There are two 10'x10' overhead coiling doors in the original portion of the warehouse. One of them has been replaced, the other has not and is damaged and does not function properly. Exposure and wind have caused the door to bend, crack and lose its finish. It is original to the building and should be scheduled for replacement. This project would provide for the removal and disposal of the motorized overhead coiling door and replacement with a new motorized overhead coiling door including remote operation, safety controls and connection to existing utilities.

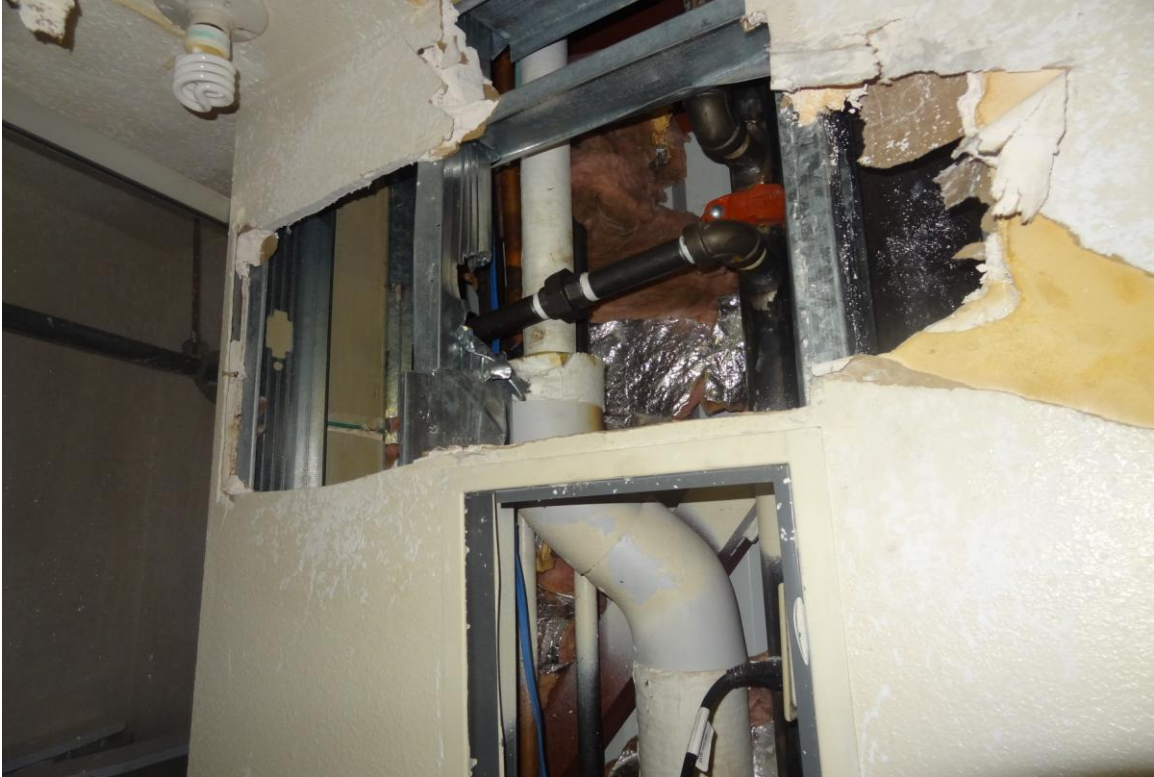
Guard Tower 3 – FCA Building #0146
Description: Water damage to the interior.

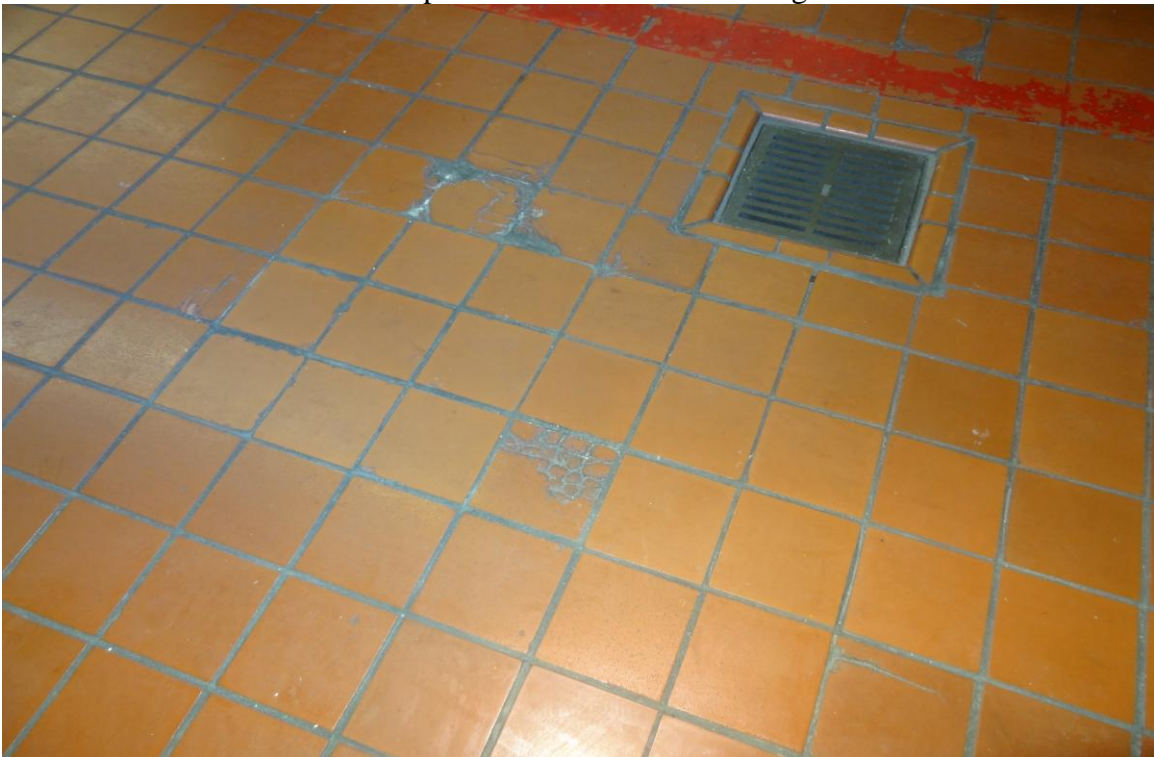
Culinary / Dining – FCA Building #0129
Description: Culinary floor in need of replacement.
