State of Nevada
Department of Health & Human Services
Division of Child & Family Services

SOUTHERN NEVADA CHILD & ADOLESCENT SERVICES

Site Number: 9991
STATE OF NEVADA PUBLIC WORKS DIVISION
FACILITY CONDITION ANALYSIS

Report distributed in October 2021

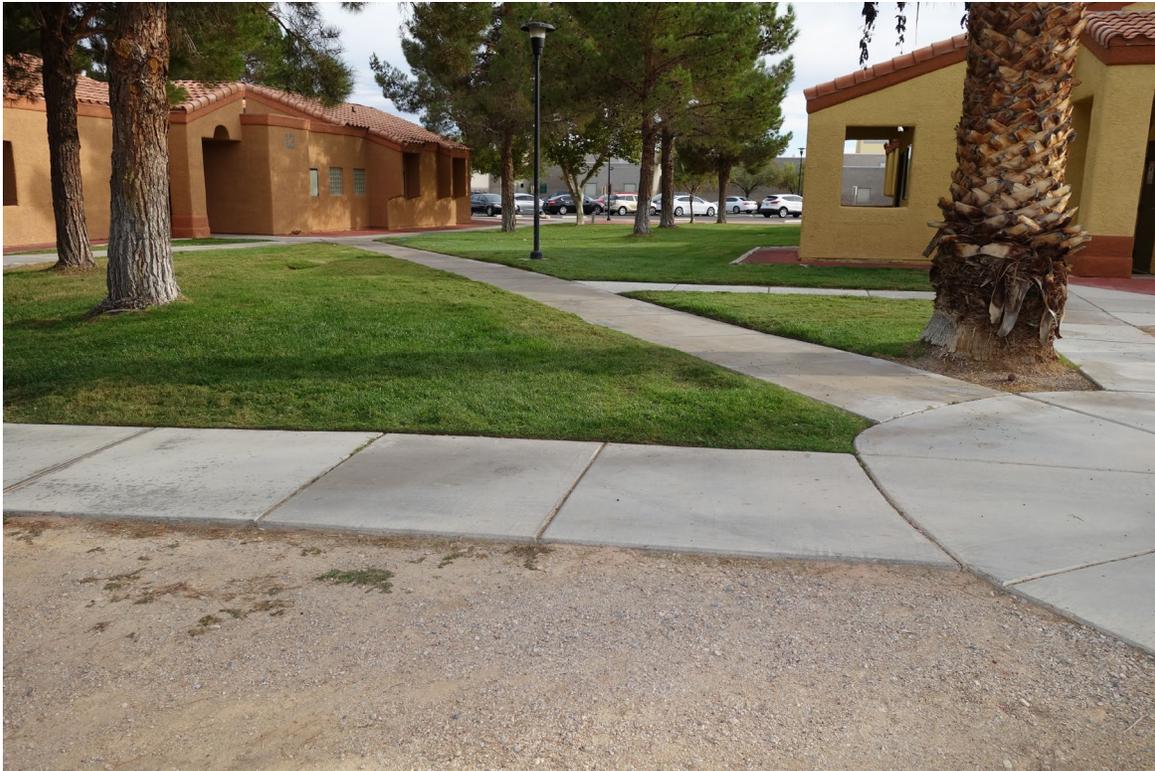
Southern Nevada Child & Adolescent Services Site – FCA Site #9991
Description: View of Portion of Sitewide Sidewalk Replacement.

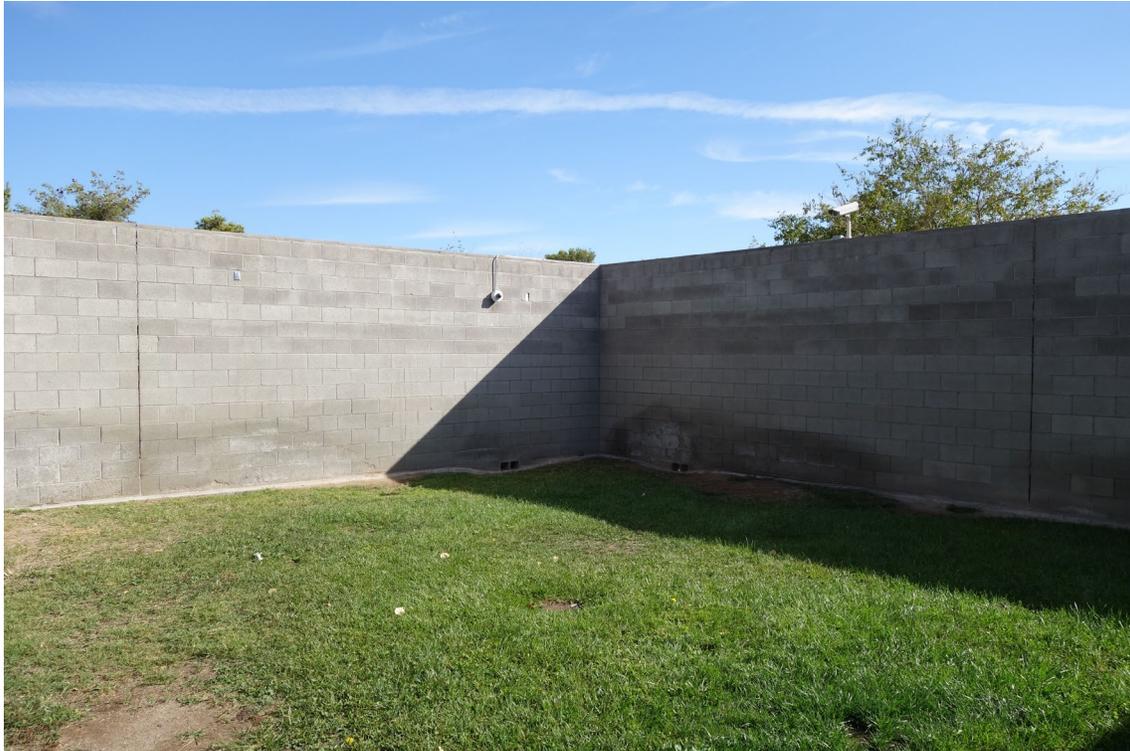
The building and courtyard walls have considerable damage to the concrete masonry units (CMU) from lawn sprinklers wetting the CMU and poor drainage. Four of the five courtyards are due to be re-worked in order to prevent further damage. This project would remove the turf within three feet of the CMU walls, adjust the sprinklers so they do not wet the walls and re-grade or install French drains to ensure proper drainage out of the courtyards.

#17 Desert Willow Treatment Center – FCA Building #1994
Description: Water Damage to CMU Wall in Courtyard.

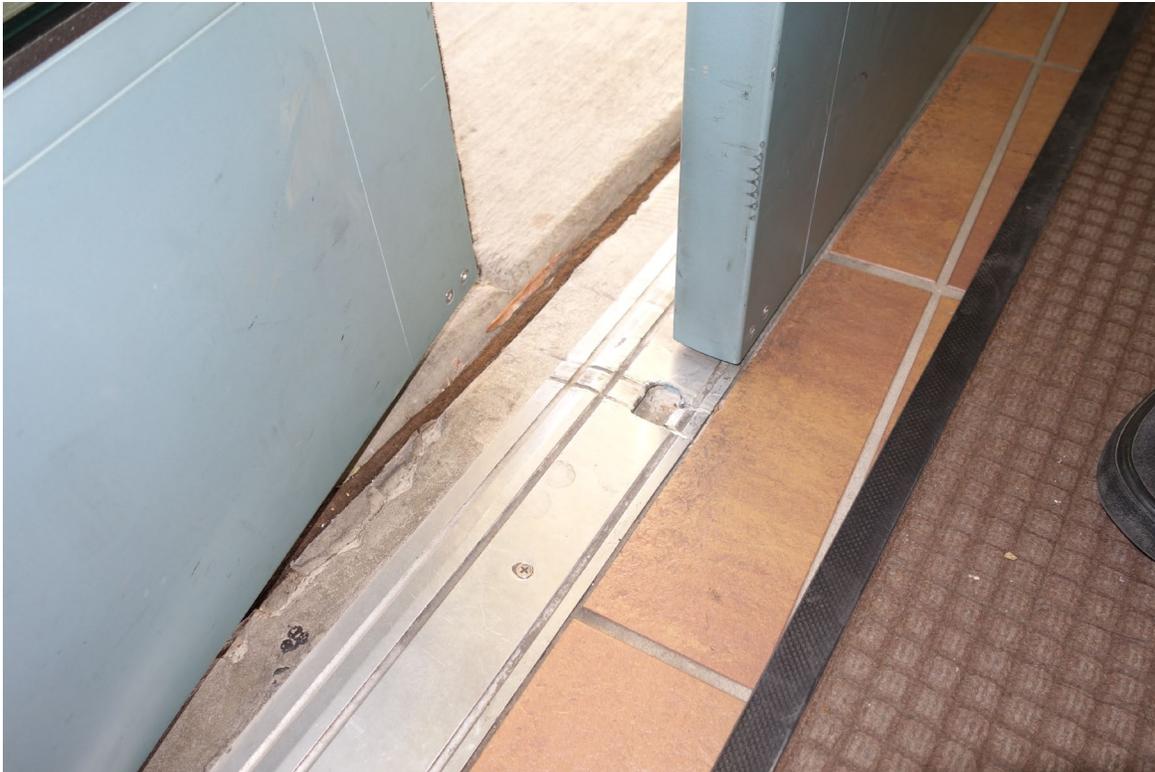
The front entry storefront doors are damaged from age and general wear and tear and have reached the end of their expected life. They do not open and close smoothly and have problems with the locking mechanisms. This project would provide for the replacement of door assemblies with new storefront doors and hardware. Removal and disposal of the existing doors is included in this estimate.

#17 Desert Willow Treatment Center – FCA Building #1994
Description: Main Entry Storefront Door Replacement Needed.

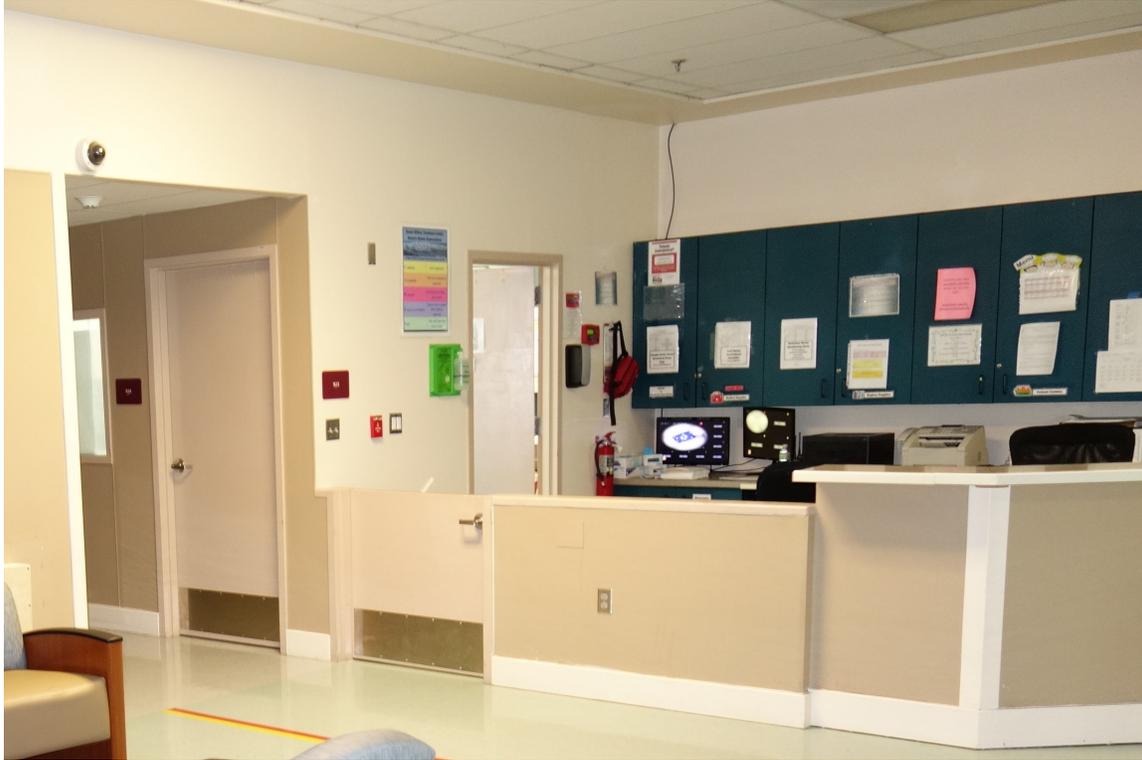
Patients at this psychiatric hospital may occasionally react aggressively towards the staff or towards the equipment behind the nurses stations. The existing nursing stations have an open design that lack protective barriers so patients are able to walk into the nursing stations freely. This barrier would serve to protect the state's property and the safety of the clients and staff. This project will design and construct new protective barriers and replace the casework and countertops at the nurse's stations and the front reception desk in the main lobby.

#17 Desert Willow Treatment Center – FCA Building #1994
Description: Safety Enclosures for Nurses Stations Needed.

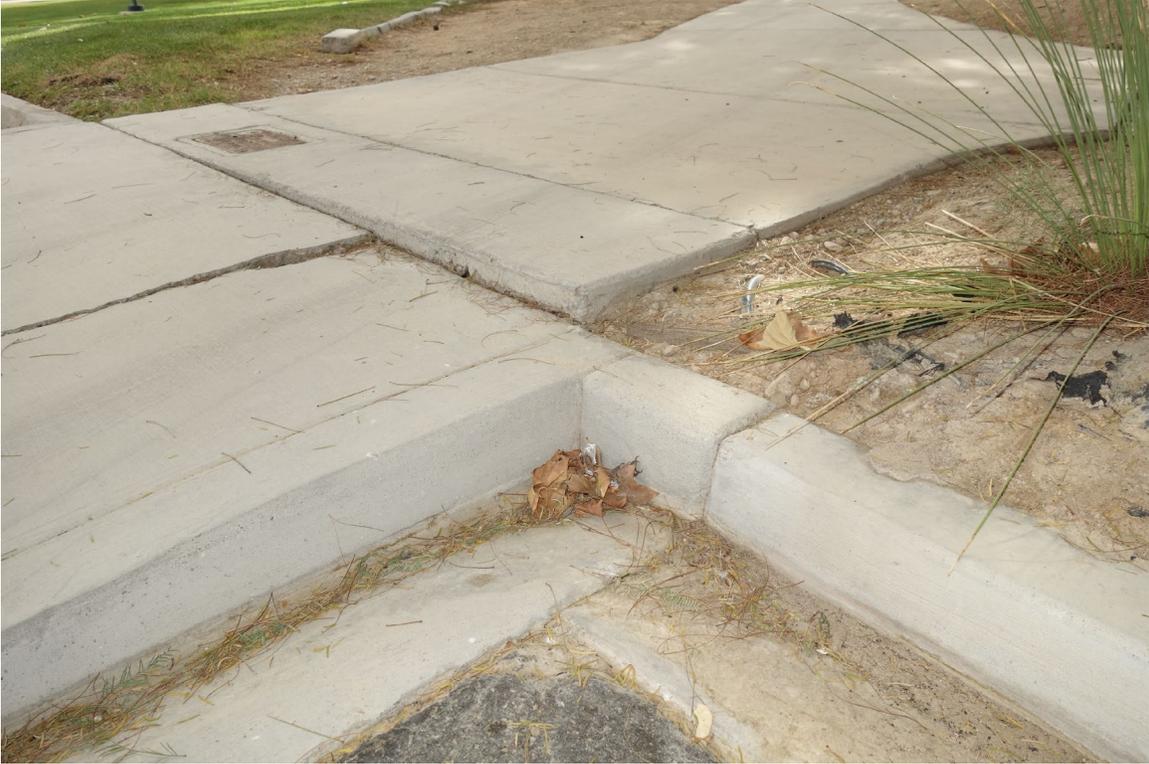
A portion of the concrete sidewalk on the path of travel to the building is in need of replacement. They have cracks and are heaving from tree roots. This project would provide for the removal and replacement of the concrete sidewalks. 300 SF of 4" thick concrete was used for this estimate. The 2018 IBC, ICC/ANSI A117.1, NRS 338.180 and the most current version of the ADA Standards for Accessible Design were used as a reference for this project.

#15 West Neighborhood Family Services – FCA Building #1993
Description: ADA Path of Travel Sidewalk Replacement Needed.
