State of Nevada  
Department of Health & Human Services  
Aging and Disability Services Division

# DESERT REGIONAL CENTER SITE

1391 South Jones Blvd.  
Las Vegas, Nevada 89146

**Site Number: 9993**  
**STATE OF NEVADA PUBLIC WORKS DIVISION**  
**FACILITY CONDITION ANALYSIS**

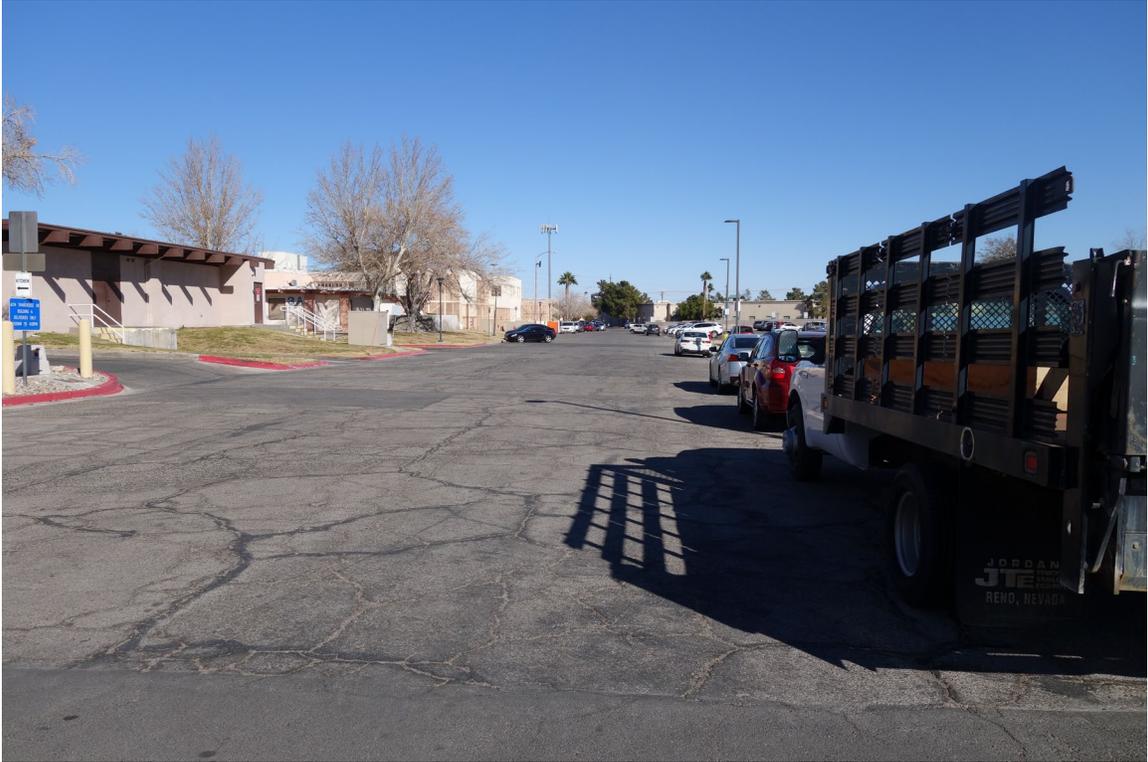
There are numerous places where drainage ponding occurs on Transverse Drive. The entire roadway is in poor condition should be replaced. A new sidewalk with curb and gutter should be installed to achieve proper drainage. This project provides for removal and replacement of the asphalt paving and installation of sidewalks. 40,000 square feet of roadway and sidewalks was used to generate the estimate.

Desert Regional Center Site – FCA Site #9993  
Description: Transverse Drive Pavement Replacement & Drainage Needed.

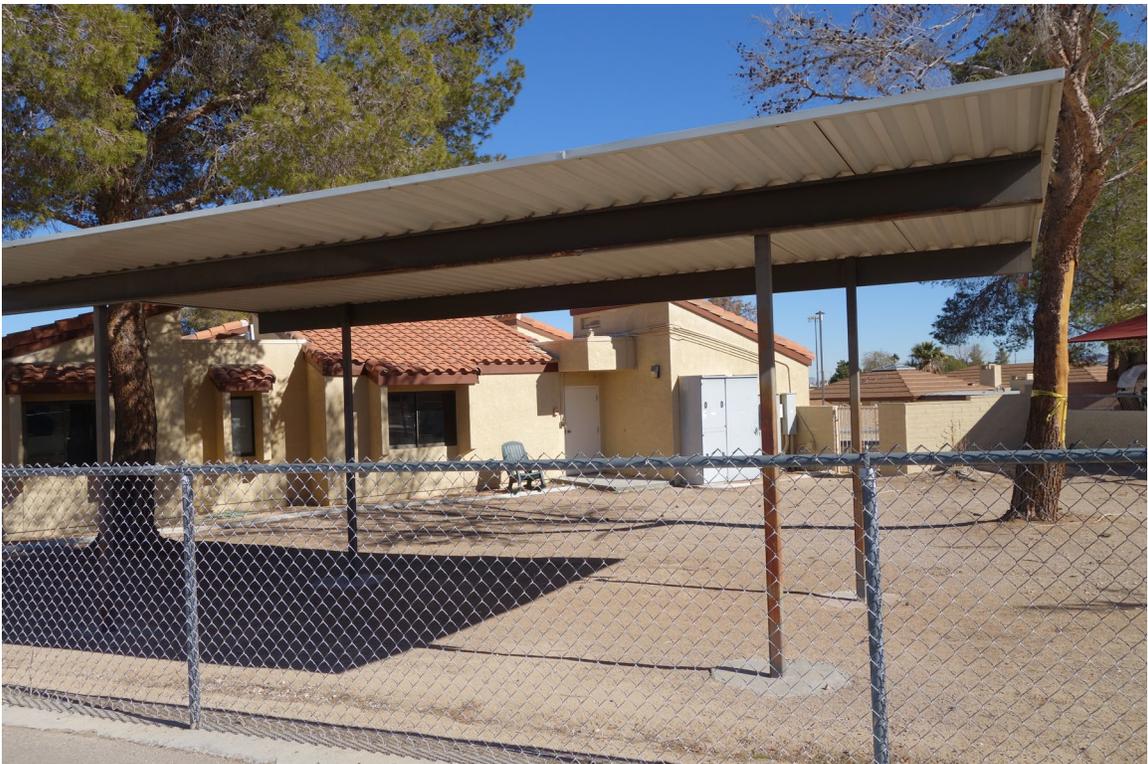
There are 10 steel ramadas in different locations throughout the site which measure 18'x22' each for a total of 3,960 square feet. It is important to maintain the finish, weather resistance and appearance of the structures. This project would provide for painting of the structures and it is recommended that this project be scheduled on a cyclical basis to maintain the integrity of the structures.

Desert Regional Center Site – FCA Site #9993 (Building # 2773 thru 2782)  
Description: Site Wide Ramadas Exterior Finishes Needed.

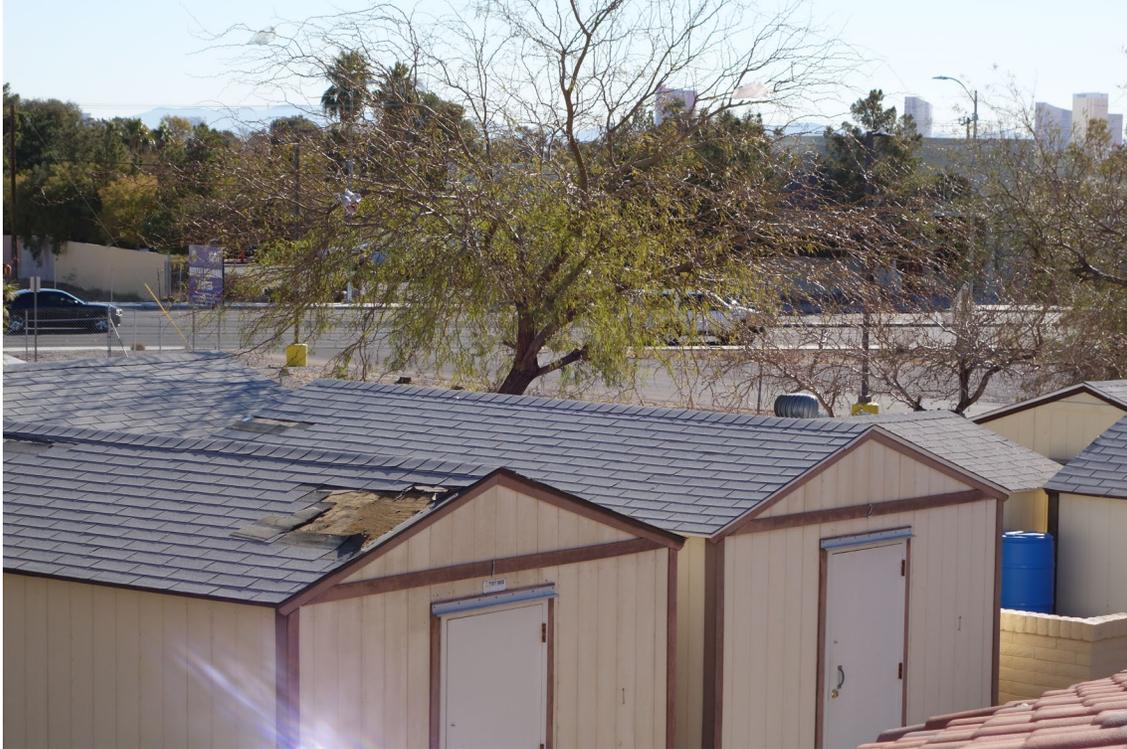
There are 18 storage sheds located throughout the site ranging from 100 to 216 square feet each for a total of 2,560 square feet. The asphalt composition shingle roofs on these sheds were in poor condition at the time of the survey. It is recommended that these sheds be re-roofed in the next 2 - 3 years with a new 50 year asphalt composition roofing shingle and new underlayment. This estimate includes removal and disposal of the old roofing system.

Desert Regional Center Site – FCA Site #9993 (Building # 2755 thru 2772)  
Description: Site Wide Storage Shed Roof Replacement Needed.

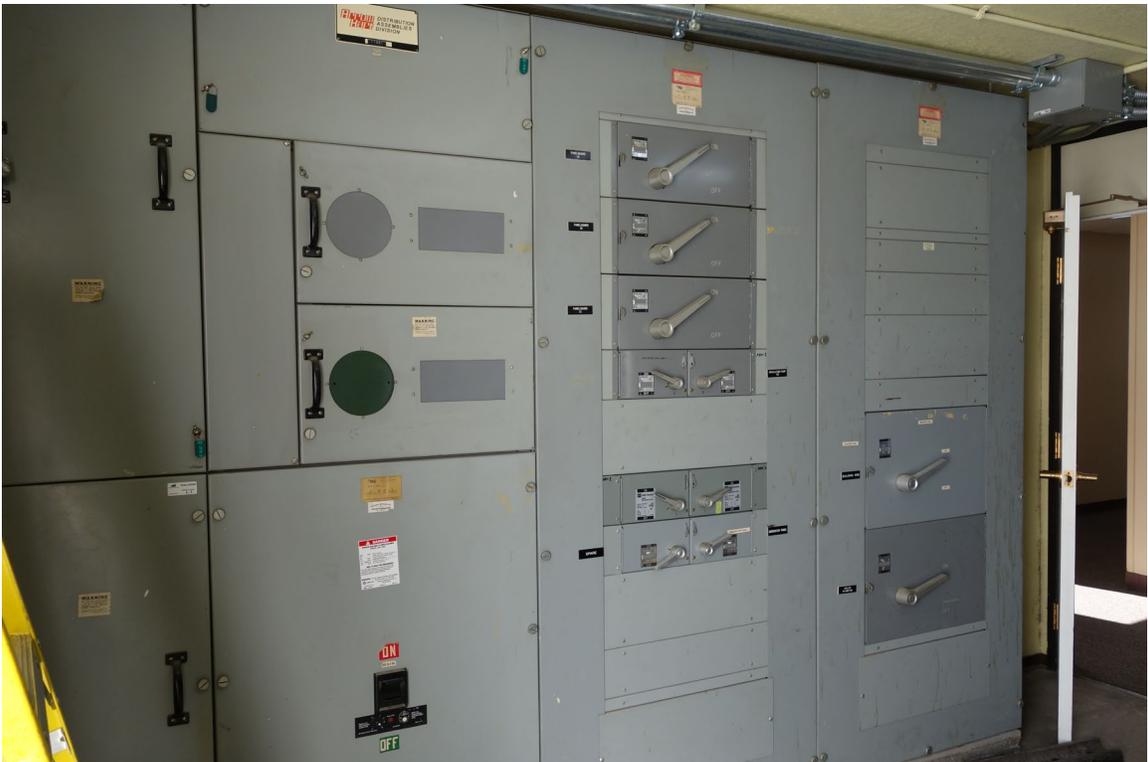
#1391 DRC Administration – FCA Building #0256  
Description: Electrical Upgrade Needed.
