State of Nevada  
Department of Corrections  
Southern Nevada Correctional Center  
Facility Condition Analysis

# SOUTHERN NEVADA CORRECTIONAL CENTER SITE

Site Number: 9994  
STATE OF NEVADA PUBLIC WORKS DIVISION  
FACILITY CONDITION ANALYSIS

Report Printed in August 2016

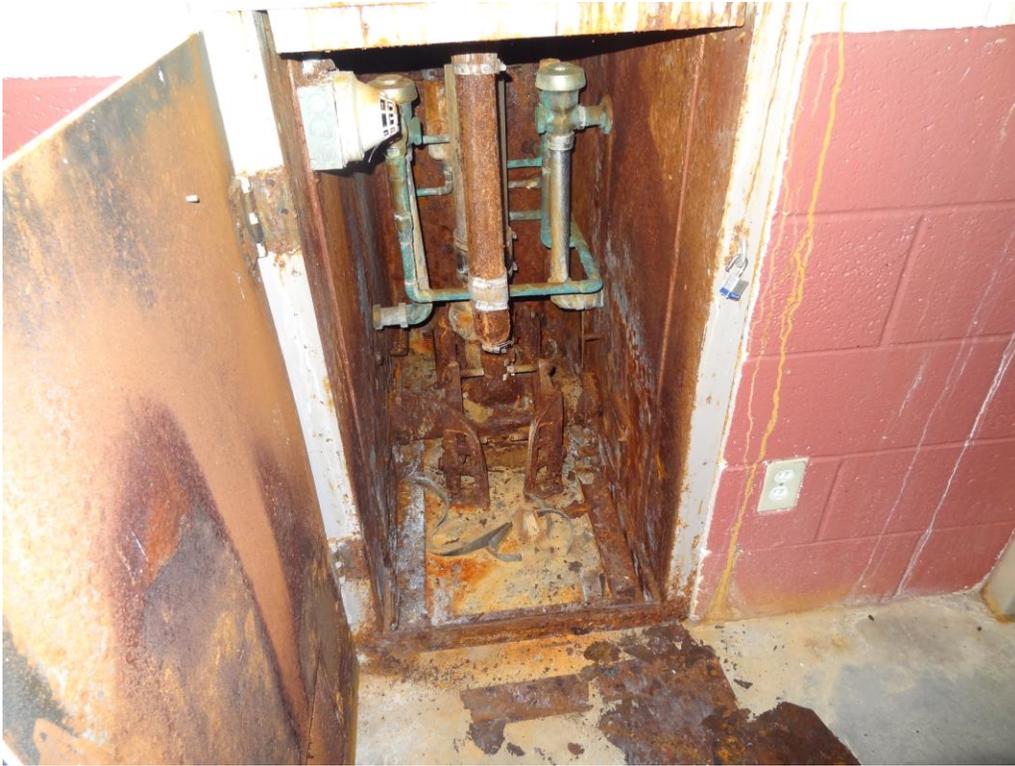
Housing Unit 5 - Building #0184  
Description: Water damage from leaking pipes.

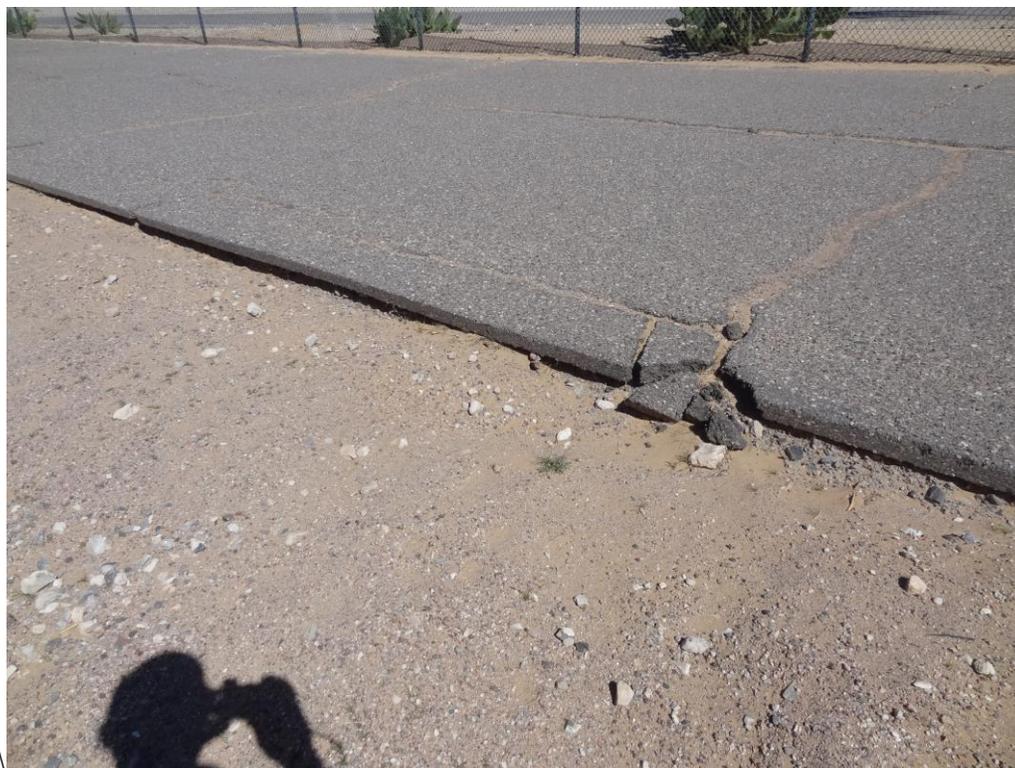
The access road and the parking area around the Maintenance and Auto Shop area is in poor condition and has significant alligating and large cracks. The paving has deteriorated to the point that it is no longer viable to re-seal. This project would provide for the removal and disposal of the existing A.C. paving and installation of 80,000 square feet of A.C. paving over a compacted sub-base. This estimate includes striping for parking areas and safety zones and excludes the main public / employee parking area.

Southern Nevada Correctional Center Site - Site #9994  
Description: AC paving in need of replacement.

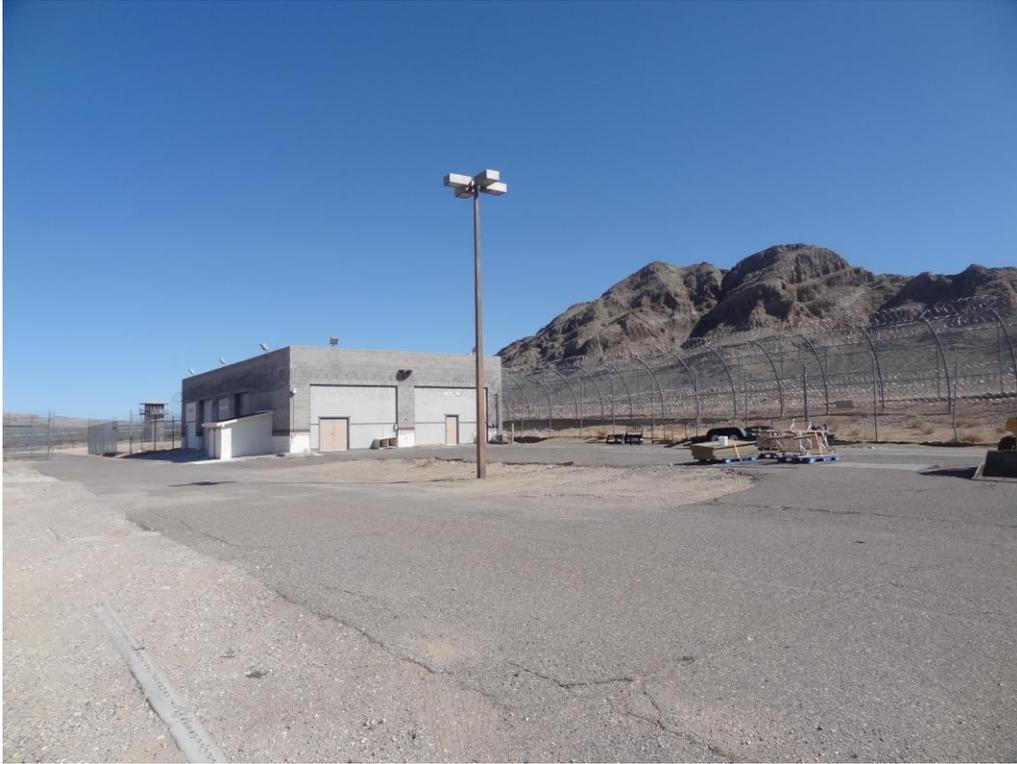
Southern Nevada Correctional Center Site - Site #9994  
Description: AC paving in need of replacement.

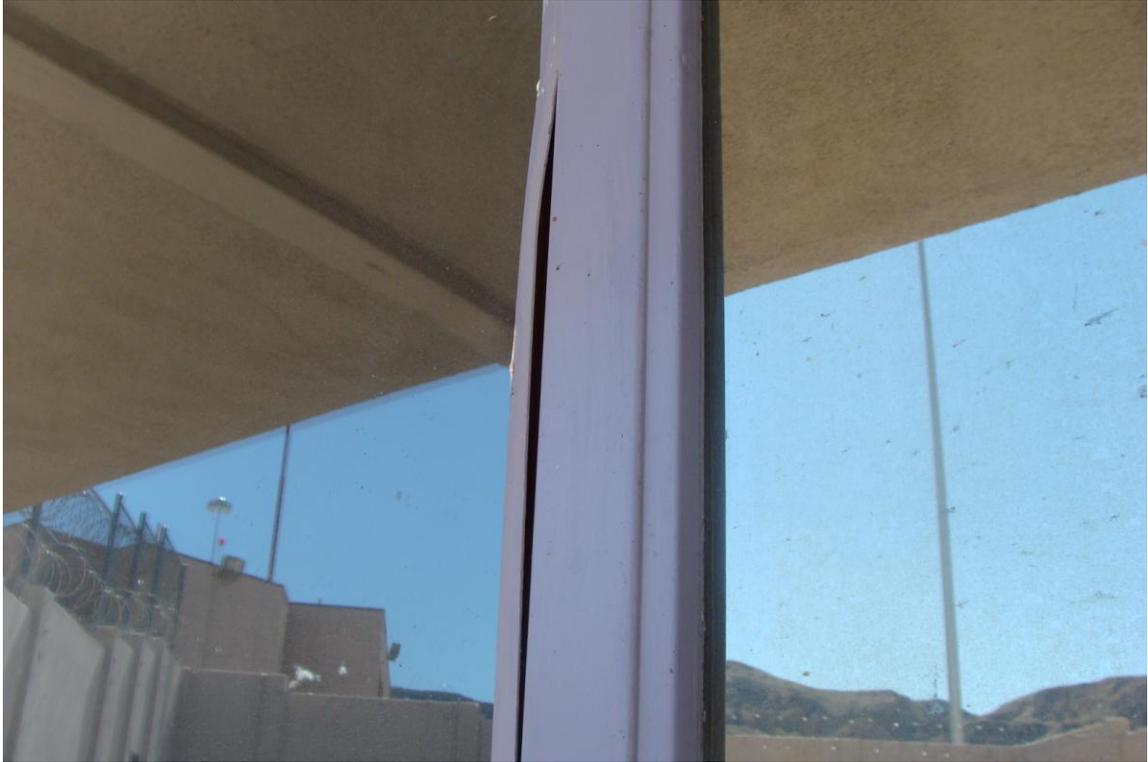
Administration / Visitation - Building #0176  
Description: Damaged curtain window glazing stops.

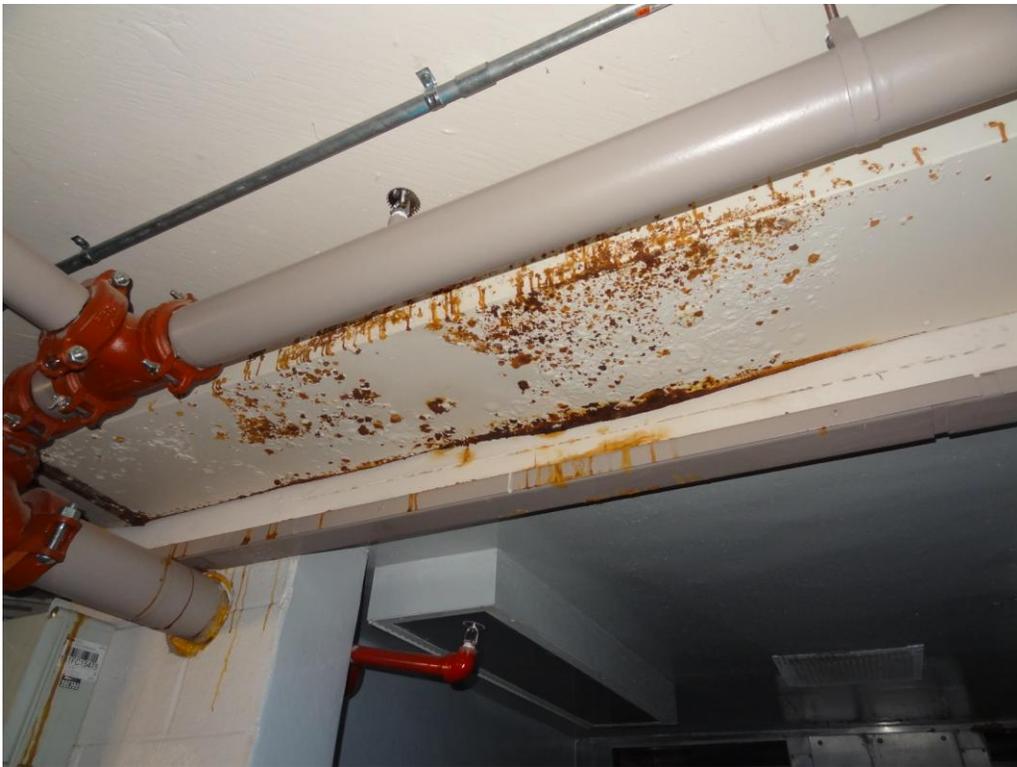
Housing Unit 1 - Building #0180  
Description: Water damage from leaking pipes.

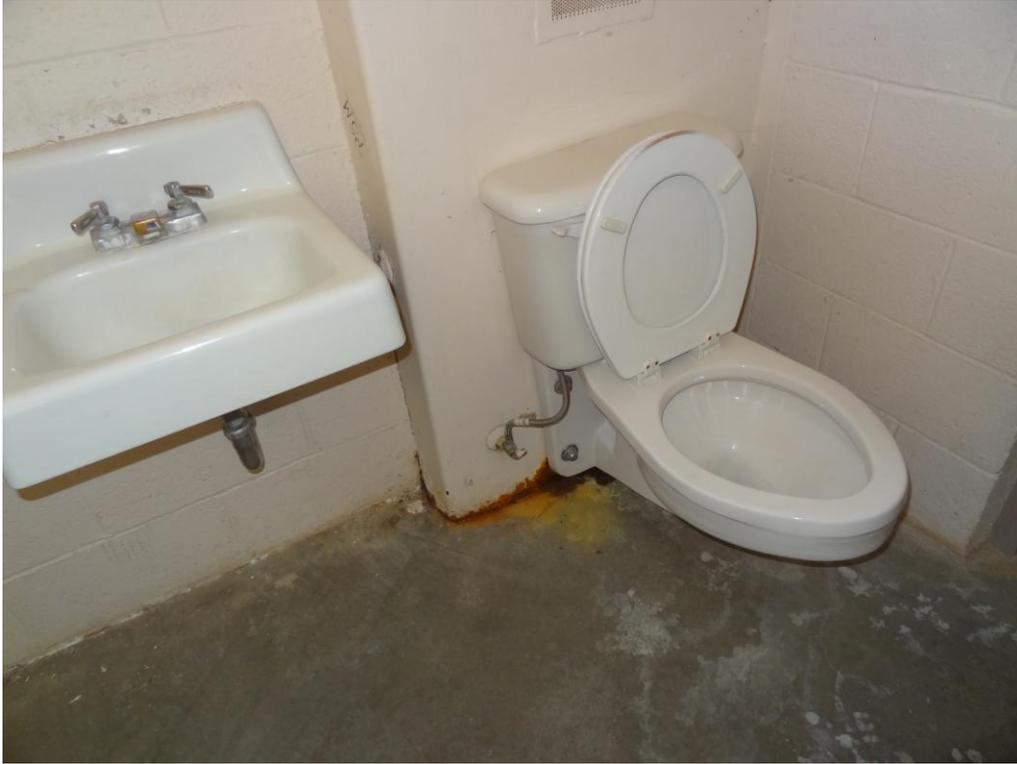
Housing Unit 1 - Building #0180  
Description: Water damage from leaking pipes at cell fixtures.

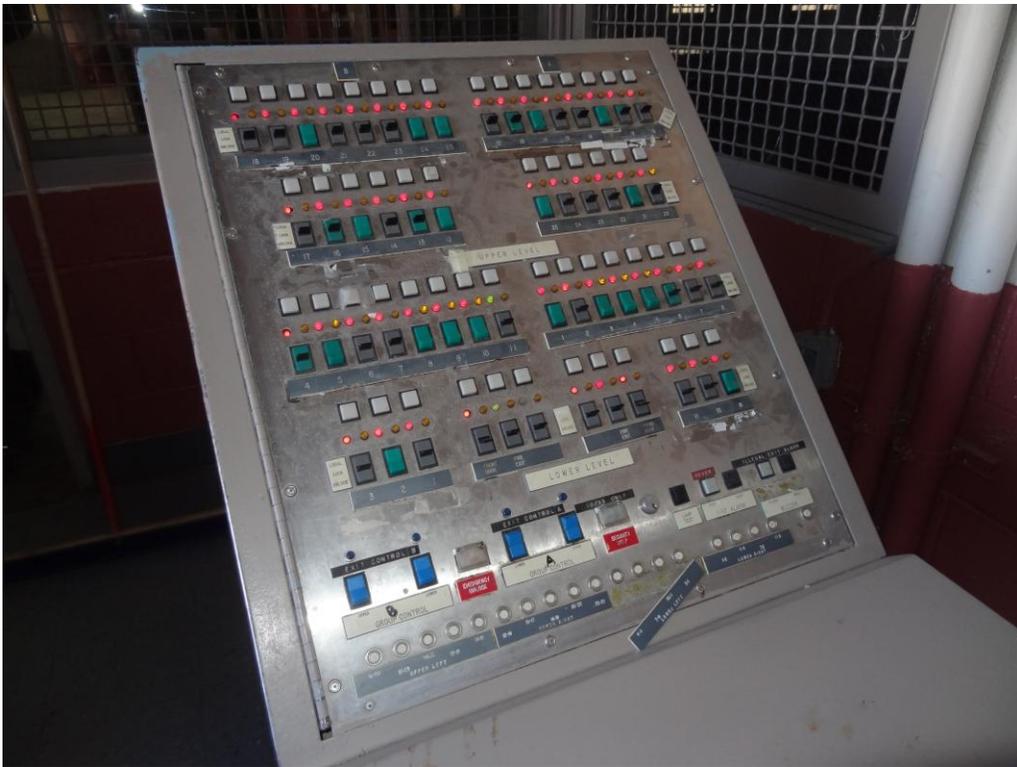
Housing Unit 1 - Building #0180  
Description: Control panel in need of replacement.

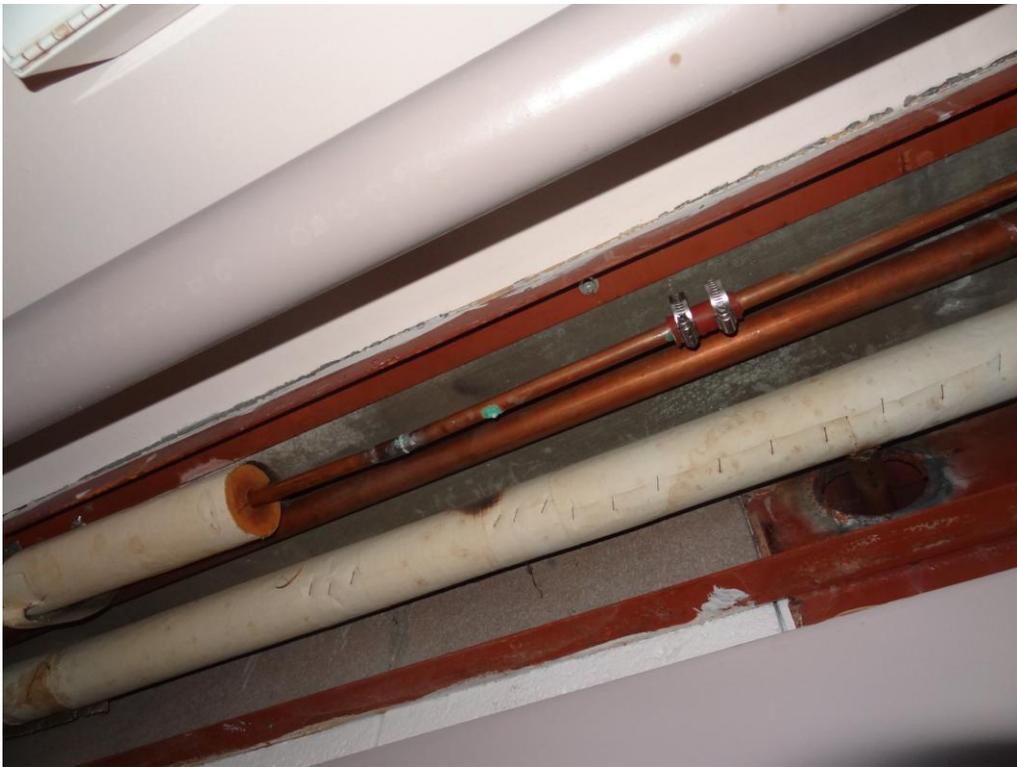
Housing Unit 3 - Building #0182  
Description: Active and repaired pinhole leaks in copper plumbing.

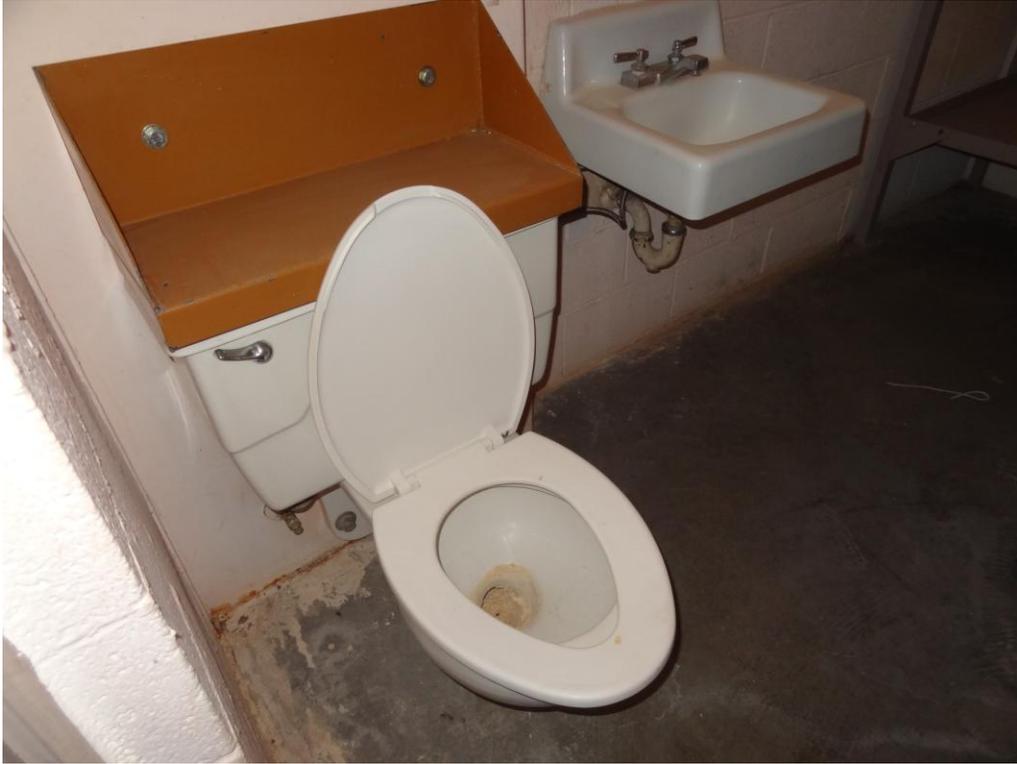
Housing Unit 3 - Building #0182  
Description: Porcelain fixture in cell with dried out water closet.

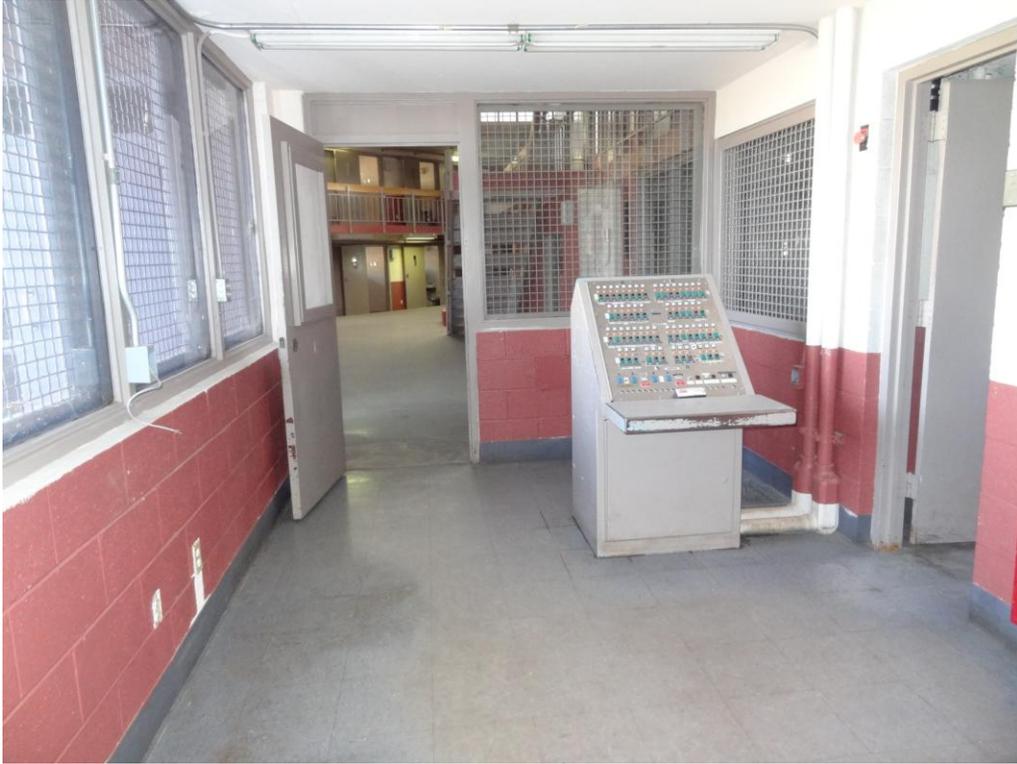
Housing Unit 4 - Building #0183  
Description: Officer station with limited line of sight to cells.

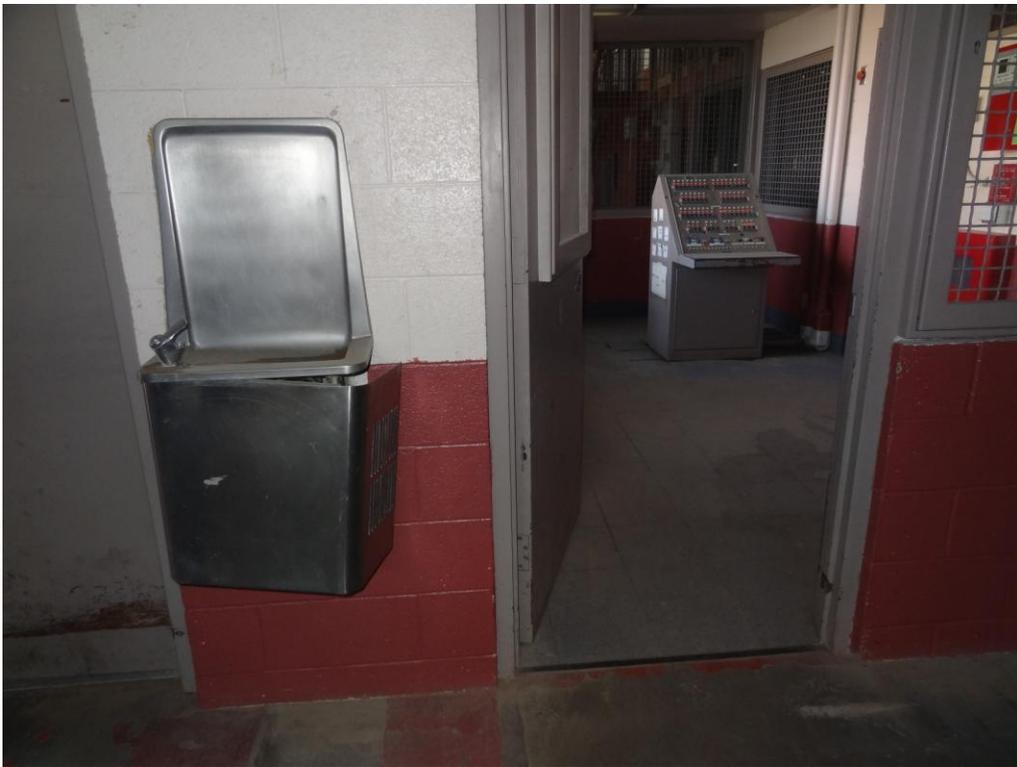
Housing Unit 5 - Building #0184  
Description: Broken drinking fountain.

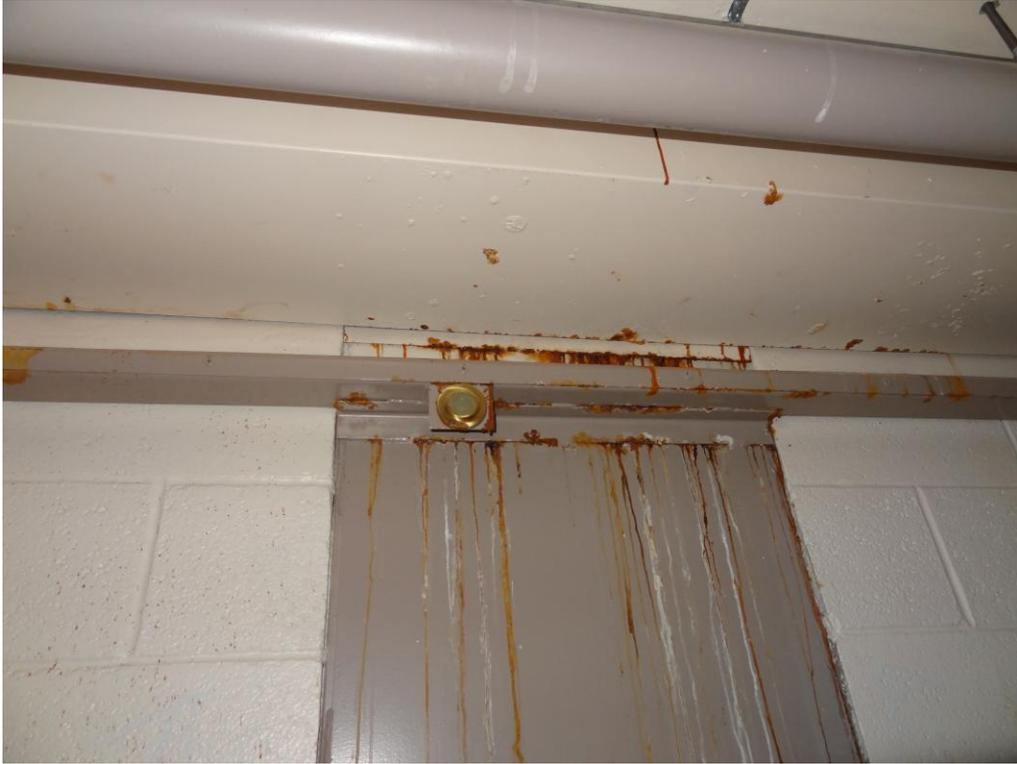
Housing Unit 5 - Building #0184  
Description: Water damage from leaking pipes.

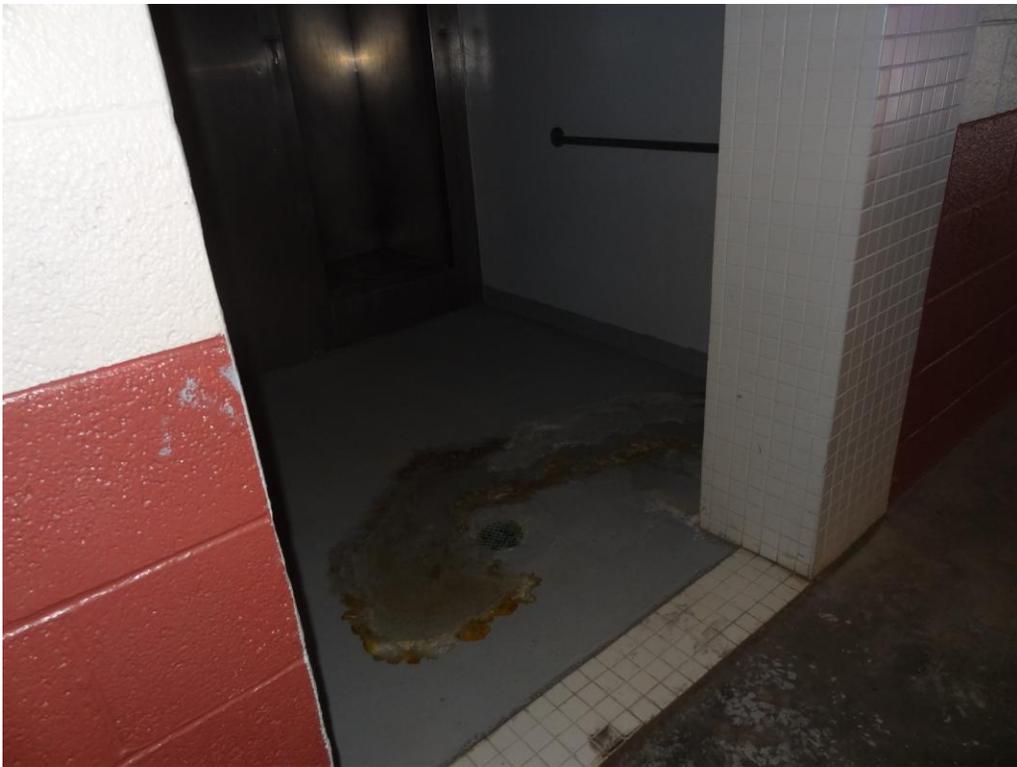
Housing Unit 6 - Building #0185  
Description: Water damage in shower area.

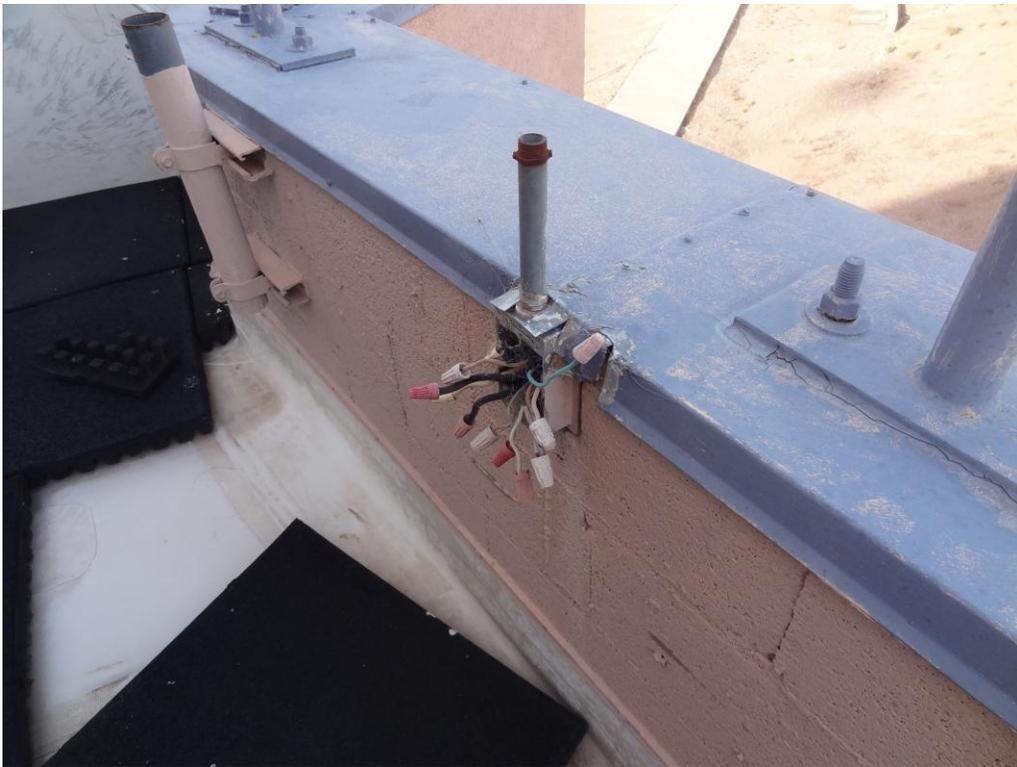
Recreation/ Gym - Building #0186  
Description: Roof mounted electrical box in need of cover plate.

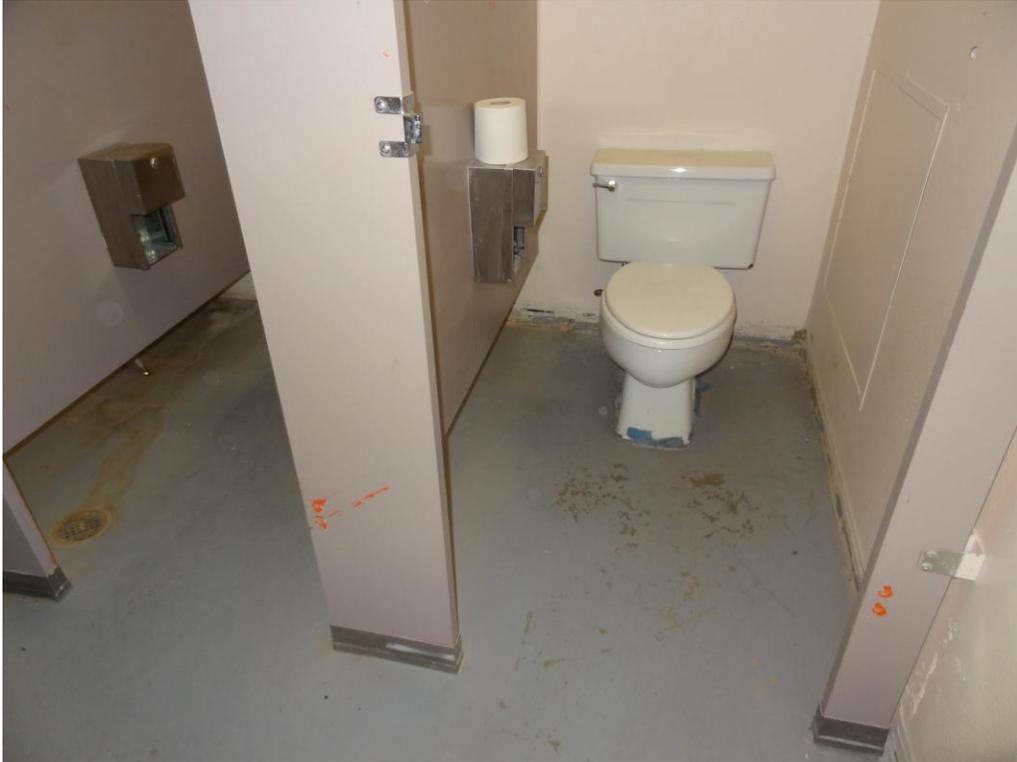
Recreation/ Gym - Building #0186  
Description: Typical non-ADA restroom stall.

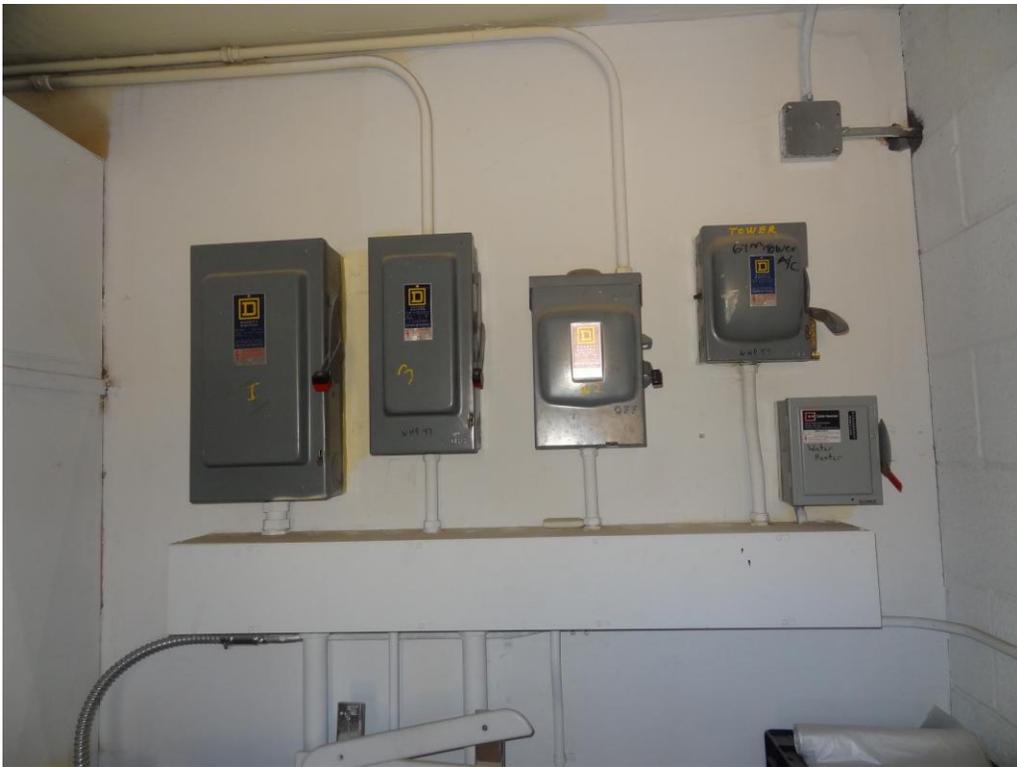
Recreation/ Gym - Building #0186  
Description: Electrical equipment in need of replacement.

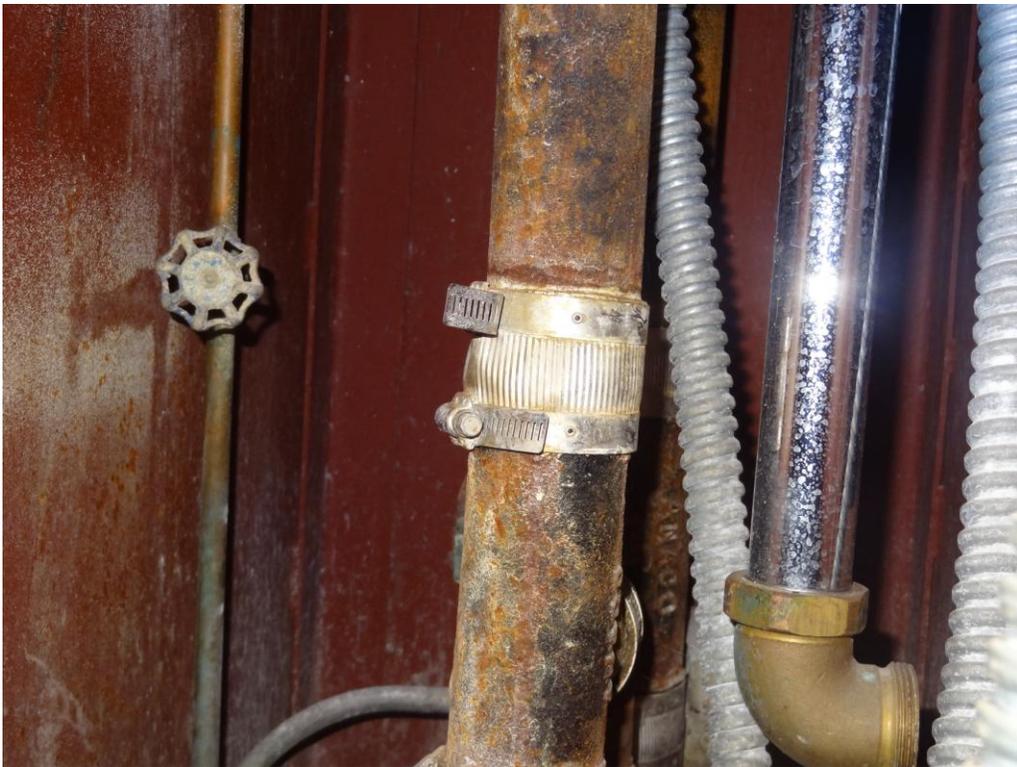
Housing Unit 7 - Building #0187  
Description: Plumbing lines in need of replacement.

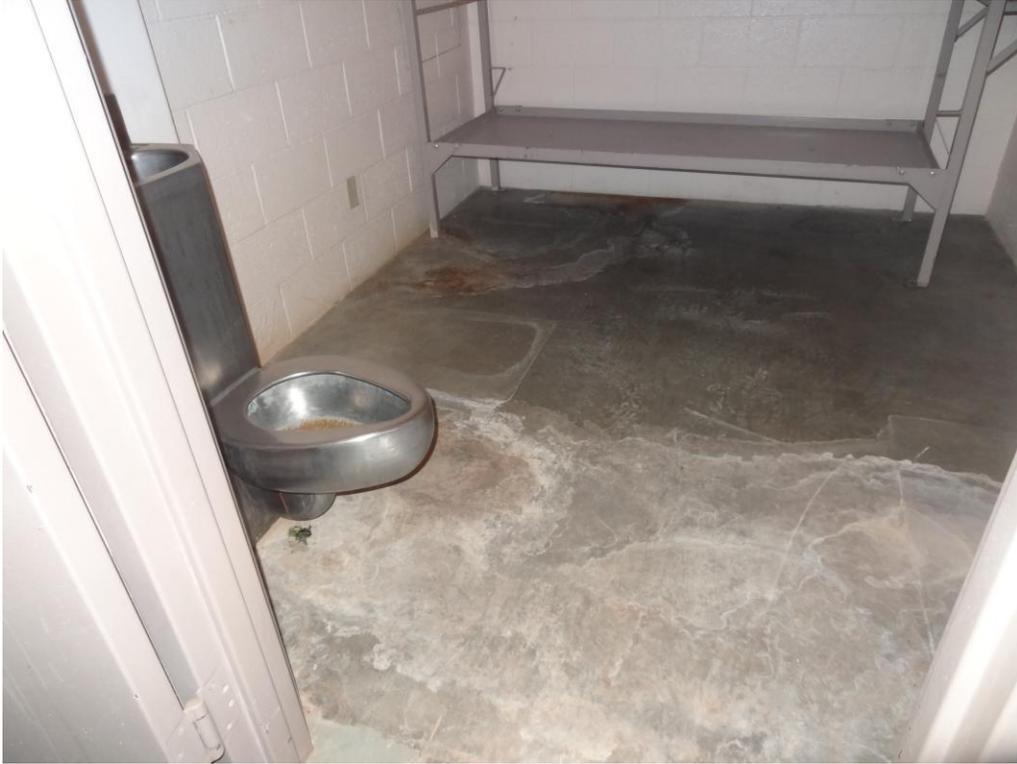
Housing Unit 7 - Building #0187  
Description: Water damage from plumbing leaks.

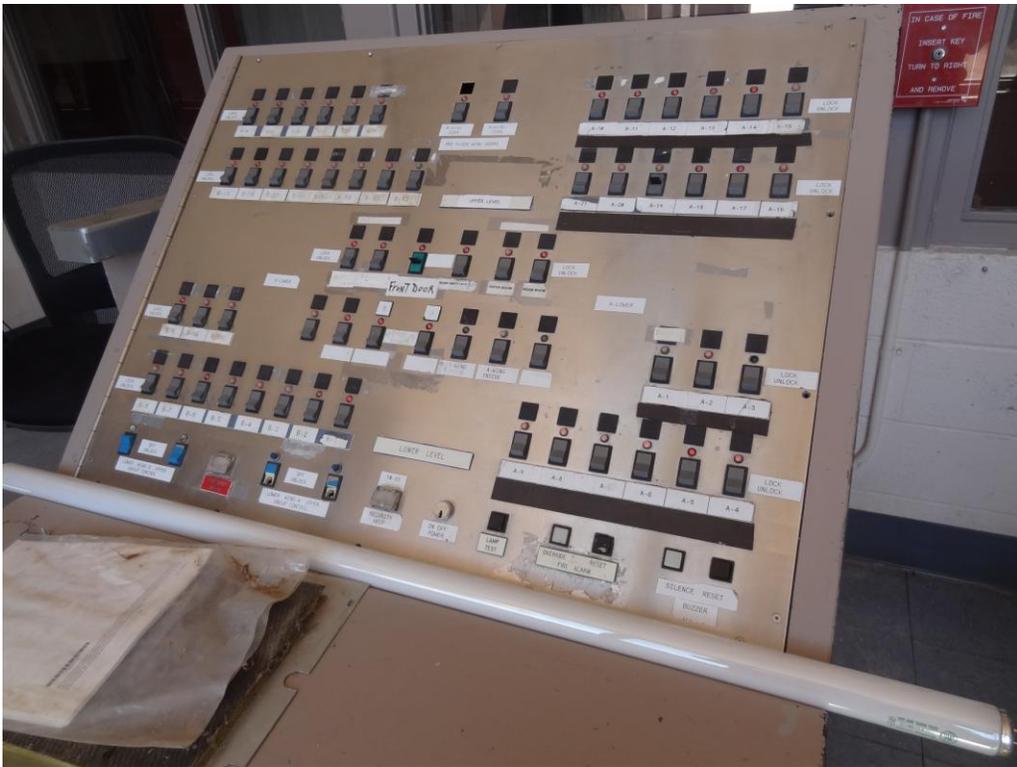
Housing Unit 7 - Building #0187  
Description: Control panel in need of upgrade.

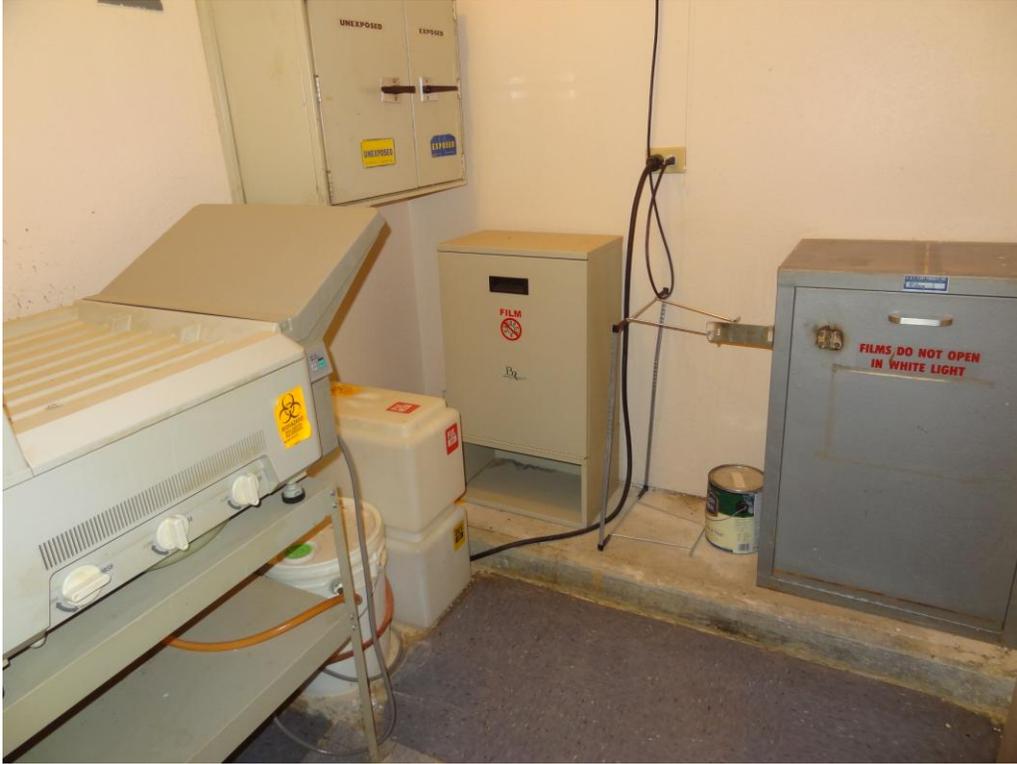
Medical Unit 8 - Building #0188  
Description: Outdated medical equipment.

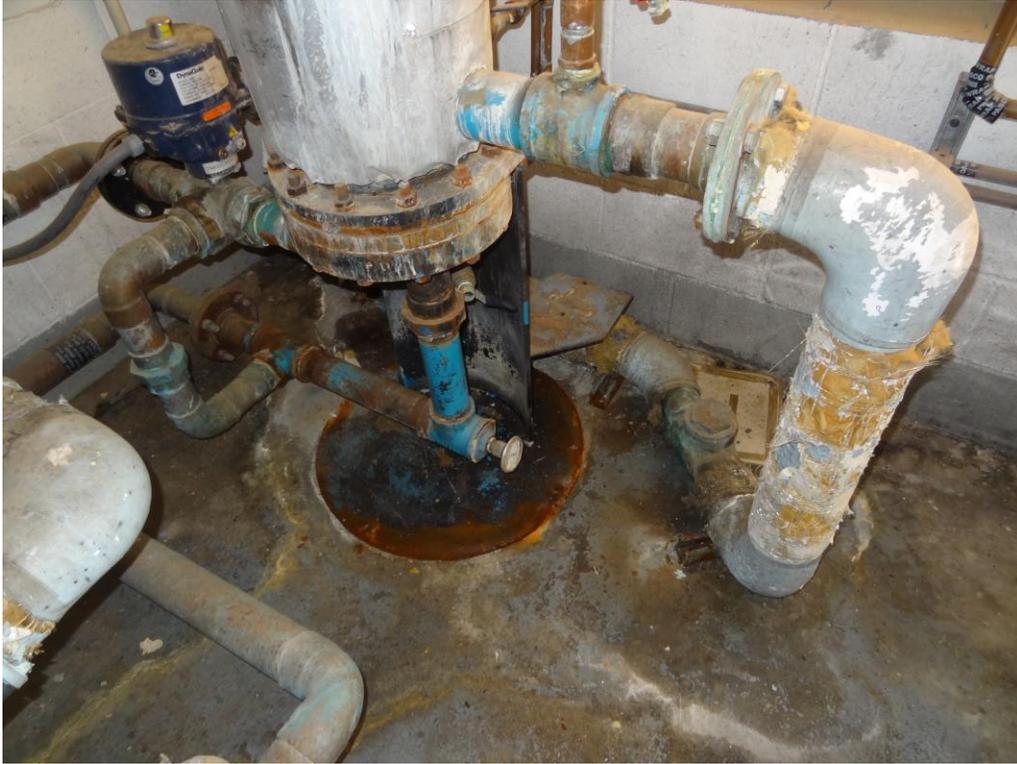
Culinary/ Dining/ Central Plant - Building #0190  
Description: Central Plant equipment in need of replacement.

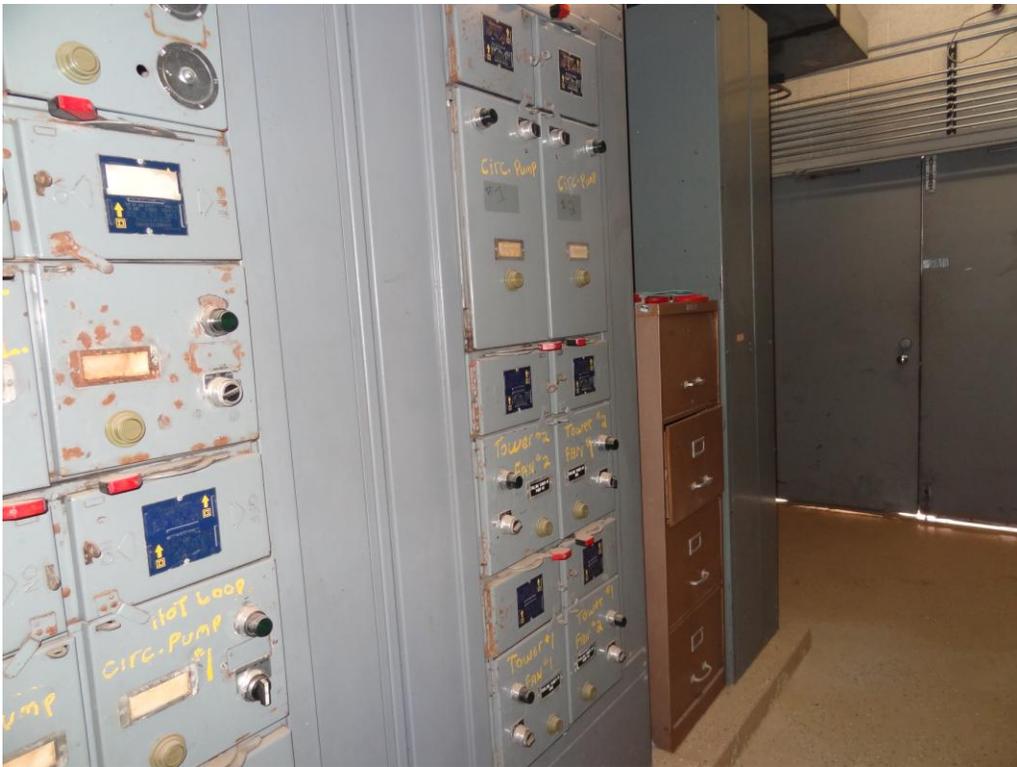
Culinary/ Dining/ Central Plant - Building #0190  
Description: Electrical equipment in need of replacement.

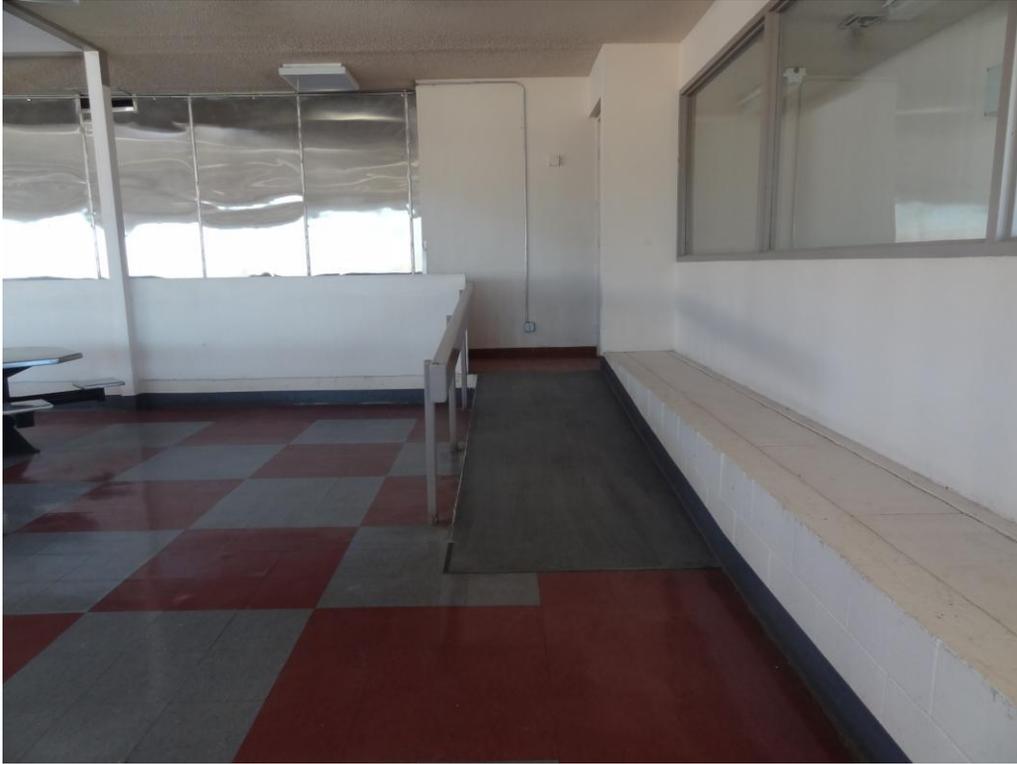
Culinary/ Dining/ Central Plant - Building #0190  
Description: Non-ADA compliant ramp in dining.

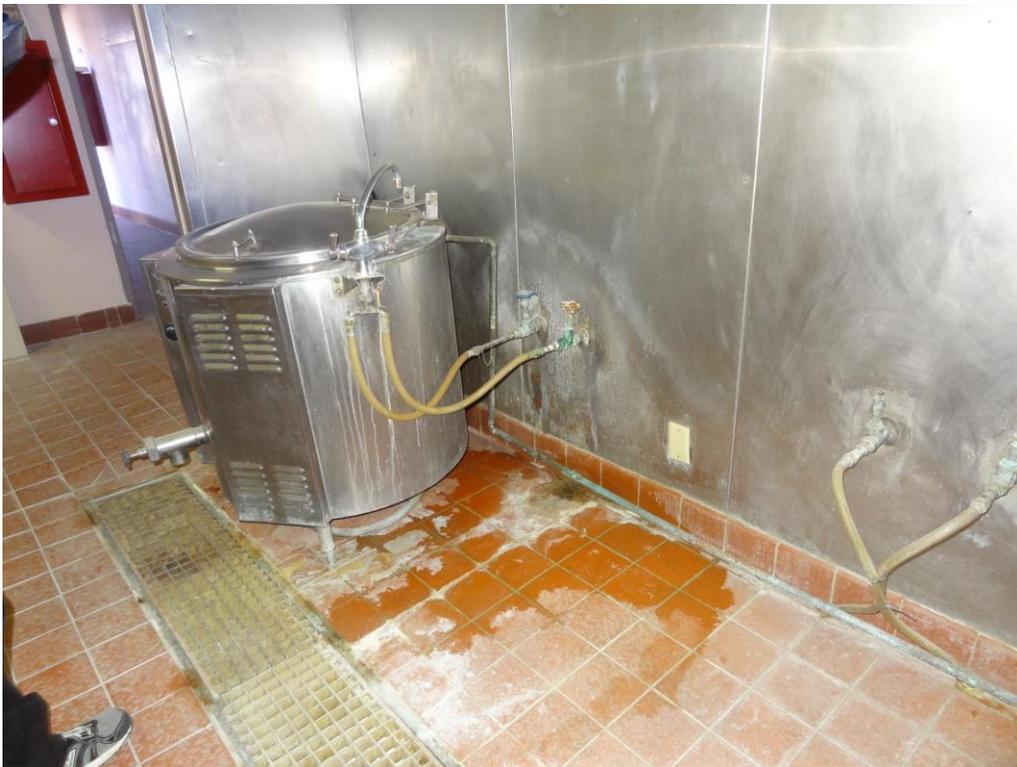
Culinary/ Dining/ Central Plant - Building #0190  
Description: Damaged and missing cooking equipment.

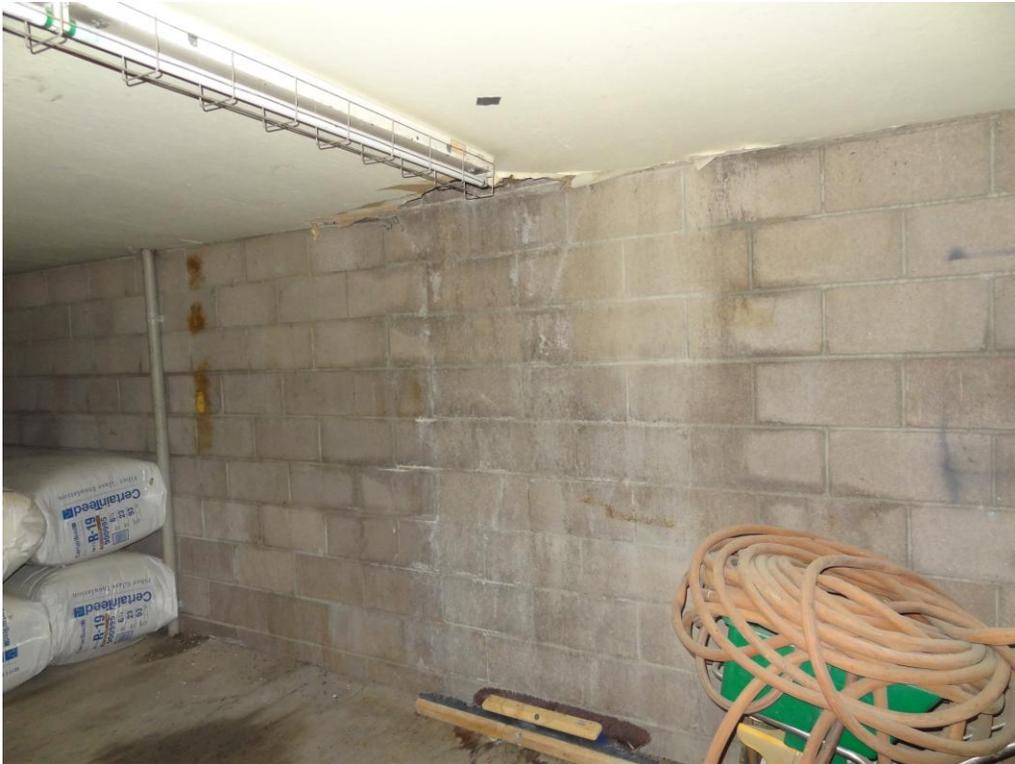
Auto Maintenance Shop/ Warehouse - Building #0192  
Description: Interior of the building with water damage.
