# **Grant Sawyer State Office Building** Programming and Feasibility Studies

Volume Two | Property Condition Assessment January 2, 2019

Prepared for the Nevada State Public Works Division January 2, 2019

# **Volume Two** Property Condition Assessment

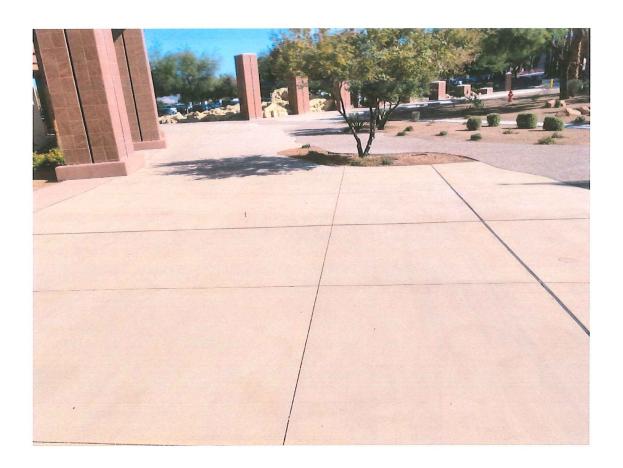
SIDEWALK CRACK NEAR THE SOUTHWEST CORNER OF THE BUILDING

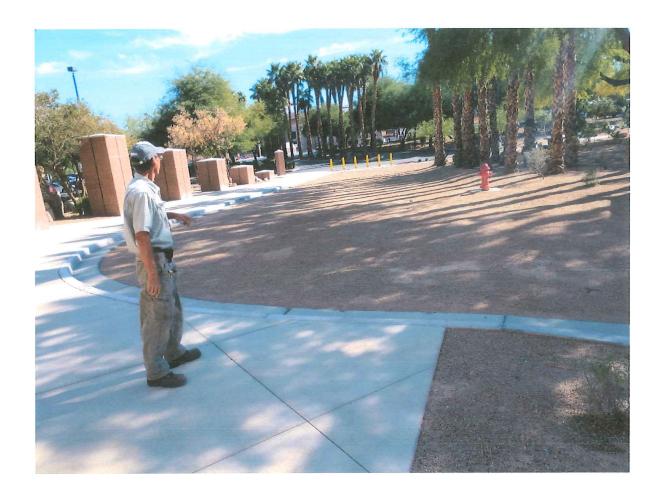
FIRE HYDRANT MAY BE INACCESSIBLE – LOCATED AT THE EAST PORTION OF THE SITE, AT THE VETERAN'S MEMORIAL AREA

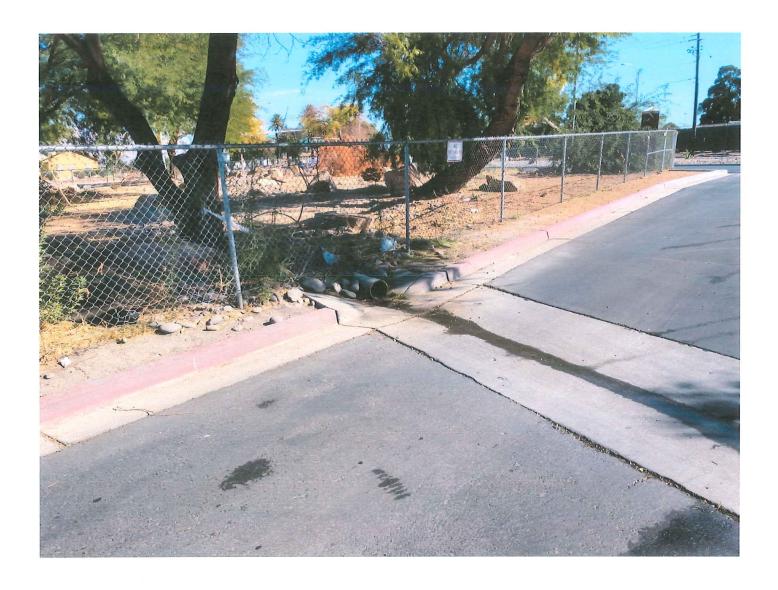
All storm facilities appear to function adequately except the valley gutter crossing the access gate controlled southeast driveway. The original design was for all site runoff to flow on the surface via a 5-foot wide valley gutter east through the Fantasy Park area then south to an existing drop inlet along the north side of Washington Avenue at the southeast corner of the site. At some point in time, it appears an 8-inch diameter steel pipe was placed on the bottom of the 5-foot valley gutter and was covered with fill material. This appears to create a ponding condition on the valley gutter crossing this driveway. While the site may generate over sixty six (66) cubic feet per second of runoff volume during a 100-year storm event, it is doubtful the 8-inch pipe can convey any more than one (1) cubic foot per second of flow. This creates a ponding situation that slowly drains and appears to create the need for excess maintenance. It is our recommendation to remove the pipe and to clean the valley gutter of all fill and debris along the length of the parking lot to the back of the Washington Avenue drop inlet.

PONDING ON THE VALLEY GUTTER AT THE SOUTHEAST. NOTE THE FILL OVER PIPE VALLEY GUTTER AT THE SOUTHEAST, EXITING THE PARKING LOT

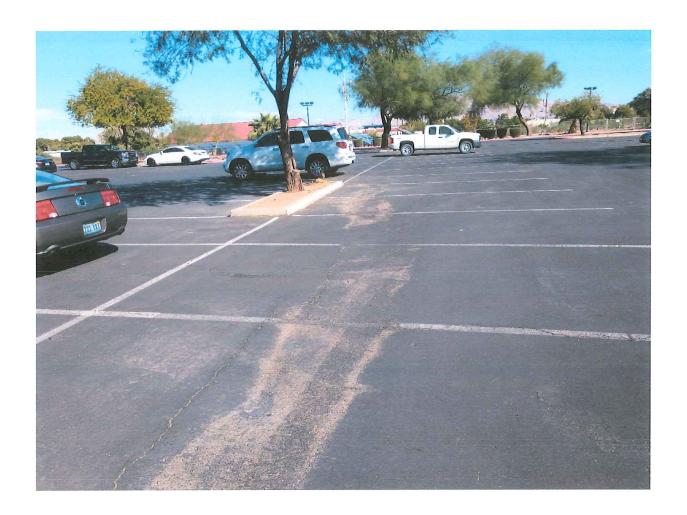
The site asphalt appears to be in fair condition for its age. Some cracking and slow draining areas were observed but failure was not. Regular asphalt maintenance should occur every five  $\pm$  years for a maximum life extension. This maintenance should include heavy crack sealing with a thick asphalt material and slurry seal with a thinner emulsion. Restriping will also be required during this maintenance and as warranted.

EAST PARKING LOT. SOME CRACKING BUT NOT APPARENT FAILURE

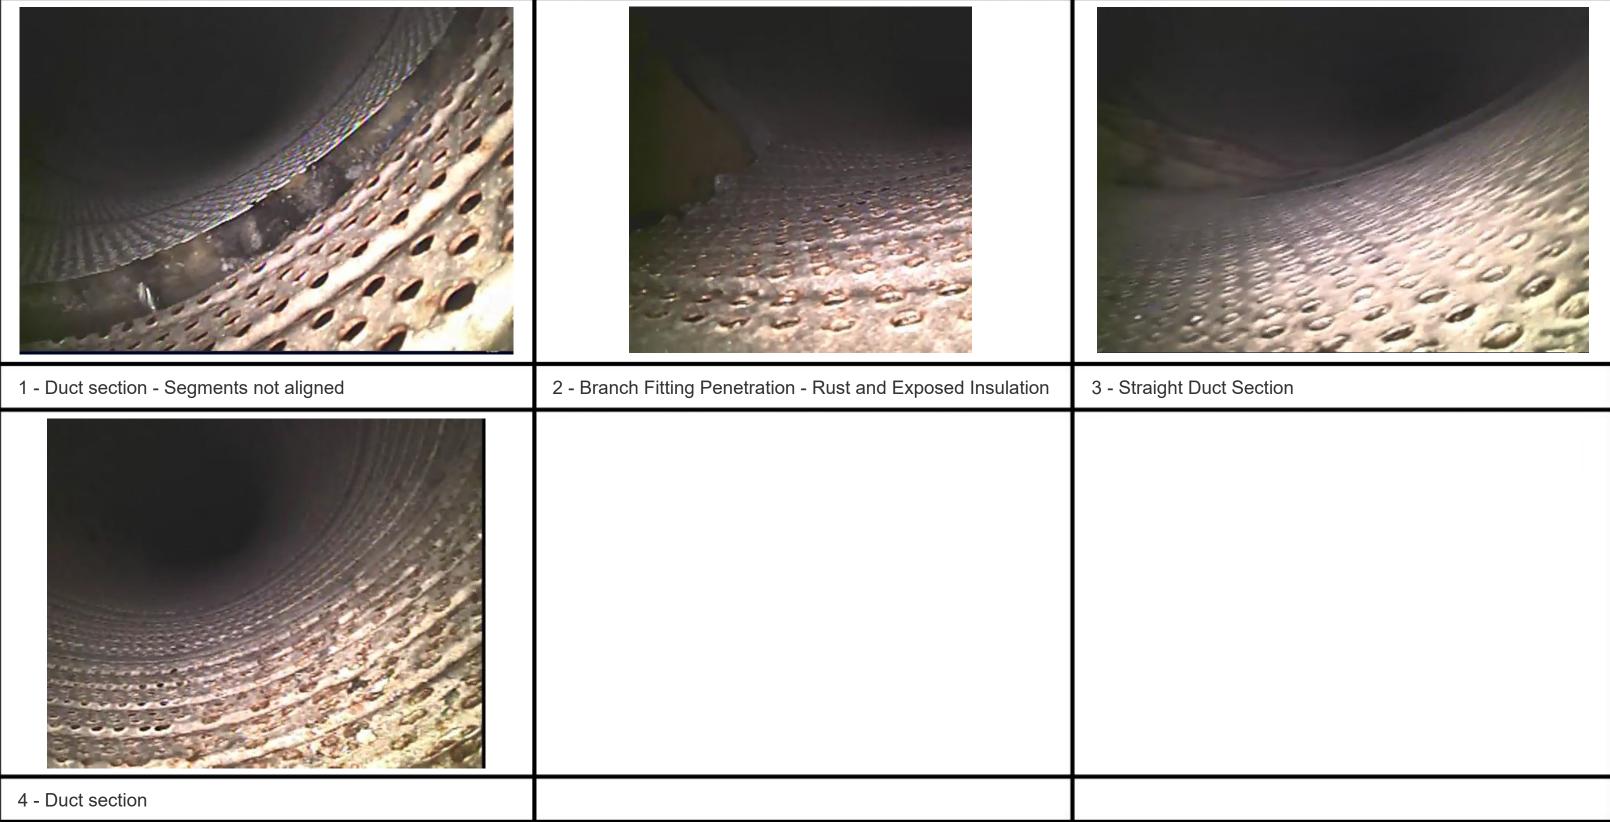
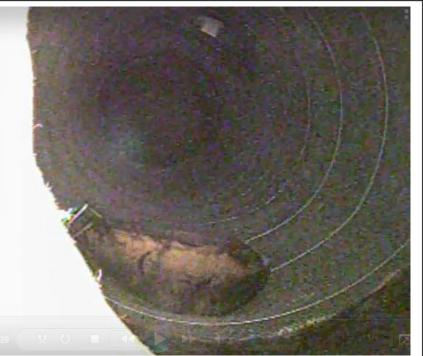
## **LEVEL 5 - HVAC DUCTWORK**

Conclusion: All exposed and lined medium pressure ductwork to be replaced. Exterior ductwork on roof shows the signs of corrosion and may have been compromised during the initial operation with evaporative cooling sections. Per field investigation on Level 5, multiple segments of ductwork have friable fiberglass material in the airstream as part of the original acoustical treatment of ductwork. Level 5 ductwork shall be completely removed and replaced with new ductwork.

2018-12-06-16-20-02
1 - Exposed Fiberglass - Missing Inner core	2 - Duct Sections - Branch Penetration - Exposed Insulation	3 - Duct Sect

ection - Fitting Penetration - Exposed Fiberglass

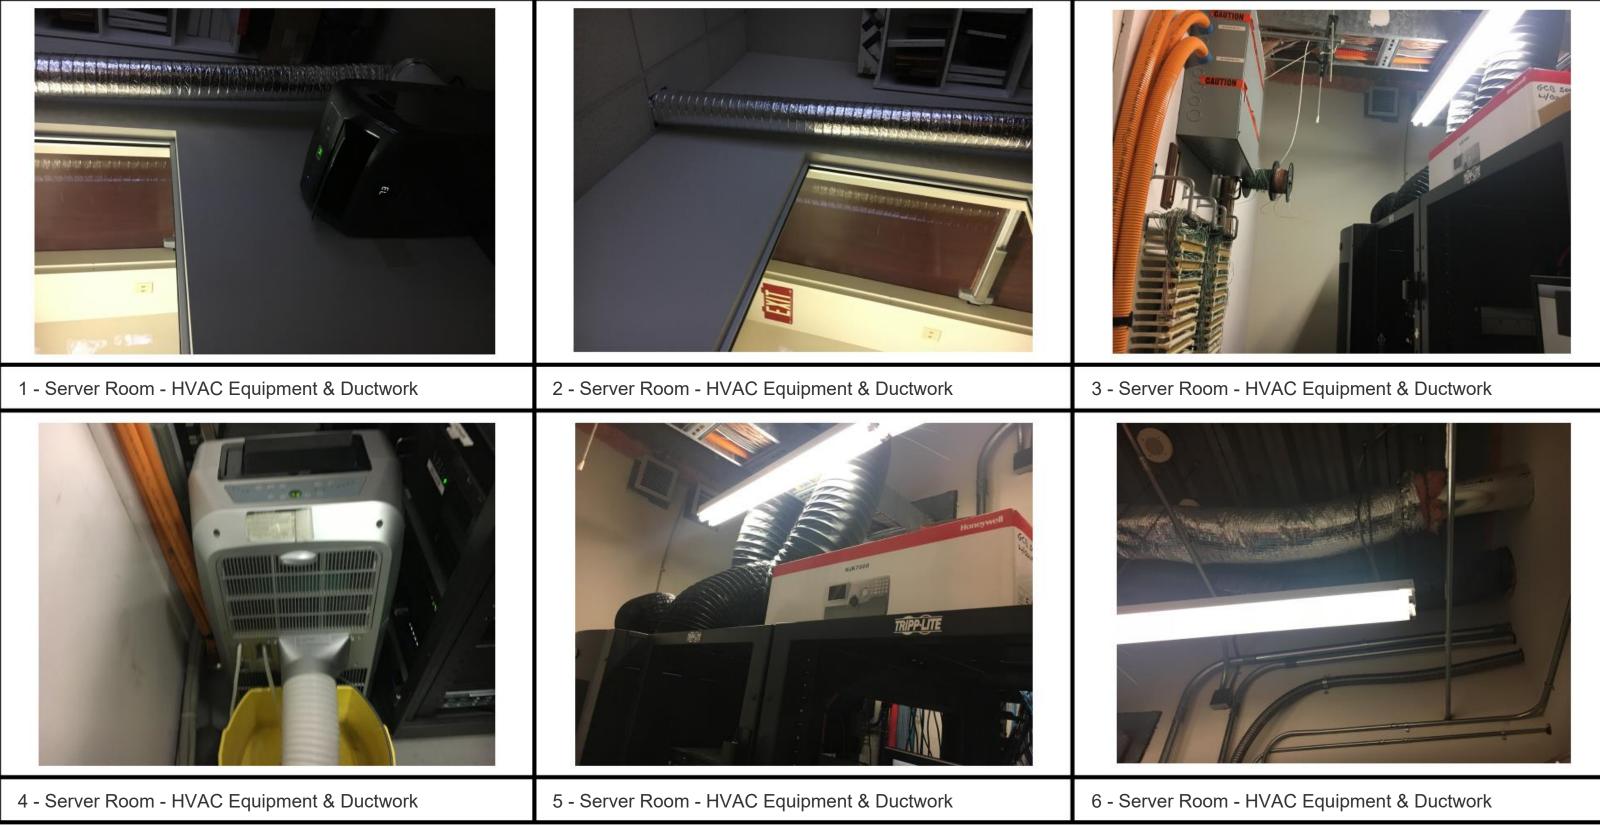
## **B. Servers/Data Rooms Cooling**

Interior medium pressure ductwork compromised with openings & flex duct connections for additional cooling of server rooms shall be repaired by disconnecting of flex ductwork and properly sealing the system.

1 - Server Room Equipment	2 - Server Room - HVAC Equipment & Ductwork

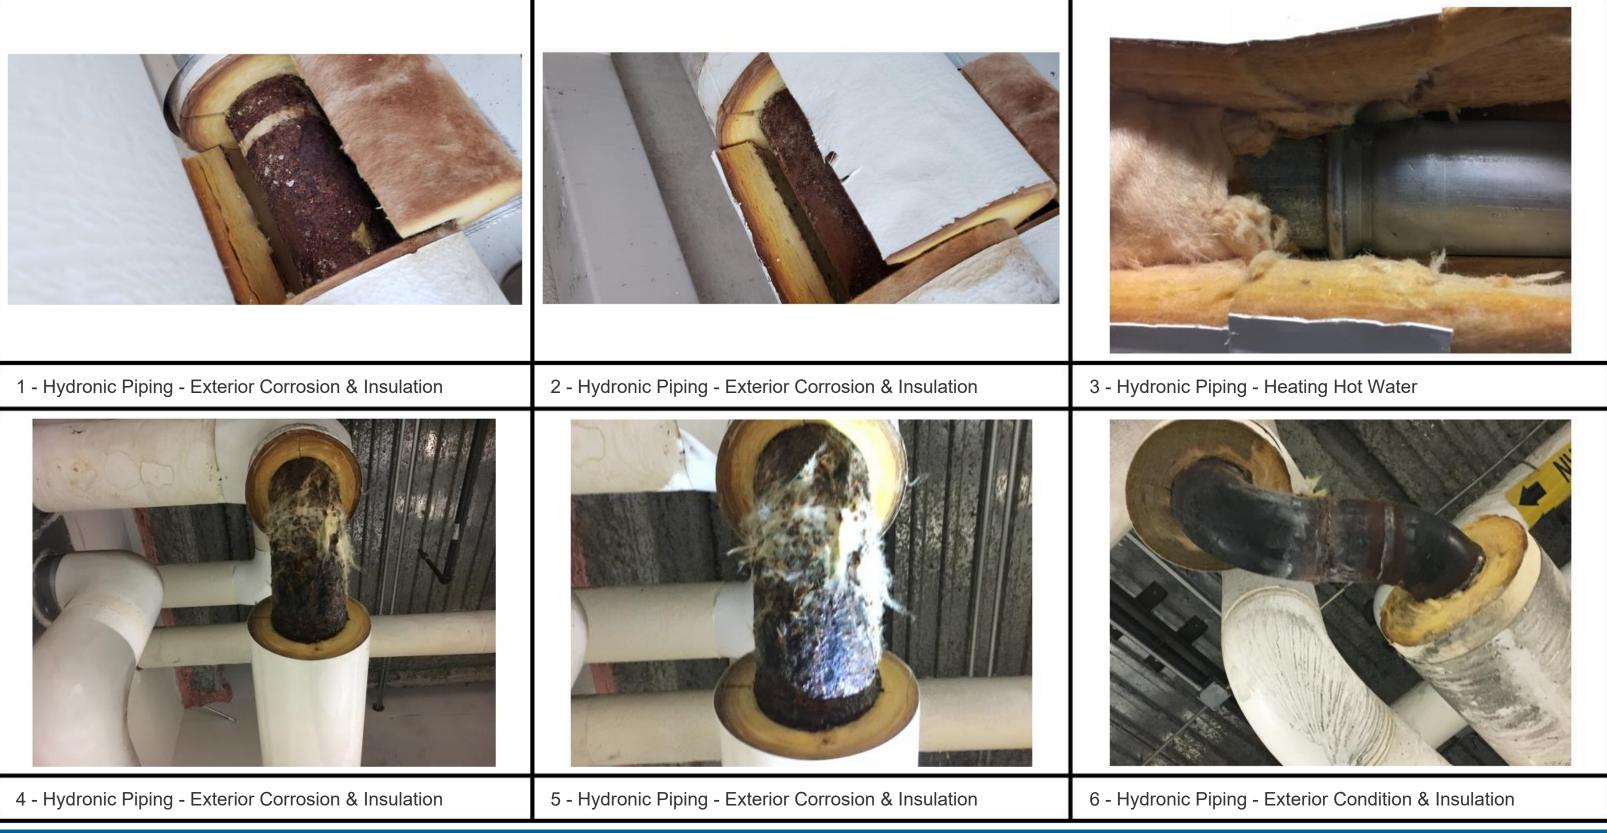
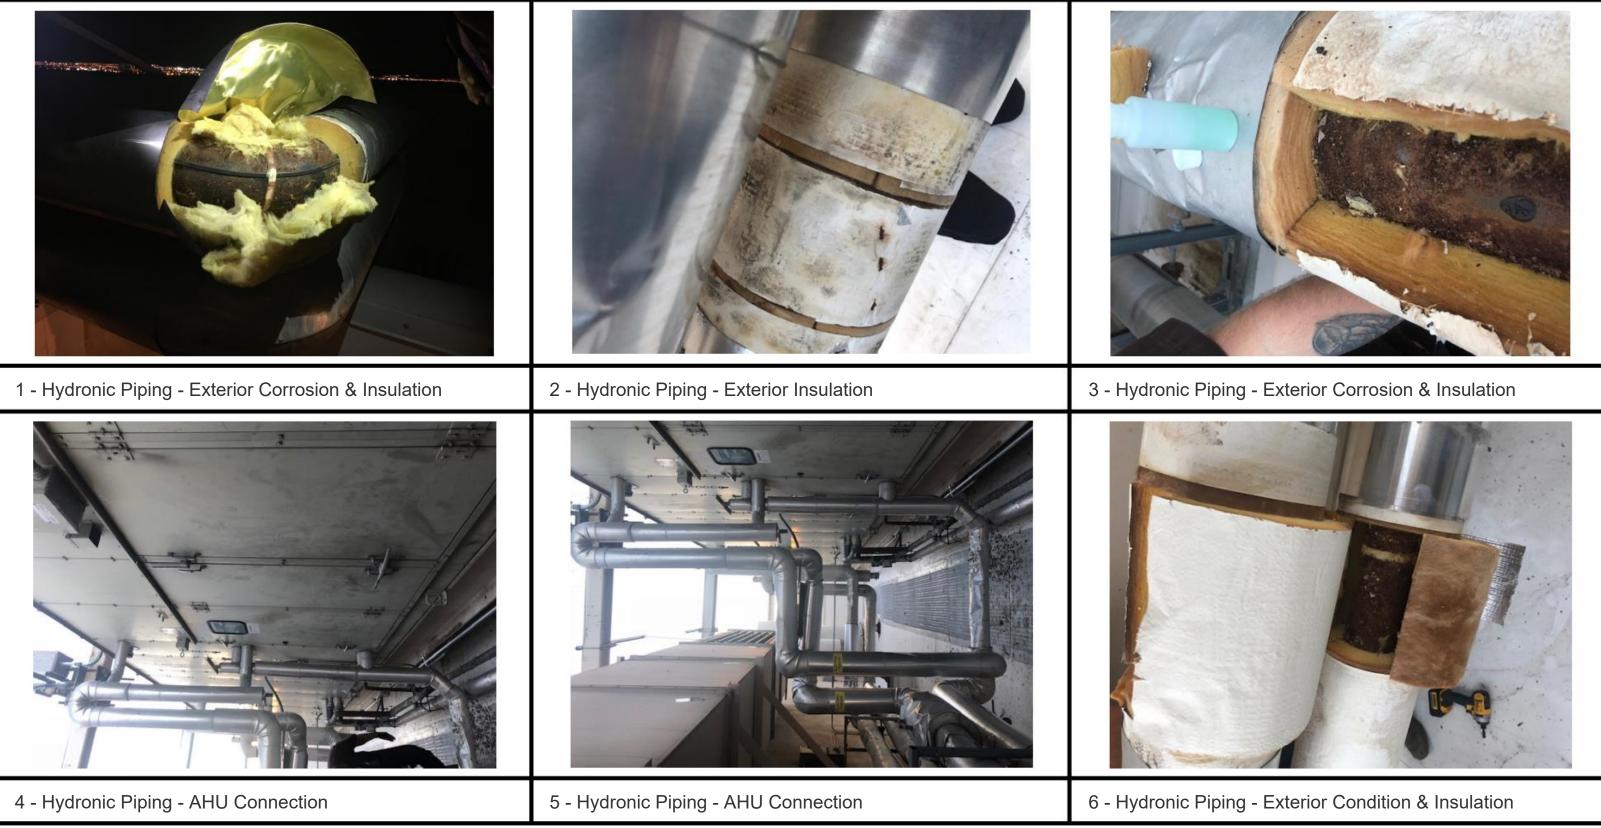
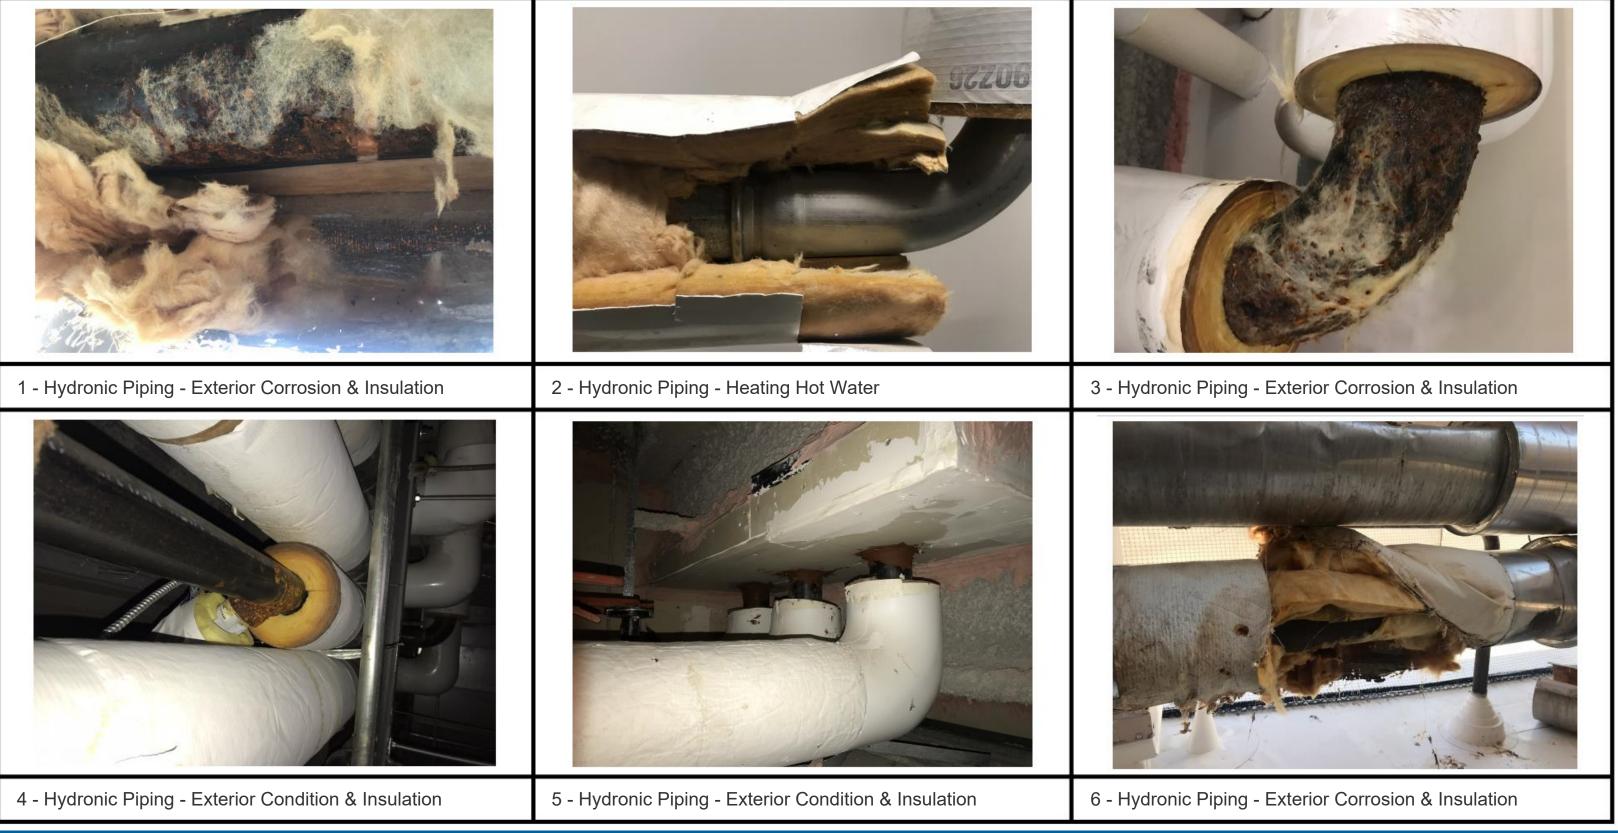
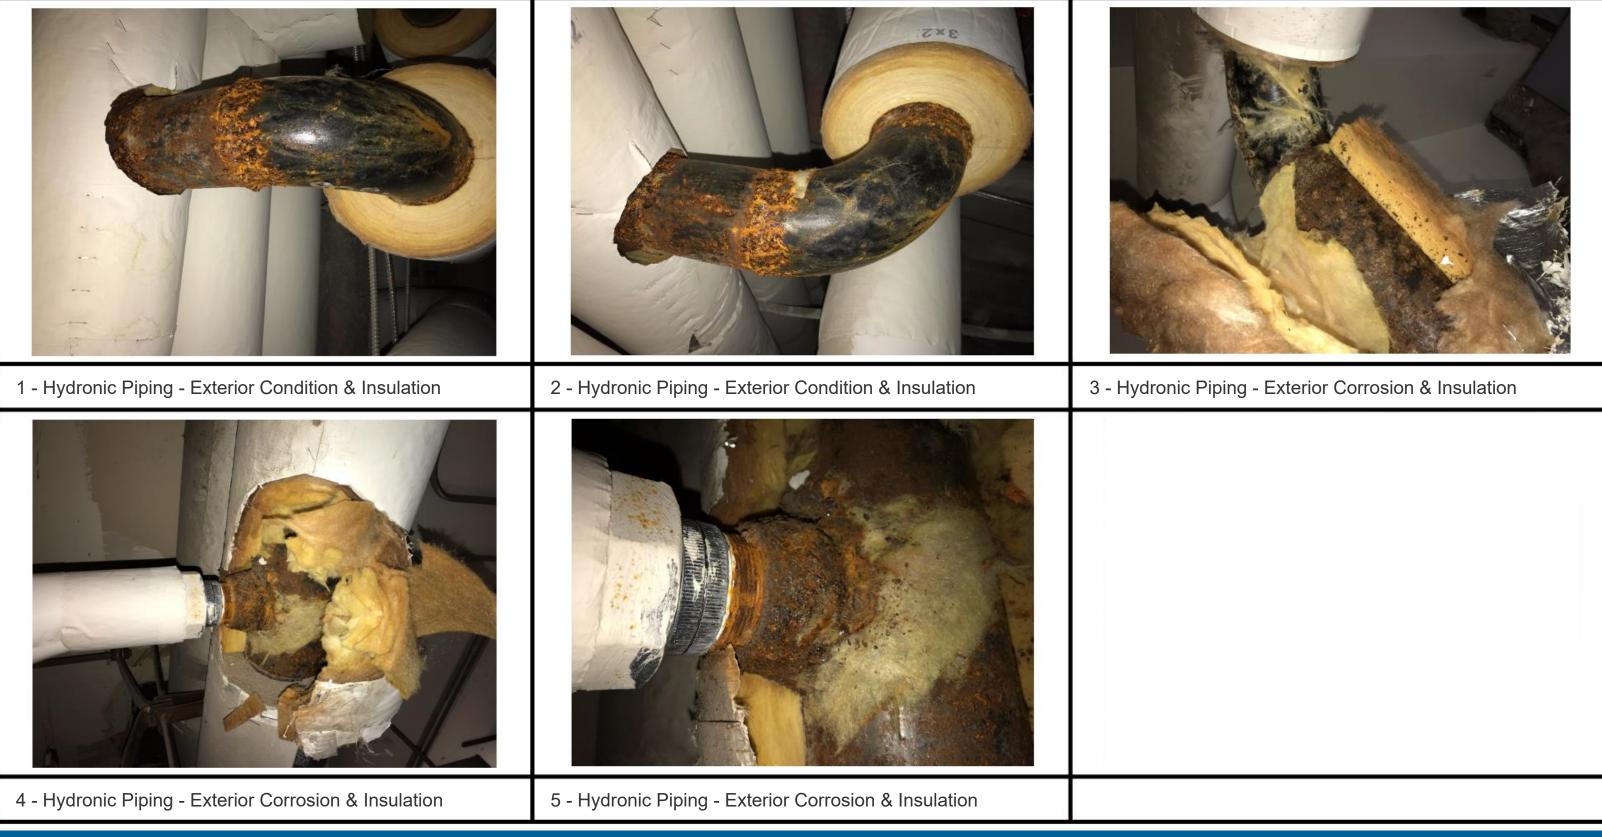
### **D. Hydronic Piping - Exteriors**

- Chilled Water piping external corrosion due to gap w/insulation. Verify all mains on all floors and identify the sections of corroded piping.
- Verify the status of insulation throughout
- Heating hot water piping failing gasketed joints. Identify the issues and original piping material and joints • used.
- It was discovered that all 2" and smaller hot water piping was installed utilizing the galvanized piping. This • has to be corrected throughout.

Conclusions: Chilled water hydronic piping shows considerable exterior corrosion at the multiple fittings, takeoffs and elbows, due to incorrect insulation type and compromised vapor barrier or damaged service jacket. To mitigate this issue, complete chilled water piping system shall be replaced and 100% of the insulation shall be replaced with rigid polyisocyanurate insulation with correct vapor barrier and provision of dams at each pipe fitting to prevent any condensation.

The heating hot water hydronic piping shall be completely removed and replaced with new piping per current standards.

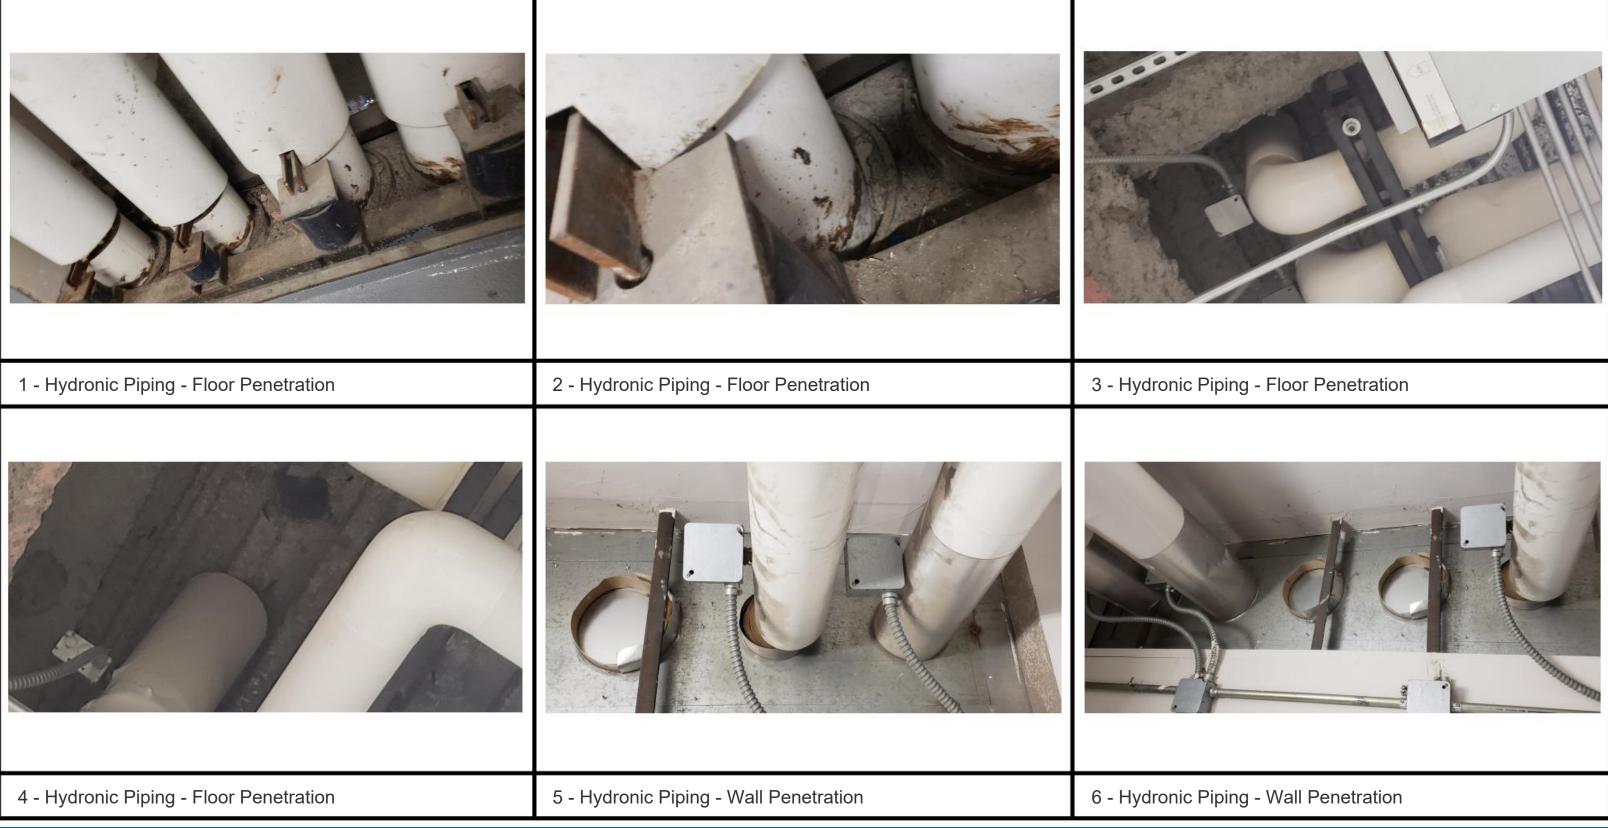
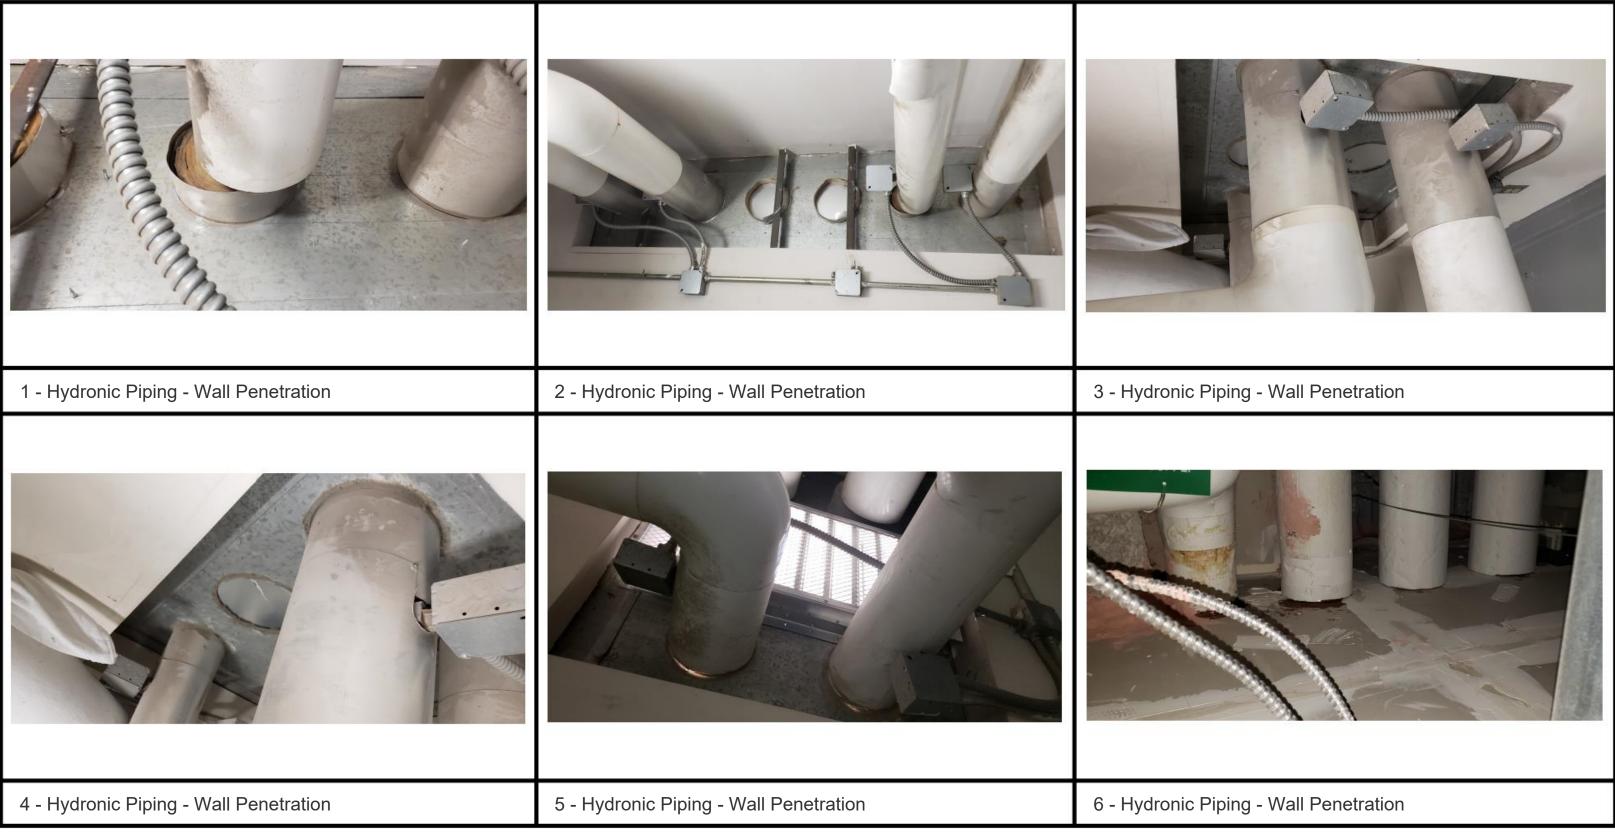
### **E. Hydronic Piping - Wall Penetrations**

Conclusions: Based on our initial findings through-the-wall penetrations are compromised, indicating the missing insulation and presence of exterior corrosion.

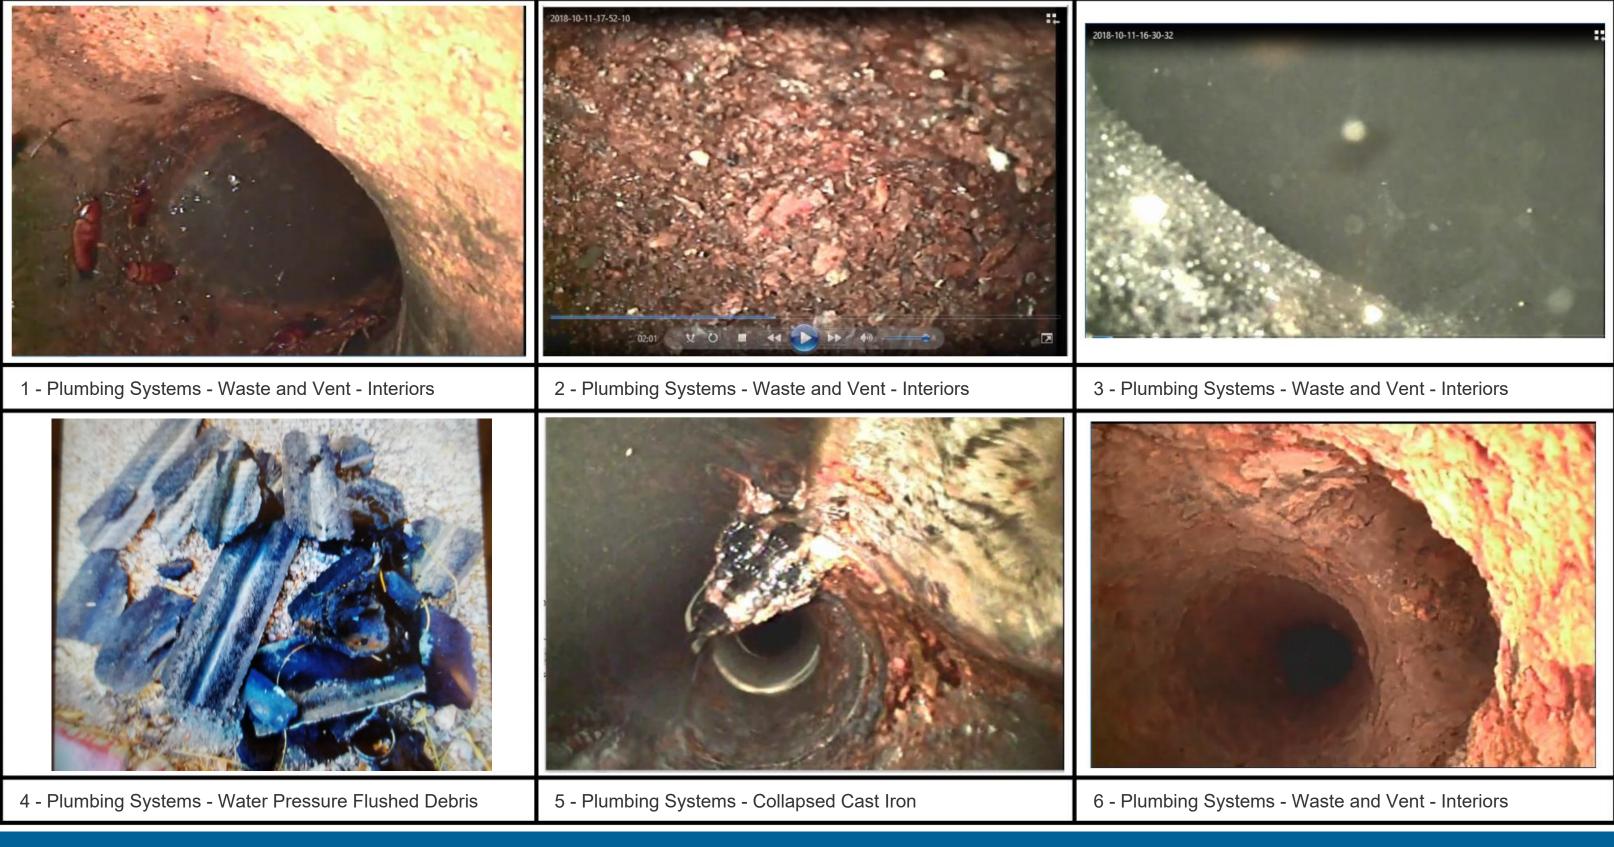
### G. Plumbing Systems - Waste and Vent - Interiors

Conclusions: Complete underground cast iron piping to be removed and replaced with PVC properly sloped system with 2% slope.

2018-10-11-16-42-54
1 - Plumbing Systems - Underground - Collapsed Cast Iron	2 - Plumbing Systems - Underground - Collapsed Cast Iron	3 - Plumbing

ng Systems - Underground - Collapsed Cast Iron
