HISTORICAL OVERVIEW OF THE NEVADA STATE CAPITOL AND CAPITOL ANNEX

EXISTING CONDITIONS AND OBSERVATIONS

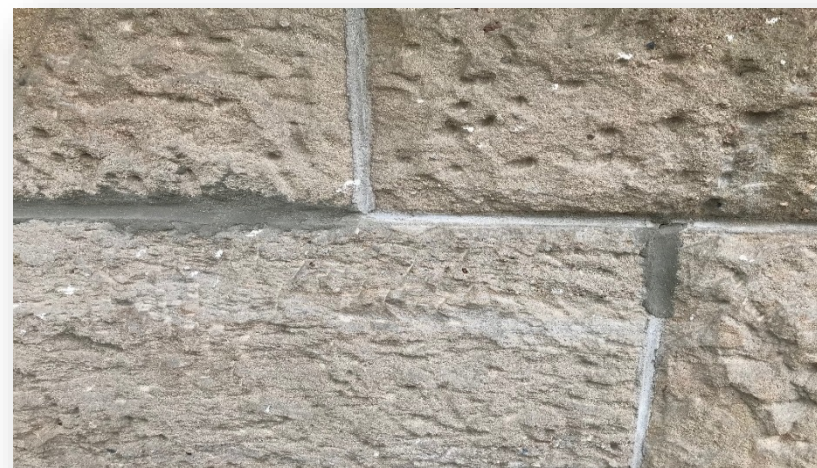
The dark gray mortar (vertical joint) is a repair while the light, thin line of mortar is the oxidation from the original white lead tuck-pointing. This particular grout joint on the Capitol Building tested positive for lead, thus confirming the use of white lead oxide.

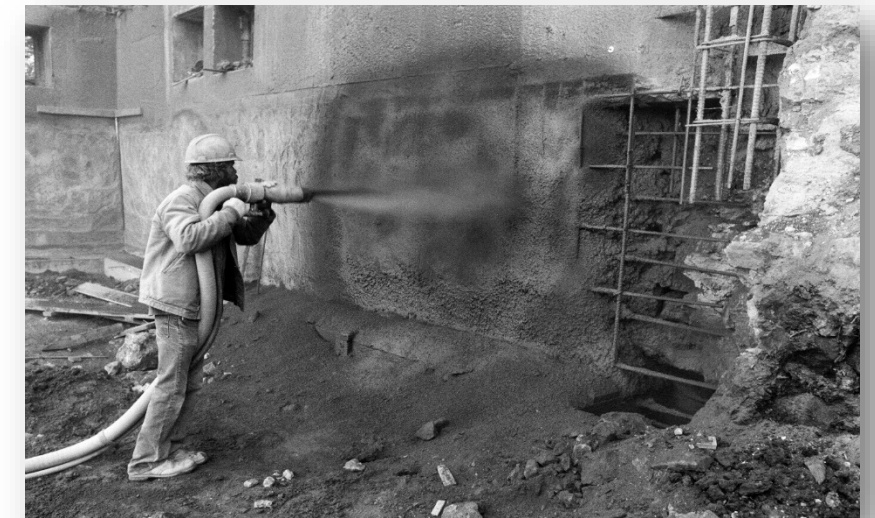
Shotcrete and rebar applied to the backside of the sandstone masonry veneer, 1978-1979 rehabilitation project.

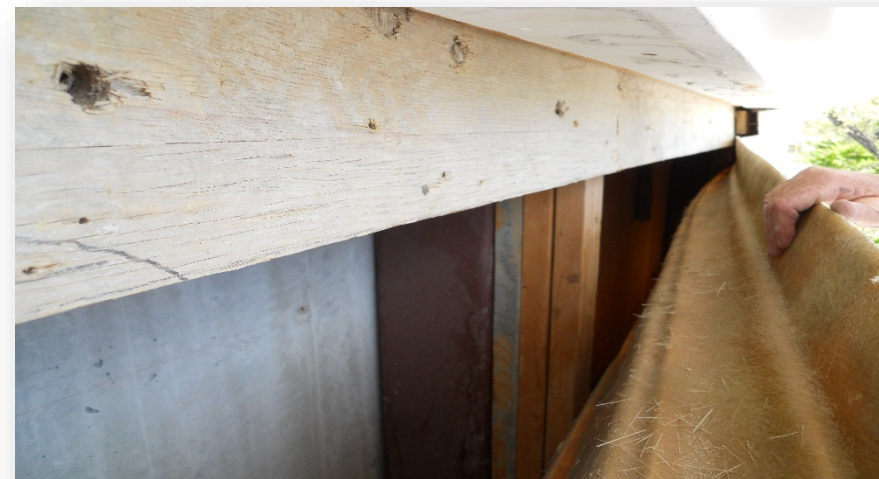
Fiberglass sub-structure at entablature: plywood attached to built-up 2x4s attached to a metal structure. Notice the concrete staining on the 2x4 and the plywood is also concrete stained as if it were a form board.

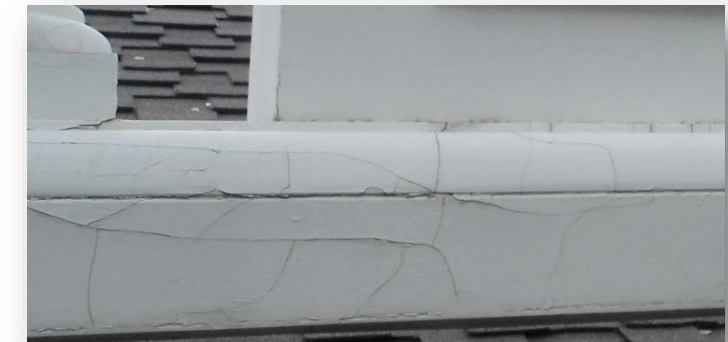
Cracking paint on the fiberglass substrate.

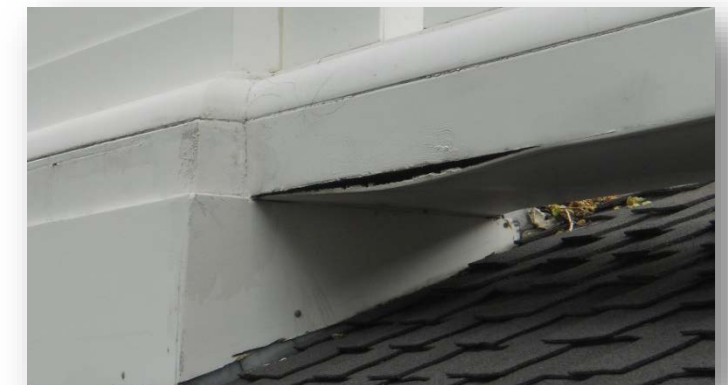
It was also observed that there were some areas on the Capitol Building where the fiberglass has cracked or has torn, mainly at the balustrade. It was also observed that the paint on the fiberglass has severely cracked and worn away in some places. In fact, the majority of the paint on the fiberglass was cracked and failing. It was also observed that the fiberglass balustrade and fiberglass windows had numerous fasteners and fastener holes for attaching rope lighting, Christmas lights, and other items (possibly banners). Some of the balustrades also had missing pieces at the junction of the roof and base of the balustrade. It was also observed that many of the fasteners holding the fiberglass to the building have backed out of the fiberglass and in some places the fasteners were missing all together. Furthermore, the majority of sealant at each joint in the fiberglass construction has failed to some degree. Some sealant is completely missing while other sealant is still and tact, but cracking and pulling apart. Another notable observation was the amount of staining on the fiberglass. It appears that water has entered the fiberglass system from above and exited on the face of the fiberglass causing very visible surface staining of a brown color.

Large tear in fiberglass balustrade at horizontal and vertical edge.

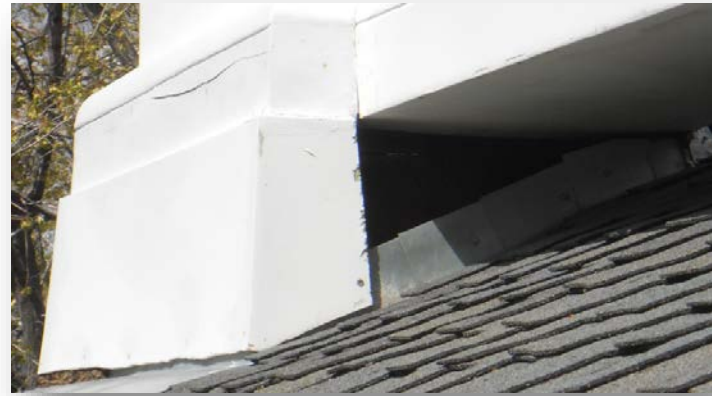
Missing base piece of balustrade. Potential nesting place for birds and vermin.

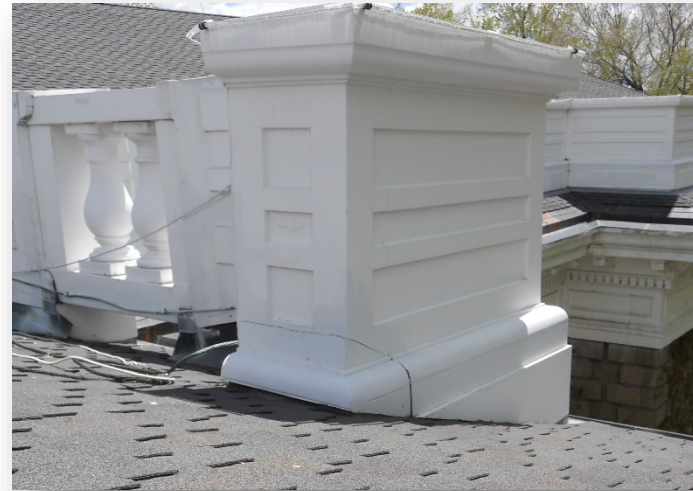
Rope lighting fastened to the top of the balustrade.

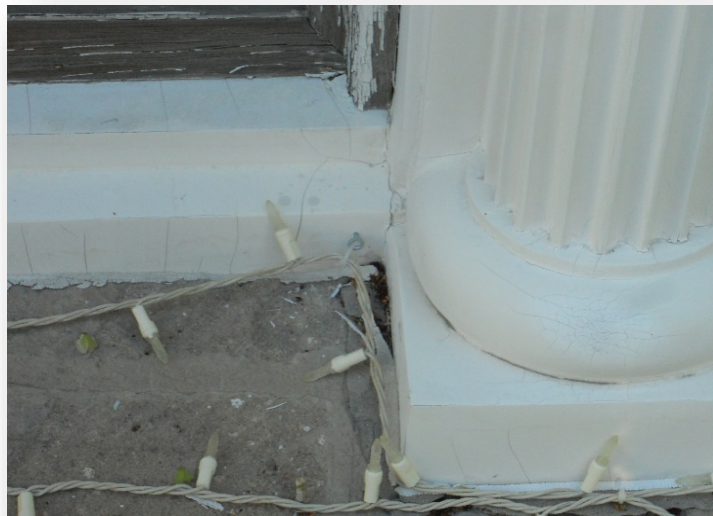
Eye hook inserted into fiberglass frame for hanging of Christmas lights. Also notice the deteriorated wood frame of the window versus the fiberglass frame of the window.

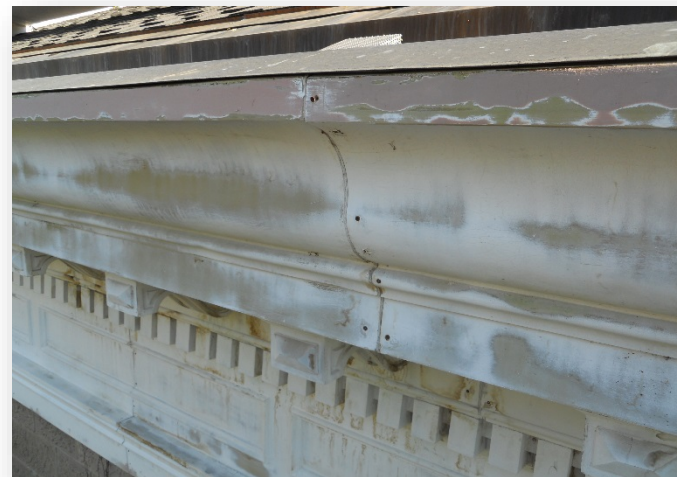
Worn away paint on the fiberglass panels.

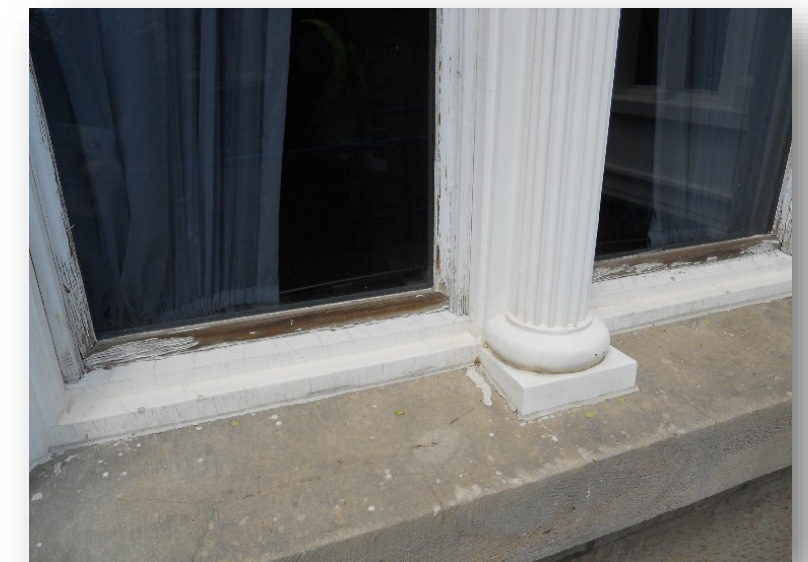
Typical condition at wood and fiberglass windows. Paint has worn away at wood window sills, note the fiberglass is in good condition with only cracking and peeling of paint.

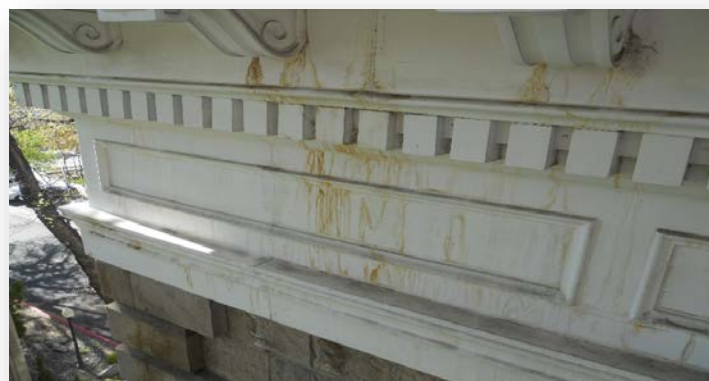
Staining on the fiberglass entablature, a sign of water intrusion from above.

With the gutters coming apart at the seams and allowing water to enter the cornice, it can be concluded that this could be the source for the brown staining of the fiberglass entablature. This could also be the source for other water staining and water intrusion noted by Buildings and Grounds on the interior of the building.

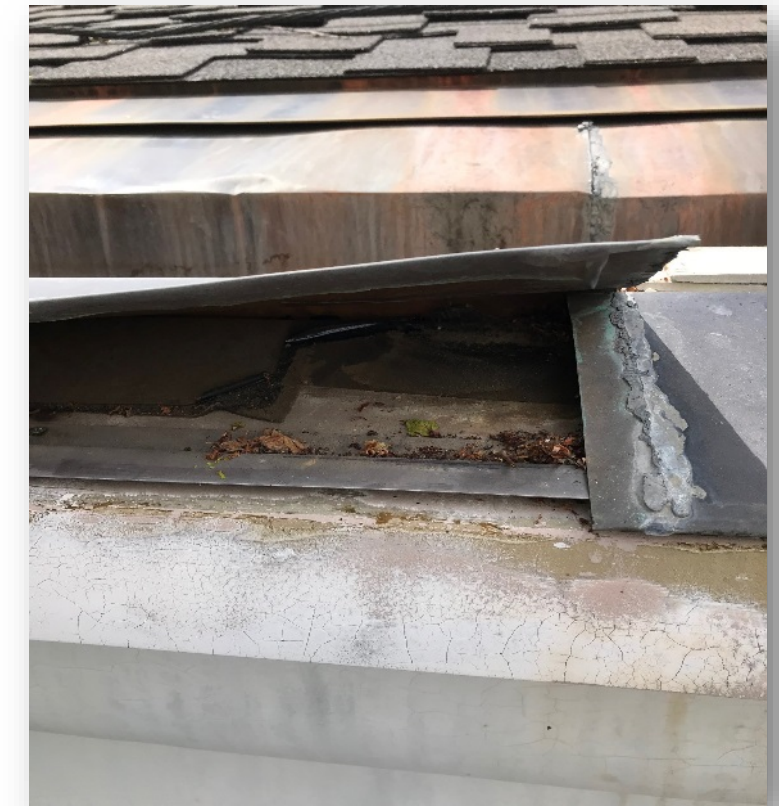
Copper gutter coming apart at the seam, allowing water to penetrate the roof eave.

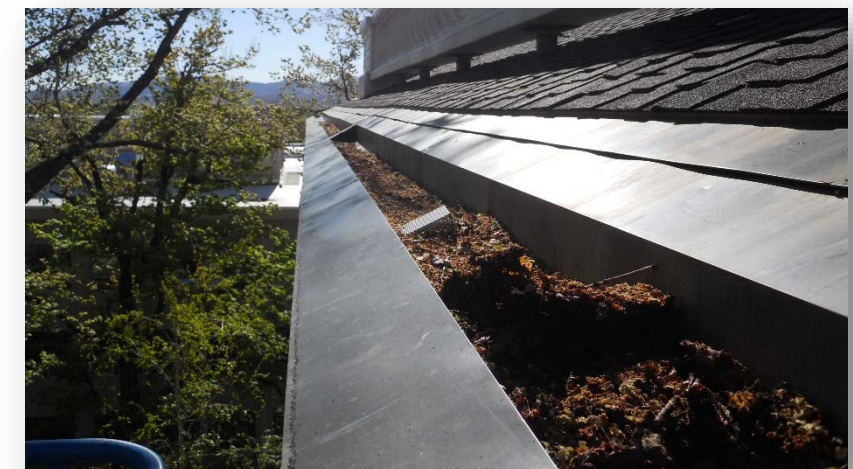
Copper gutter filled with dirt and debris.

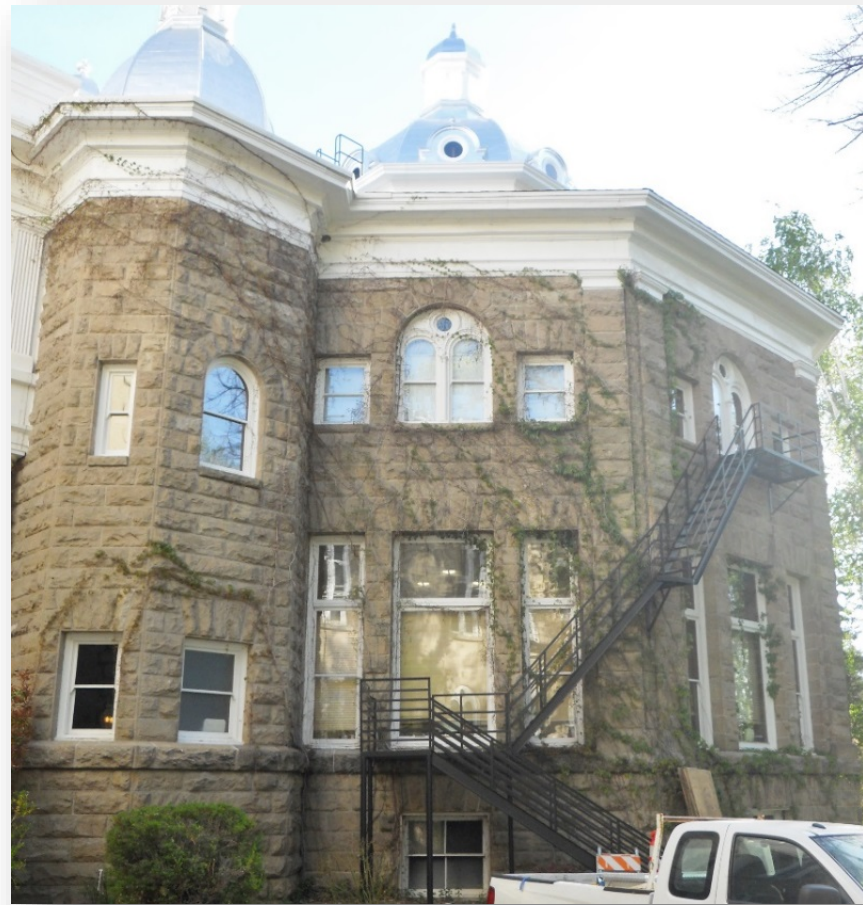
Plants such as creeping vines (Virginia Creeper) have made their way on to the sandstone veneer of the State Capitol and Capitol Annex. At the Capitol Annex the vines dominate each façade and extend from the ground level to the roof eaves. These vines have attached to the sandstone masonry and have penetrated some of the metal soffit and eave cladding, pulling apart the cladding and creating openings for water intrusion. They have also penetrated mortar joints and other openings in the building, creating more opportunity for water to enter the building and degrade the veneer and cladding. This intrusion at the sandstone masonry has caused some mortar joints to come loose.

Vine growth on the Capitol Annex.

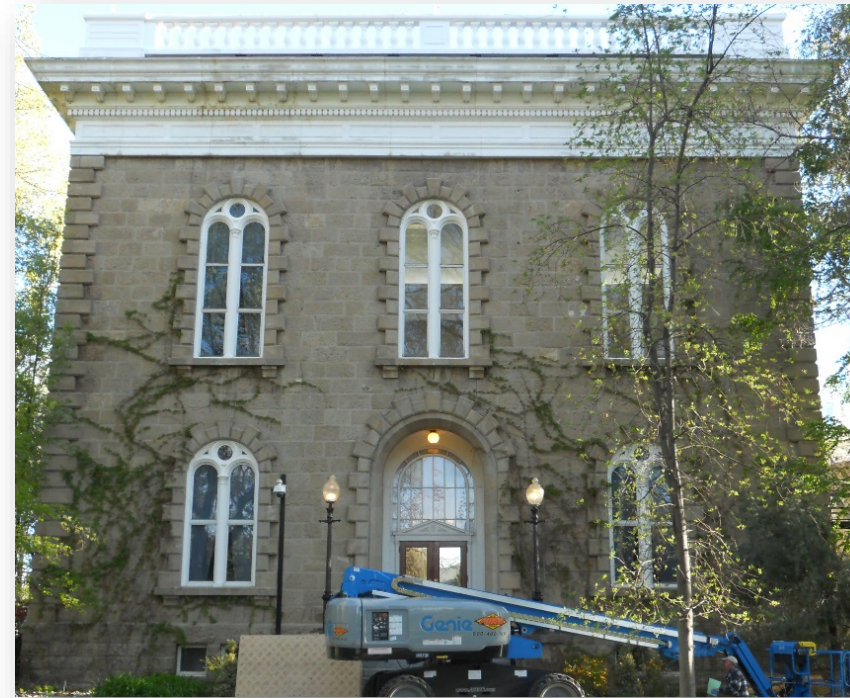
At the Capitol Building the vines are less dominate but are still present on some facades. These vines pose the same problems as on the Capitol Annex.

Vine growth on the Capitol Building.
