Capitol Fence

Historic Structure Report

SPWD Project #15-A025

February 2016

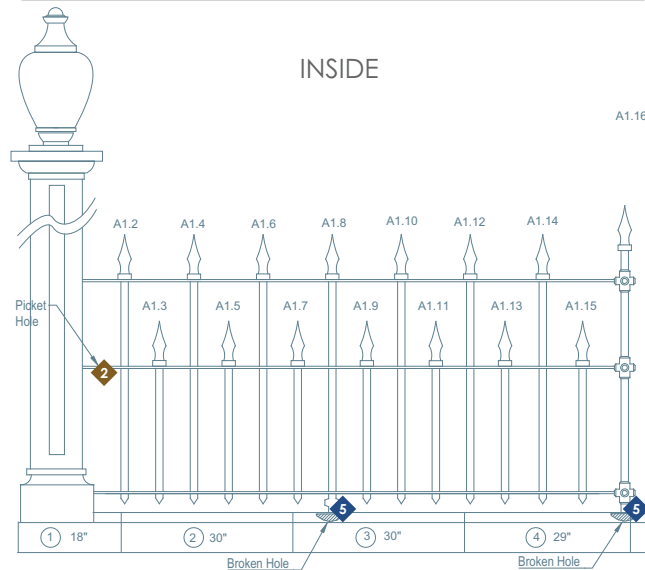
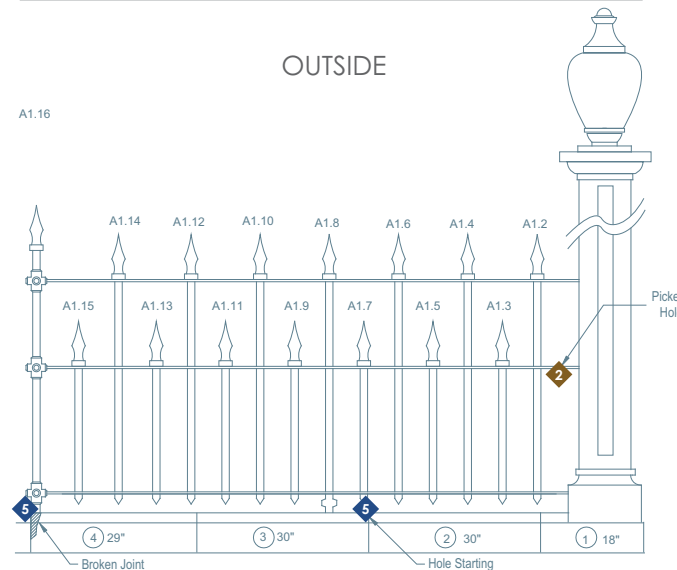
A1

Ironwork Corrosion

1. Repair holes, cracks and casting defects using filler compound containing iron particles in an epoxy resin binder
2. Replace missing or severely damaged cast iron components with in-kind casting technique and material
3. Major cracks and inappropriate repairs to be repaired by brazing with special nickel alloy welding rods

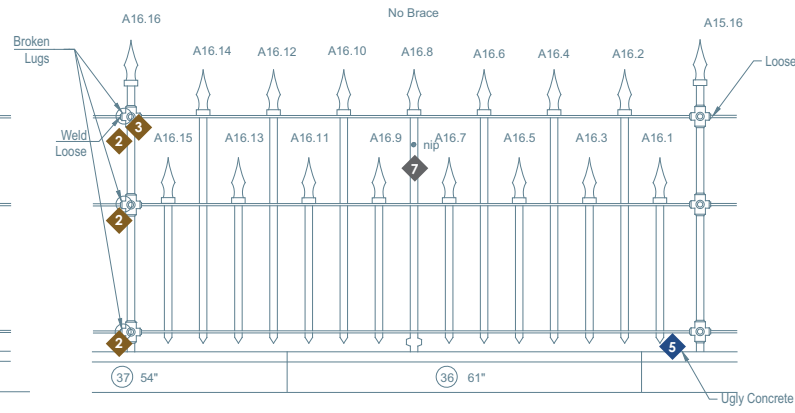
A16

Ironwork Corrosion

1. Repair holes, cracks and casting defects using filler compound containing iron particles in an epoxy resin binder
2. Replace missing or severely damaged cast iron components with in-kind casting technique and material
3. Major cracks and inappropriate repairs to be repaired by brazing with special nickel alloy welding rods

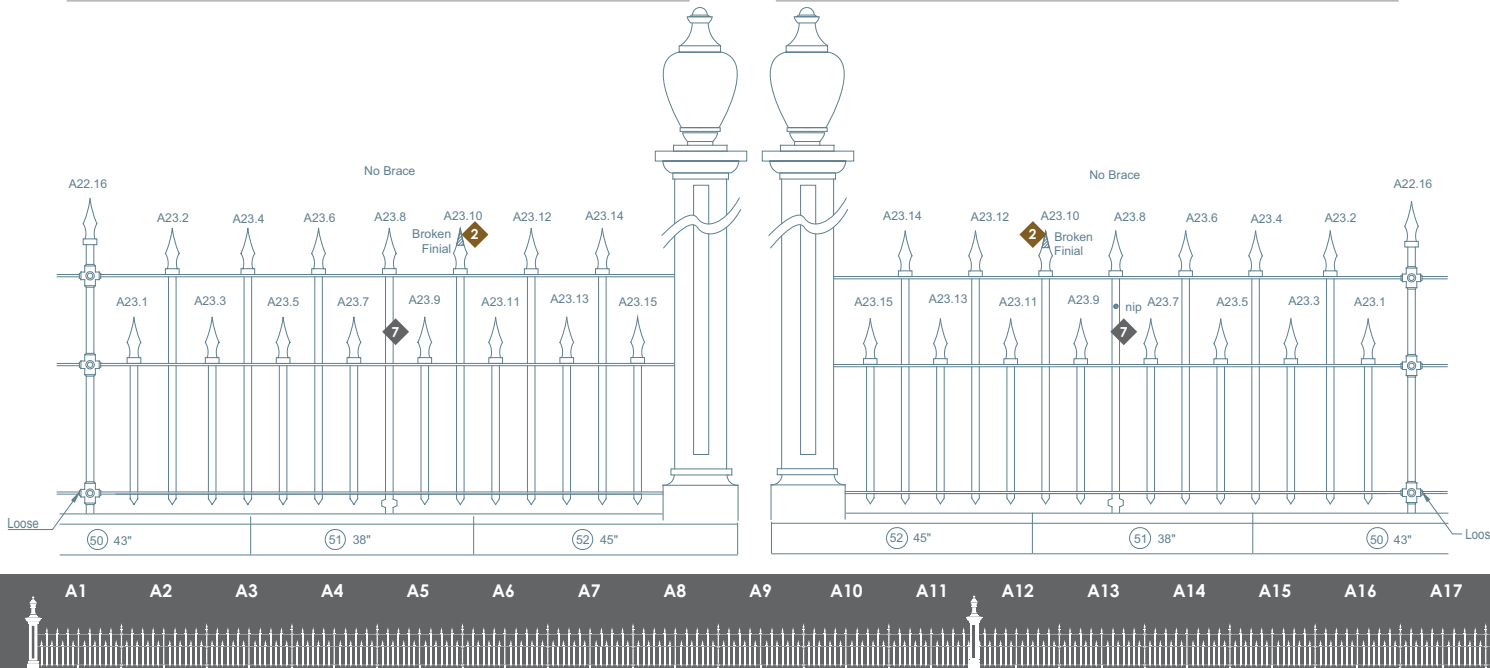
SECTION A23

Ironwork Corrosion

1. Repair holes, cracks and casting defects using filler compound containing iron particles in an epoxy resin binder
2. Replace missing or severely damaged cast iron components with in-kind casting technique and material
3. Major cracks and inappropriate repairs to be repaired by brazing with special nickel alloy welding rods

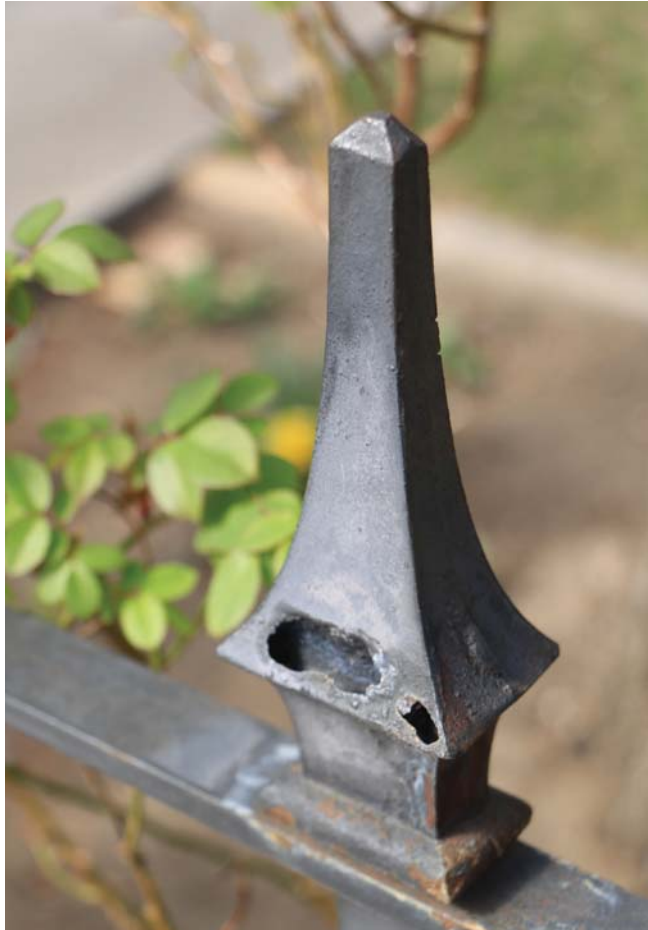
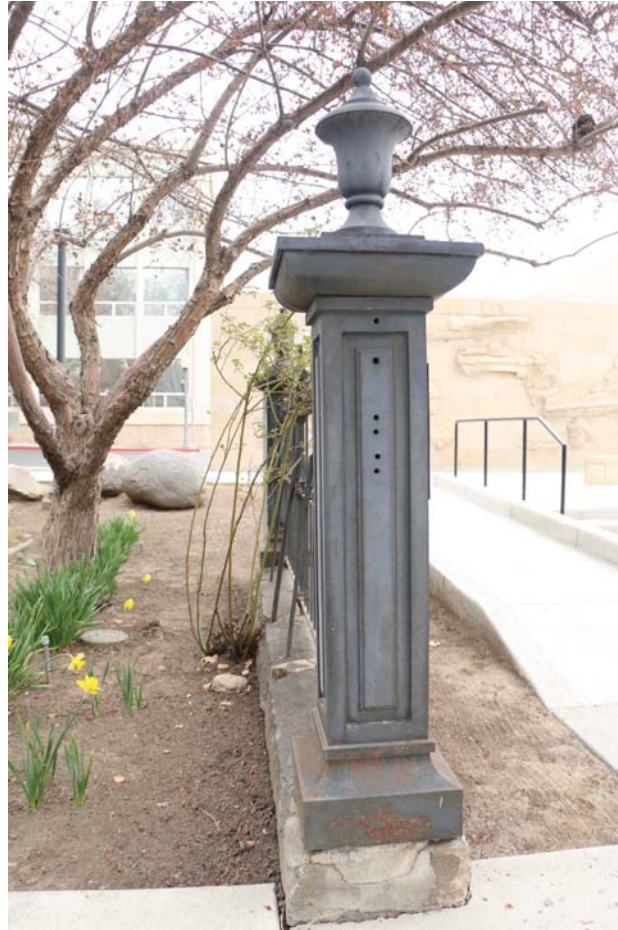
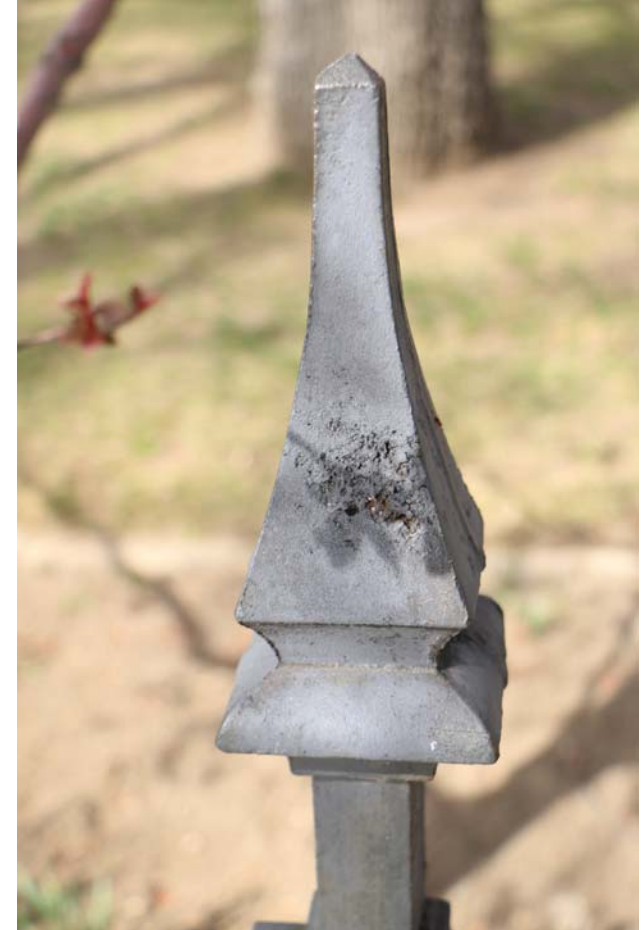
Photo Documentation - Ironwork Corrosion

The primary purpose of the maintenance program is to control corrosion. As soon as rusting is noted, it should be carefully removed and the protective coating of the iron renewed in the affected area. Repair holes, cracks and casting defects using filler compounds containing iron particles in an epoxy resin binder. Fractures are common in cast iron which is a brittle material. Some fractures can be repaired, using a variety of methods as outlined above, though occasionally it may be necessary to replace all or part of a fractured element if the degree of fracturing is too extensive. Not everything that looks like a fracture necessarily is; original casting flaws can look like a fracture but may be merely cosmetic. Cast iron components are hollow; cracks can allow water intrusion, leading to rust or freeze/thaw damage.

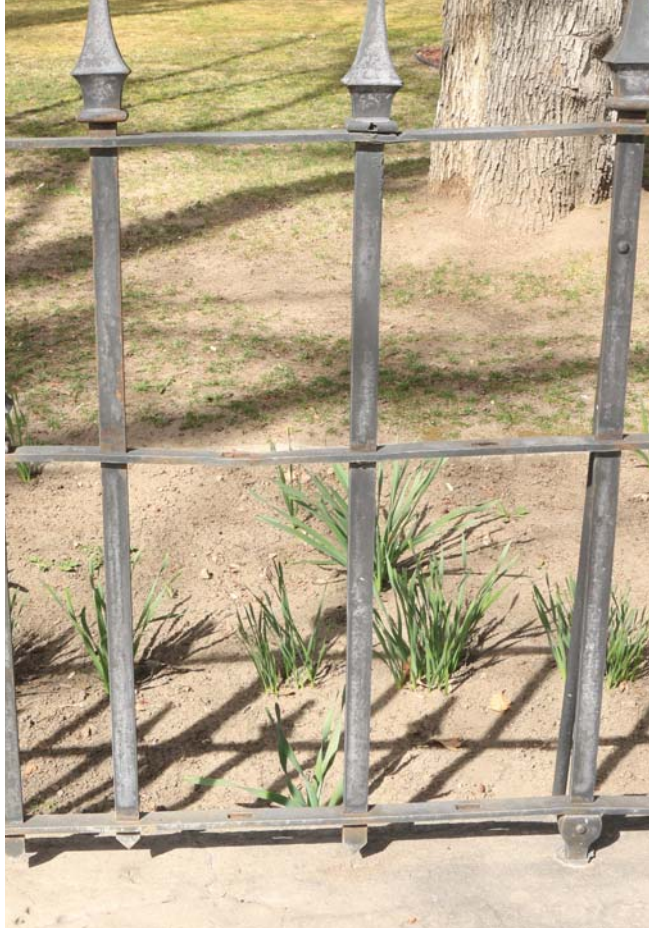
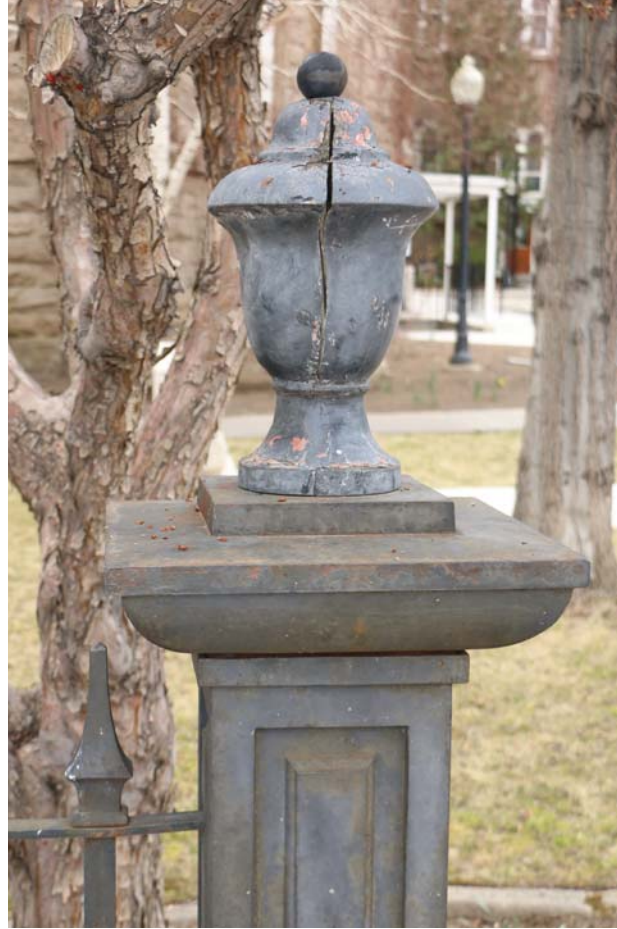
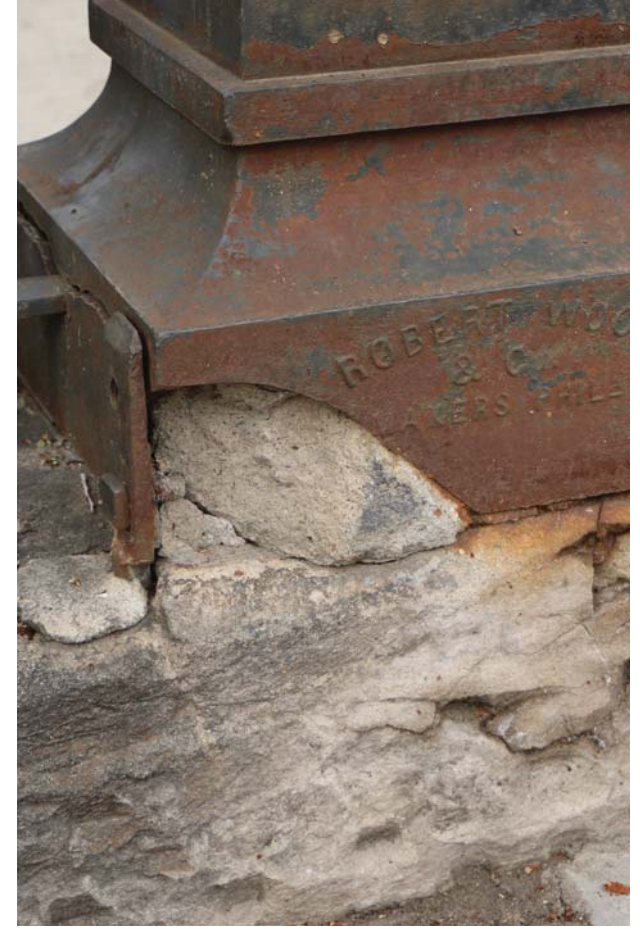
Photo Documentation - Ironwork Corrosion

Cast iron is an alloy of the elements iron, carbon and silicon that is formed into shapes by pouring the molten metal into a mold. The technique was invented by the Chinese more than 2,000 years ago. Replace missing, non-original materials, and/or severely damaged cast-iron components with salvage and/or in-kind casting technique and material. Left exposed, iron and steel are inevitably destroyed by rust. Rust, the oxidation of ferrous metals, is commonly caused by exposure to water and air. Ironwork is usually painted or coated in an attempt to prevent moisture and air coming into contact with the metal surface and causing corrosion. Rebuild wood urns with epoxy and seal prior to painting.

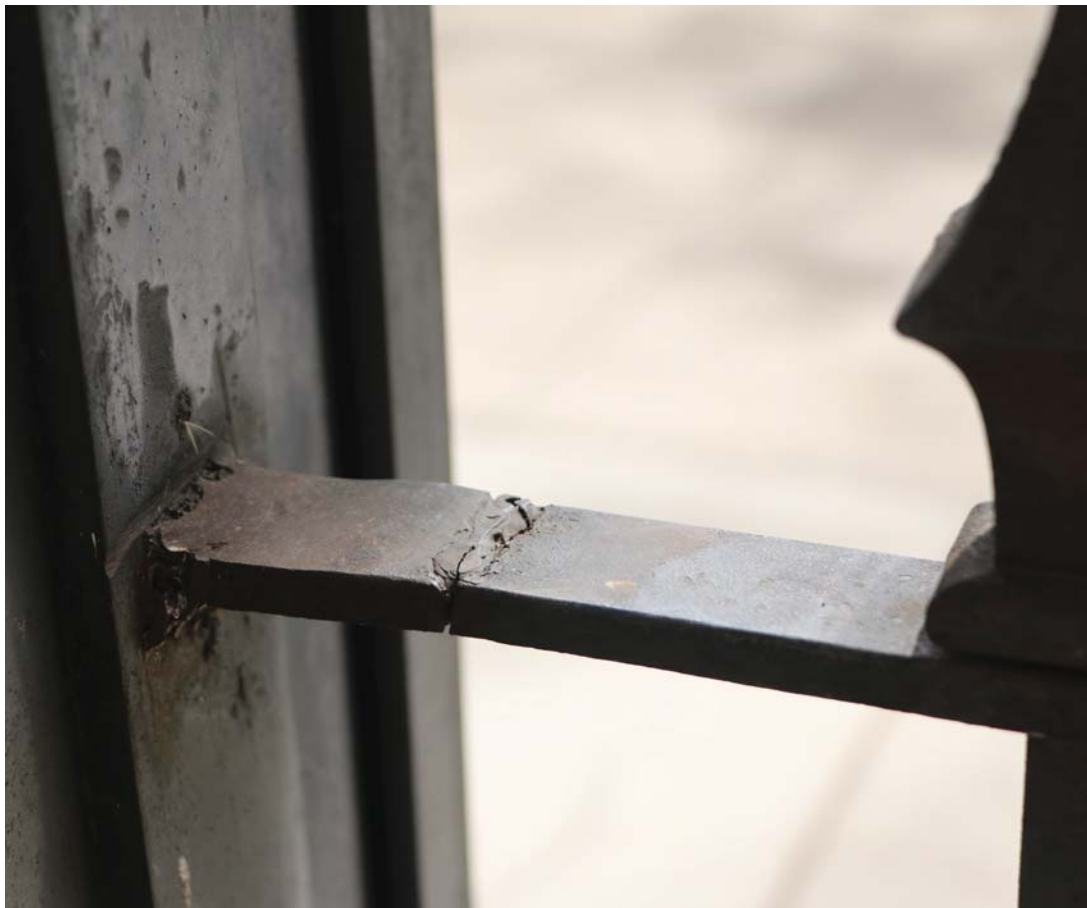
Photo Documentation - Ironwork Corrosion

Major cracks and inappropriate repairs to be repaired by brazing or welding with special nickel-alloy welding rods. Generally, welding is not a good solution for fine or delicate cast iron, although it can in some circumstances work well - usually in heavier castings. Original casting flaws are relatively common and can appear as holes, ranging from tiny to quite large, and occasionally as folds, which can look like cracks. These were sometimes hidden by foundries using various filling materials which are usually removed during the cleaning process.

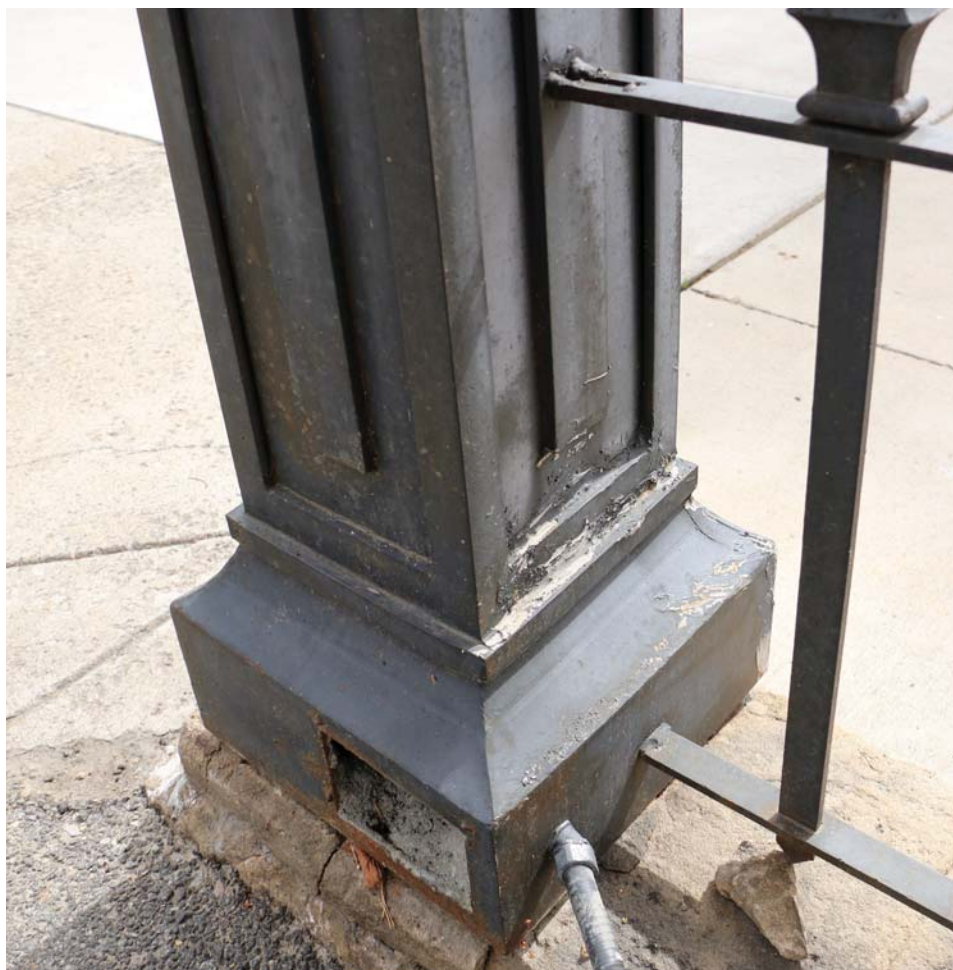
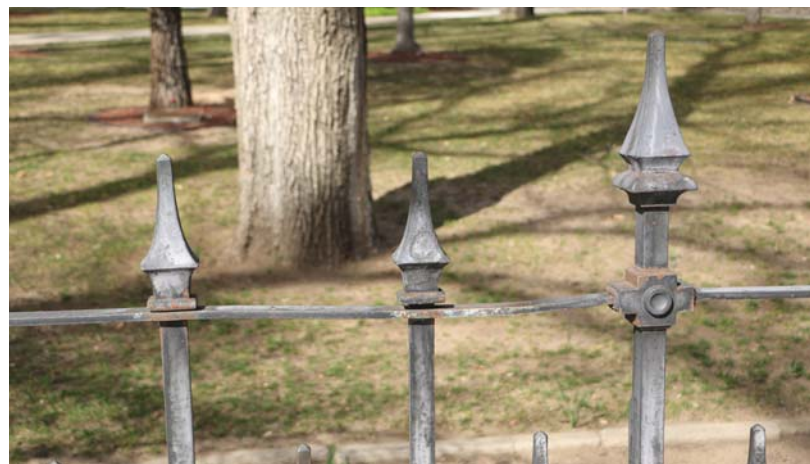
Photo Documentation - Structural Instability

Fence instability caused by 1980 light fixture rehab; attachment points compromised, footing unstable, electrical feed to be upgraded. Repair lead sleeve; railings secured into masonry sockets using hot poured lead; melt lead to close the gaps. Realign and stabilize fence to include straightening bent, bowed, or out of plumb fence section(s) and / or individual horizontal or vertical component(s), repair post base. Bent or damaged parts can be straightened with a crowbar. A straight panel is only important if fence components are not fitting together correctly.
