State of Nevada
Department of Motor Vehicles & Department of Public Safety

DMV/PUBLIC SAFETY SITE

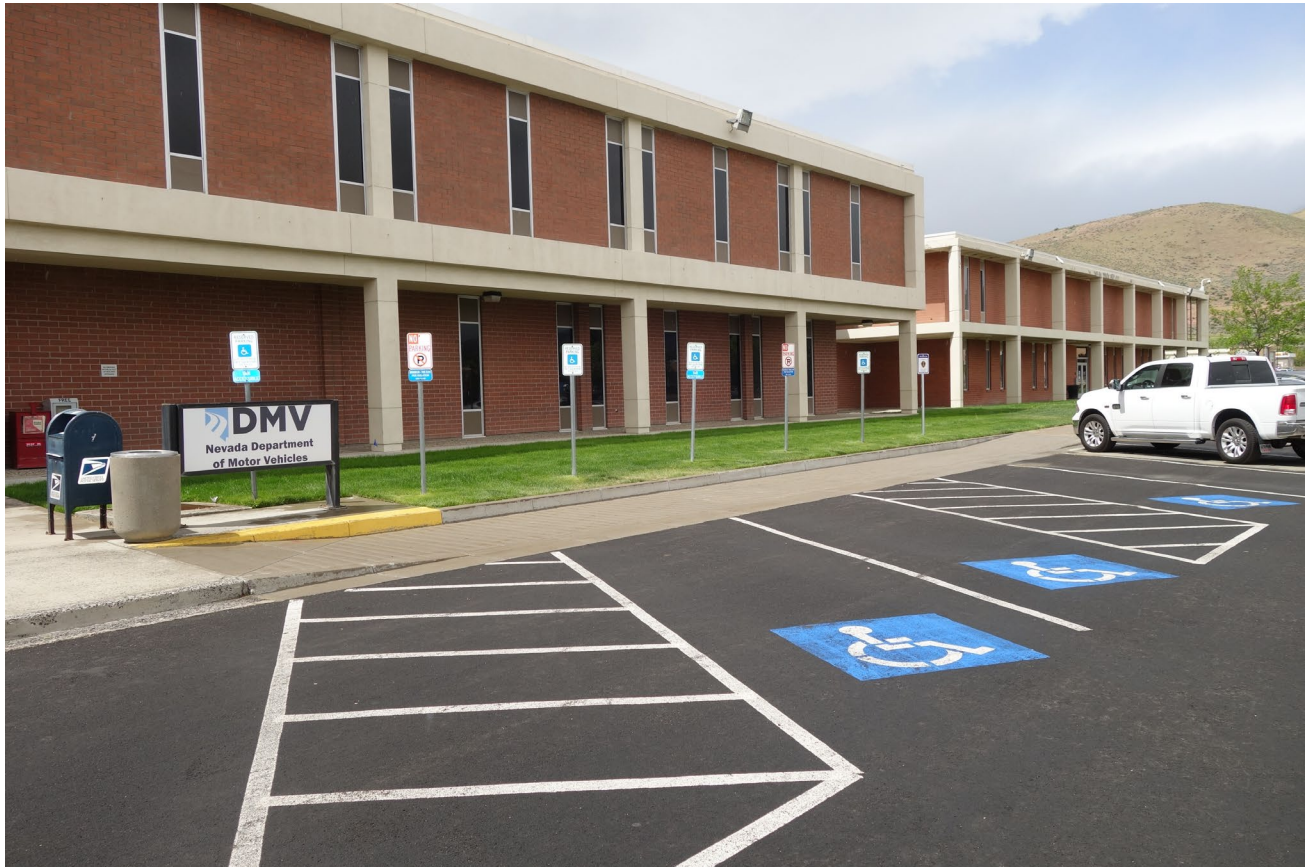
Report distributed in December 2021

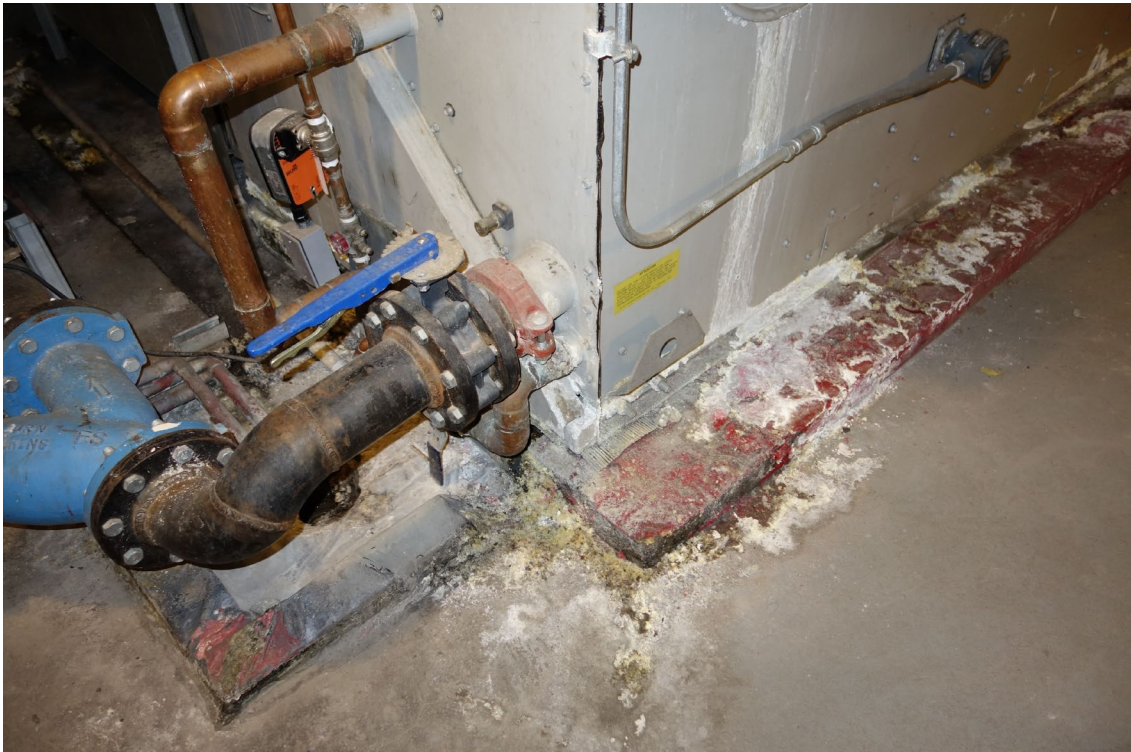
DMV Office Building (West Wing) - Building #0209
Description: HVAC Replacement Project.

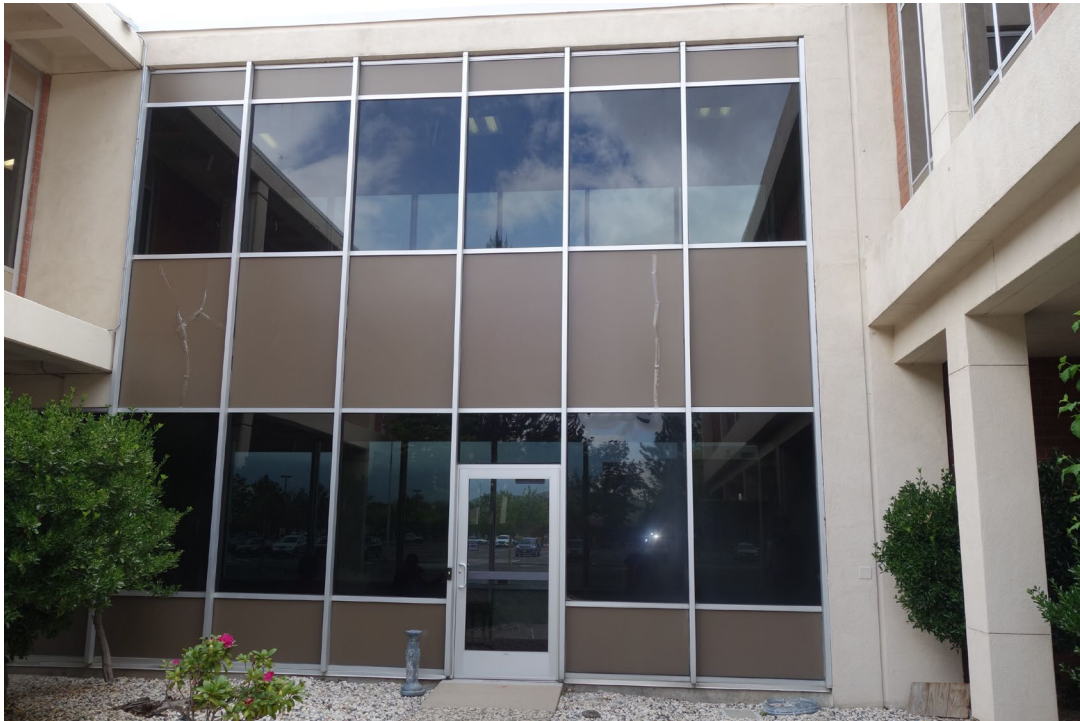
DMV Office Building (West Wing) - Building #0209
Description: Spandrel Glass Replacement.

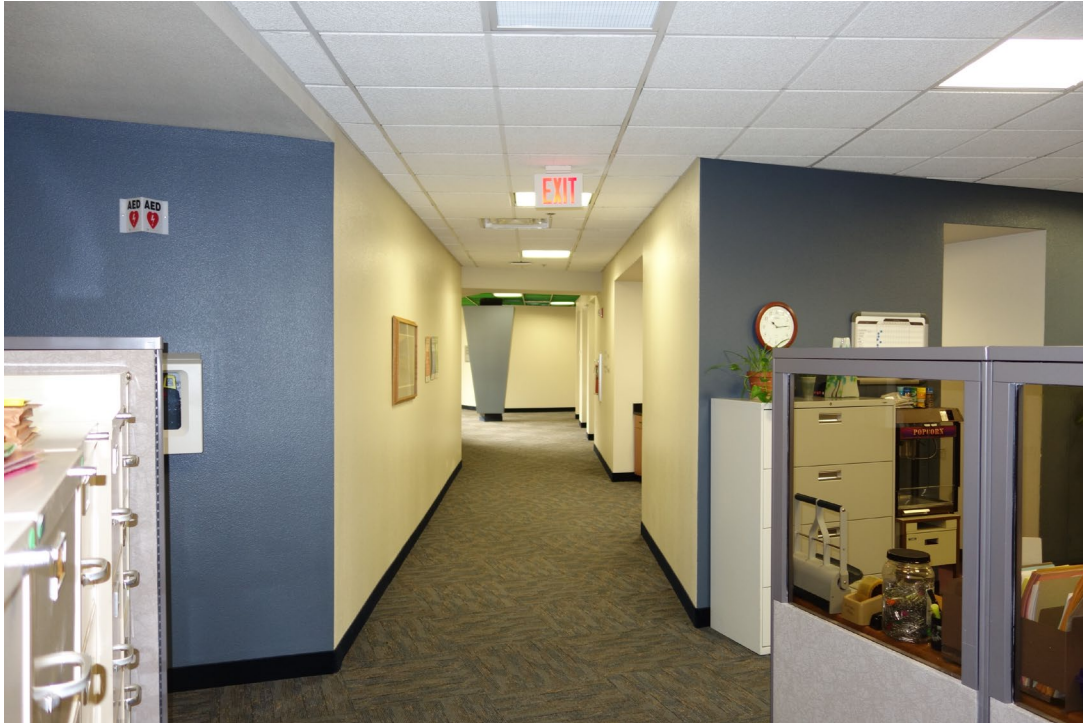
DMV Office Building (West Wing) - Building #0209
Description: Interior of the Building.

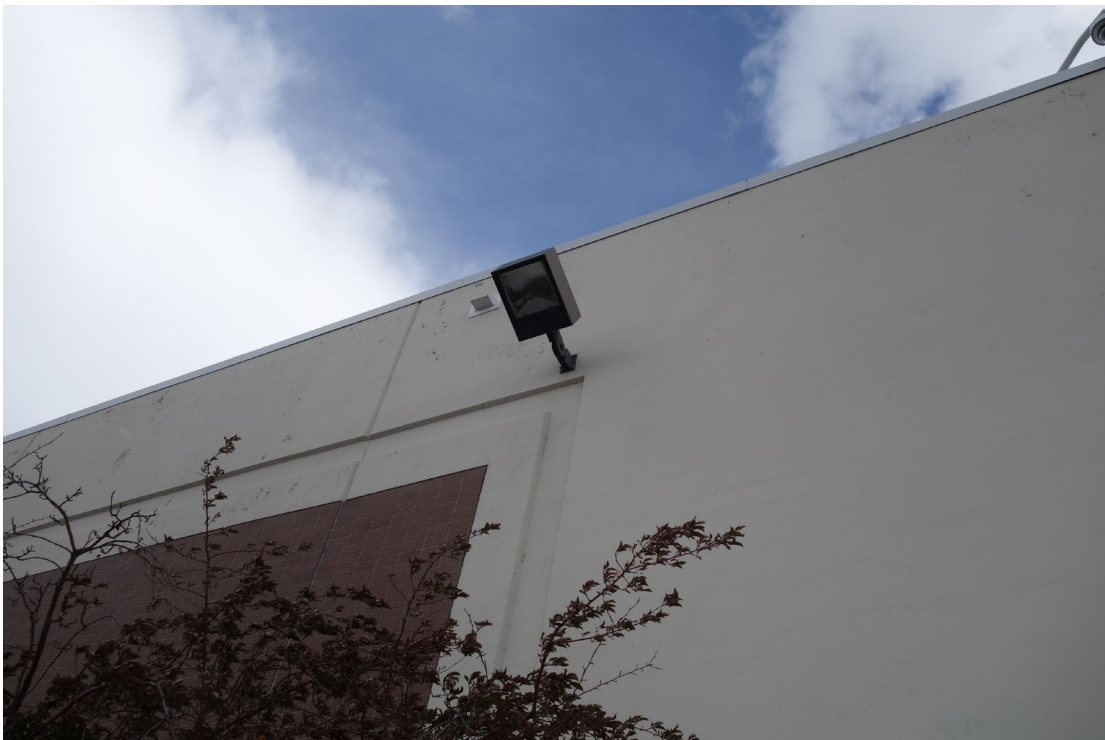
DMV Warehouse - Building #1990
Description: Exterior Lighting Replacement.

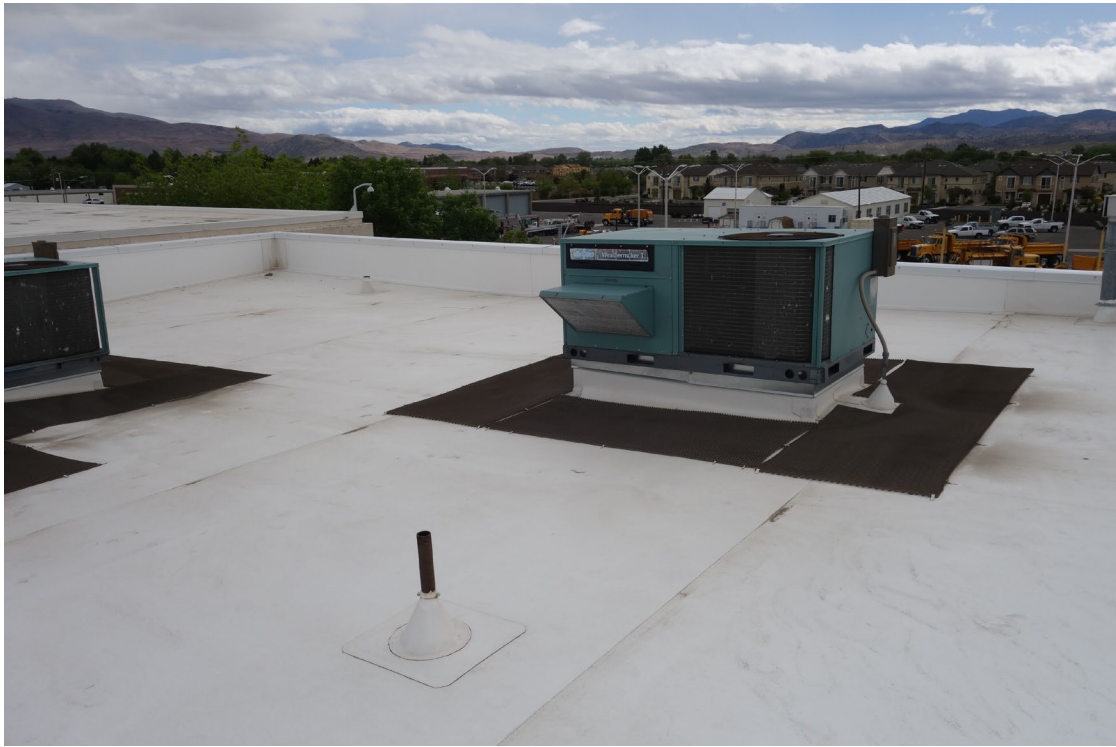
DMV Warehouse - Building #1990
Description: HVAC Equipment Replacement.

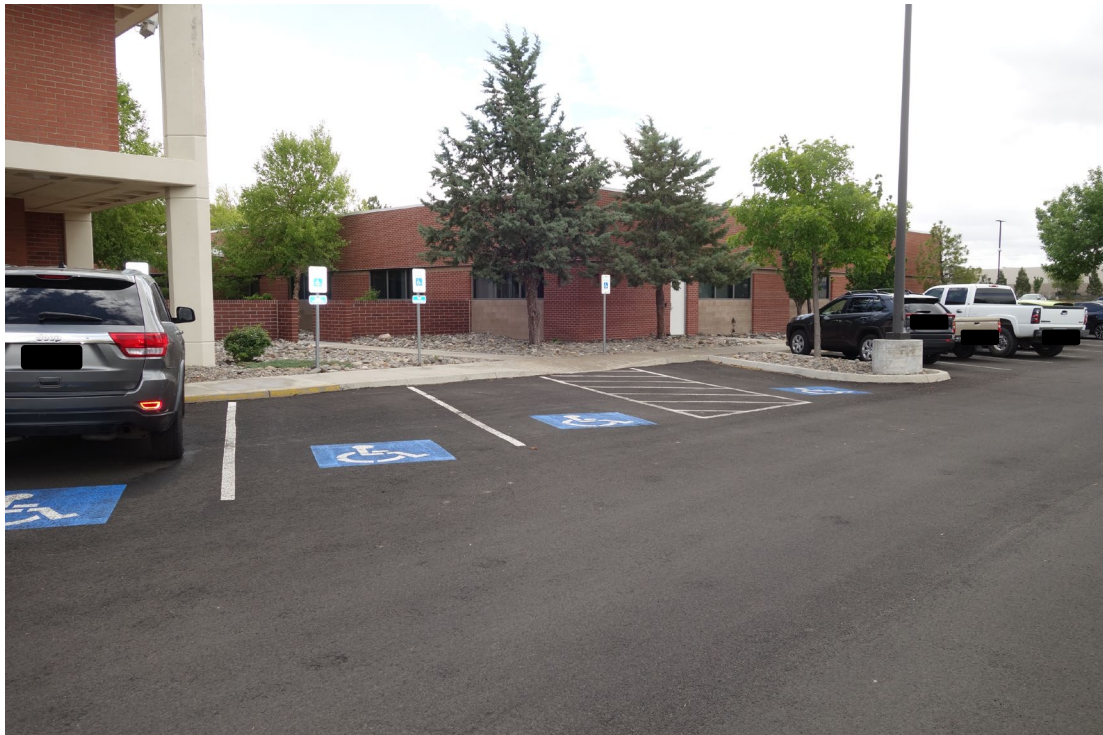
DMV Computer Facility - Building #2037
Description: Exterior of the Building.

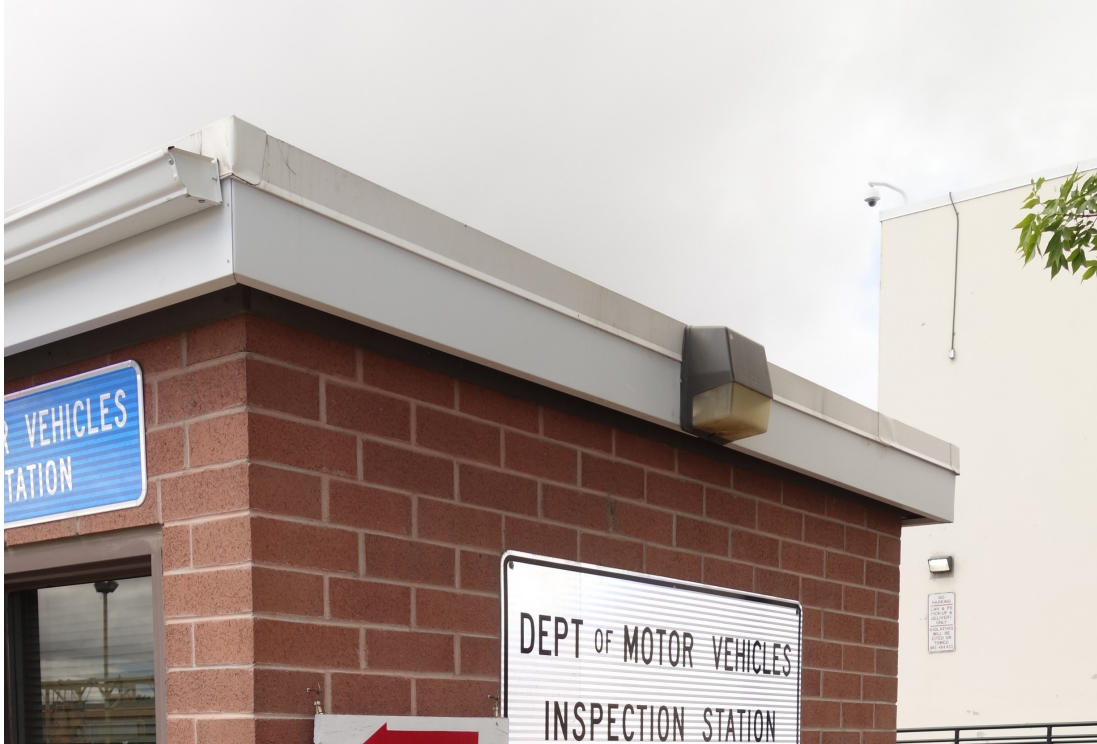
Large Vehicle Scale Building - Building #2459
Description: Exterior Lighting Replacement.

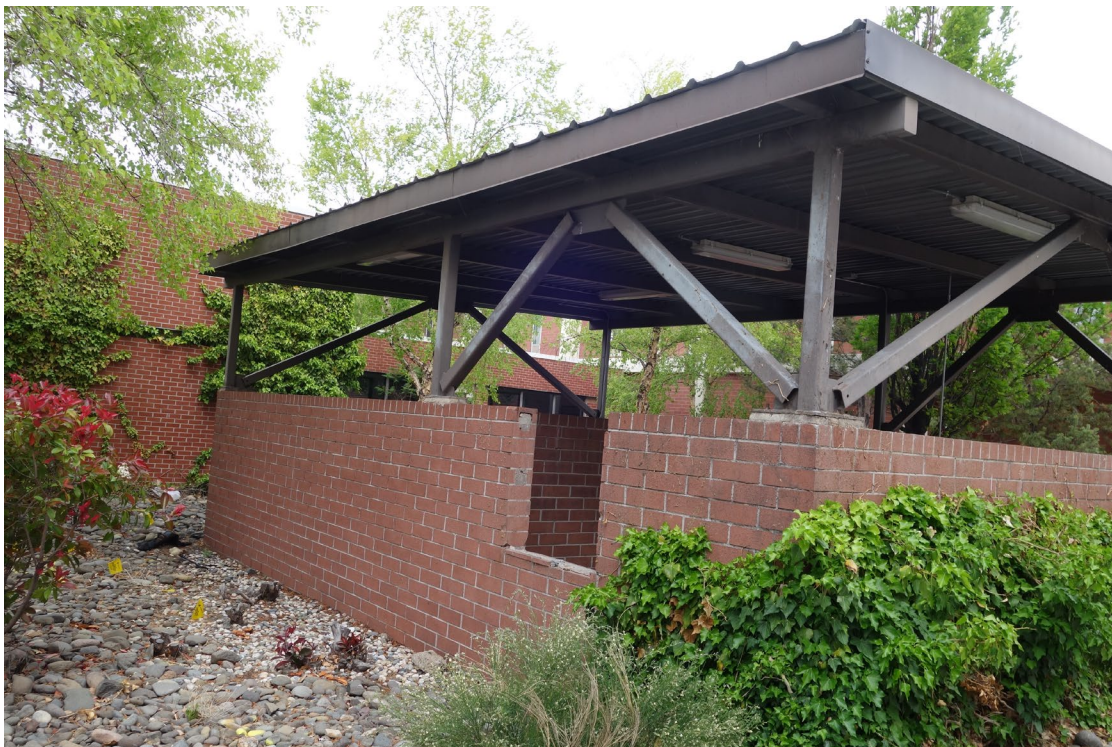
Generator Building - Building #2965
Description: Exterior of the Building (Currently Not Used).
