State of Nevada  
Department of Administration  
Buildings and Grounds Section

# NEVADA STATE CAPITOL

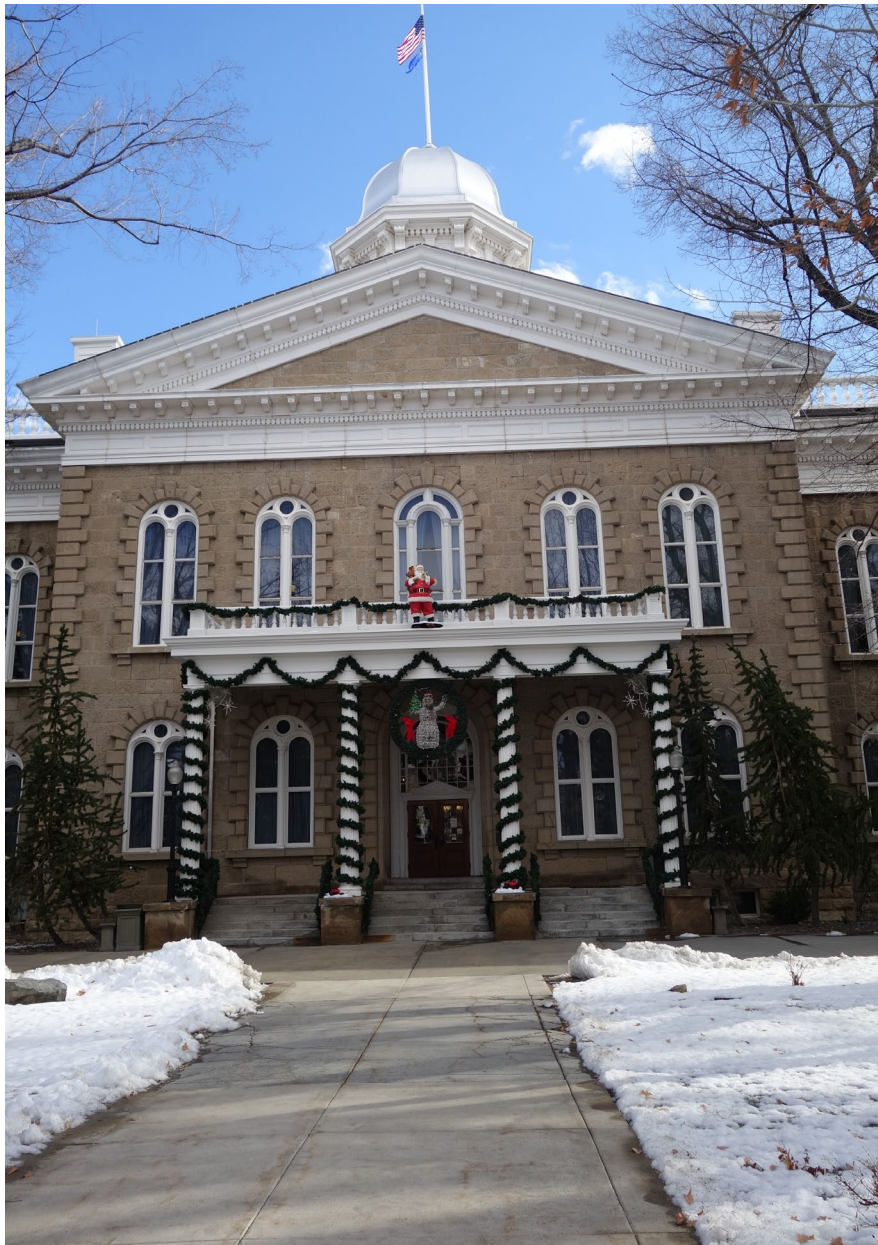
Report distributed in October 2021

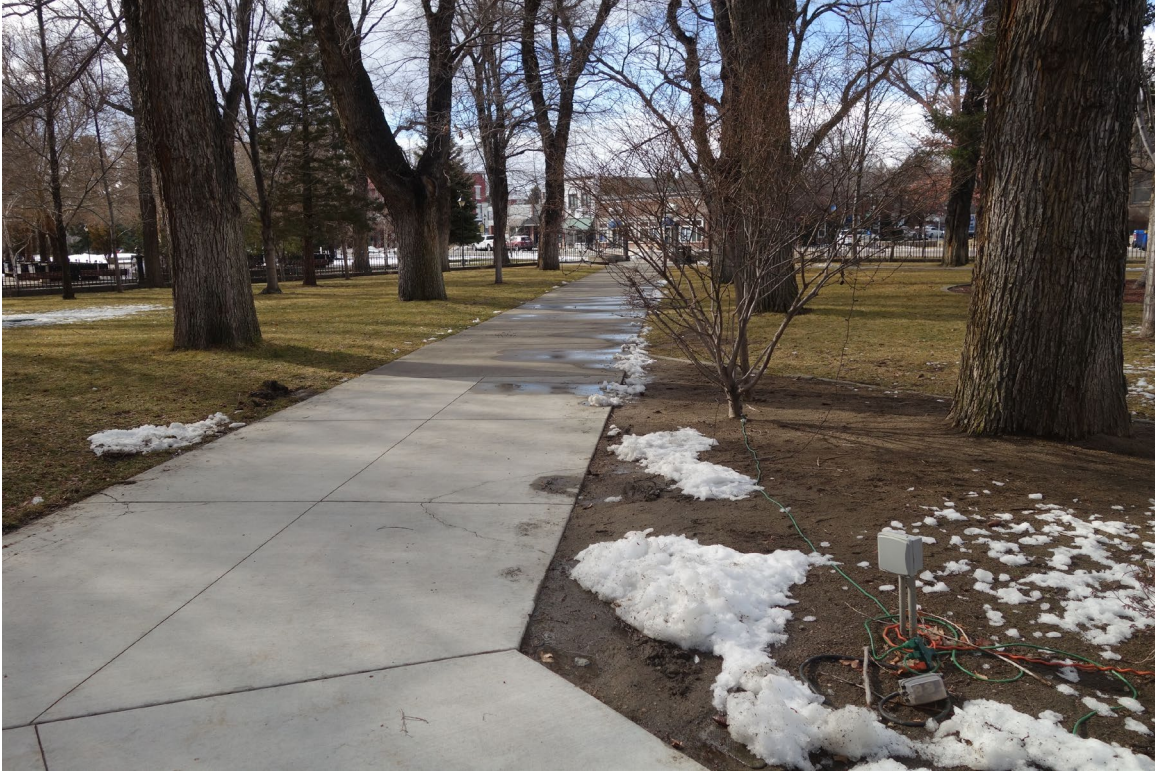
Nevada State Capitol - Site #9918  
Description: Site View to Southwest.

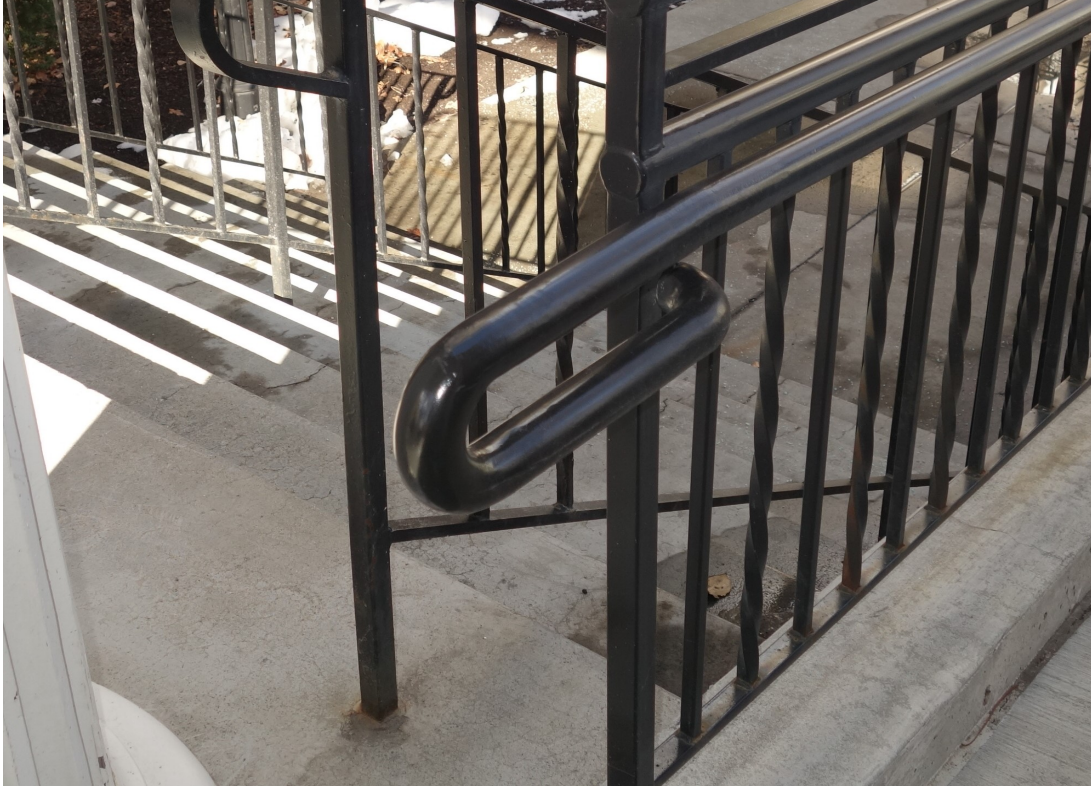
Nevada State Capitol - Site #9918  
Description: Stairs and Breezeway Concrete Replacement Needed.

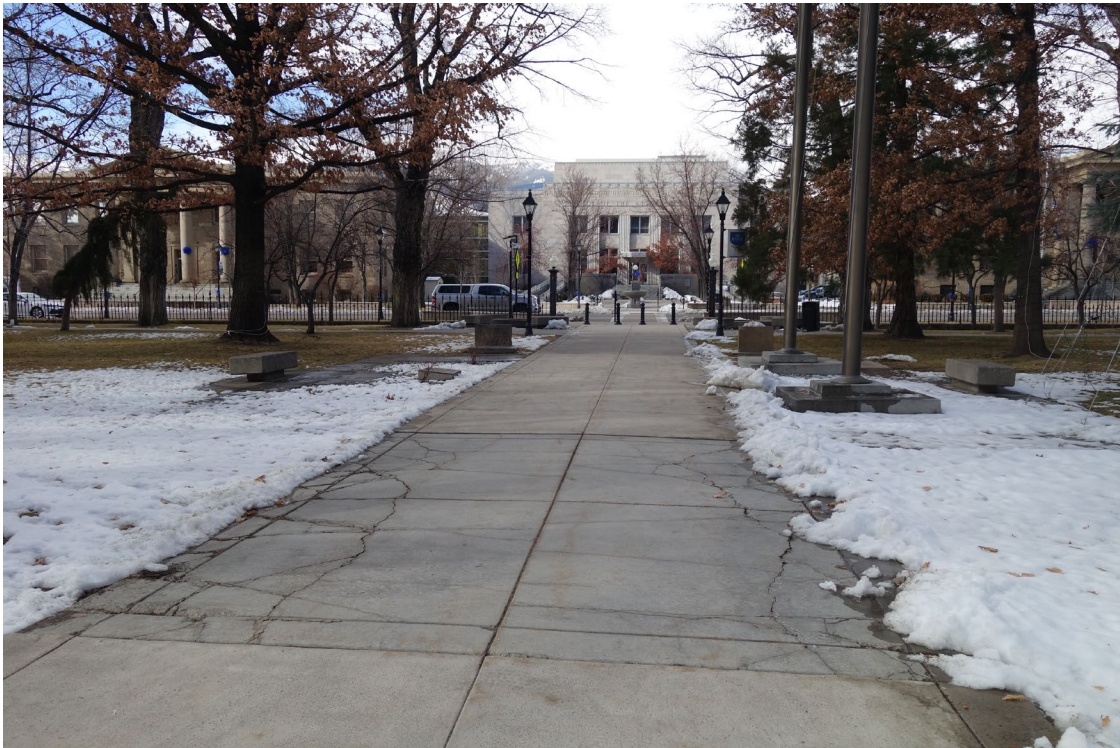
Nevada State Capitol - Site #9918  
Description: Sidewalk Replacement Needed.

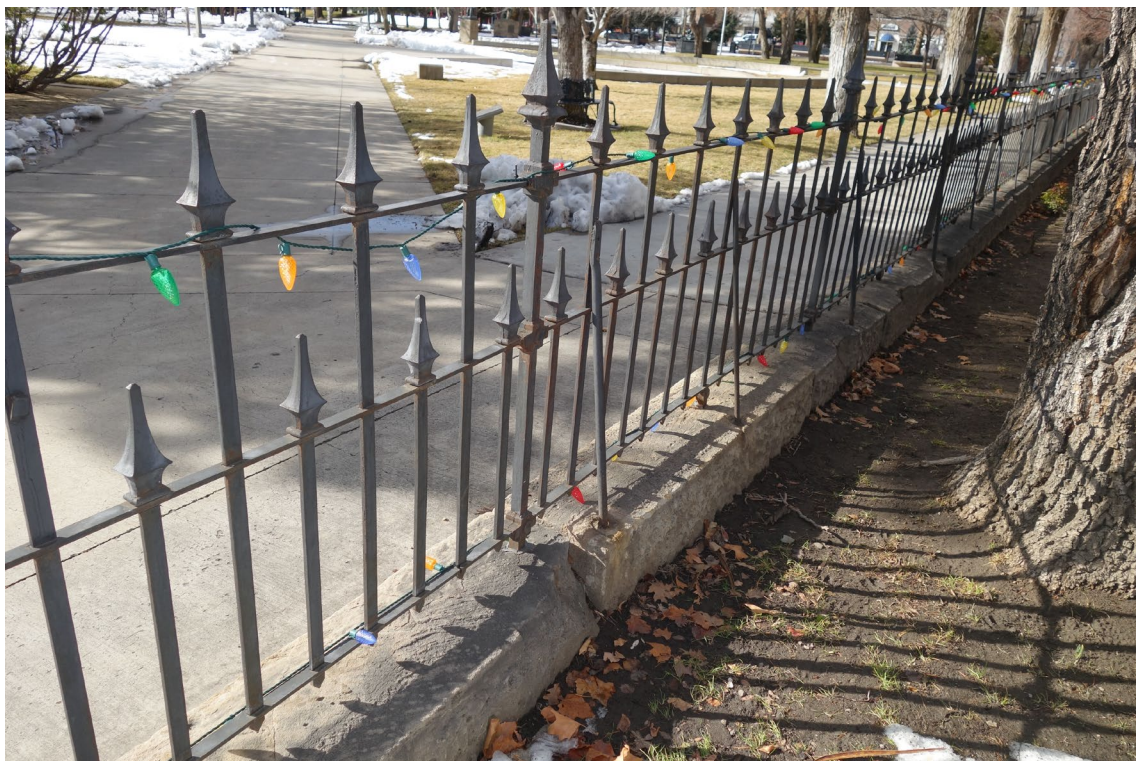
Nevada State Capitol - Site #9918  
Description: Historic Fence Preservation Needed.

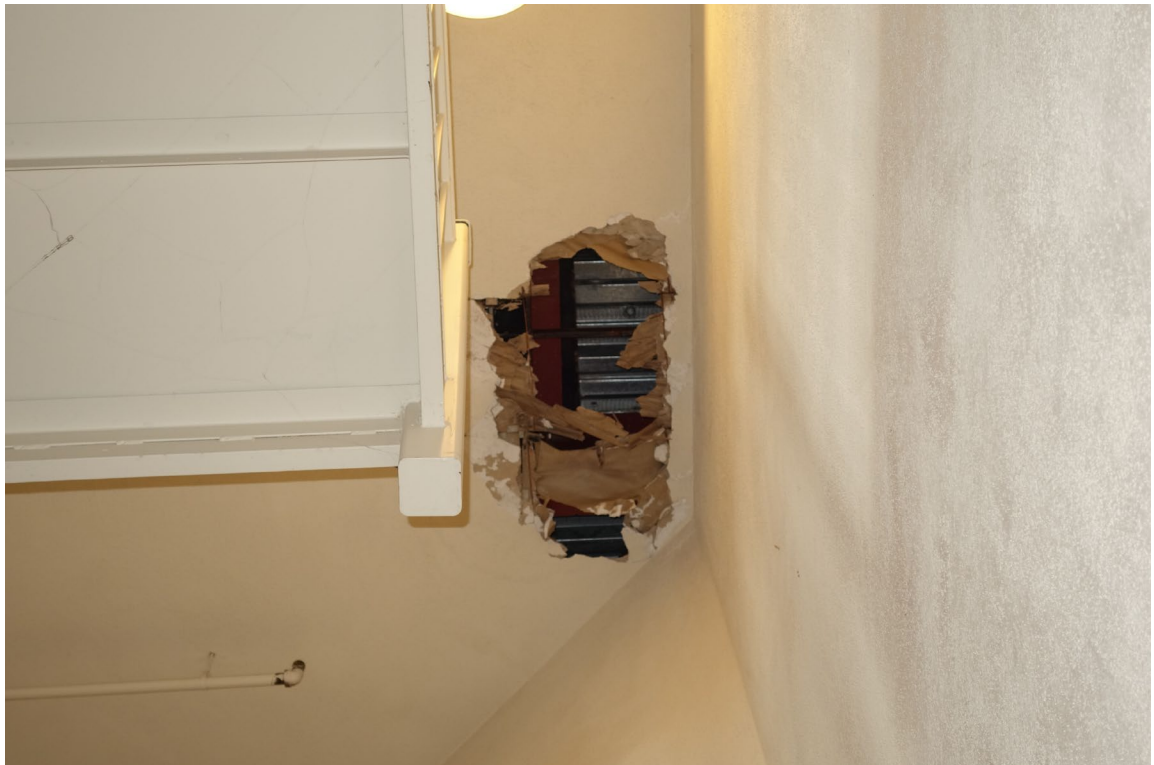
Nevada State Capitol - Building #0235  
Description: Drywall Repairs under Capitol Dome Needed.

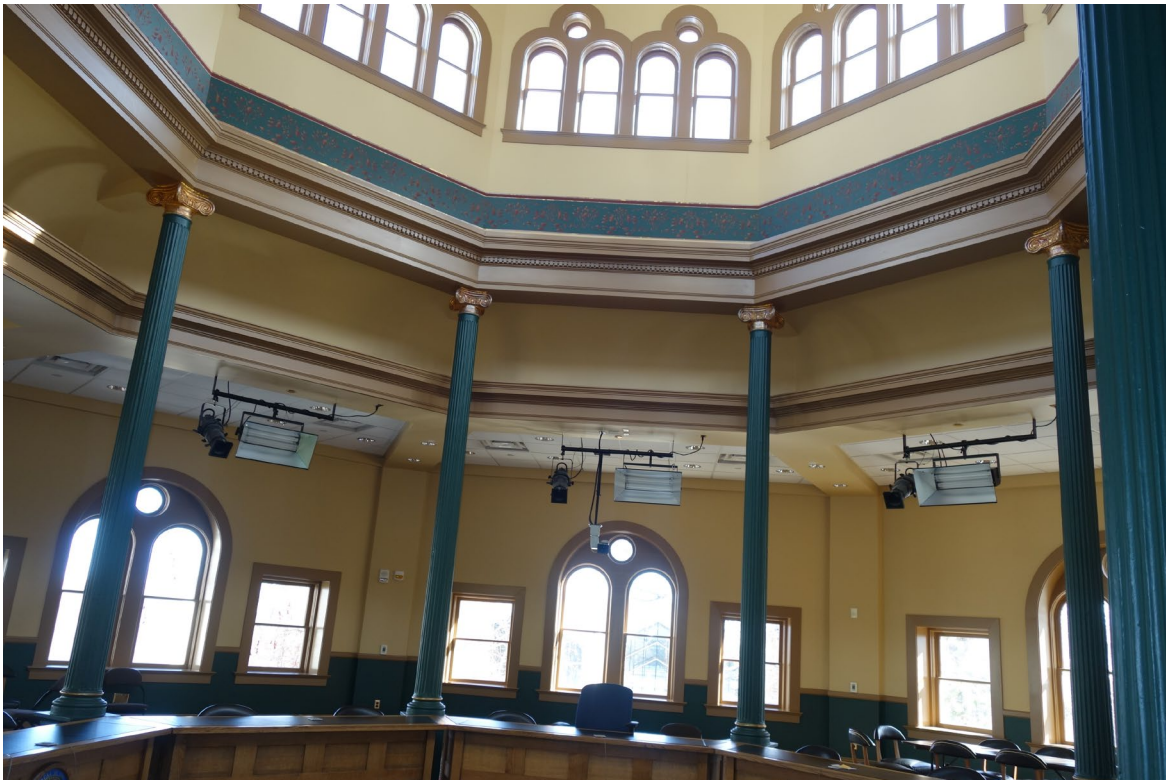
Nevada State Capitol Annex - Building #0203  
Description: Interior View of 2<sup>nd</sup> Floor.
