State of Nevada  
Department of Health and Human Services  
Division of Aging and Disability Services  
Facility Condition Analysis

# **SRC TRAINING & ADMIN, BLDG #600-601**

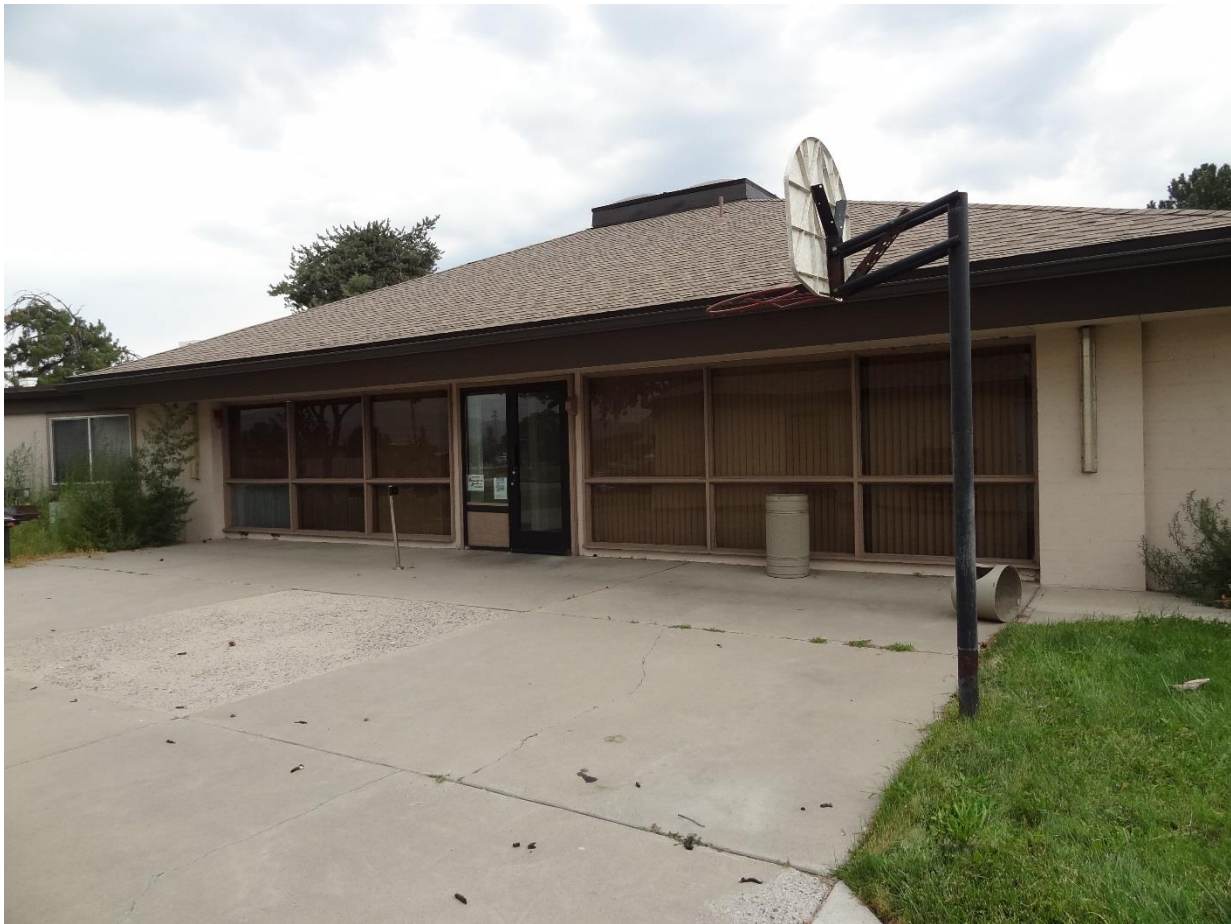
Report distributed in October 2017

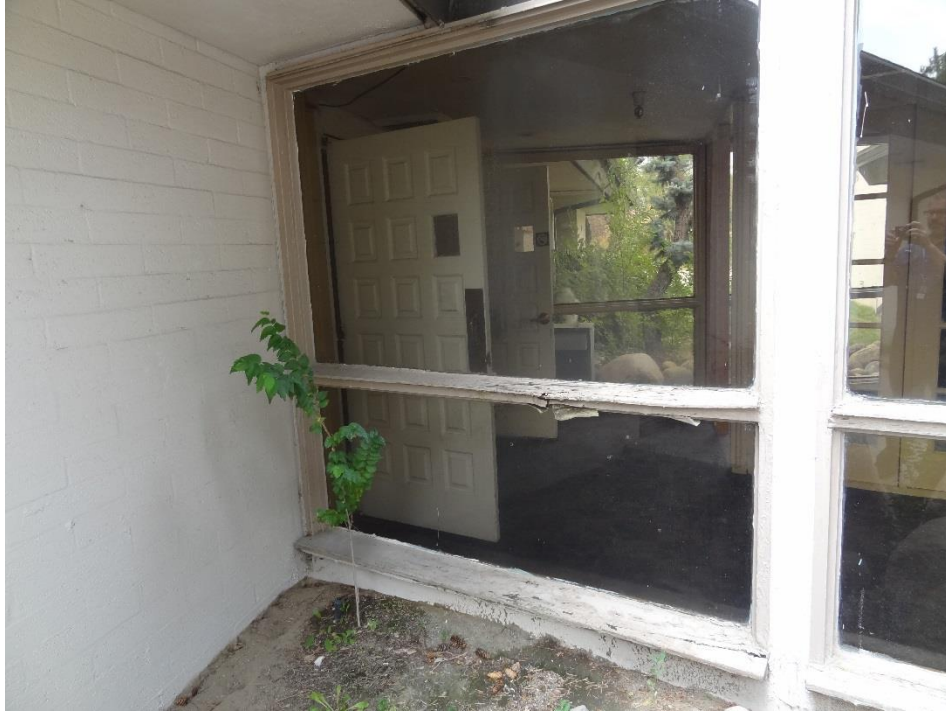
SRC Training and Admin, Building #600-601 - FCA #0322  
Description: Missing safety glazing and damaged window framing.

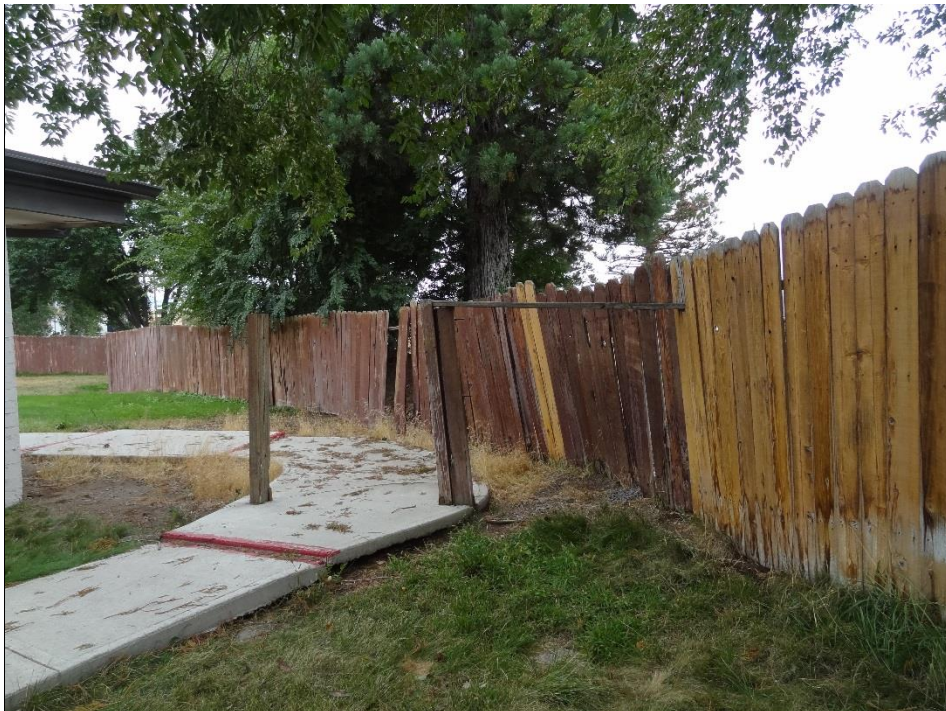
SRC Training and Admin, Building #600-601 - FCA #0322  
Description: Damaged sidewalks and fencing.

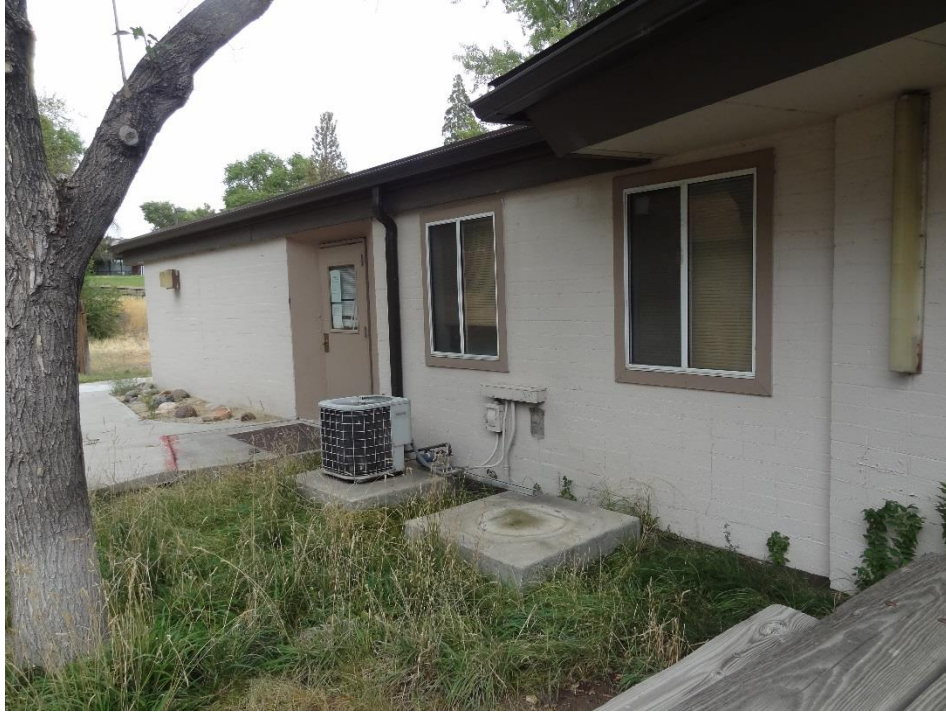
SRC Training and Admin, Building #600-601 - FCA #0322  
Description: Missing air conditioner.

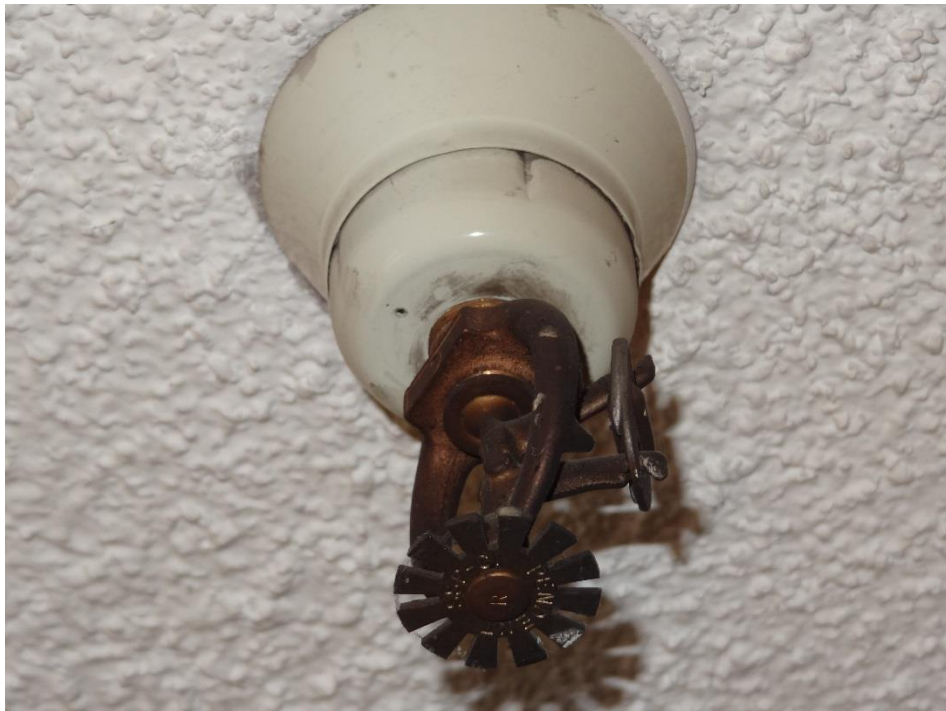
SRC Training and Admin, Building #600-601 - FCA #0322  
Description: Antiquated fire sprinkler head.

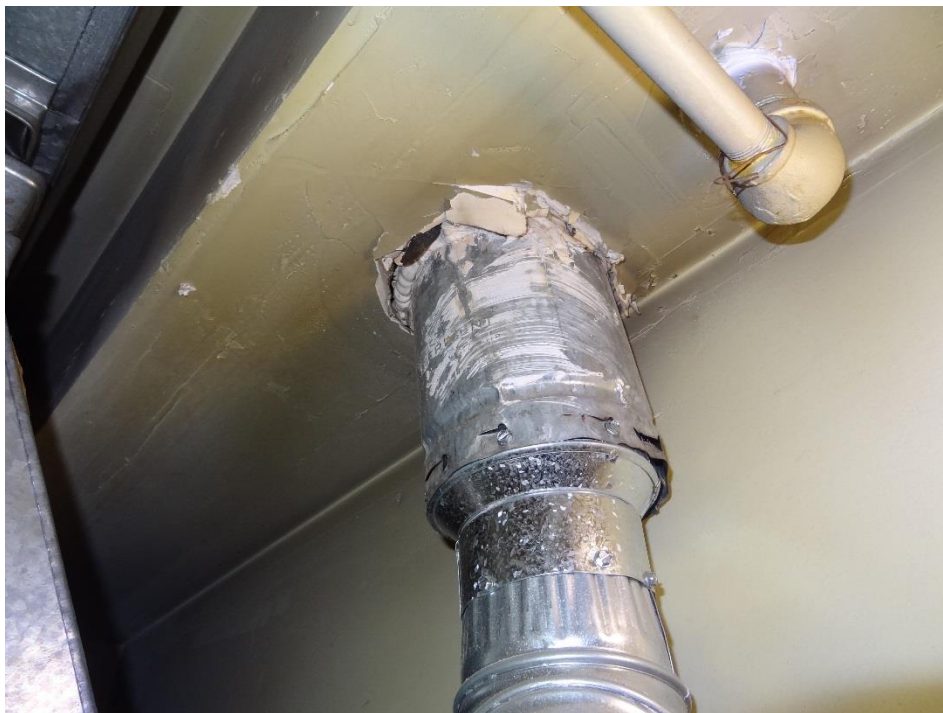
SRC Training and Admin, Building #600-601 - FCA #0322  
Description: Flue vent with improper installation.

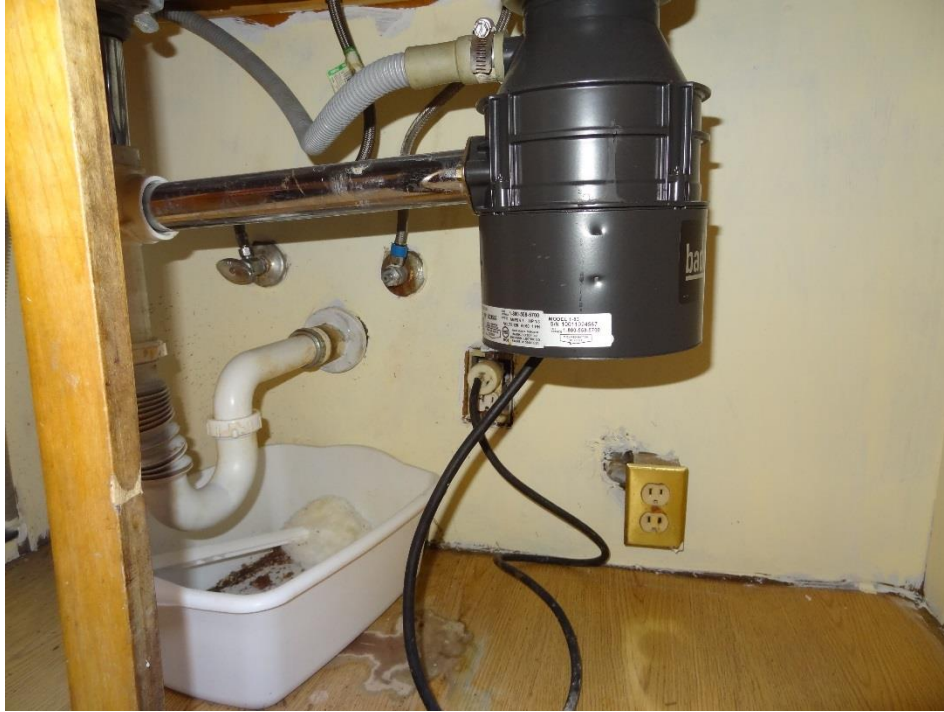
SRC Training and Admin, Building #600-601 - FCA #0322  
Description: Electrical outlet missing cover plate under sink. Leaking plumbing fixtures and water damage.

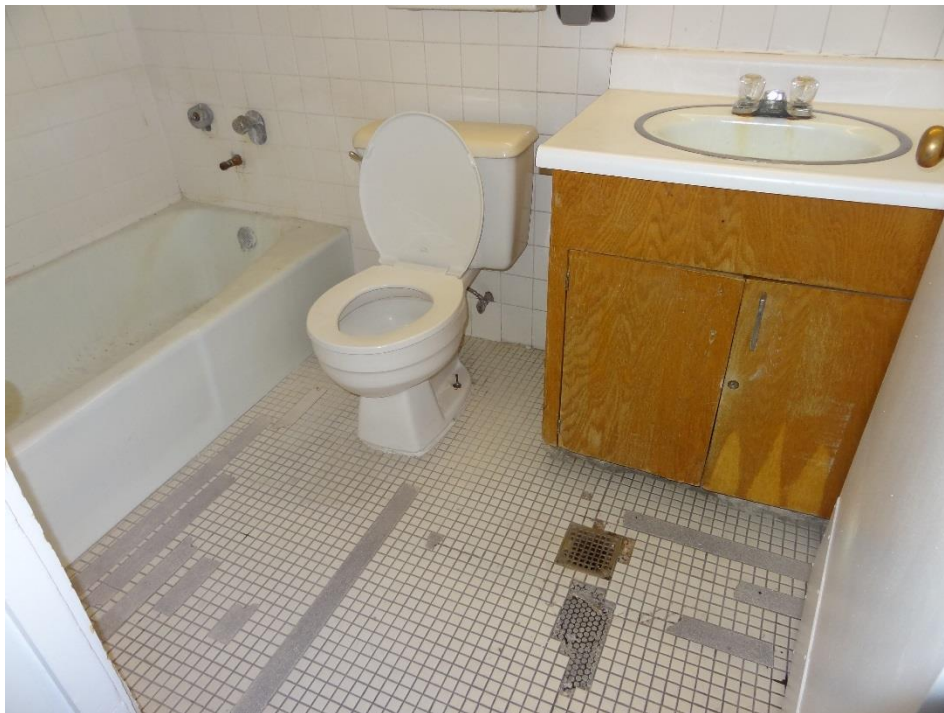
SRC Training and Admin, Building #600-601 - FCA #0322  
Description: Typical restroom finishes.
