State of Nevada Department of Agriculture

# **AGRICULTURE HEADQUARTERS OFFICE**

# Site Number: 9868 STATE OF NEVADA PUBLIC WORKS DIVISION FACILITY CONDITION ANALYSIS

Report distributed in January 2022

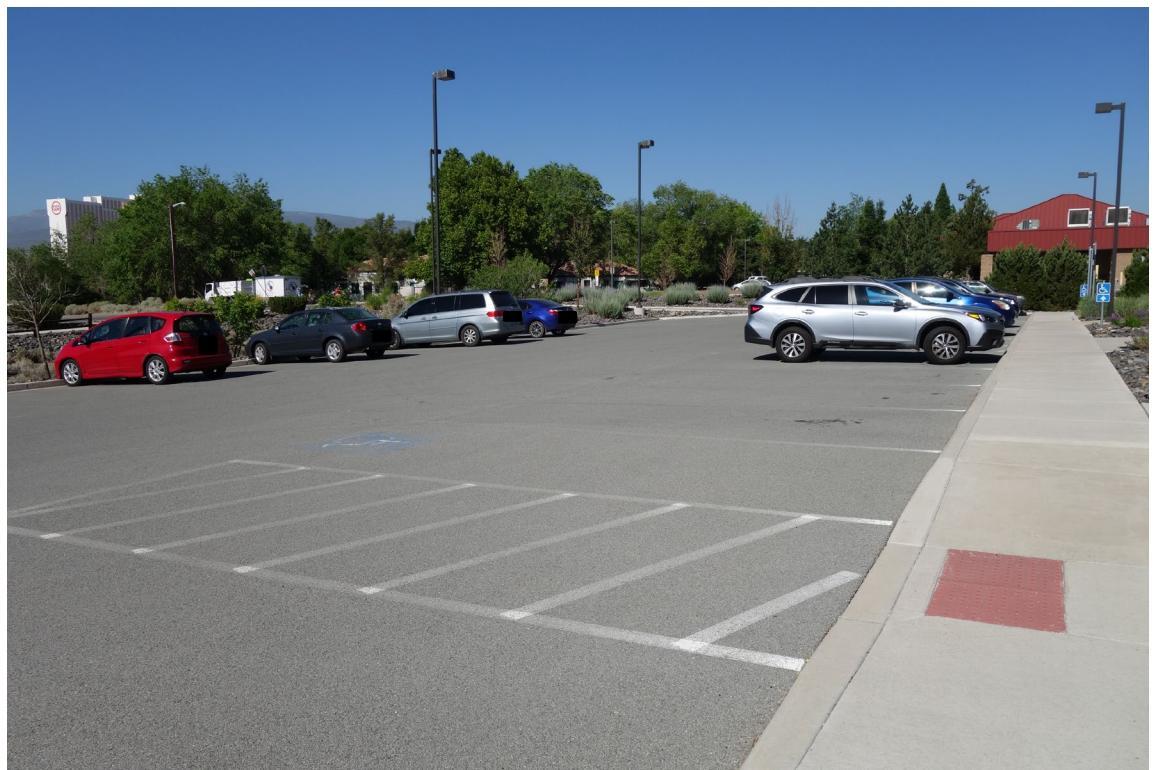
The Americans with Disabilities Act (ADA) provides for accessibility to sites and services for people with physical limitations. The accessible parking spaces and passenger loading areas in front of the Measurement Standards building are missing proper signage and striping to comply with ADA requirements. This project would provide for striping, signage and any other necessary upgrades to the parking space. The 2018 IBC, ICC/ANSI A117.1, NRS 338.180 and the most current version of the ADA Standards For Accessible Design were used as a reference for this project. This project or a portion thereof was previously recommended in the FCA report dated 11/05/2014. It has been amended accordingly to reflect conditions observed during the most recent survey date of 06/24/2021.

Agriculture Headquarters Office Site – FCA Building #9868 Description: Front Parking Area and ADA Building Access.

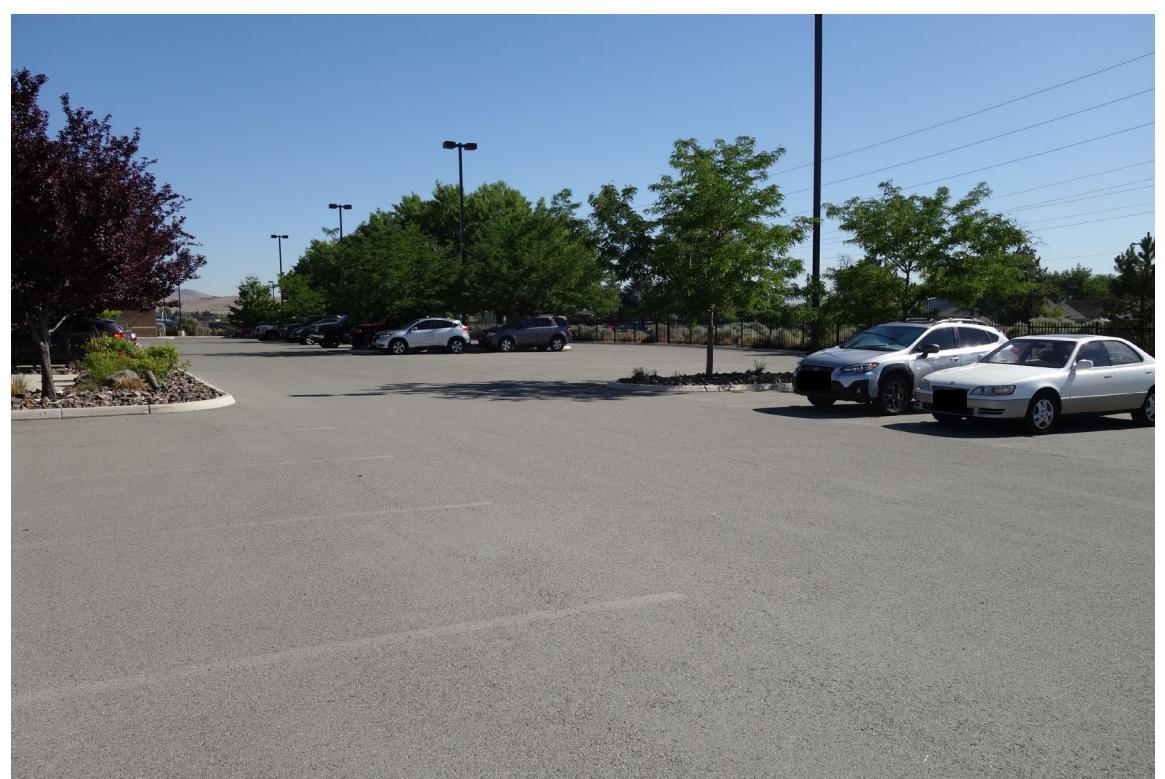
It is important to maintain the asphalt concrete paving on the site. This project would provide for minor crack filling and sealing of the paving site wide including access roads and parking areas. Striping is included in this estimate. This project should be scheduled on a 5 year cyclical basis to maintain the integrity of the paving and prevent premature failure. 34,000 square feet of asphalt area was used to generate this estimate.

Agriculture Headquarters Office Site – FCA Building #9868 Description: East Side Parking Area.

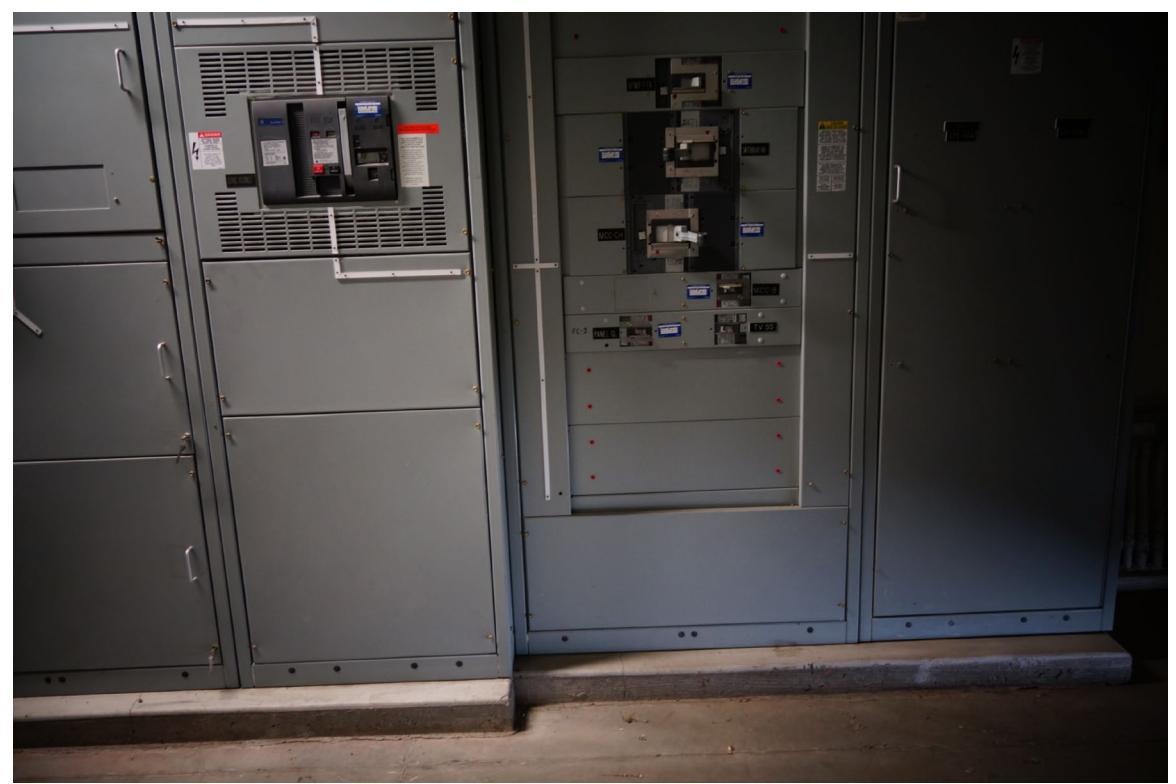
An arc flash and electrical coordination study has not been performed or is more than 5 years since the last coordination study. The latest electrical code requires coordination studies be verified and performed every 5 years and arc flash labeling on all electrical panels to provide the safety requirements for maintenance personnel. This project will perform the required coordination study, evaluation, adjustments and labeling for the building electrical distribution system.

Plant Pathology / Electrical – FCA Building #2996 Description: Main Electrical Distribution Room.

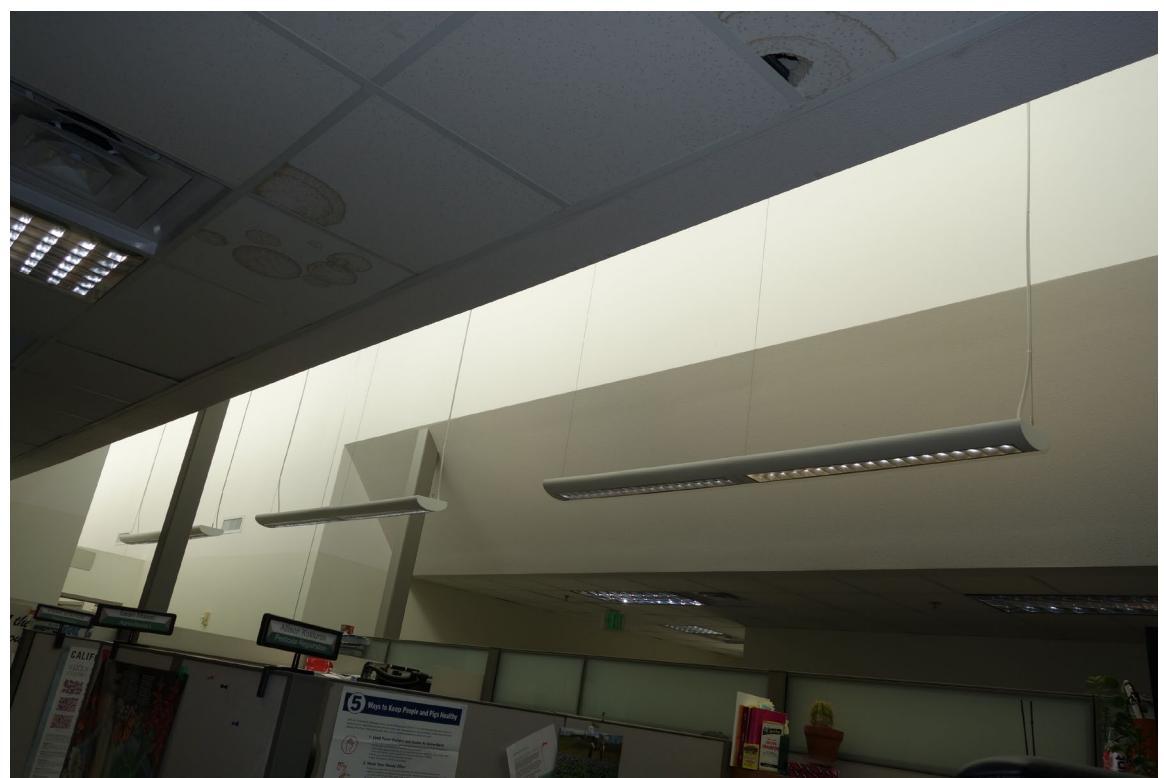
The existing clerestory glazing and flashing have numerous leaks as indicated by the stained ceiling tiles underneath. These leaks will cause premature deterioration to the building interior finishes. The entire clerestory glazing and flashing needs a comprehensive inspection and repairs to eliminate these leaks.

Headquarters & Lab – FCA Building #2989 Description: Ceiling Tile Staining from Clerestory / Roof Flashing Leaks.

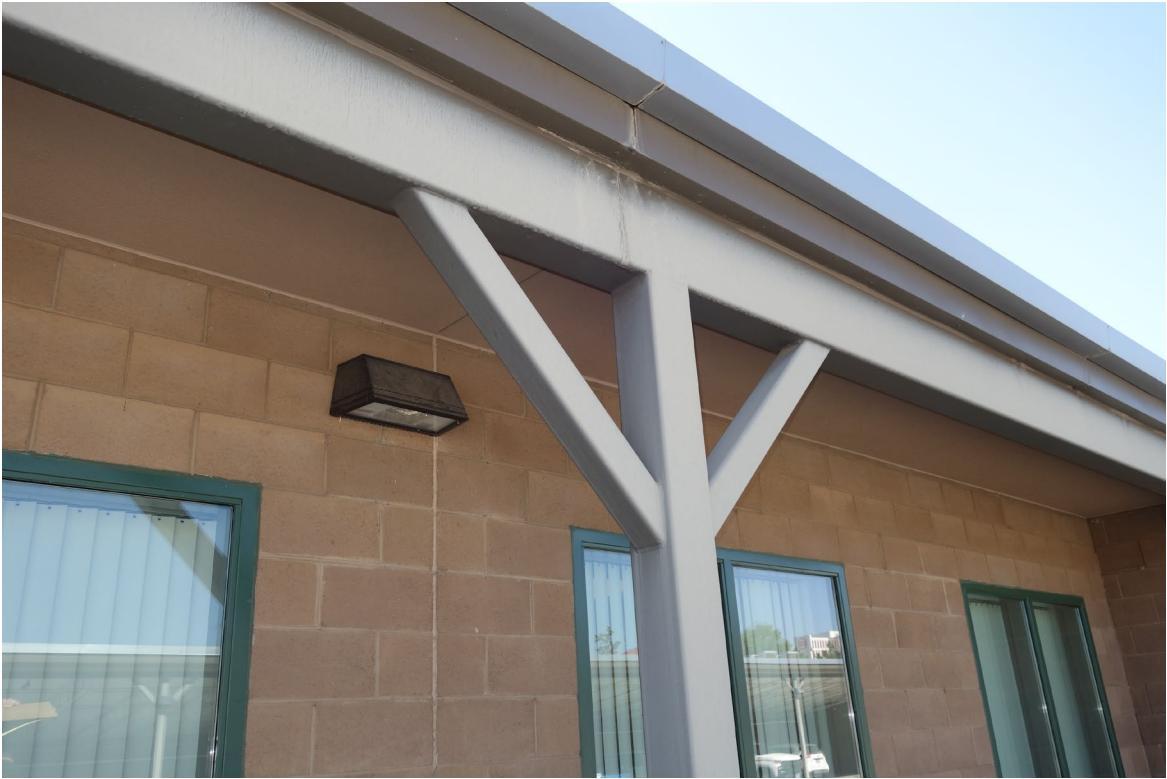
The building mounted wall pack lights appear to be original to the building. These fixtures have High Intensity Discharge (HID) lamps and are less efficient. This project would provide for the replacement of the existing wall pack fixtures with LED wall packs using the existing wiring.

Headquarters & Lab – FCA Building #2989 Description: Exterior Wall Pack Lighting Replacement.

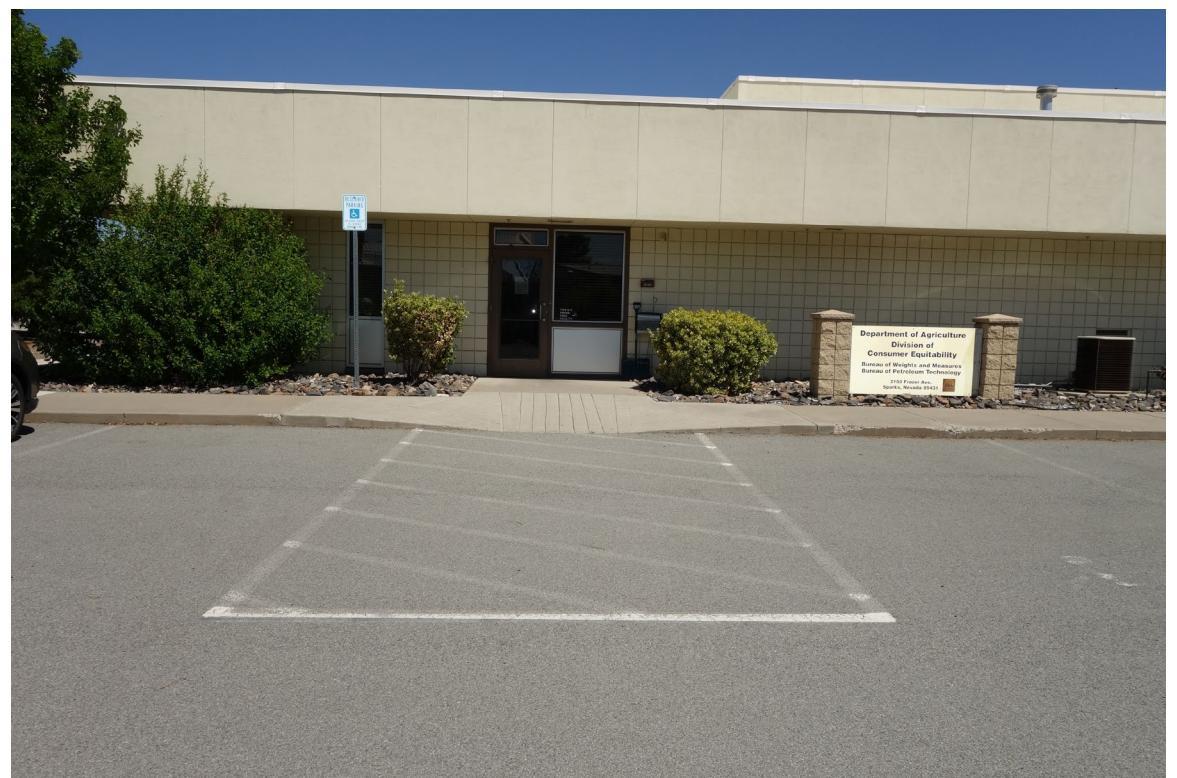
Measurement Standards – FCA Building #0274 Description: Exterior of the Building, ADA Signage Update & Striping Needed.

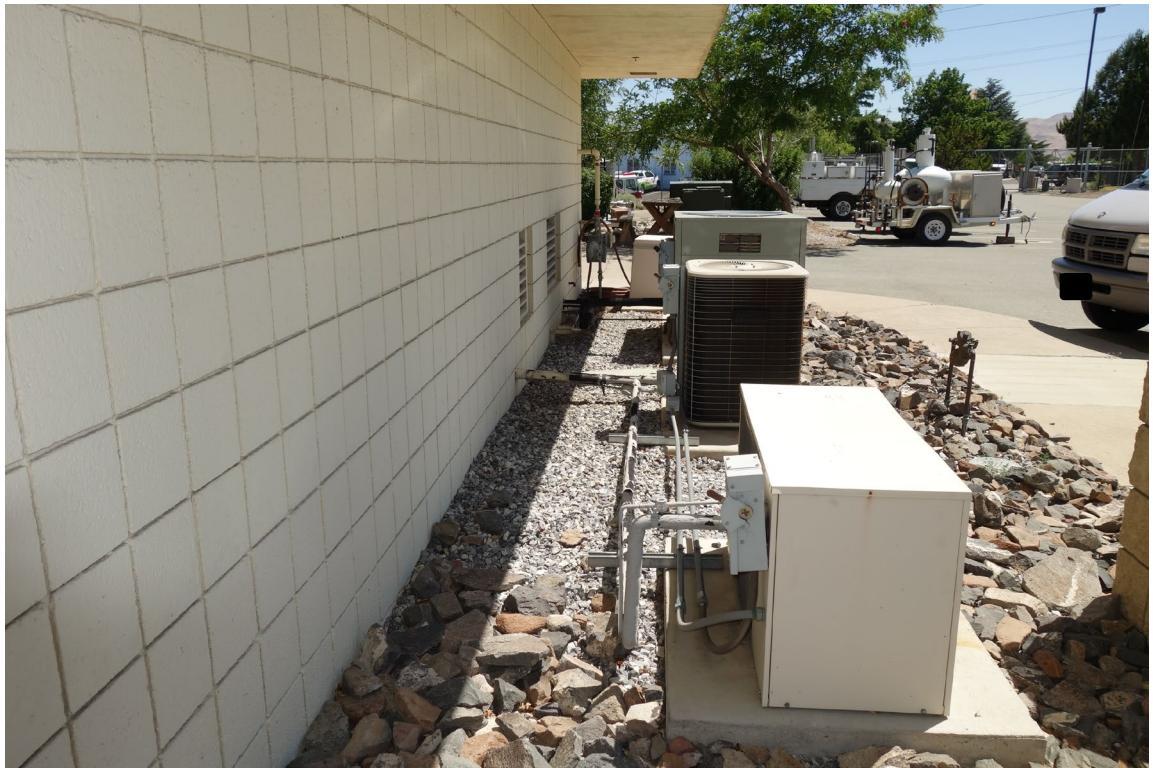
The majority of HVAC units are more than 20 years old. They have been problematic and have outdated R-22, which will be obsolete by January 1, 2020. The HVAC equipment should be scheduled for replacement within 2 - 4 years. This project would provide for the replacement of the equipment and cleaning of the existing duct work and grills. This project includes the removal and disposal of the existing equipment and all required connections to utilities.

Measurement Standards – FCA Building #0274 Description: HVAC Equipment Replacement Needed.
