State of Nevada
Department of Wildlife
Facility Condition Analysis

EASTERN REGION WILDLIFE OFFICE

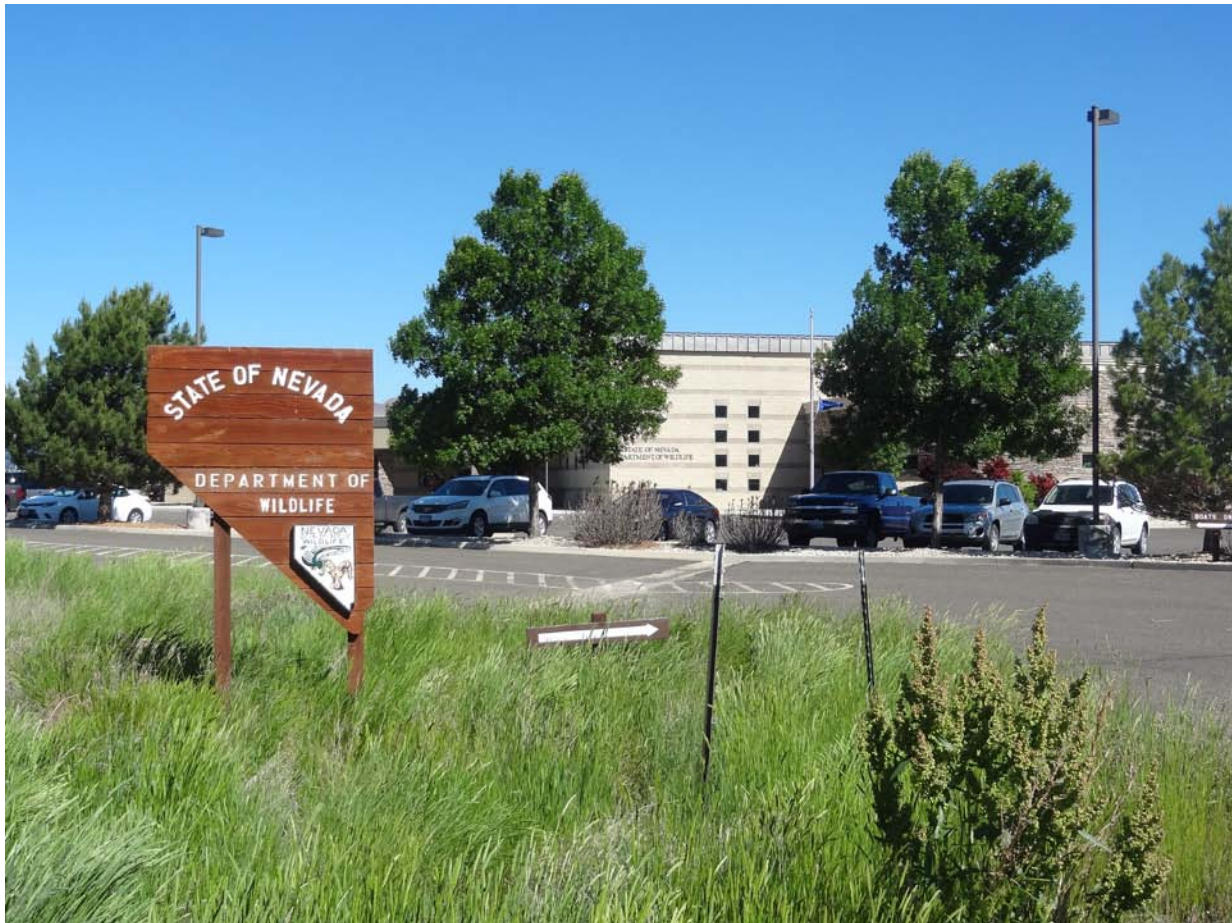
Report distributed in January, 2018

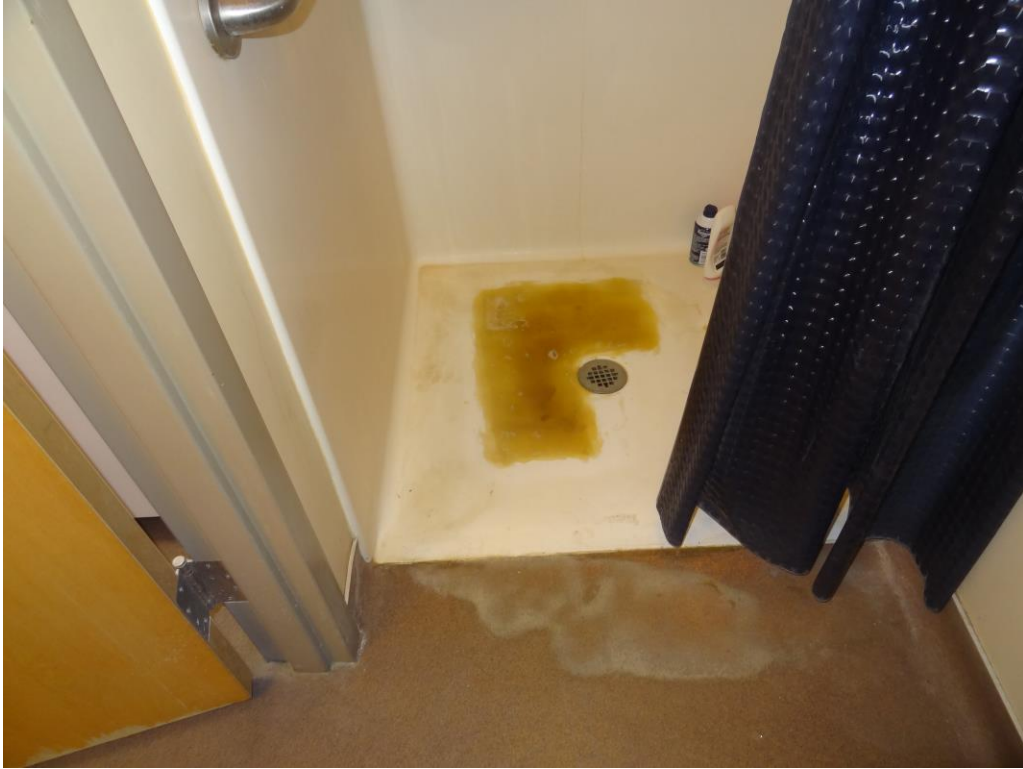
Elko Eastern Region Office - Building #2297
Description: ADA shower upgrade needed.

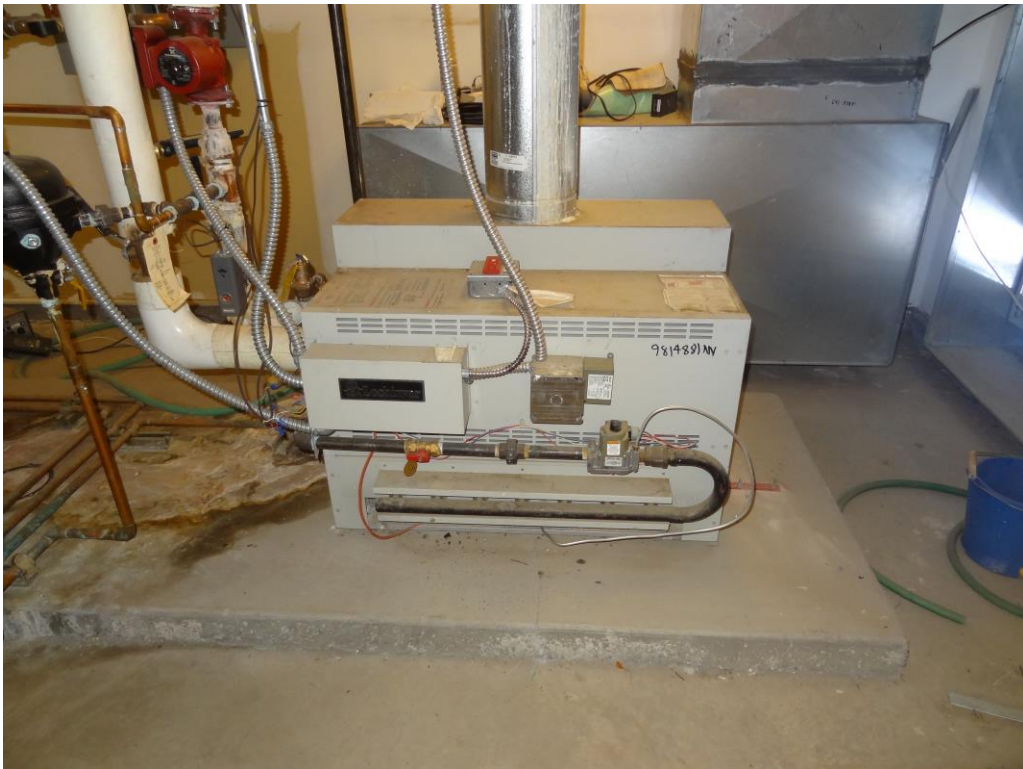
Elko Eastern Region Office - Building #2297
Description: Boiler replacement needed.

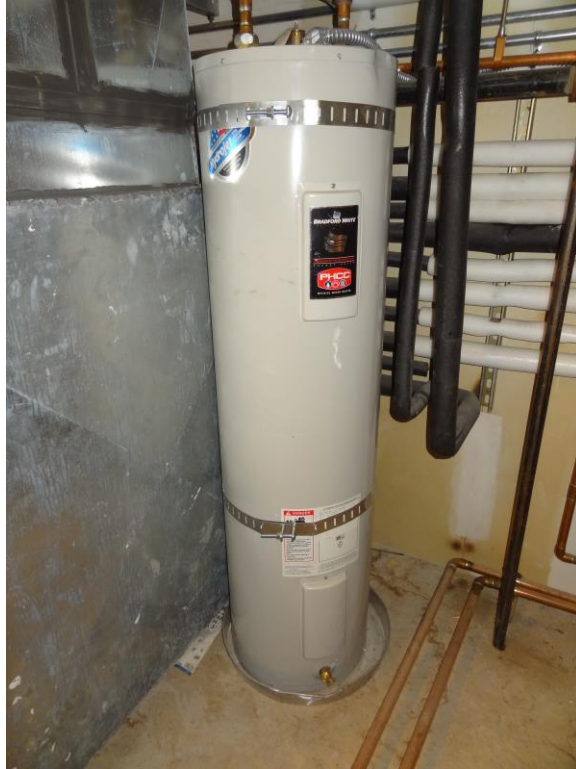
Elko Eastern Region Office - Building #2297
Description: Water heater replacement needed.

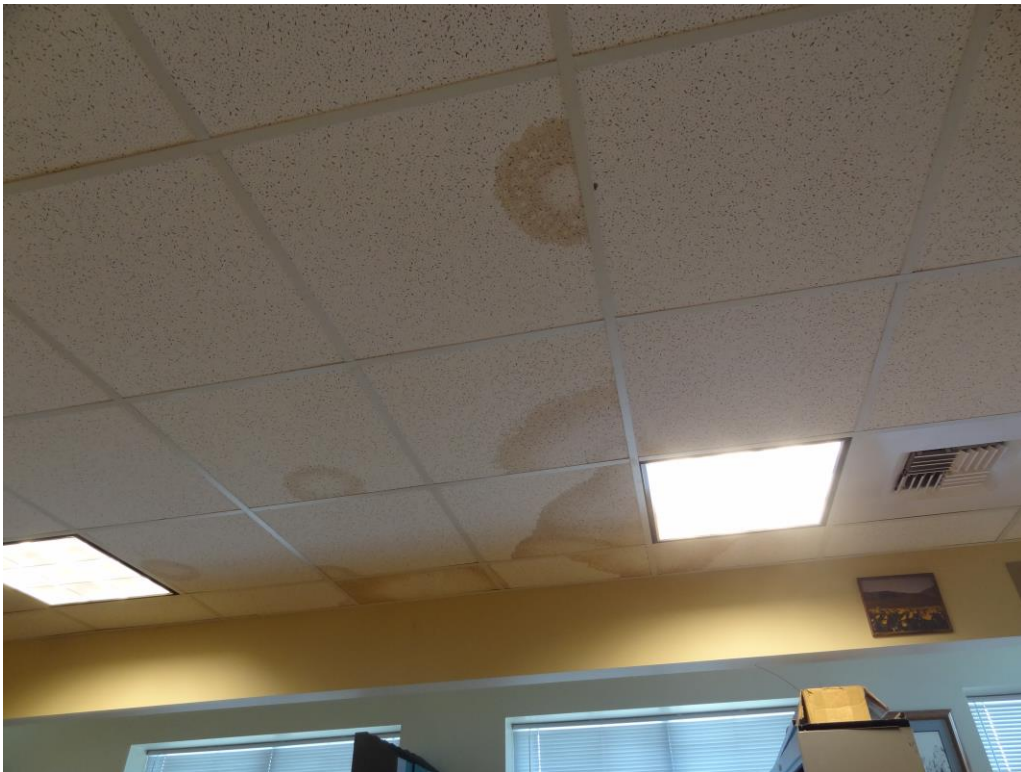
Elko Eastern Region Office - Building #2297
Description: Ceiling tile replacements needed.

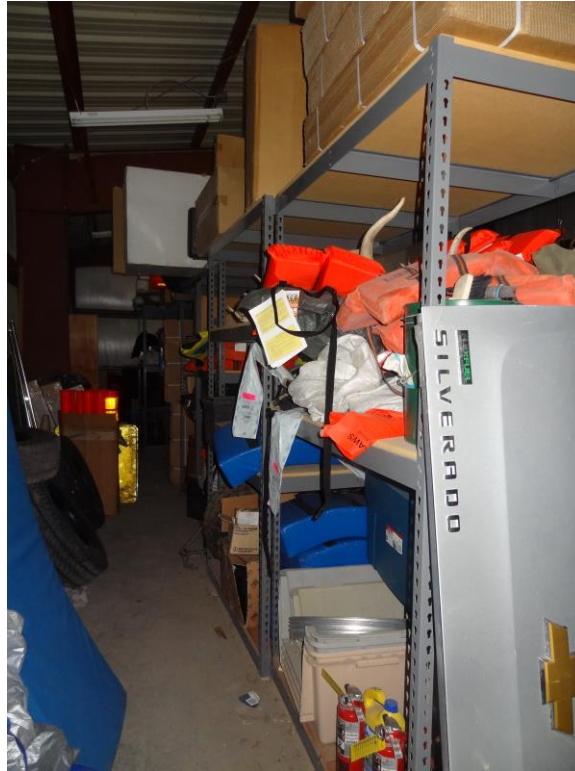
Elko Eastern Region Garage - Building #2298
Description: Housekeeping storage needed.
