State of Nevada Department of Corrections Lovelock Correctional Center Facility Condition Analysis

# LOVELOCK CORRECTIONAL CENTER

Site Number: 9962 STATE OF NEVADA PUBLIC WORKS BOARD FACILITY CONDITION ANALYSIS

Report Printed in September 2010

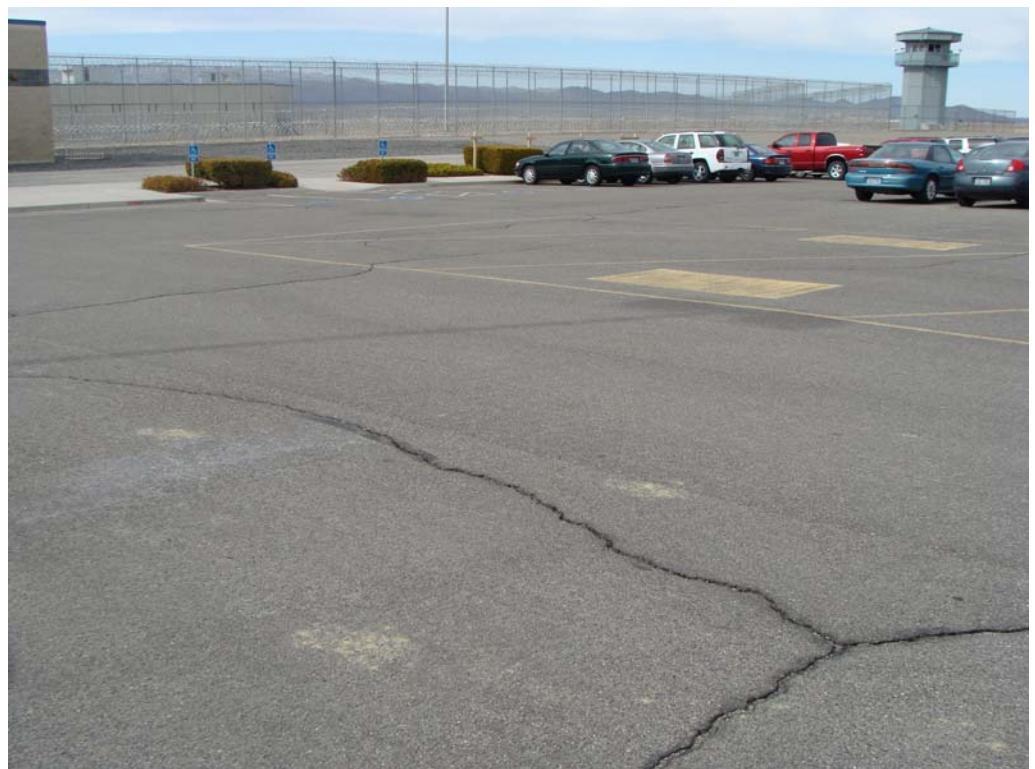
Lovelock Correctional Center Site - Site #9962 Description: Paved parking with ADA spaces in background.

It is important to maintain the asphalt concrete paving on the site. This project would provide for minor crack filling and slurry sealing of the paving site wide including access roads, parking areas, the maintenance yard, and the basketball court at Building #8. Striping is included in this estimate. This project should be scheduled on a 5 year cyclical basis to maintain the integrity of the paving and prevent premature failure. 350,000 square feet of asphalt area was used to generate this estimate.

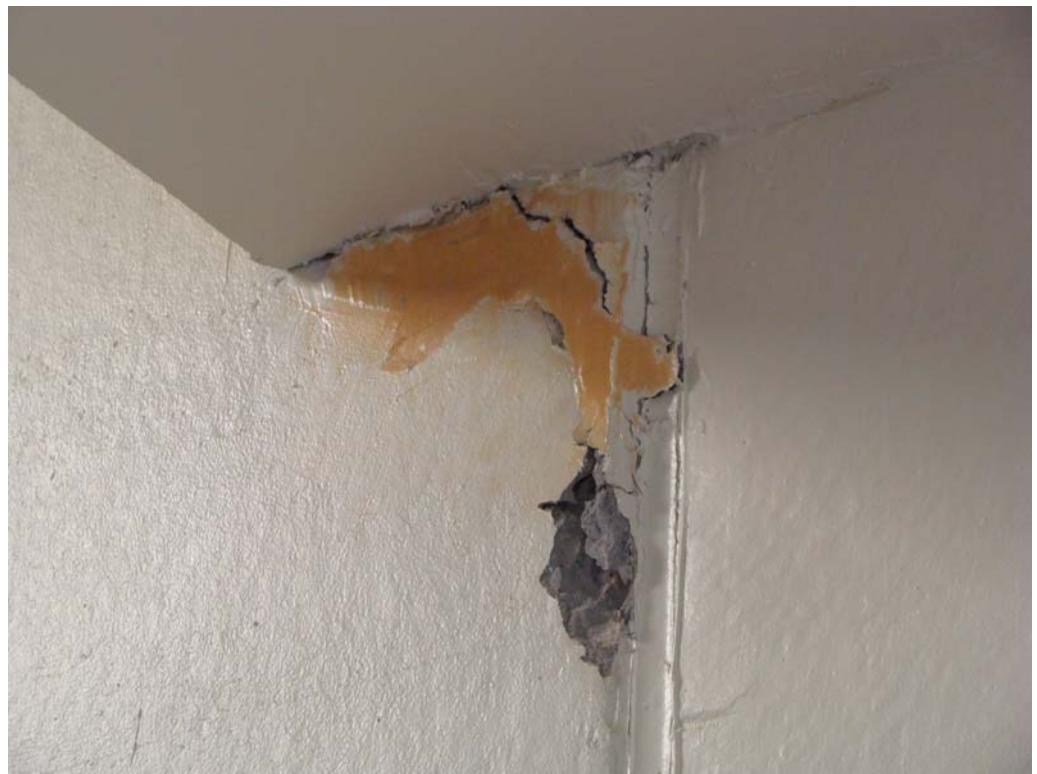
Housing Unit 6 - Building #1902 Description: Damage to interior concrete wall.

The interior finishes are in fair condition. This project would provide funding to maintain the interior of the building. Included in the cost is painting the walls and ceilings, sealing the exposed masonry, repairing cracks in the masonry and replacing grout and caulk as needed. An epoxy-based paint should be utilized in wet areas for durability. It is recommended that the interior of the building be painted, sealed and repaired in the next 2-3 years and that this project be scheduled on a cyclical basis to maintain the integrity of the structure.

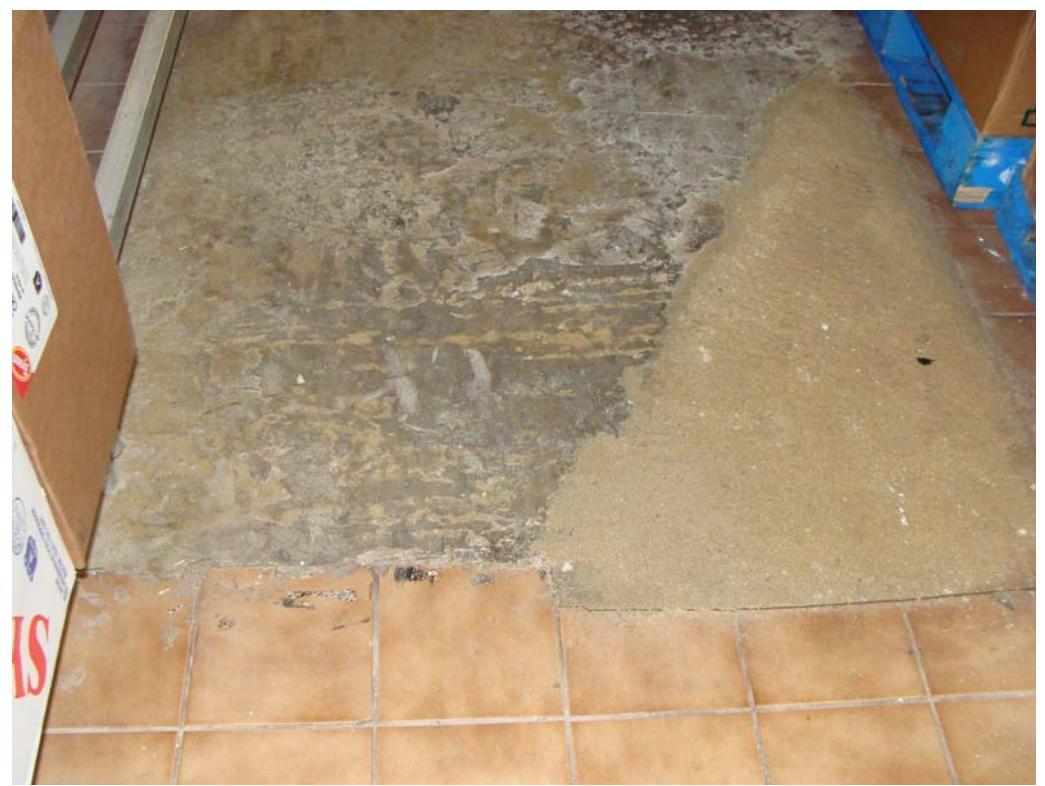
Building 03 – Gym / Culinary / Dining - Building #1696 Description: Damaged floor tile.

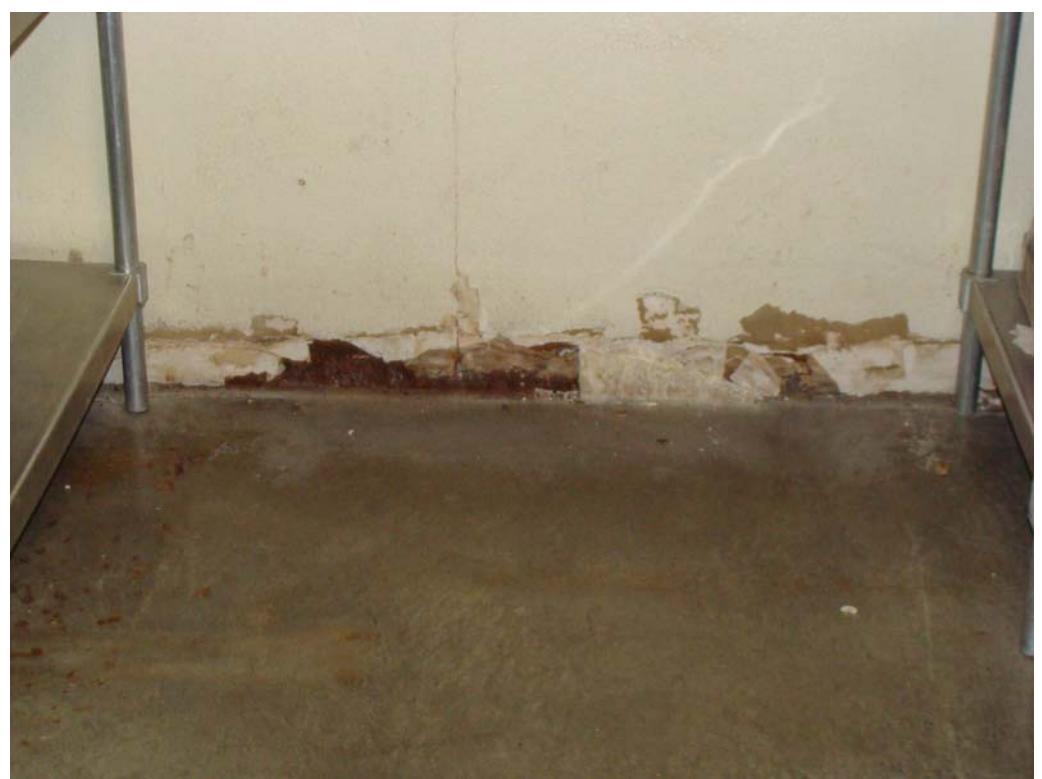
Building 03 – Gym / Culinary / Dining - Building #1696 Description: Water damaged wall.

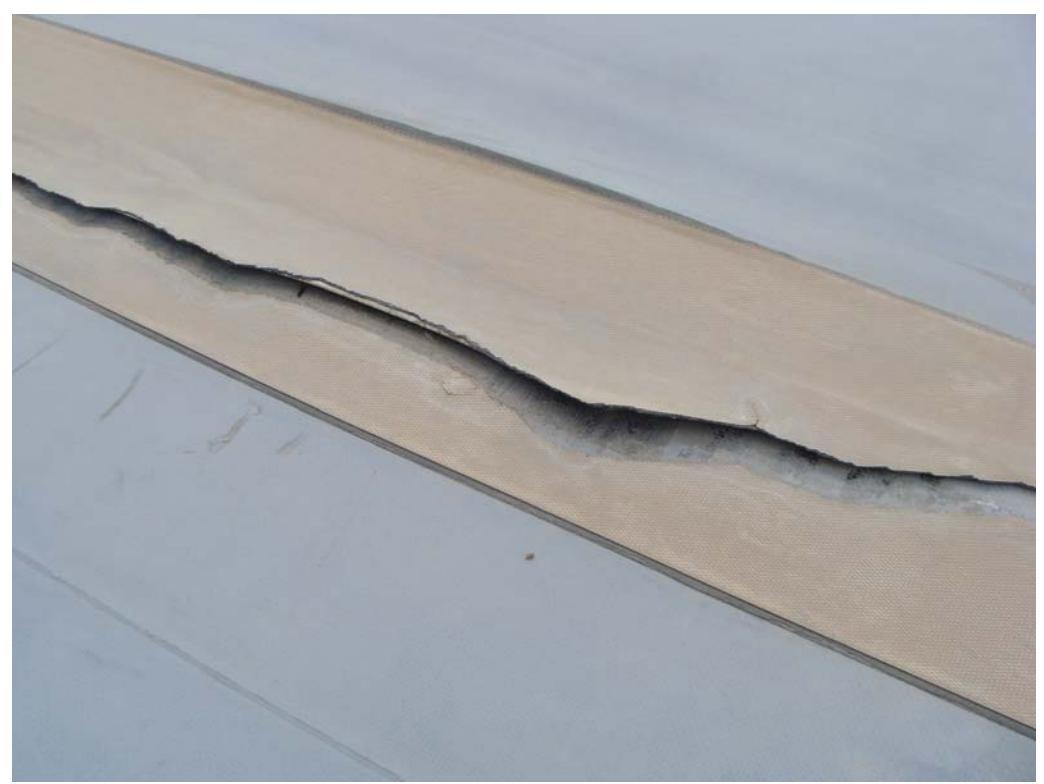
Housing Unit 3 - Building #1692 Description: Roof membrane damage.
