State of Nevada
Department of Conservation & Natural Resources
Division of Forestry Volunteer Fire station
Facility Condition Analysis

NDF VOLUNTEER FIRE STATION

Deeth, Elko County, Nevada

Building Number: 0600
FACILITY CONDITION ANALYSIS

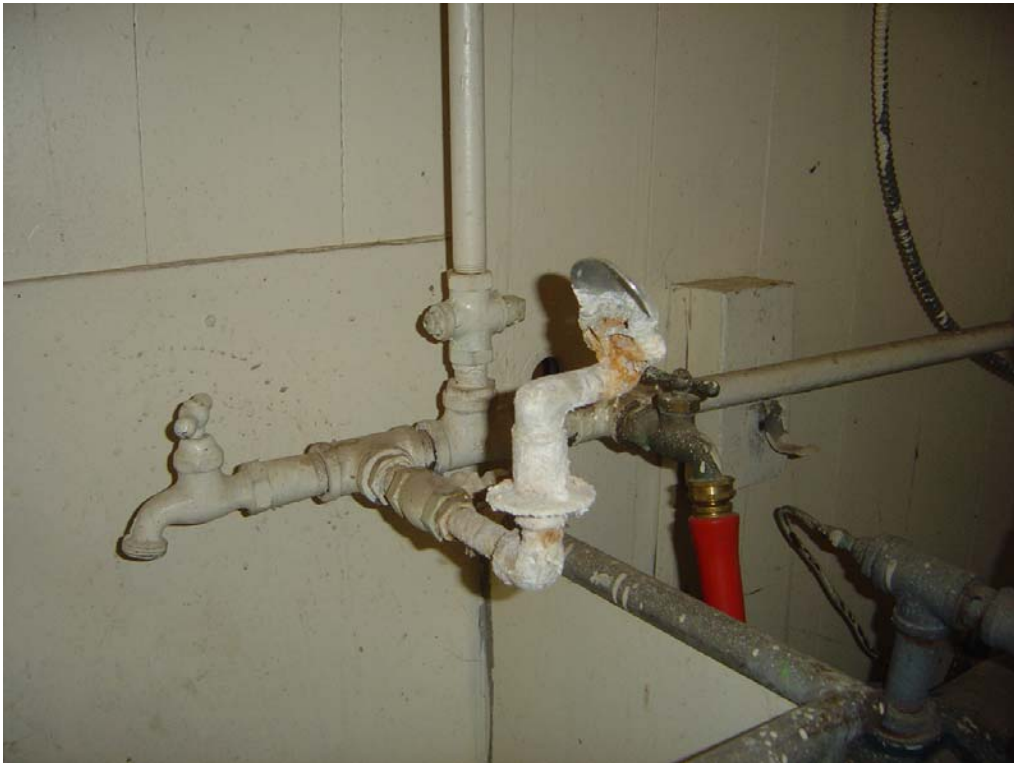
NDF Volunteer Fire Station - Building #0600
Description: Corroded drinking fountain.

SINK AND WATER FOUNTAIN REPLACEMENT

The sink and water fountain is severely damage from corrosion. This project would provide for a water softener and the replacement of the sink and water fountain.

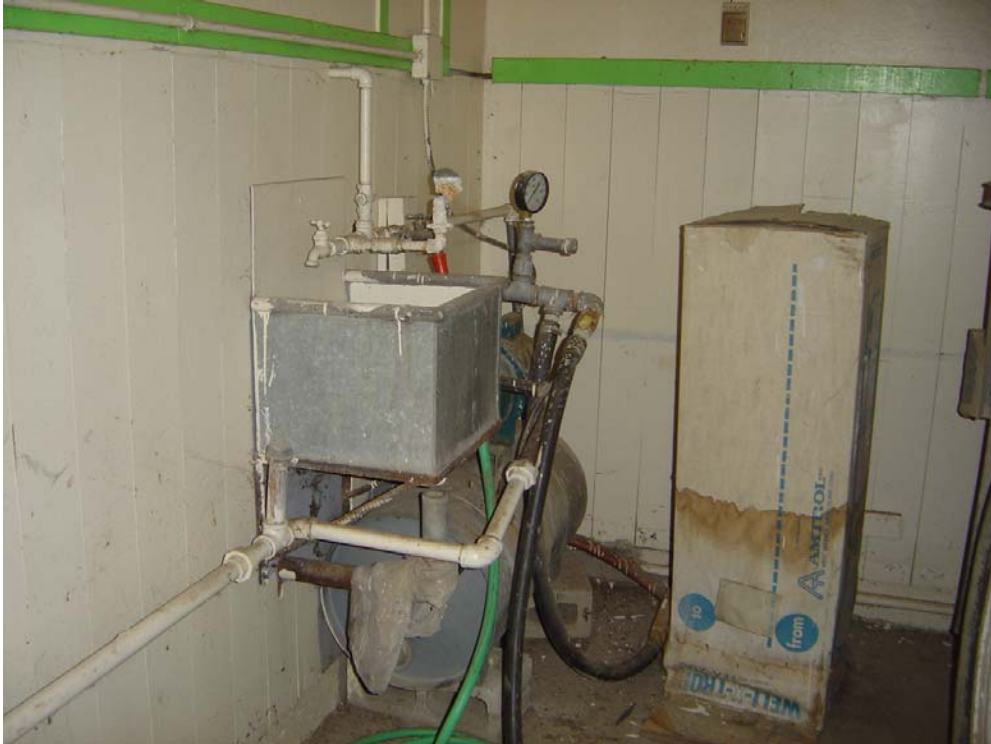
NDF Volunteer Fire Station - Building #0600
Description: Sink/Water service area.

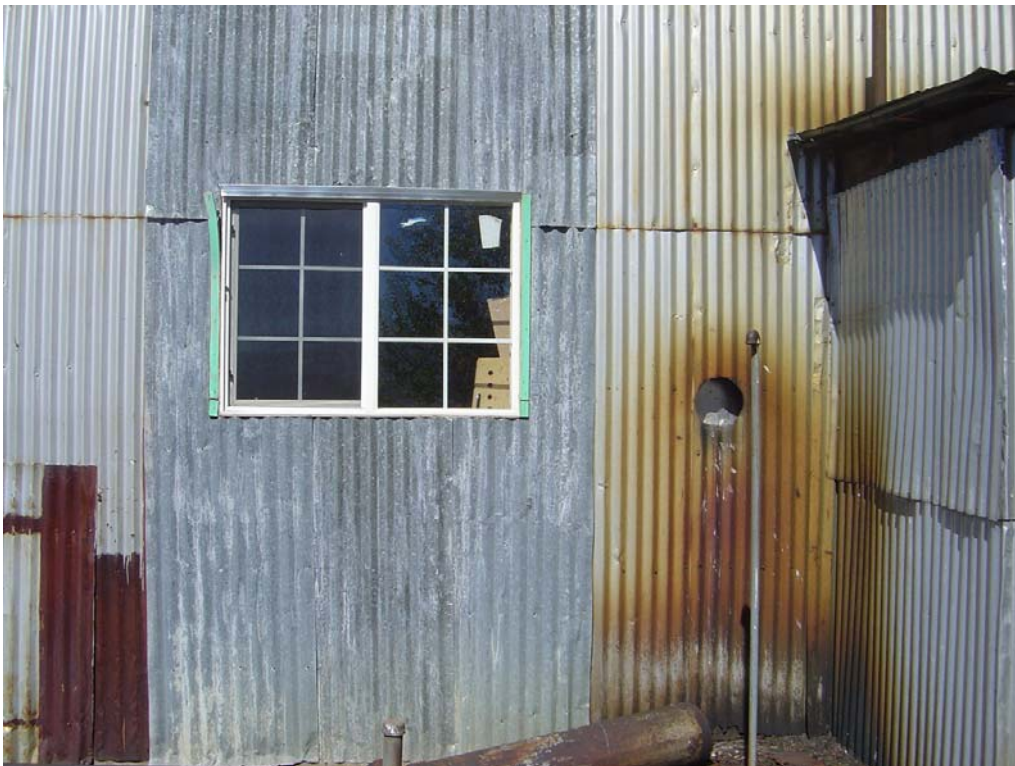
NDF Volunteer Fire Station - Building #0600
Description: Exterior view of damaged siding.

REPLACE METAL SIDING

The metal siding and roof is deteriorated, has tears and been patched. This project would provide funding for new metal insulated rim siding to be install on the on the sides and roof.
