DETR LAS VEGAS OFFICE SITE

Site Number: 9837

**STATE OF NEVADA PUBLIC WORKS DIVISION
FACILITY CONDITION ANALYSIS**

Report distributed in December 2022

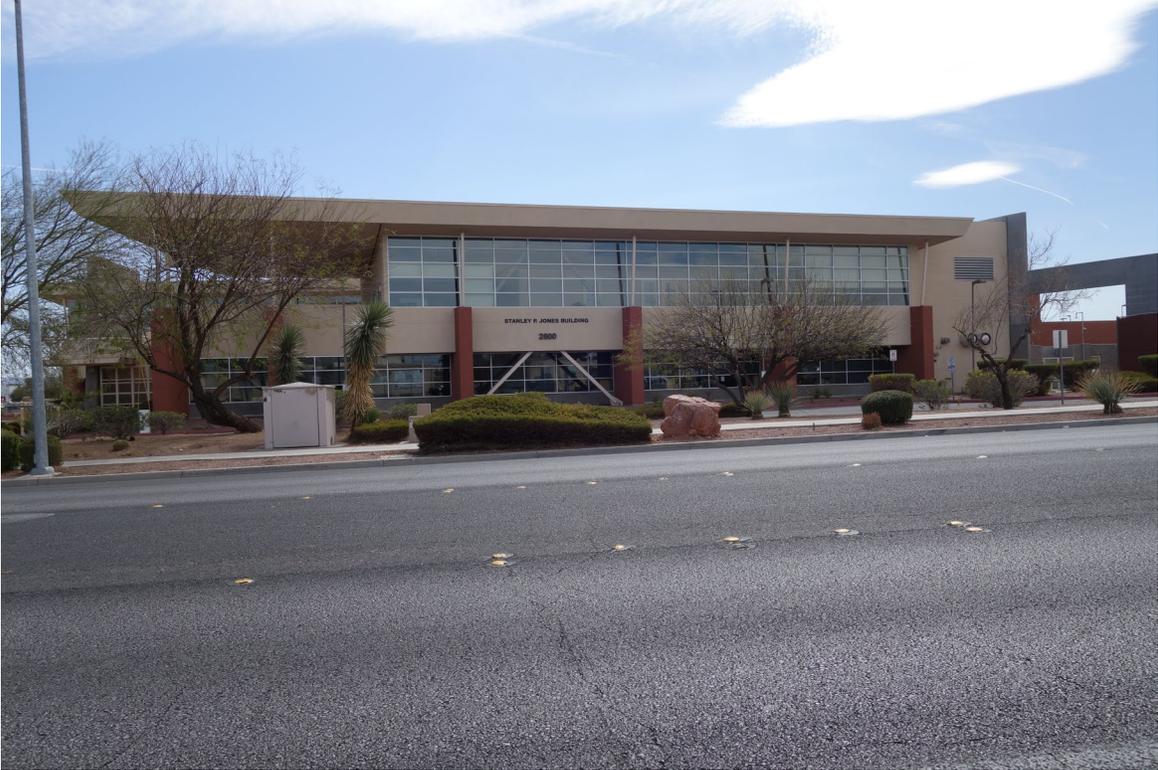
DETR Las Vegas Office Site – FCA Site #9837
Description: Building Exterior from E. St. Louis Ave.

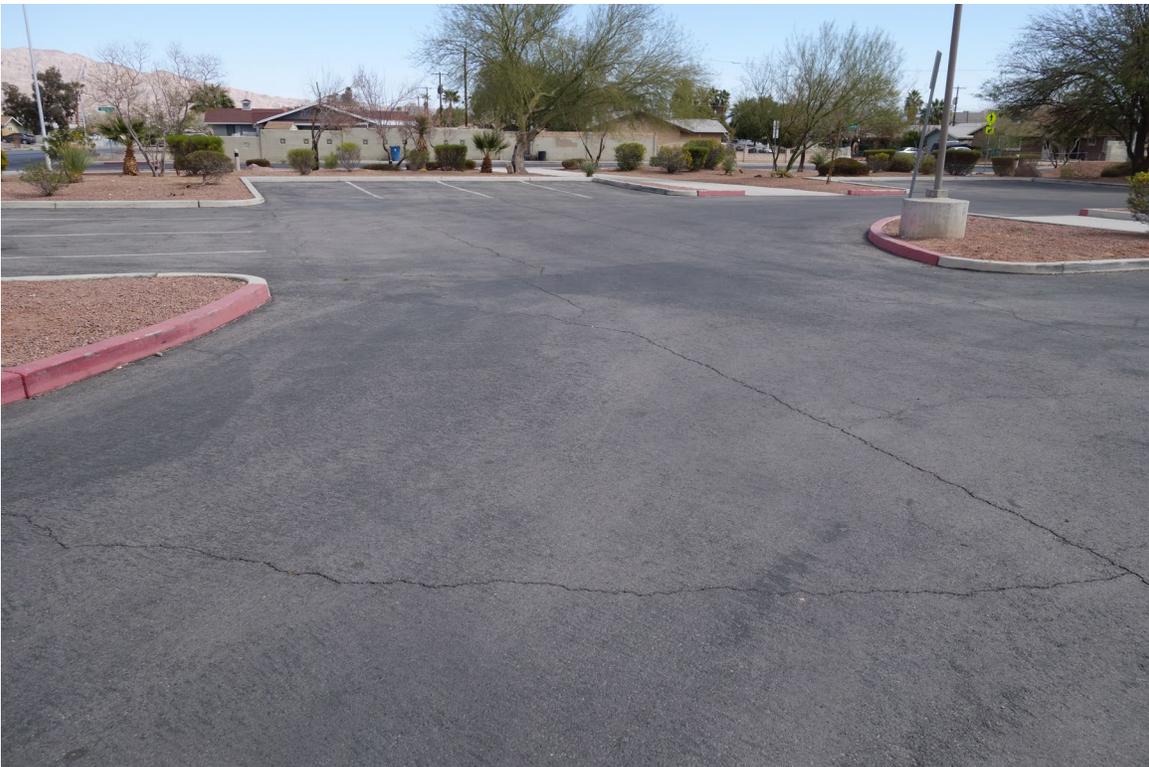
The existing asphalt concrete paving on site is in fair condition. It was re-sealed in 2011. This project would provide for crack filling as needed and sealing and striping the pavement in the next 3 - 4 years. This project should be completed on a cyclical basis based on environmental conditions and use.

DETR Las Vegas Office Site – FCA Site #9837
Description: Public Parking Re-sealing Needed.

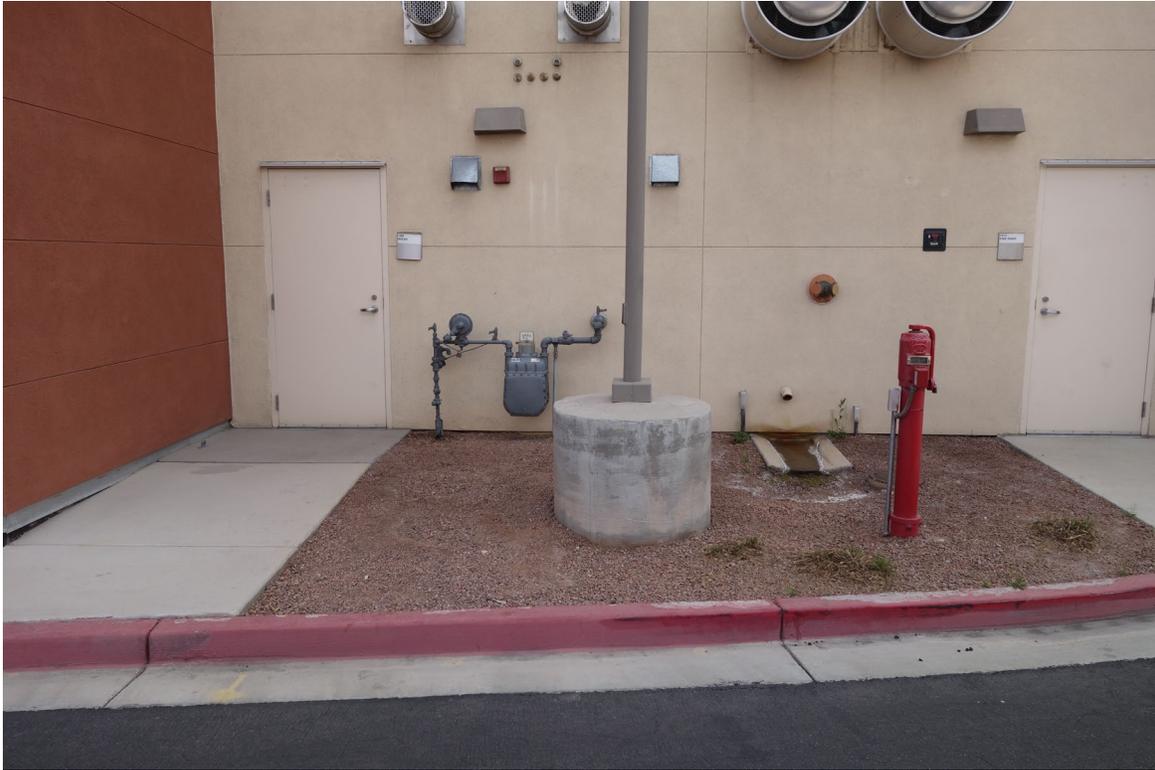
DETR Las Vegas Office - FCA Building #2565
Description: Seismic Gas Isolation Valve Needed.

This project would provide for the installation of a seismic gas shut-off valve on the main gas service piping prior to entering the building. Alternately, for propane services or a site gas services with a single site metering station, consider installation at the tank or main meter service if it feeds multiple buildings. This estimate is based on the manufacturer Pacific Seismic Products or approved equal, equipped with the optional Model MS remote monitoring switch (to be interfaced with the direct digital control system and/or with an audible alarm). The gas piping immediately adjacent to the seismic gas valve shall be secured to the building utilizing unistrut channel bracing.

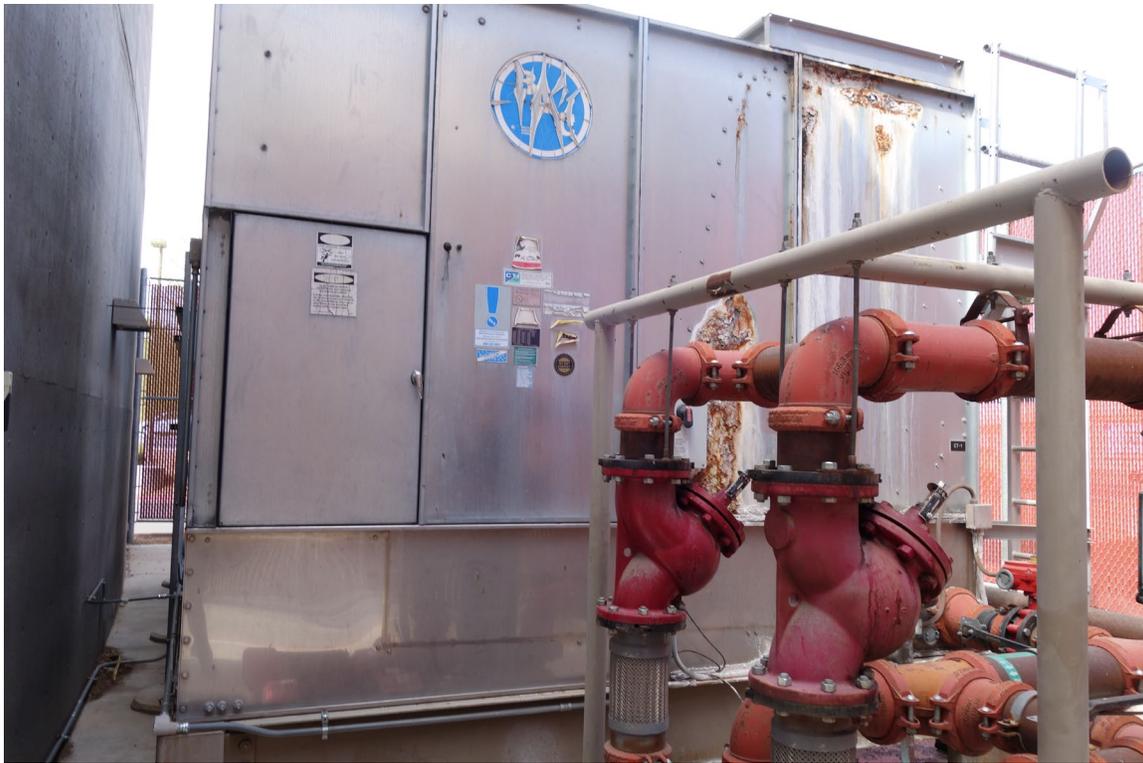
The existing HVAC central plant is original equipment built in 2006. According to the American Society of Heating Refrigeration and Air conditioning Engineers (ASHRAE), typical large HVAC equipment life expectancy is 20 - 25 years. Planning should take place for a complete replacement of the central plant and the datacenter cooling systems. The cooling towers are failing and reaching the end of their useful life, the datacenter cooling system operates on R-22 and the chillers are operating with a transition R-22 refrigerant called R-407c. The R-22 refrigerant in the datacenter cooling system is no longer EPA compliant and its production was phased out completely January 1, 2020. This project recommends a complete replacement of the central plant equipment including the chillers, cooling towers, boilers, pumps and the datacenter cooling system in the next 4 - 6 years. The urgency for replacement is driven by the condition of the cooling towers. It would provide for replacing the existing equipment with new, high efficiency equipment and cleaning the existing duct work and grilles. This project includes removal and disposal of the existing HVAC equipment and all required connections to utilities.

DETR Las Vegas Office - FCA Building #2565
Description: Planning for HVAC Central Plant Replacement Recommended.
