State of Nevada  
Department of Employment, Training & Rehabilitation  
Department of Employment, Training & Rehabilitation Las Vegas Office  
Facility Condition Analysis

# DETR LAS VEGAS OFFICE

2800 East St. Louis  
Las Vegas, Nevada 89104

**Site Number: 9837**  
**STATE OF NEVADA PUBLIC WORKS DIVISION**  
**FACILITY CONDITION ANALYSIS**

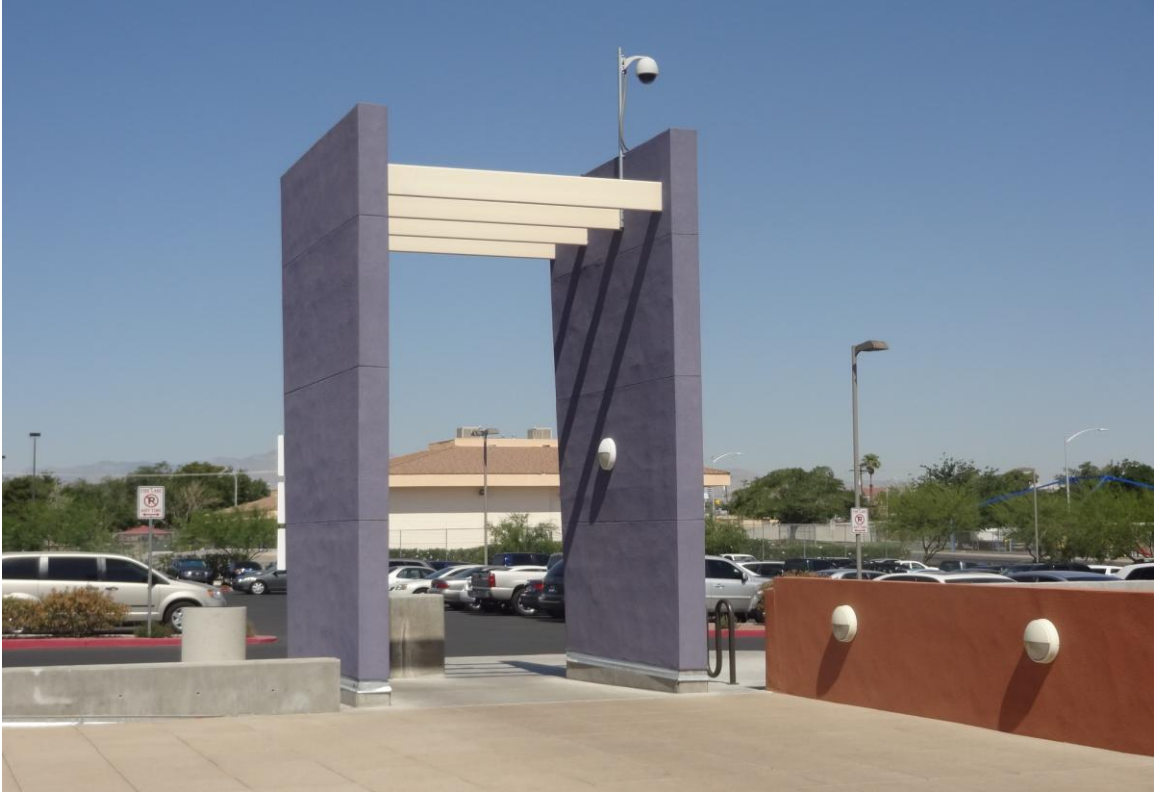
**DETR Las Vegas Office Site – FCA Site #9837**  
**Description: Employee entrance and parking area.**

The existing asphalt concrete paving on site is in good condition. This project would provide for crack filling as needed and sealing and striping the pavement in the next three to four years. This project should be completed on a cyclical basis based on environmental conditions and use.

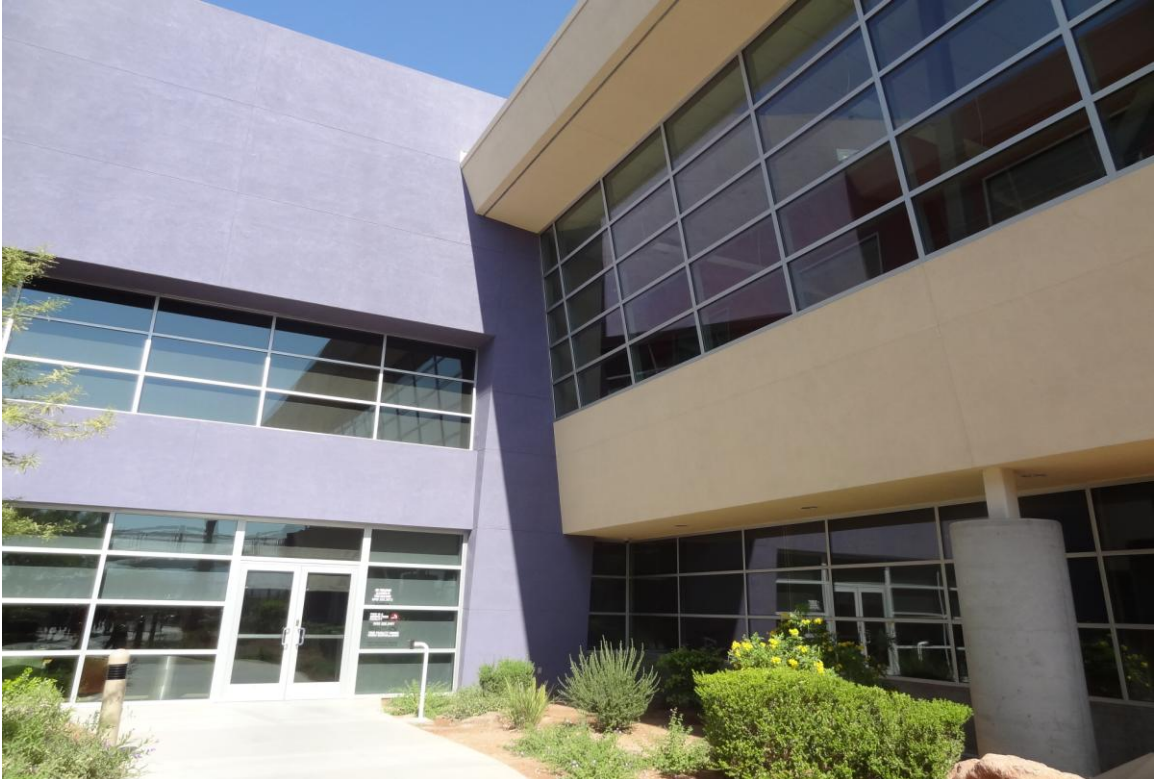
**DETR Las Vegas Office - FCA Building #2565**  
**Description: Public entrance into the facility.**

It is important to maintain the finish, weather resistance, and appearance of the building. This project would provide funding to protect the exterior building envelope, other than the roof, including painting, staining, or other applied finishes, and caulking around windows, flashing, fixtures, and other penetrations to maintain the building in good, weather tight condition. This project will protect the building envelope and is recommended on a cyclical basis based on environmental conditions.

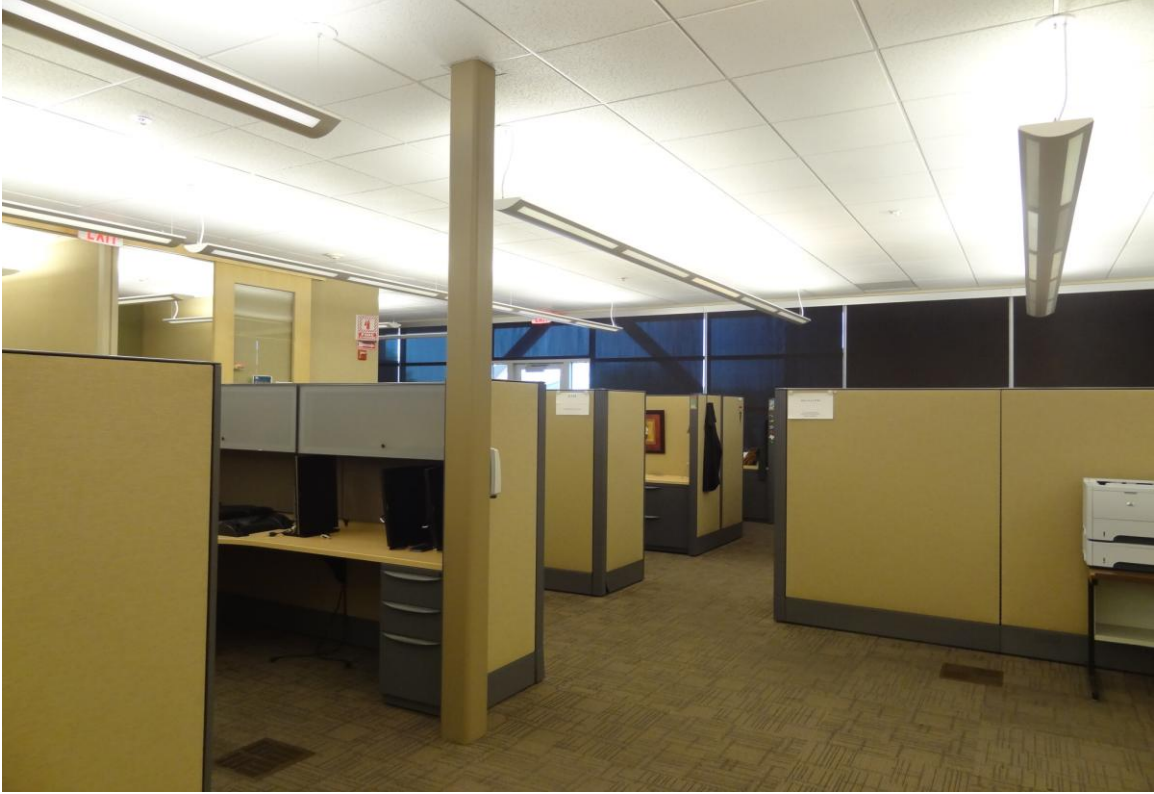
DETR Las Vegas Office - FCA Building #2565  
Description: Typical interior office space.

The interior finishes are in good condition. It is recommended that the interior walls and ceilings be painted at least once in the next four to six years and every 5 to 7 years thereafter to maintain the integrity of the interior of the building. Prior to painting, all surfaces should be repaired and prepped. An epoxy-based paint should be utilized in wet areas for durability.

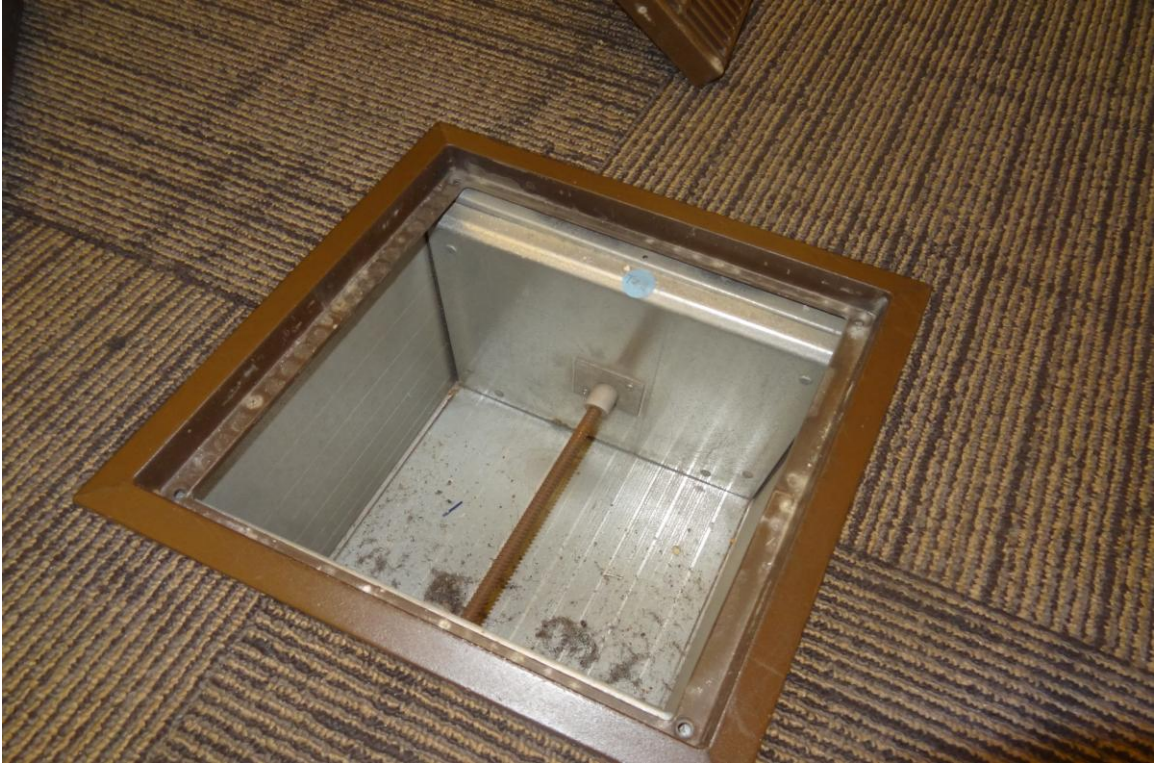
DETR Las Vegas Office - FCA Building #2565  
Description: Access floor vent.
