State of Nevada  
Department of Wildlife  
Laughlin Wildlife Field Office  
Facility Condition Analysis

# LAUGHLIN WILDLIFE FIELD OFFICE

**Site Number: 9838**  
**STATE OF NEVADA PUBLIC WORKS DIVISION**  
**FACILITY CONDITION ANALYSIS**

Report Printed in November 2012

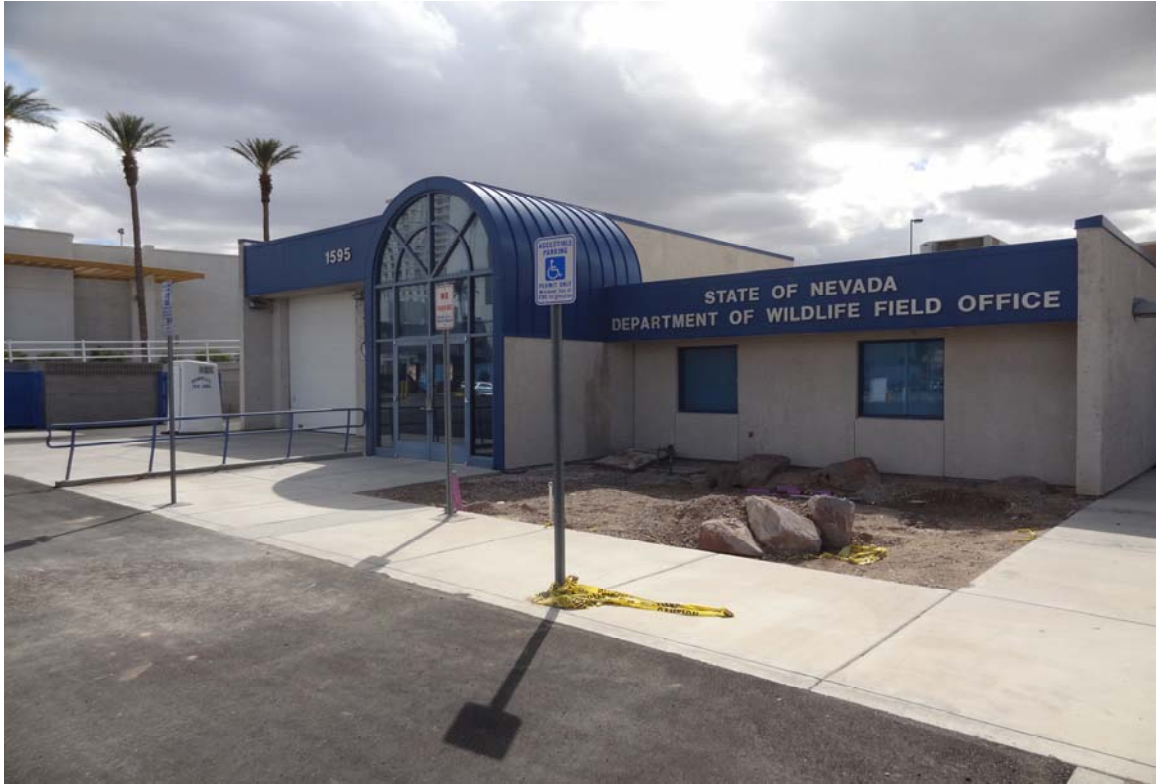
Laughlin Wildlife Field Office Site - Site #9838  
Description: Paved parking and public entrance.

It is important to maintain the asphalt concrete paving on the site. This project would provide for minor crack filling and sealing of the paving site wide including access roads, parking areas and vehicle storage areas. Striping is included in this estimate. This project should be scheduled on a 5 year cyclical basis to maintain the integrity of the paving and prevent premature failure. 32,000 square feet of asphalt area was used to generate this estimate.

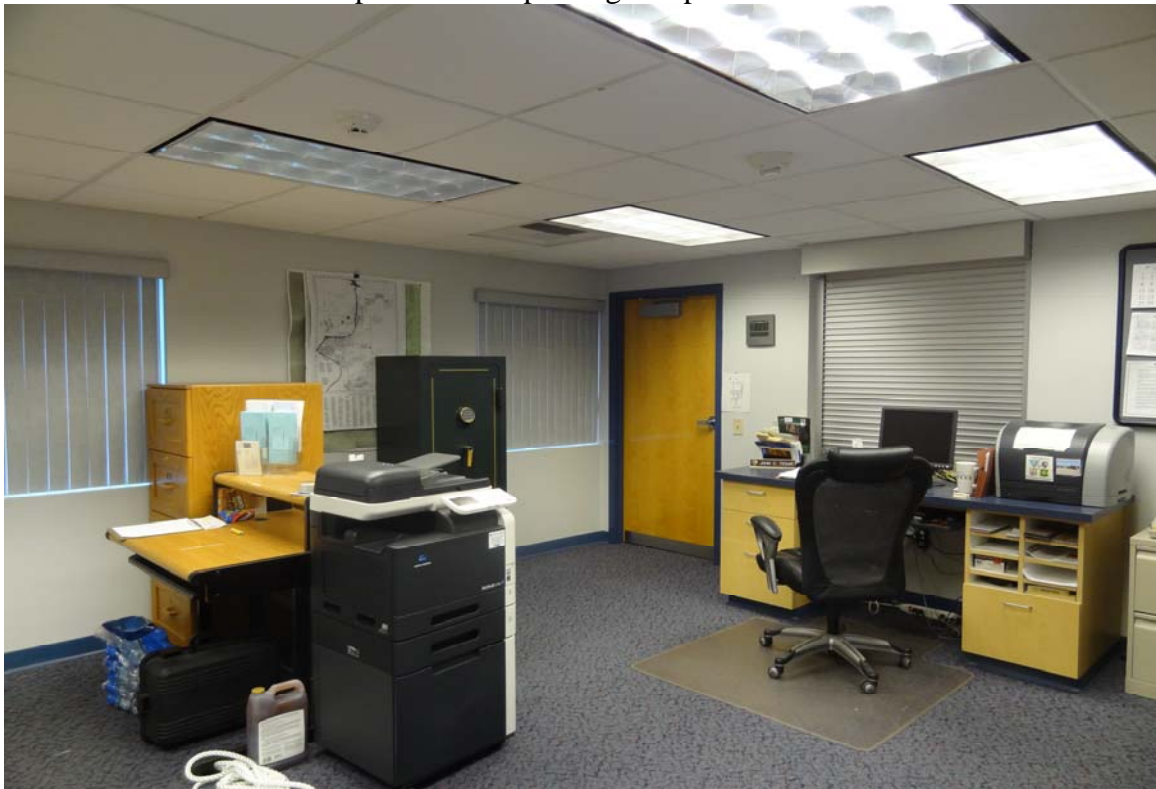
Laughlin Wildlife Field Office - Building #2470  
Description: Interior of the office area.

The interior finishes are in fair condition. It is recommended that the interior walls and ceilings be painted at least once in the next 3-4 years and that this project be scheduled on a cyclical basis to maintain the integrity of the structure. Prior to painting, all surfaces should be repaired and prepped. An epoxy-based paint should be utilized in wet areas for durability.

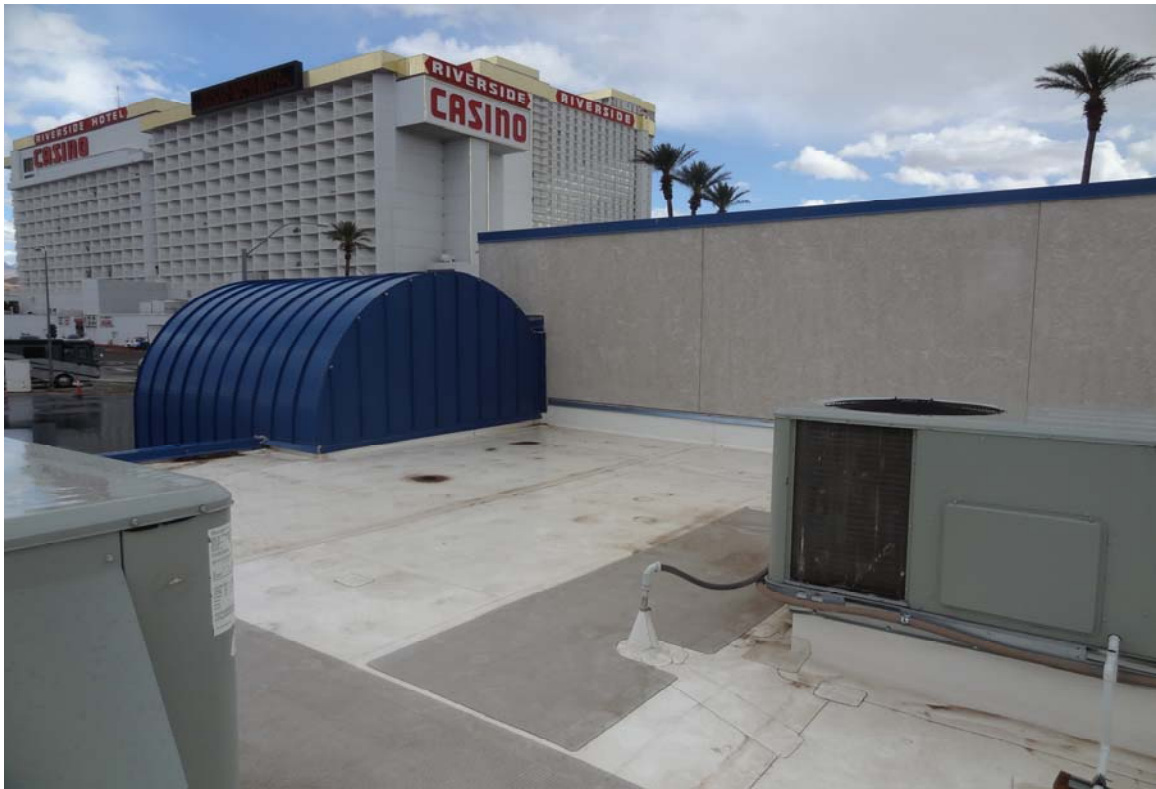
Laughlin Wildlife Field Office - Building #2470  
Description: View of the roof & equipment.

The two HVAC roof top AC units serving the Vehicle Storage Garage are over 20 years old. They are not energy efficient and have reached the end of their expected and useful life. This project would provide for installation of two new HVAC units and cleaning of the existing duct work and grilles. This project includes removal and disposal of the existing HVAC units and all required connections to utilities.

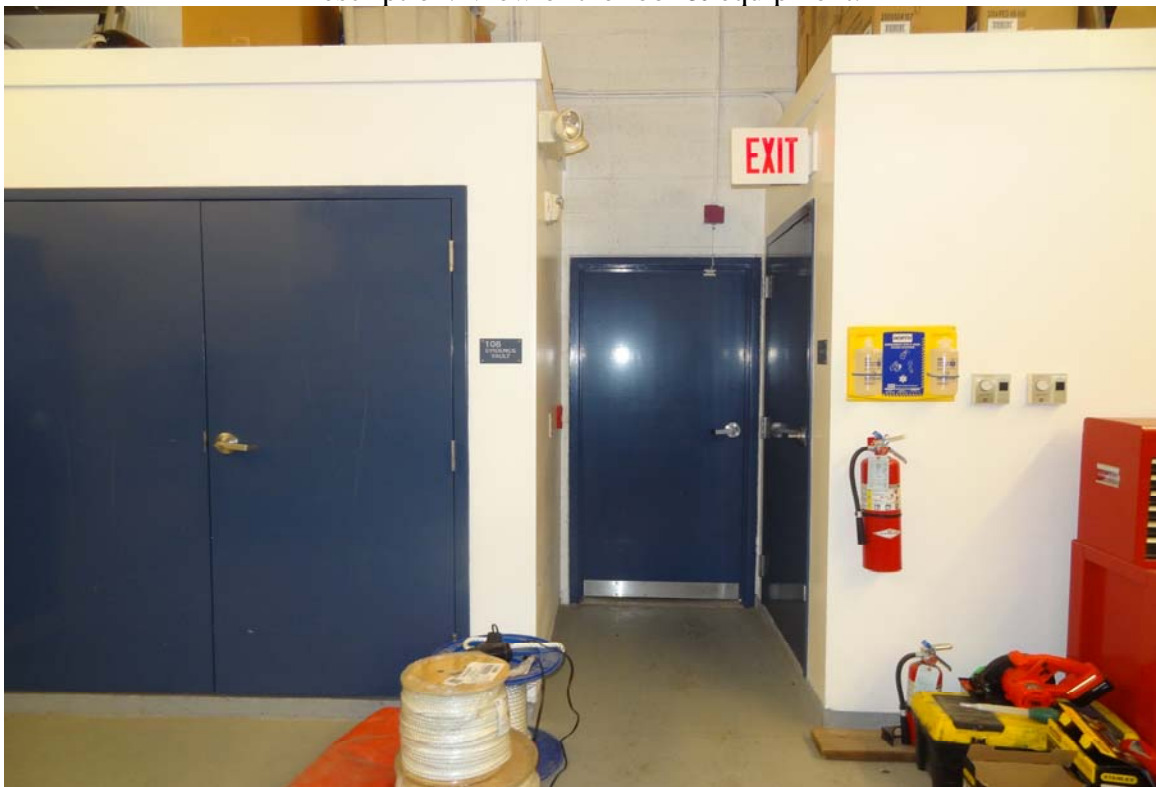
Laughlin Wildlife Field Office - Building #2470  
Description: Interior of the apparatus bay.
