State of Nevada  
Department of Cultural Affairs  
State Library and Archives Division  
Nevada State Library and Archives  
Facility Condition Analysis

# NEVADA STATE LIBRARY AND ARCHIVES

**Site Number: 9866**  
**STATE OF NEVADA PUBLIC WORKS BOARD**  
**FACILITY CONDITION ANALYSIS**

Report Printed in March 2011

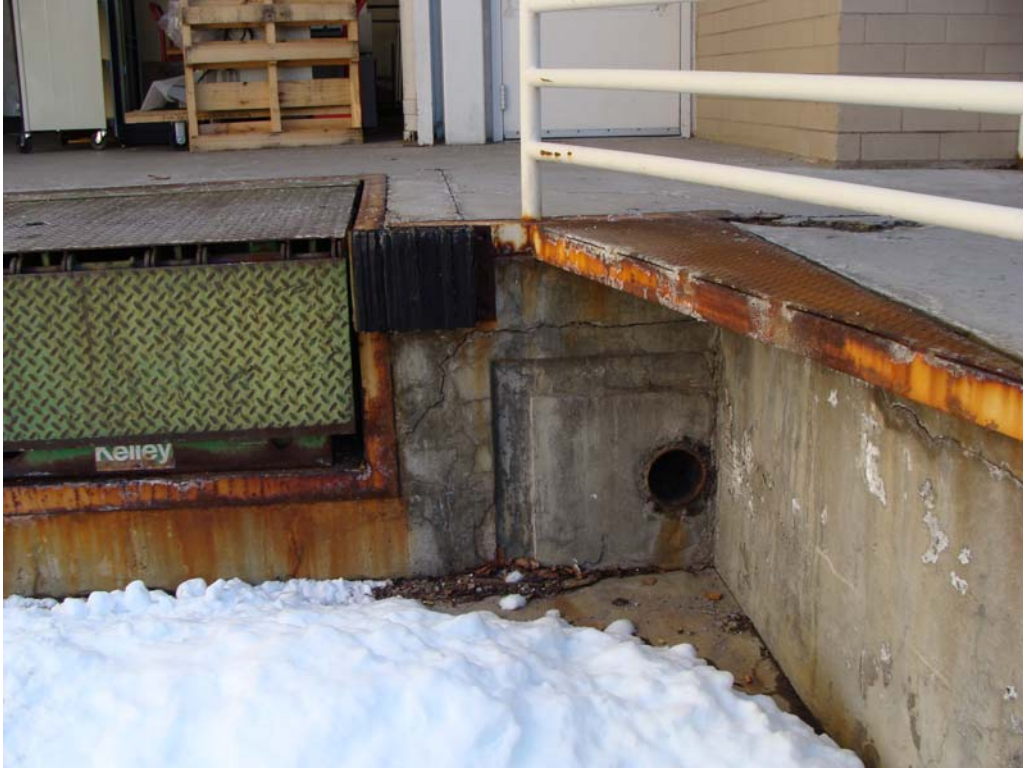
Nevada State Library & Archives - Building #1675  
Description: Loading dock in need of rehabilitation.

The existing loading dock on the west side of the building is damaged. There is exposed rebar and severely cracked concrete including the stairs and side retaining walls. This project would provide for the removal and replacement of the damaged steel, concrete walls, sidewalk and handrails. The existing lift is not included in this estimate.

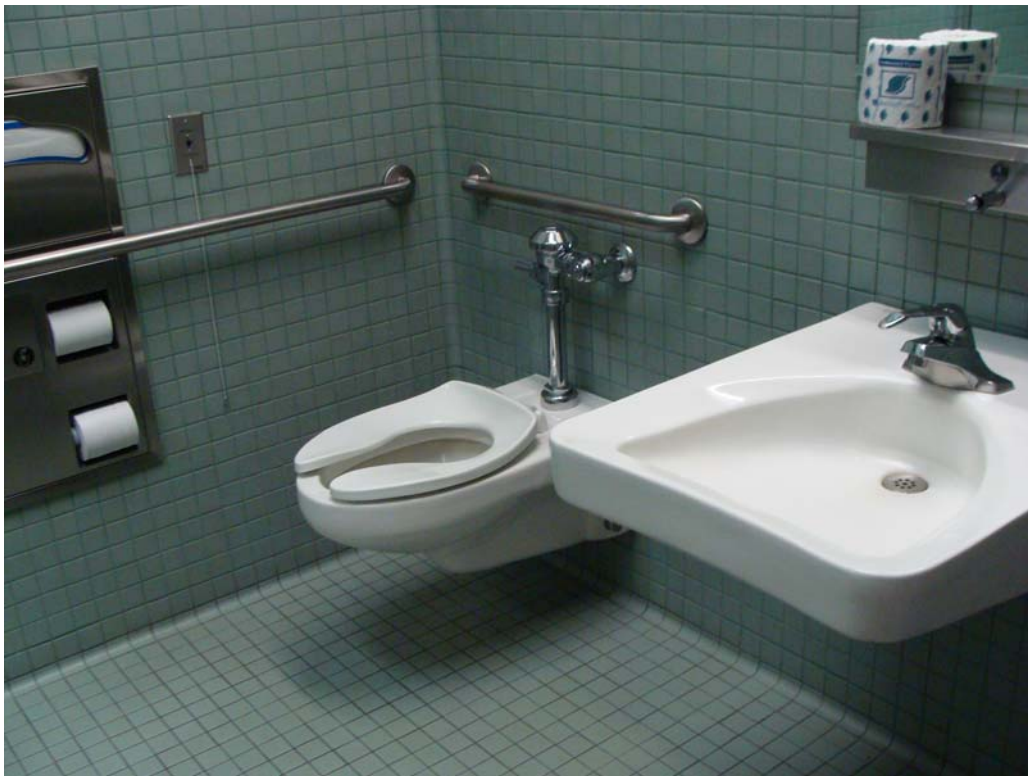
Nevada State Library & Archives - Building #1675  
Description: ADA unisex restroom, note flush handle on wrong side.

The designated ADA restrooms on the first floor of the Library are not compliant. The doors do not meet space requirements, the flush handles are on the wrong side of the water closets and the pipes under the sinks are not protected. This project would provide for an automatic door opener for each door, automatic flush valves for the water closets and pipe protection. A survey by an ADA professional should be conducted to verify these findings and determine whether any additional work is required. NRS 338.180, IBC - 2006, ICC/ANSI A117.1 - 2003 and the most current version of the Americans with Disabilities Act Accessible Guidelines (ADAAG) were used as a reference for this project.

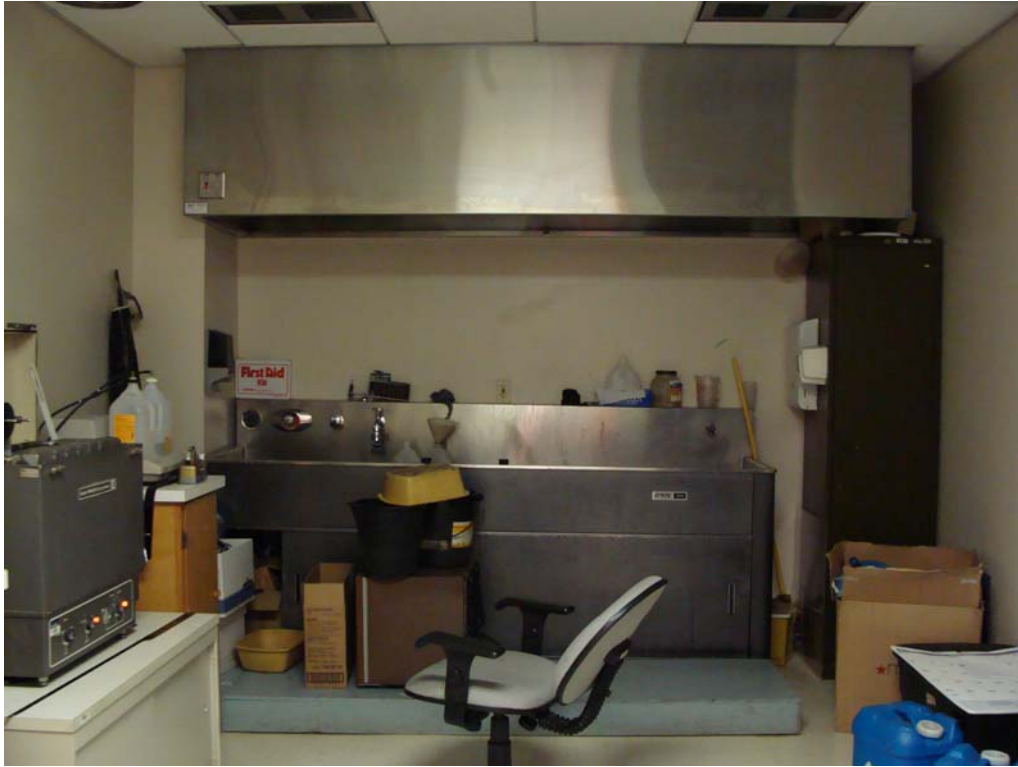
Nevada State Library & Archives - Building #1675  
Description: Non-operational fume hood.

The existing fume hood is non-operational and the existing venting for the microfiche machine does not work properly. This project will provide funds for the repair of the fume hood exhaust fan and microfiche venting system.

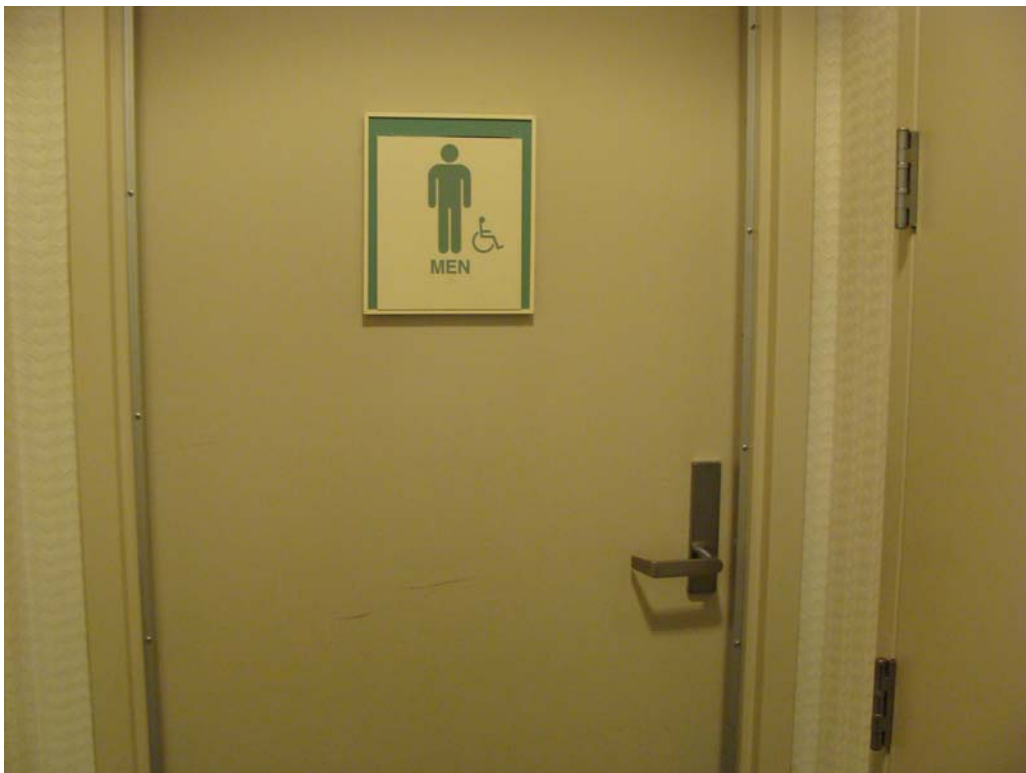
Nevada State Library & Archives - Building #1675  
Description: ADA signage in wrong location.

Americans with Disabilities Act (ADA) regulations pertaining to building access has established building signage criteria for permanent spaces in buildings. The criteria includes: sign mounting heights and locations; character heights and proportions; raised and Braille characters/pictograms; and sign contrast and finish. The signage in this facility does not comply with this criteria. It is recommended that applicable signage be installed where required. NRS 338.180, IBC - 2006, ICC/ANSI A117.1 - 2003 and the most current version of the Americans with Disabilities Act Accessible Guidelines (ADAAG) were used as a reference for this project.

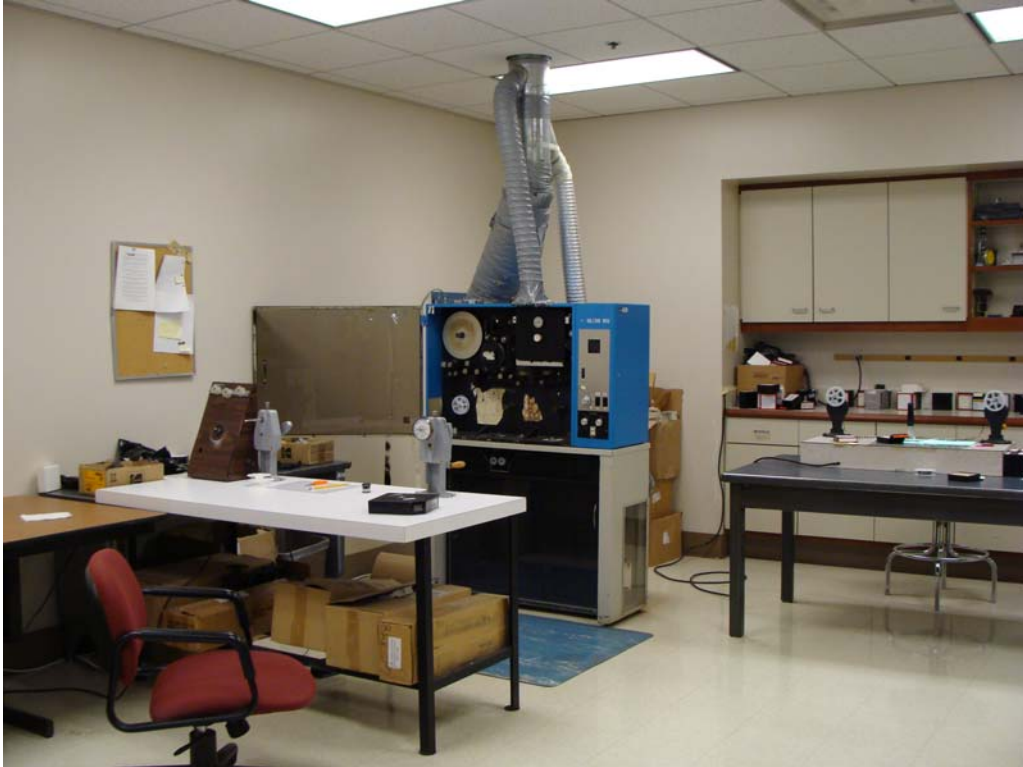
Nevada State Library & Archives - Building #1675  
Description: Ammonia processing machine in need of venting modifications.

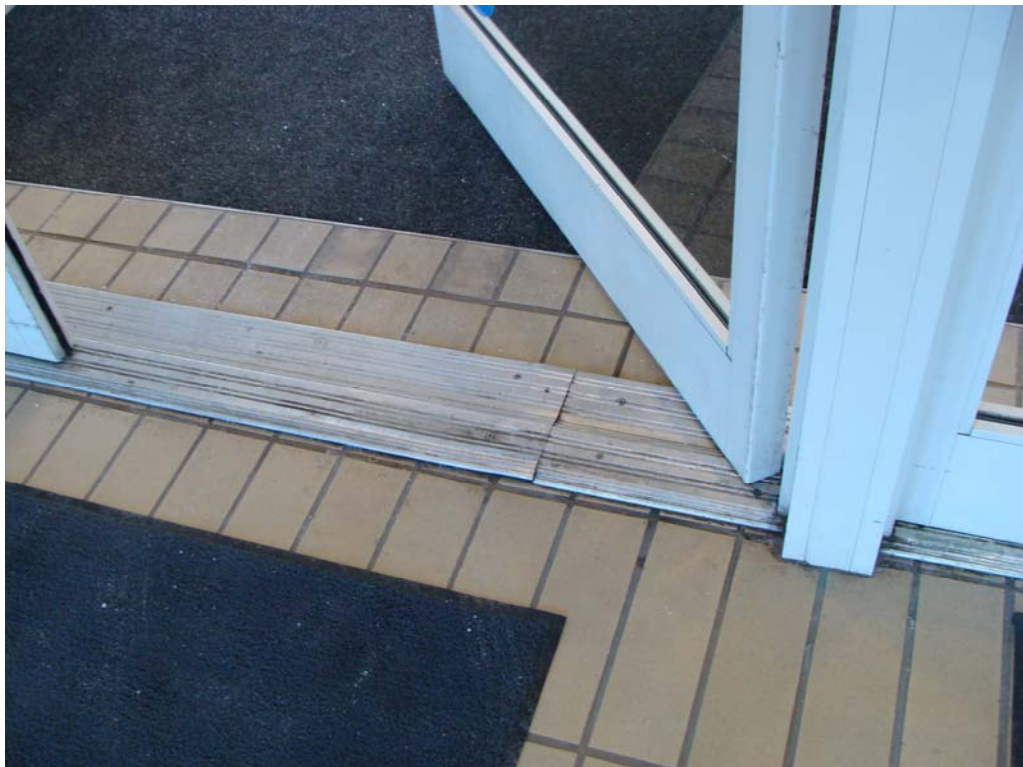
Nevada State Library & Archives - Building #1675  
Description: Lobby entrance threshold in need of replacement.

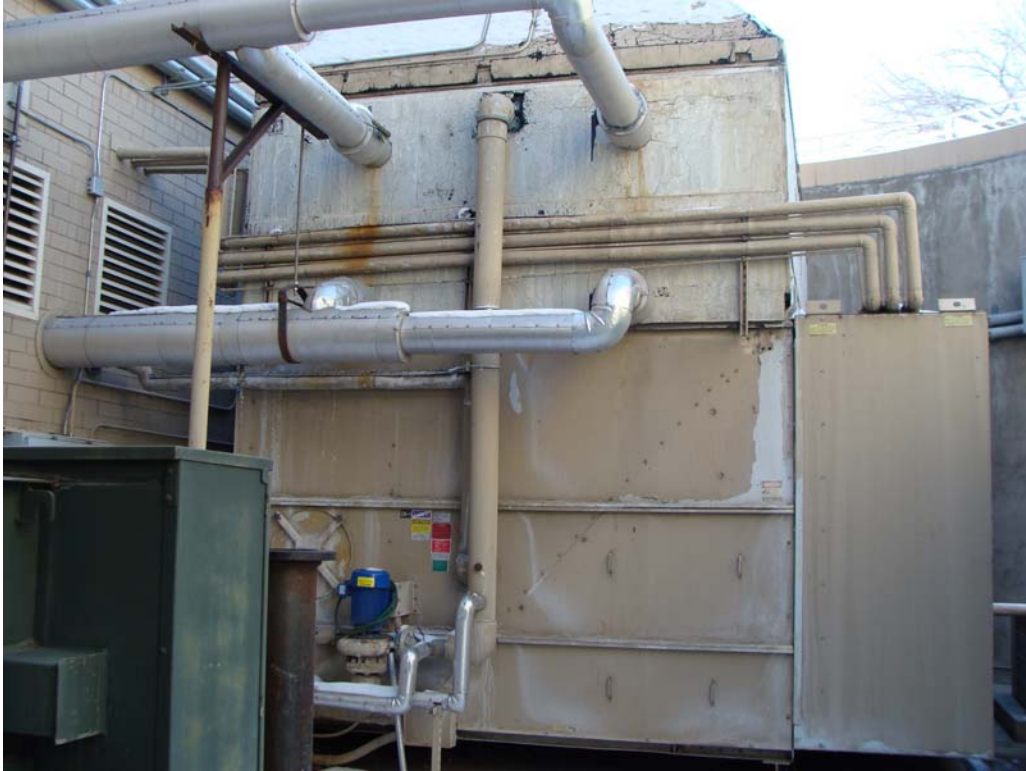
Nevada State Library & Archives - Building #1675  
Description: Non-operational cooling tower.

The building is cooled by a chiller and cooling tower system. The cooling tower and its associated equipment is non-operational and should be scheduled for replacement. Rust and water freezing in the pipes has greatly reduced the efficiency of the equipment. Three incidents of the heat transfer coil freezing have occurred since the tower was installed. This project provides for disposal of the existing equipment and replacement with a new cooling tower, heat exchanger and piping including connections to utilities. This project is currently funded under CIP 09-M01 but the contract had not been executed at the time of the survey of 2011..

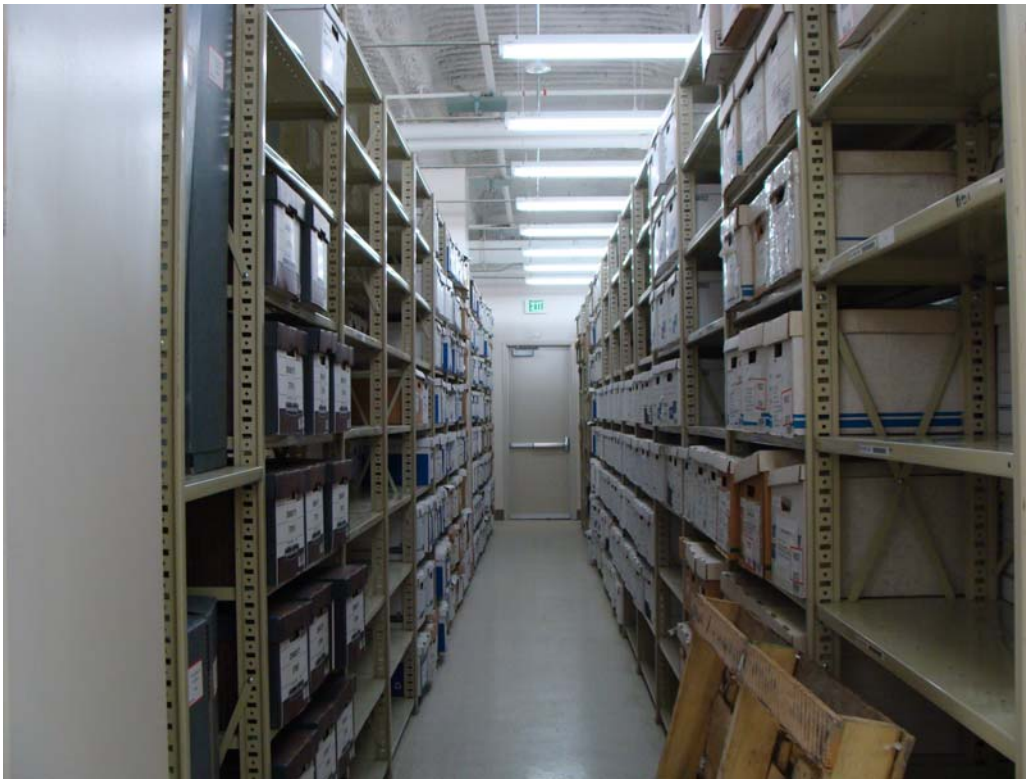
Nevada State Library & Archives - Building #1675  
Description: Archive storage area.

The static shelving in the State Records Center and in the State Archives room is reaching capacity and will no longer be able meet storage demands. In order to maintain control and security of the records it is recommended to replace the existing shelving with a new compact shelving system as opposed to utilizing offsite storage facilities. The new system will store twice as much material in the same amount of space. The estimate includes removal and disposal of existing shelving and purchase and installation of new compact shelving.
