State of Nevada
Department of Corrections
Casa Grande Transitional Center
Facility Condition Analysis

CASA GRANDE TRANSITIONAL CENTER

Site Number: 9875
STATE OF NEVADA PUBLIC WORKS DIVISION
FACILITY CONDITION ANALYSIS

Report Printed in August 2013

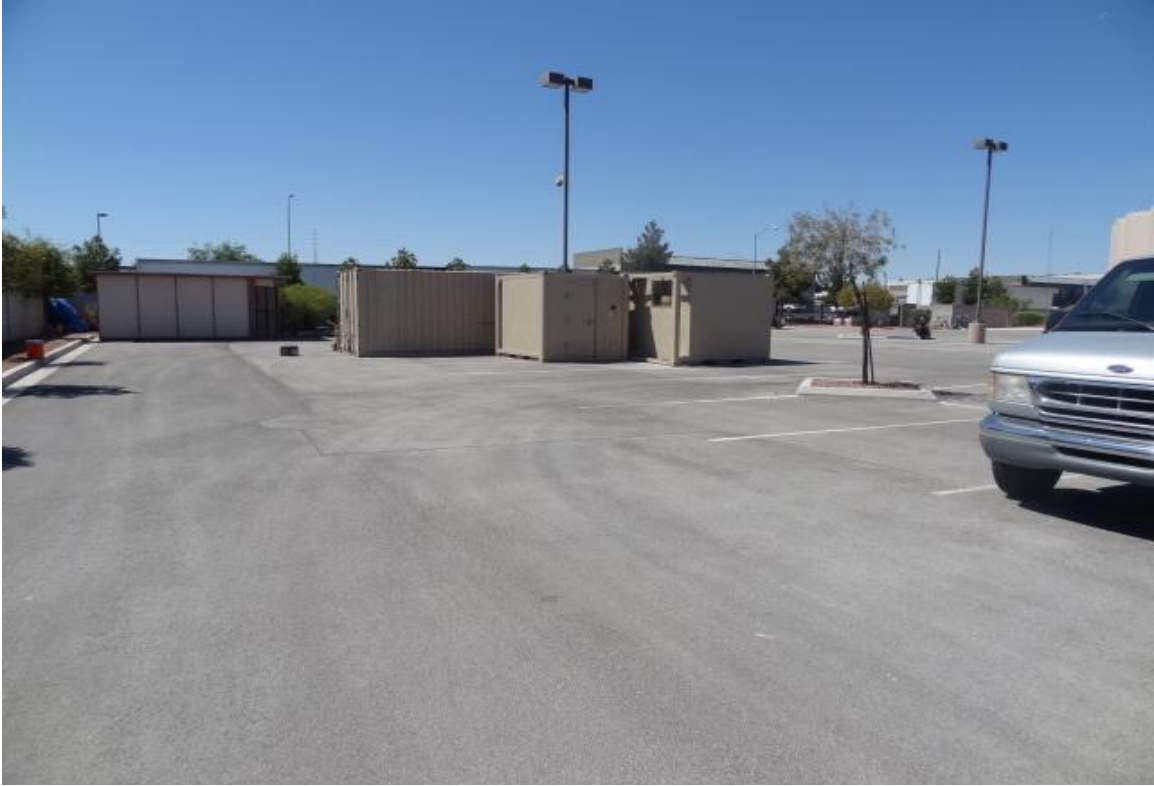
Casa Grande Transitional Center Site – FCA Site #9875

Description: Paved parking area.

The existing asphalt concrete paving on site is in good condition. This project would provide for crack filling as needed and sealing and striping the pavement in the next three to four years including striping all loading zones and ADA accessible parking spaces and route of travel. This project should be completed on a cyclical basis based on environmental conditions and use.

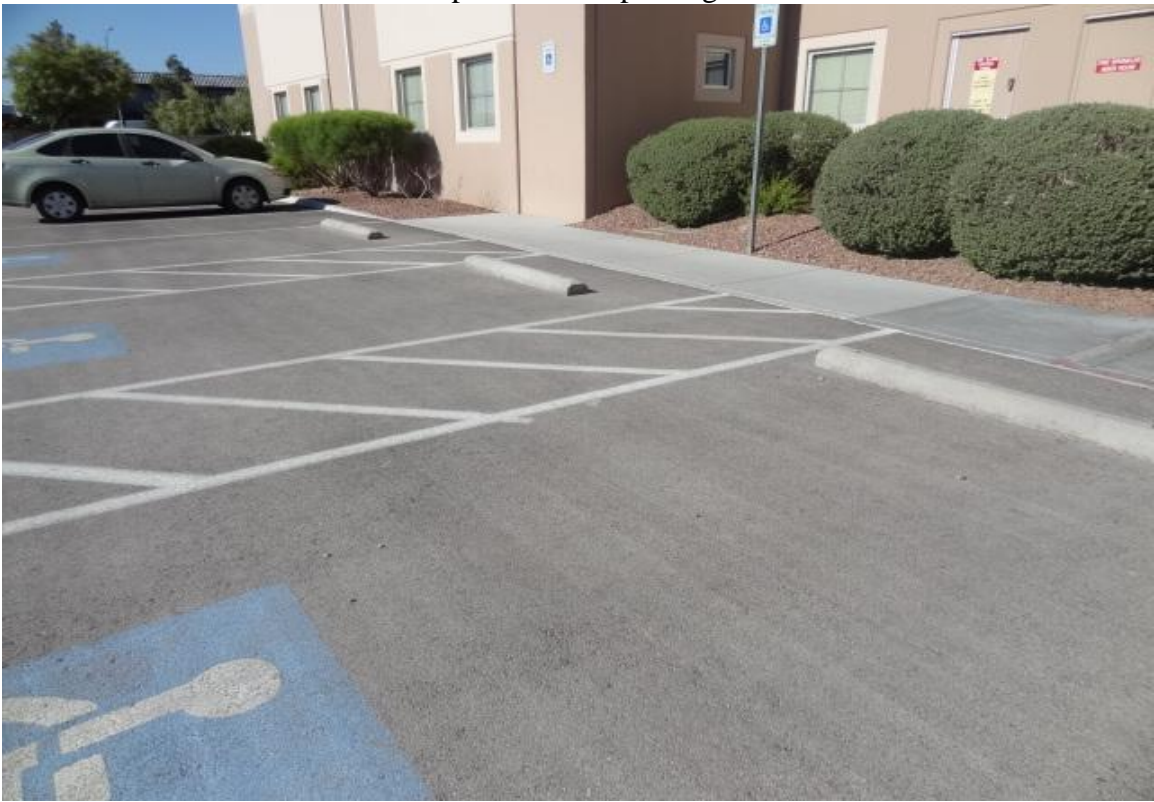
Casa Grande Transitional Center Site – FCA Site #9875

Description: ADA accessible parking at residential unit.

The existing ADA accessible parking signage is not up to current standards. This project would provide for new stickers reflecting the most current maximum fine information to be installed on the existing signs. The 2012 IBC, ICC/ANSI A117.1 - 2009, NRS 338.180 and the most current version of the ADA Standards For Accessible Design were used as a reference for this project.

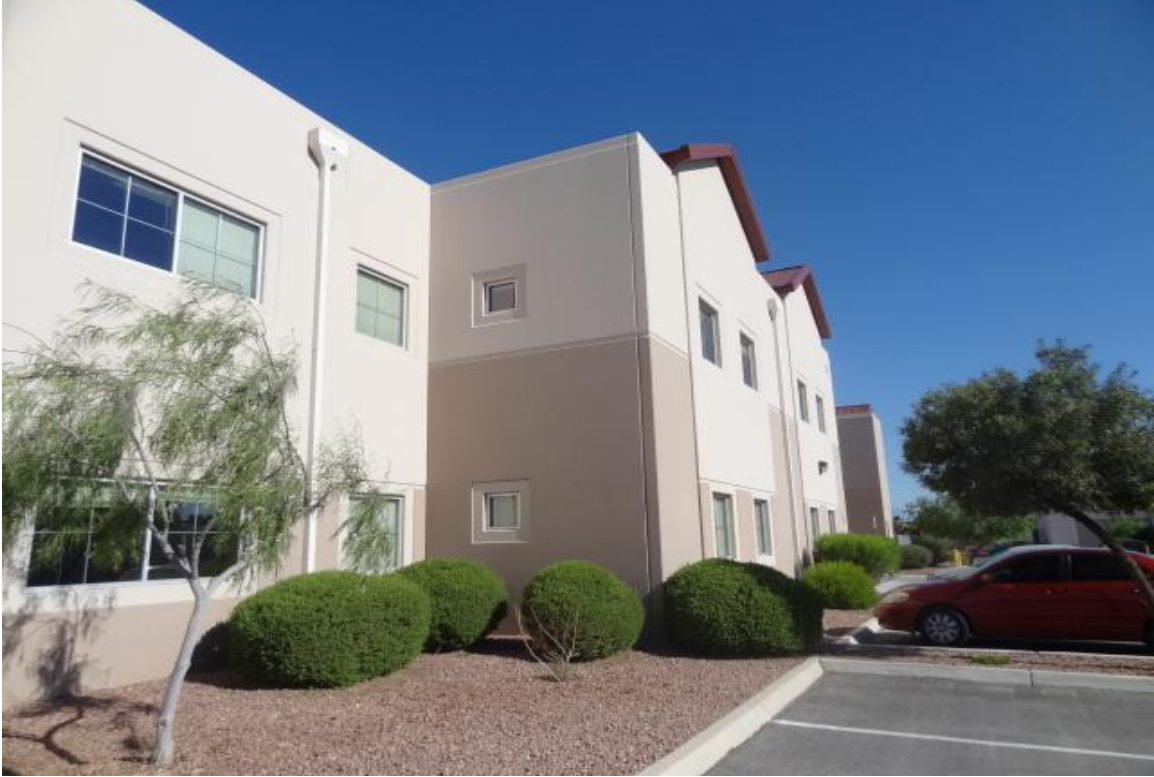
Residential Building C – FCA Building #2561
Description: Exterior of the building.

It is important to maintain the finish, weather resistance, and appearance of the building. This project would provide funding to protect the exterior of the building excluding the roof. Included in the cost is painting the concrete walls and caulking of the windows, flashing, fixtures and all other penetrations. It is recommended that the building be painted and caulked in the next 4-5 years and that this project be scheduled on a cyclical basis to maintain the integrity of the structure.

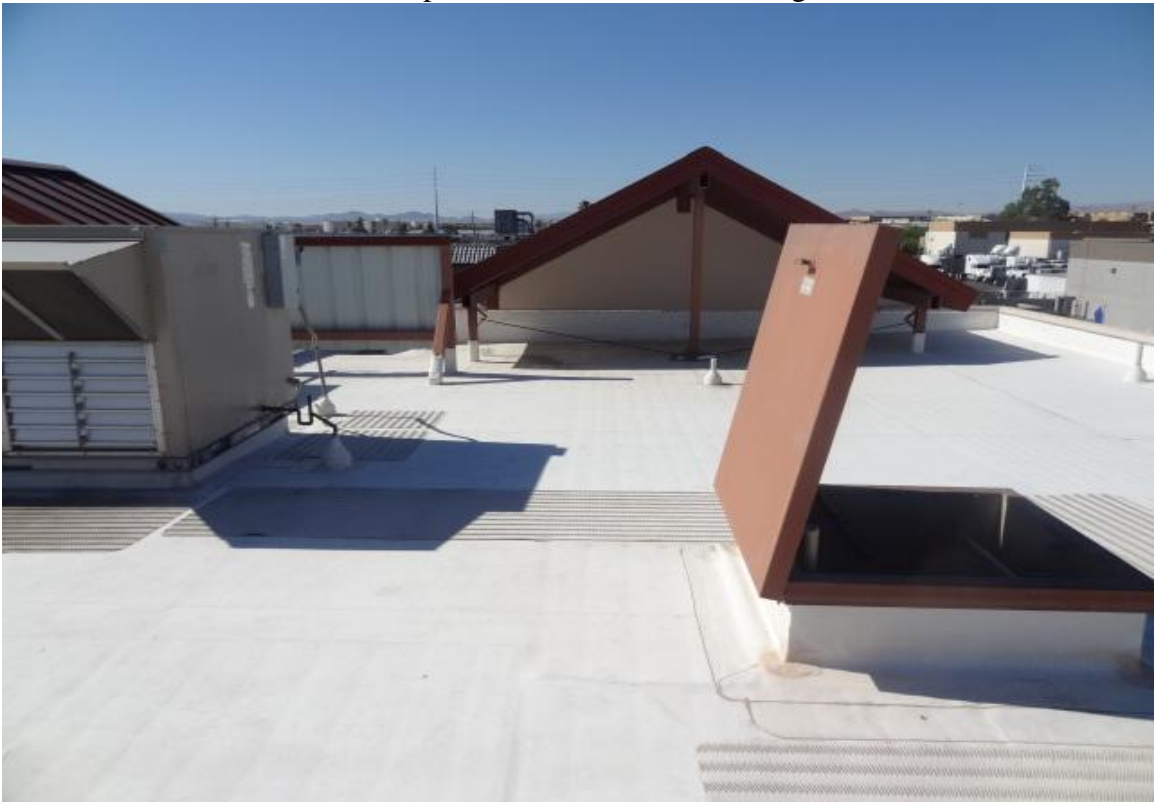
Residential Building C – FCA Building #2561
Description: View of the roof.

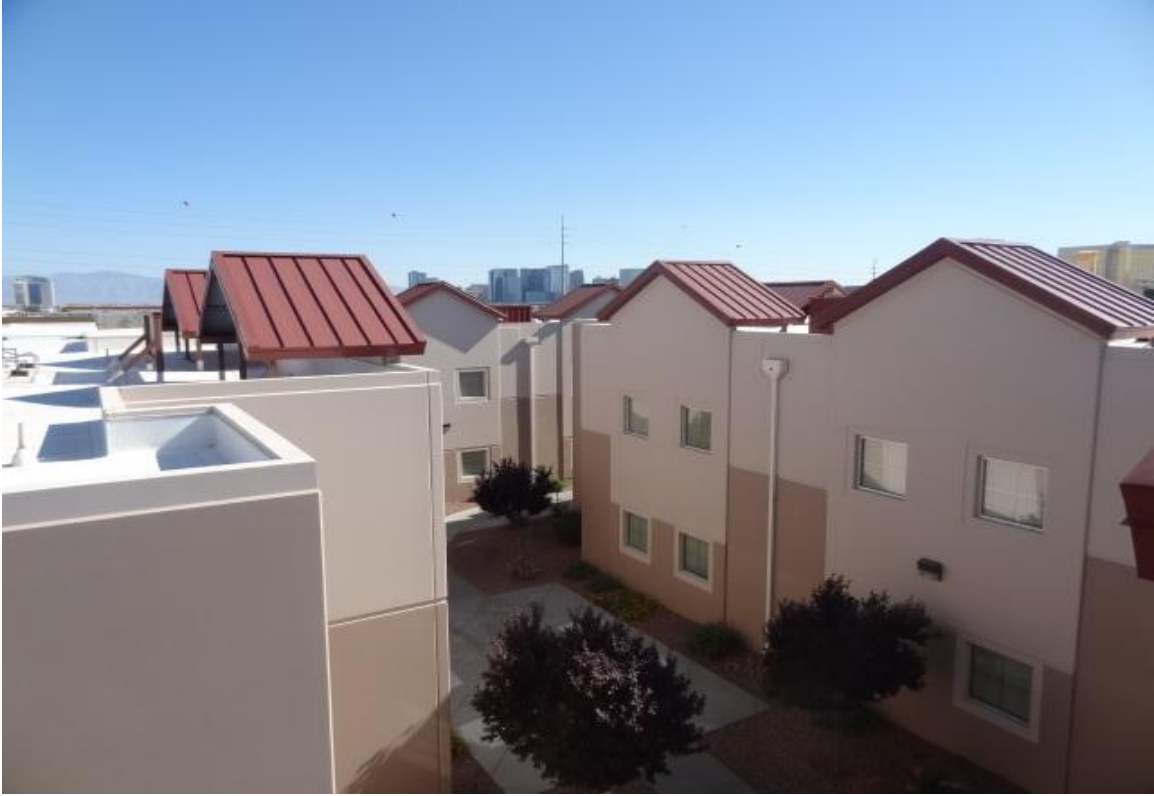
Residential Building B – FCA Building #2560
Description: Exterior of the building.

It is important to maintain the finish, weather resistance, and appearance of the building. This project would provide funding to protect the exterior of the building excluding the roof. Included in the cost is painting the concrete walls and caulking of the windows, flashing, fixtures and all other penetrations. It is recommended that the building be painted and caulked in the next 4-5 years and that this project be scheduled on a cyclical basis to maintain the integrity of the structure.

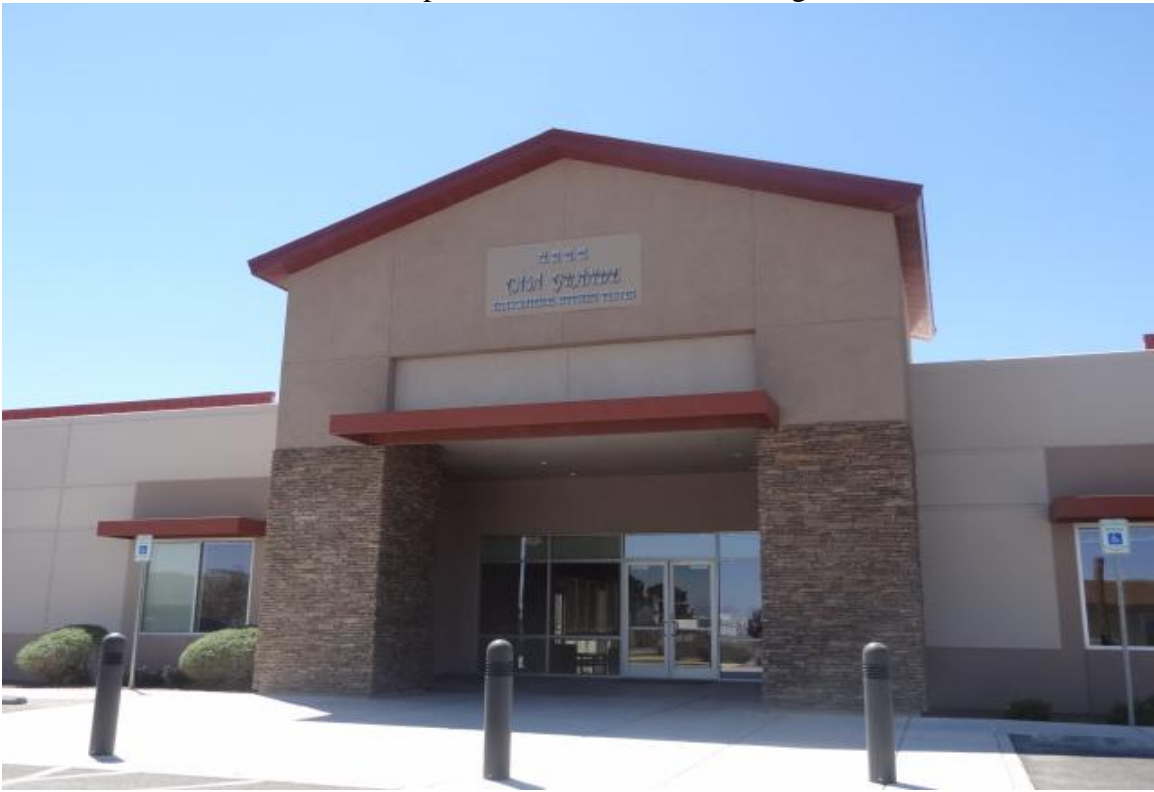
Administration Building – FCA Building #2559
Description: Exterior of the building at the public entrance.

It is important to maintain the finish, weather resistance, and appearance of the building. This project would provide funding to protect the exterior of the building excluding the roof. Included in the cost is painting the concrete walls and caulking of the windows, flashing, fixtures and all other penetrations. It is recommended that the building be painted and caulked in the next 4-5 years and that this project be scheduled on a cyclical basis to maintain the integrity of the structure.

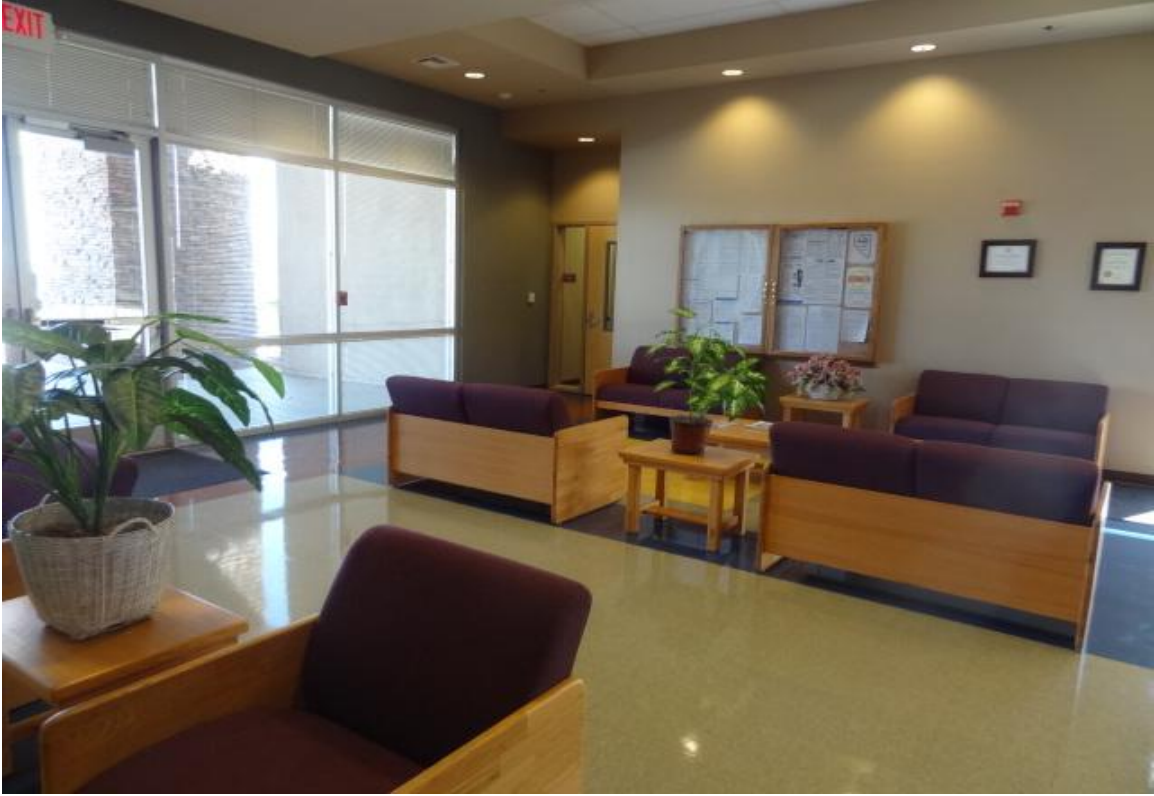
Administration Building – FCA Building #2559
Description: Interior of the lobby.

The interior finishes are in fair condition. It is recommended that the interior walls, ceilings, doors, frames, steel stairs and exposed steel framing be painted at least once in the next two to three years. Prior to painting, all surfaces should be repaired and prepped. An epoxy-based paint should be utilized in wet areas for durability.

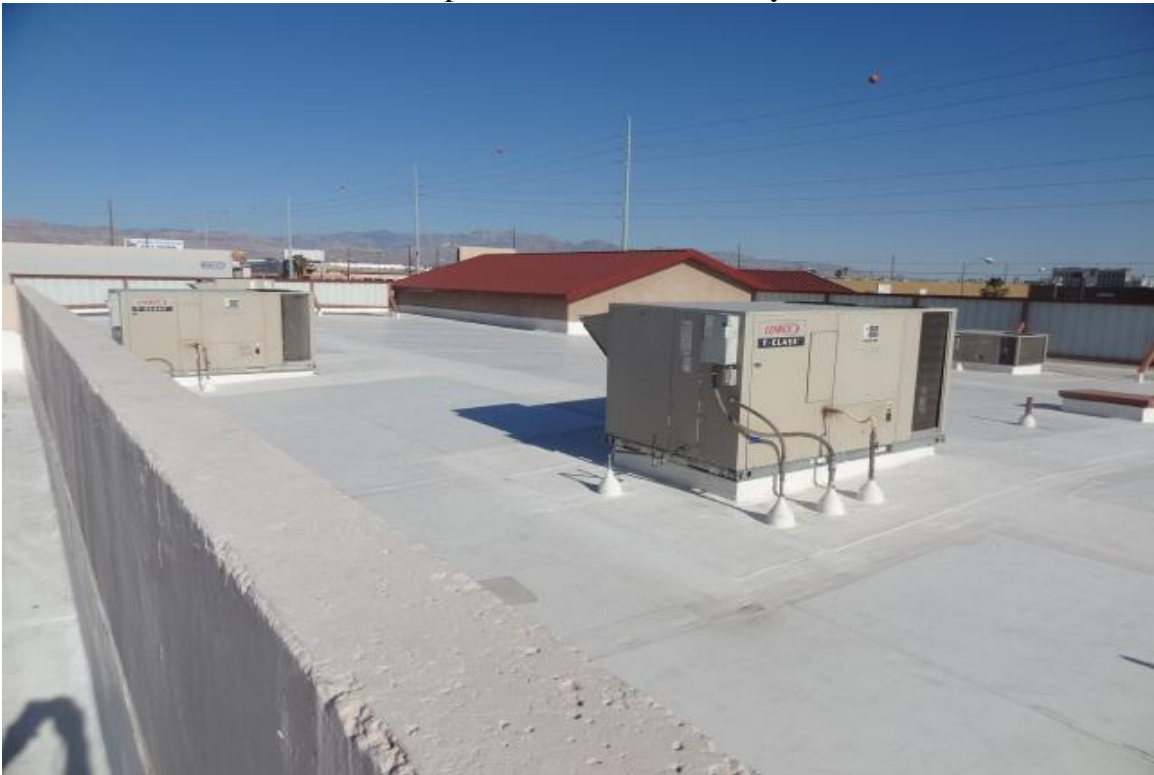
Administration Building – FCA Building #2559
Description: View of the roof / equipment.

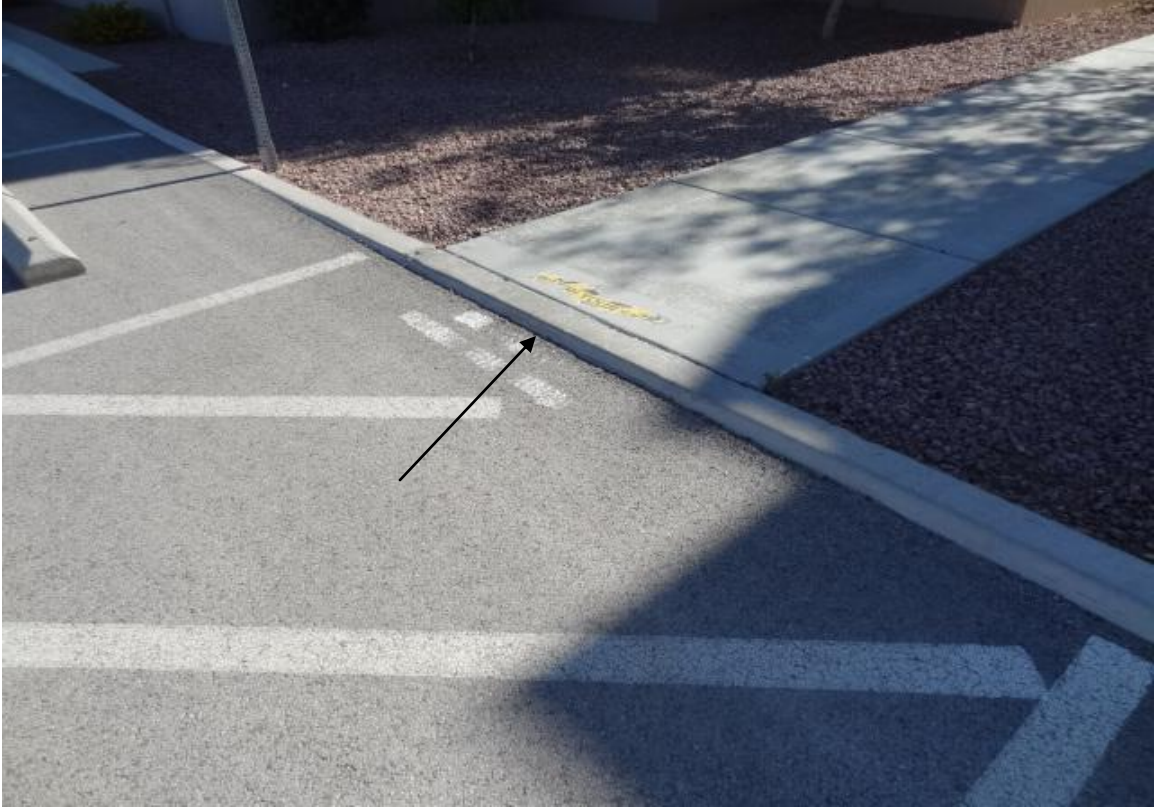
Casa Grande Site – Site Building #9875

Description: ADA accessible route transition in need of repair.

The ADA accessible route of travel at the west parking area ADA parking spaces has a non compliant step or change in elevation from the paving to the sidewalk. This project would provide for necessary repairs to be made to eliminate the step. The 2012 IBC, ICC/ANSI A117.1 - 2009, NRS 338.180 and the most current version of the ADA Standards For Accessible Design were used as a reference for this project.
