FLOYD EDSALL TRAINING CENTER

Site Number: 9879
STATE OF NEVADA PUBLIC WORKS DIVISION
FACILITY CONDITION ANALYSIS

Report distributed in November 2021

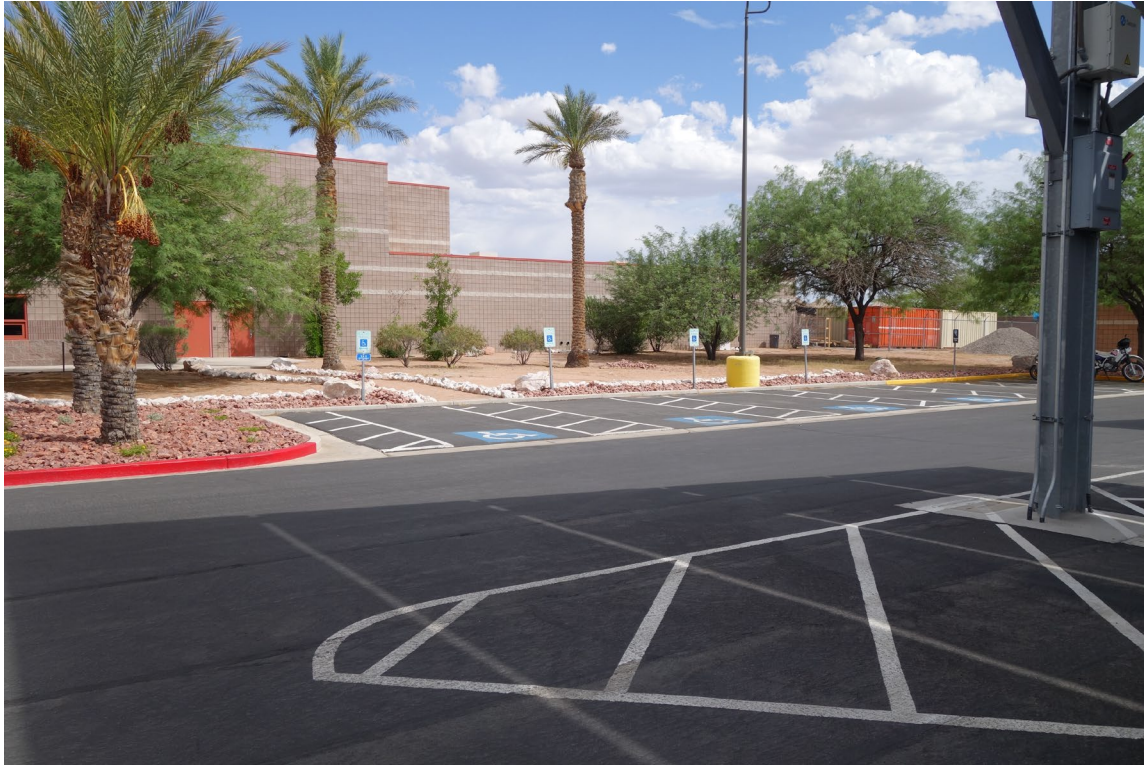
Floyd Edsall Training Center Site – FCA Site #9879
Description: ADA Accessible Parking Area.

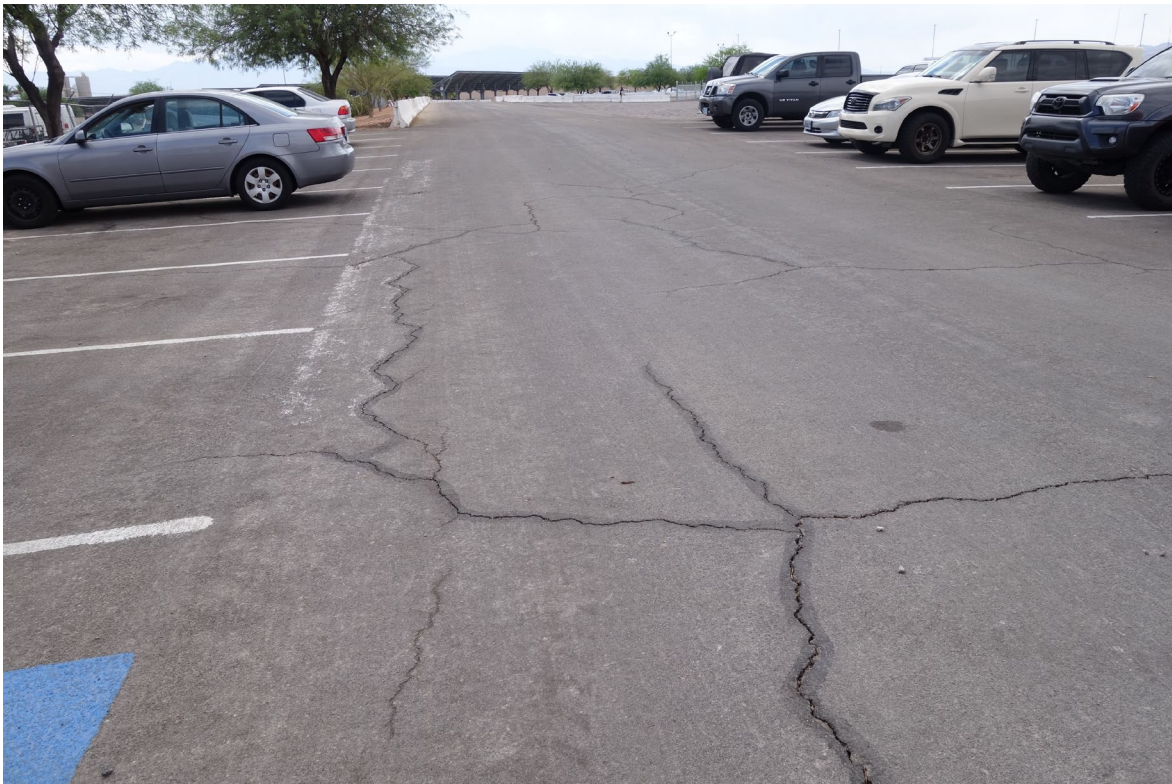
Floyd Edsall Training Center Site – FCA Site #9879
Description: Crack Fill & Seal Asphalt Paving.

It is important to maintain the asphalt concrete paving on the site. This project would provide for minor crack filling and sealing of the paving site wide including access roads, parking areas and maintenance yards. Striping is included in this estimate. This project should be scheduled on a 5 year cyclical basis to maintain the integrity of the paving and prevent premature failure. 500,000 square feet of asphalt area was used to generate this estimate.

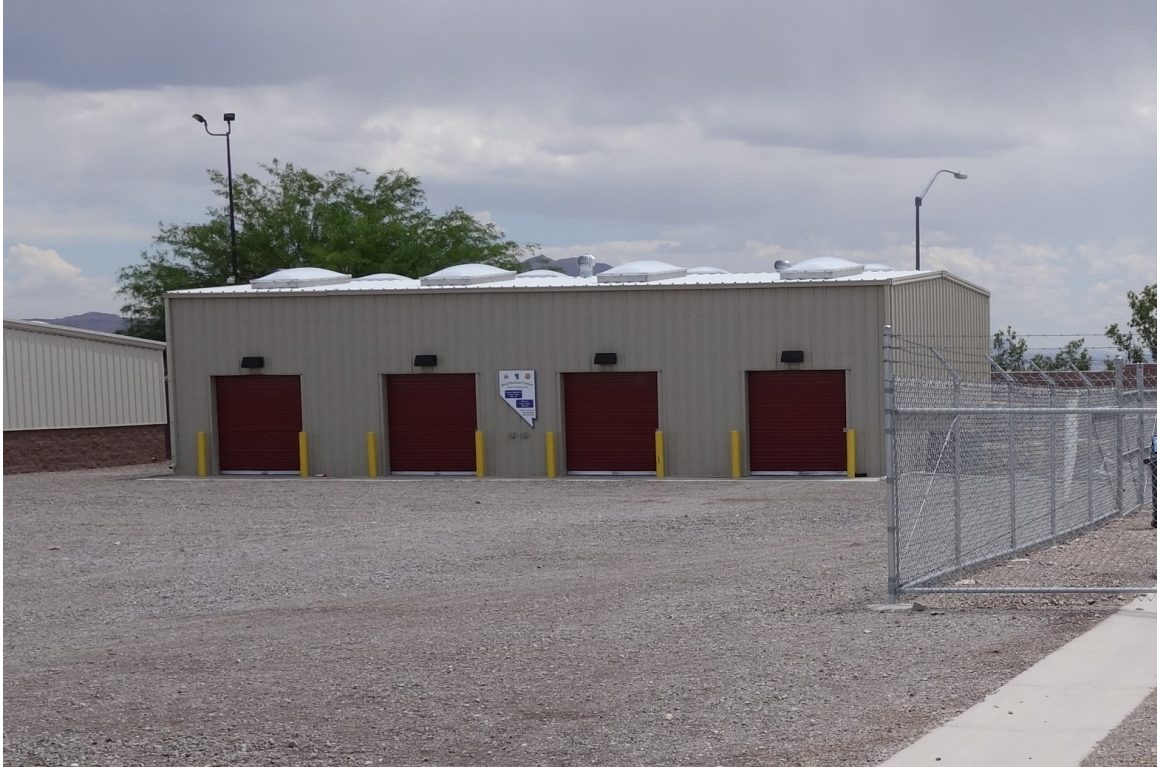
The FETC storage Building is an engineered steel structure which has 4 individual storage bays. It has a concrete slab on grade foundation and is in excellent shape.

FETC Storage Building – FCA Building #3158
Description: Exterior of the Building.

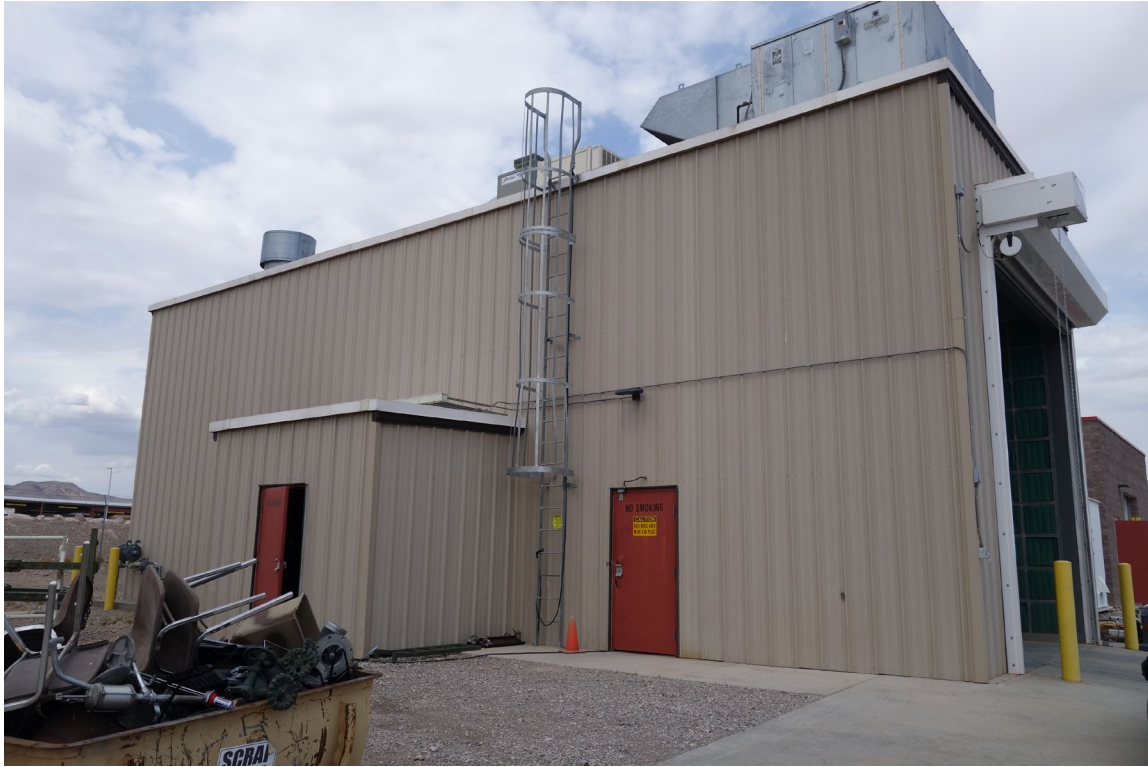
The Paint Booth is an engineered steel structure with a single-ply membrane roofing system on a concrete foundation. The building is used for the preparation and painting of National Guard vehicles and equipment. The facility is in good condition.

FETC Paint Booth – FCA Building #1964
Description: Exterior of the Building.

The exterior finishes are in fair condition. It is important to maintain the finish, weather resistance and appearance of the building. This project would provide funding to protect the exterior of the building excluding the roof. Included in the cost is the caulking and sealing of the flashing, fixtures and all other penetrations. It is recommended that the building be caulked and sealed in the next 4 - 6 years and that this project be scheduled on a cyclical basis to maintain the integrity of the structure.

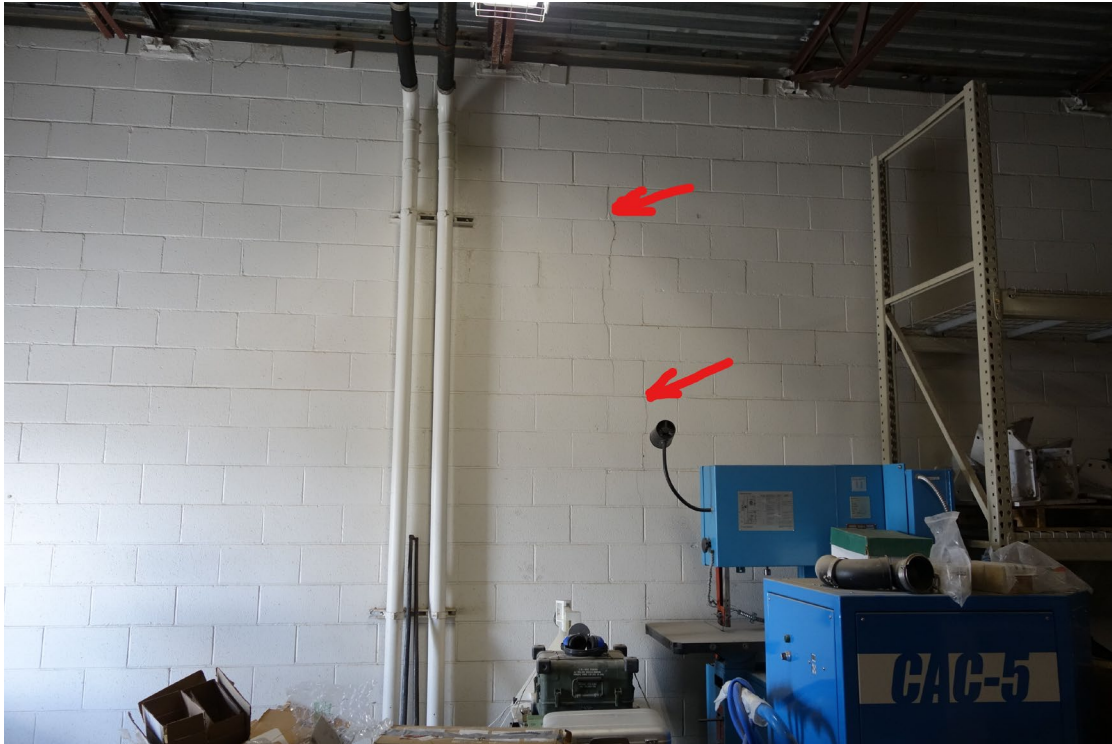
The CSMS Storage Building is constructed of concrete masonry units, concrete foundation and structural steel roof trusses covered by a single-ply roof membrane system. This facility is primarily used for storage. It is located adjacent to the paint booth. A couple of small cracks were noted on the interior of the exterior masonry wall that should be monitored periodically for potential growth. Pictures of the cracks are noted in the photolog at the end of this report.

FETC CSMS Storage Building – FCA Building #1963
Description: Wall Crack #1 in CMU Wall.

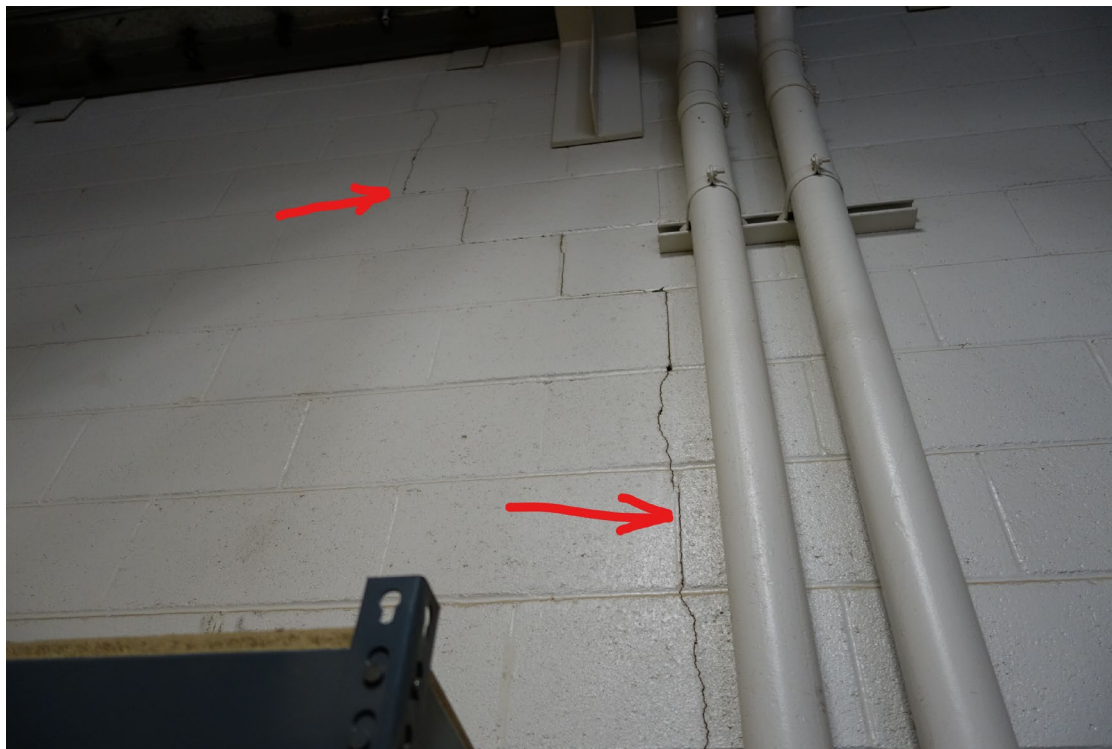
FETC CSMS Storage Building – FCA Building #1963
Description: Wall Crack #2 in CMU Wall.

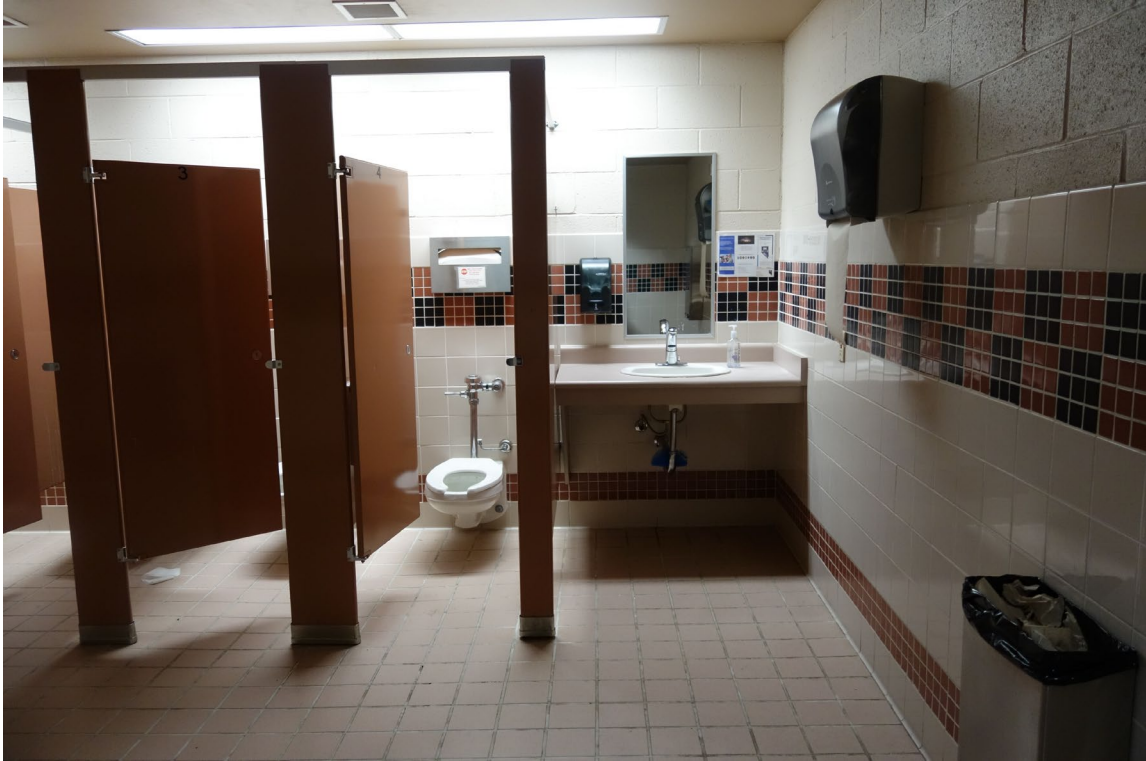
FETC Clark County Armory – FCA Building #0036
Description: Men's and Women's Restrooms Need Remodel.

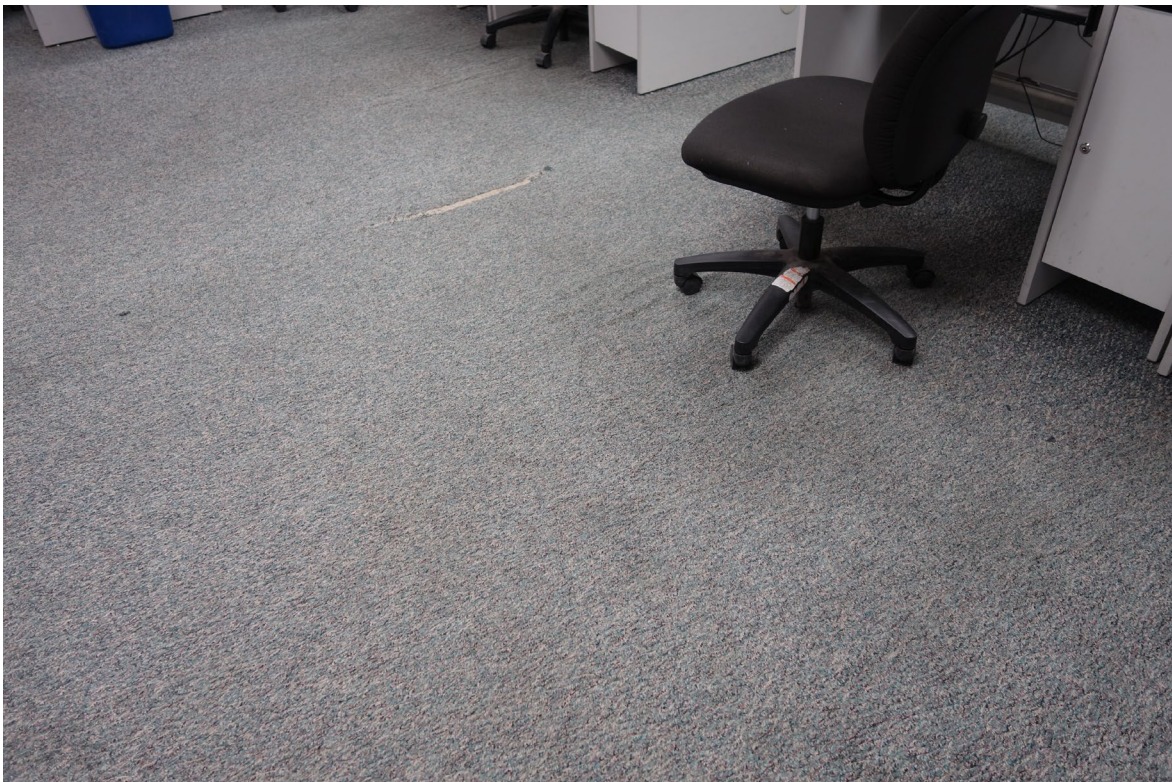
FETC Clark County Armory – FCA Building #0036
Description: Carpet Replacement Needed.
