# SOUTHERN NEVADA VETERANS HOME

100 Veterans Memorial Drive Boulder City, Nevada 89005

# Site Number: 9889 STATE OF NEVADA PUBLIC WORKS DIVISION FACILITY CONDITION ANALYSIS

Report distributed in September 2022

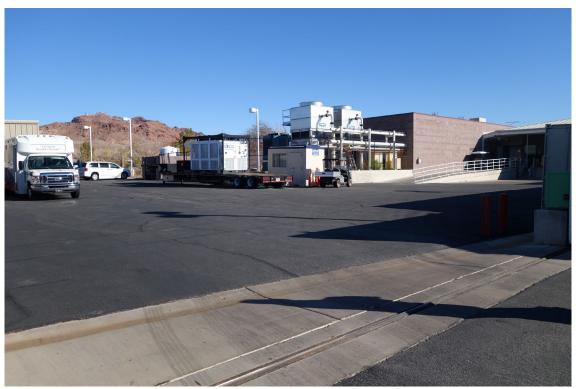
Southern Nevada Veterans Home Site – FCA Site #9889 Description: View of Loading Dock Area.

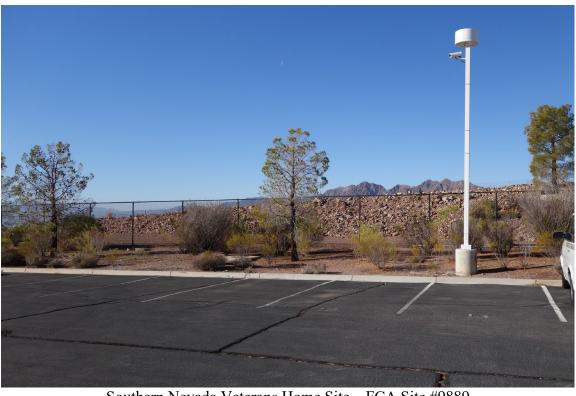
The video security system inside the building and the site is outdated and should be scheduled for replacement. The analog video and coax cable systems are over twenty years old and increasingly difficult to find replacement parts and experienced service contractors. This project addresses replacement of the cameras, conduit and wiring throughout the facility with all digital equipment as well as sufficient storage capacity.

Southern Nevada Veterans Home Site – FCA Site #9889 Description: Video Surveillance Upgrade Needed.

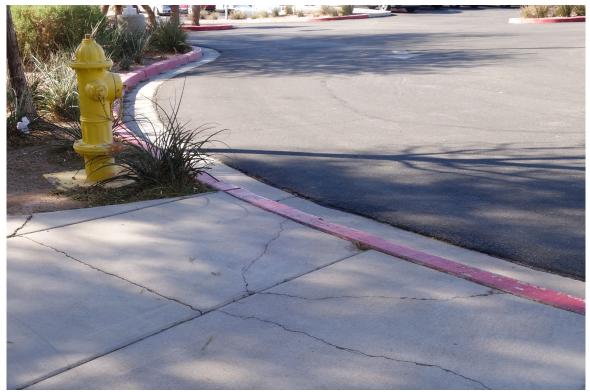
Portions of the sidewalks serving the building on this site have deteriorated. This project addresses removal and replacement of existing sidewalks as needed. 1,500 SF of 4" thick concrete sidewalk was used for this estimate. NRS 338.180, IBC - 2018, ICC/ANSI A117.1 and the most current version of the Americans with Disabilities Act Accessibility Guidelines (ADAAG) were used as a reference for this project.

Southern Nevada Veterans Home Site – FCA Site #9889 Description: Sidewalk Replacement Needed.

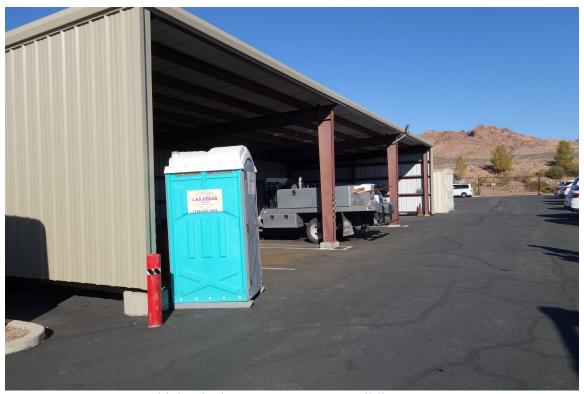
The Vehicle Shade Structure is a pre-engineered metal building enclosed on 3 sides. It has a concrete foundation and is located along the west side of the Veterans Home employee parking area.

Vehicle Shade Structure – FCA Building #3112 Description: Exterior of the Structure.

The exterior finishes were in good condition. It is important to maintain the finish, weather resistance and appearance of the building. This project would provide funding to protect the exterior of the building excluding the roof. Included in the cost is the caulking and sealing of the flashing, fixtures and all other penetrations. It is recommended that the building be caulked and sealed in the next 7 - 9 years and that this project be scheduled on a cyclical basis to maintain the integrity of the structure.

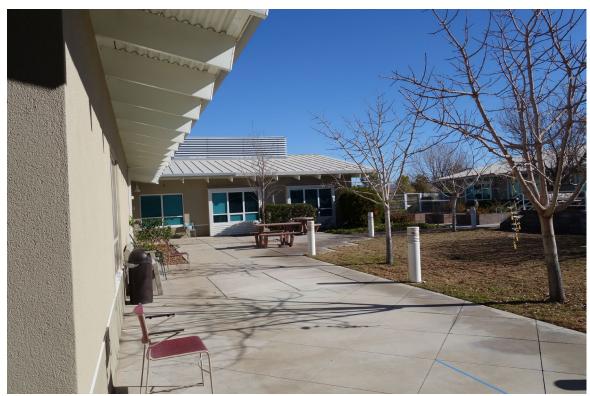
Southern Nevada Veterans Home – FCA Building #2106 Description: Typical Residence Patio Area.

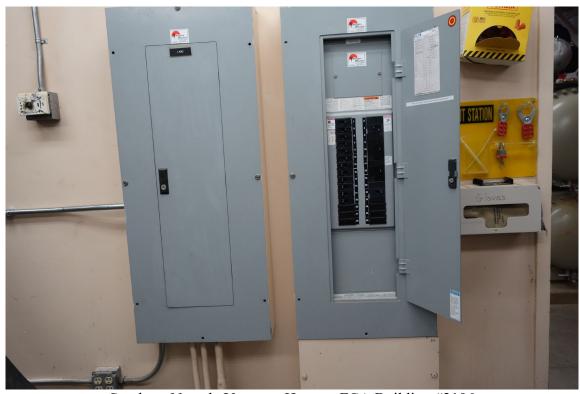
An arc flash and electrical coordination study has not been performed or is more than 5 years since the last coordination study. The latest electrical code requires coordination studies be verified and performed every 5 years and arc flash labeling on all electrical panels to provide the safety requirements for maintenance personnel. This project will perform the required coordination study, evaluation, adjustments and labeling for the building electrical distribution system.

Southern Nevada Veterans Home – FCA Building #2106 Description: Arc Flash & Electrical Coordination Study Needed.

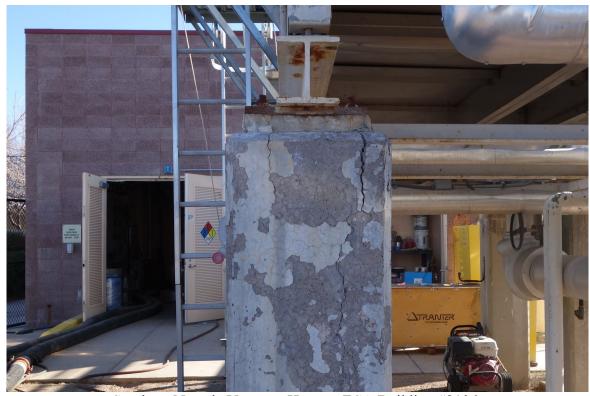
The two cooling towers at this facility are supported on 5 foot cast-in-place concrete piers. The piers have visible cracking and appear to be structurally failing. This project will design and construct pier replacements. Estimate includes cost to maintain continuity of cooling tower operation.

Southern Nevada Veterans Home – FCA Building #2106 Description: Cooling Tower Pier Replacement Needed.

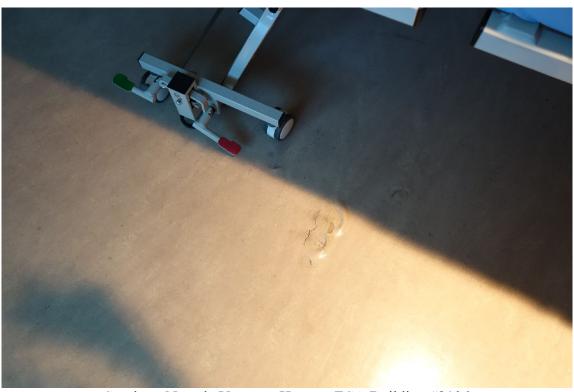
The vinyl floor coverings in the patient rooms, soiled utility room and the main corridor in the Mariner wing are in generally poor condition and have reached the end of their serviceable lives. This project would provide funding to completely remove the existing flooring and replace with heavy duty, seam welded sheet vinyl. 50,000 square feet was used for this estimate.

Southern Nevada Veterans Home – FCA Building #2106 Description: Flooring Replacement Needed.

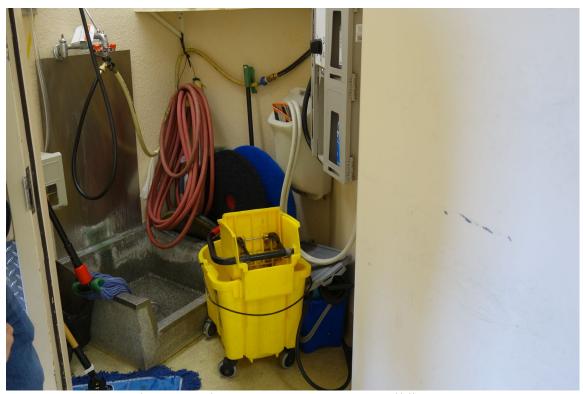
The mop sinks in the Janitors Closets are mounted adjacent to gypsum board and are showing signs of water damage. This project would provide fiberglass reinforced panels (FRP) to be installed on the walls adjacent to the mop sink. The FRP shall extend two feet beyond the edge of the sink and a minimum of 54" above the floor finish. Typical of 24 Janitors Closets.

Southern Nevada Veterans Home – FCA Building #2106 Description: Janitors Closet Repairs Needed.

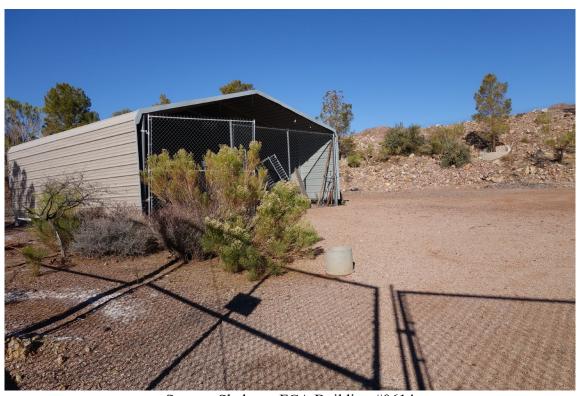
The prefabricated metal Storage Shelter structure is a new building that is used primarily for storage of landscaping and maintenance tools and equipment. The building is open on one side and is resting on a concrete slab-on-grade. The building is in good shape.

Storage Shelter – FCA Building #0614 Description: Exterior of the Structure.

The exterior finishes were in good condition. It is important to maintain the finish, weather resistance and appearance of the building. This project would provide funding to protect the exterior of the building excluding the roof. Included in the cost is the caulking and sealing of the flashing, fixtures and all other penetrations. It is recommended that the building be caulked and sealed in the next 7 - 9 years and that this project be scheduled on a cyclical basis to maintain the integrity of the structure.
