State of Nevada
Department of Administration
Marlette Lake/Ash Canyon Site
Facility Condition Analysis

MARLETTE LAKE/ASH CANYON SITE

Site Number: 9895
FACILITY CONDITION ANALYSIS

Report Printed in May 2005

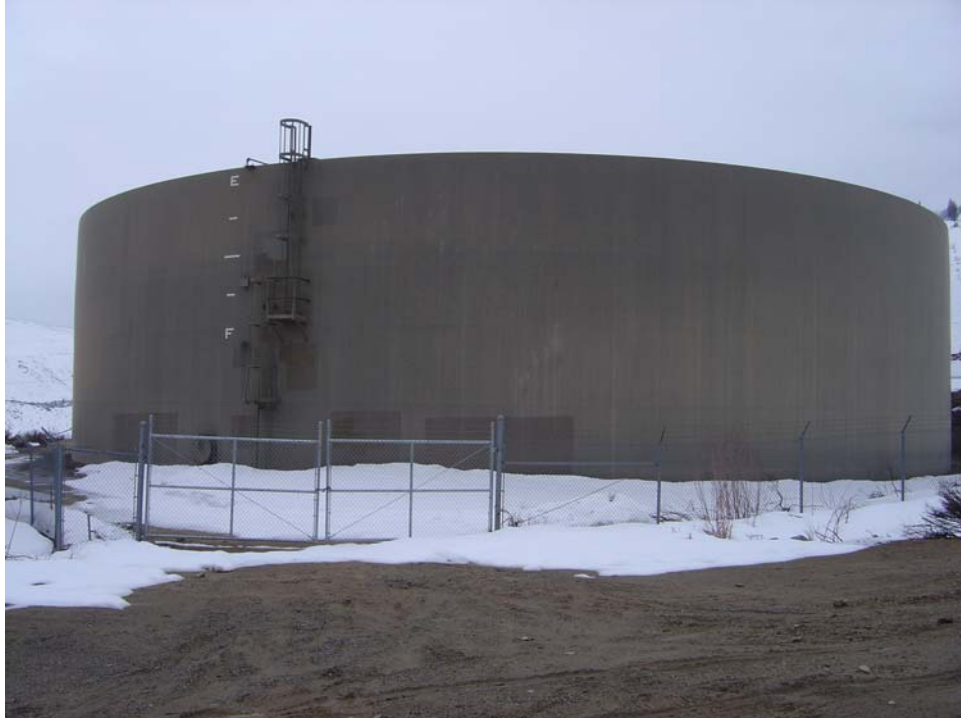
Marlette Lake / Ash Canyon- Building Index # 2485
Description: 3 Million Gallon Storage Tank

It is important to maintain the finish, weather resistance and appearance of the tank. This project recommends work to protect the exterior tank envelope, including sand blasting, painting, staining, or other applied finishes and other penetrations to maintain the tank in good, weather tight condition.

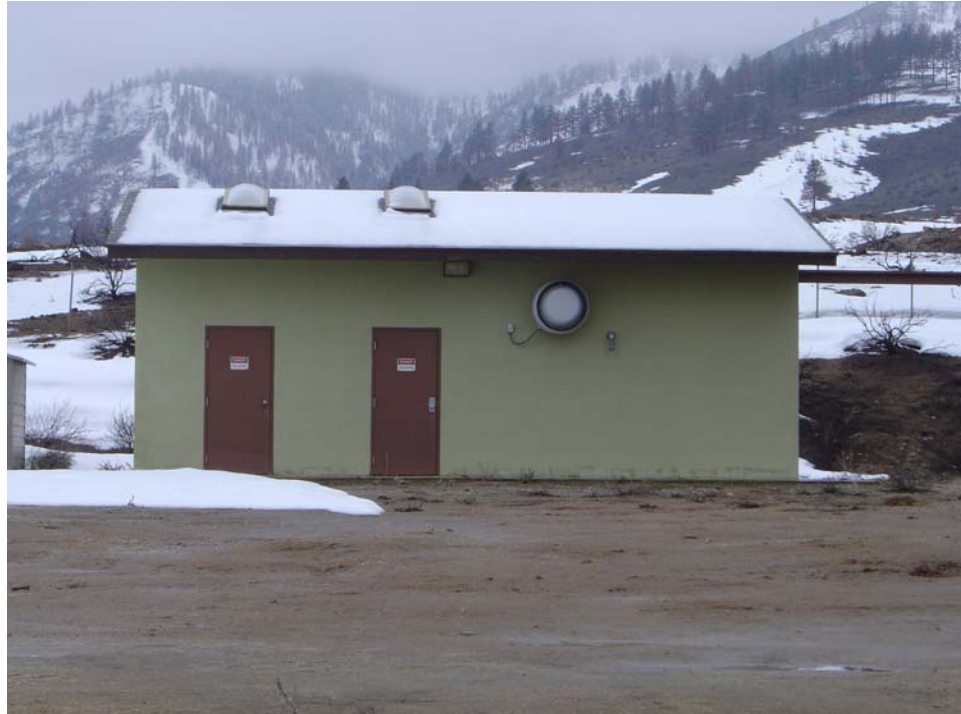
Marlette Lake / Ash Canyon- Building Index # 2489
Description: Chlorine Building Exterior

It is important to maintain the finish, weather resistance and appearance of the building. This project includes items to protect the exterior building envelope other than the roof, including painting, staining, or other applied finishes, and caulking around doors, flashing, fixtures, and other penetrations to maintain the building in good, weather tight condition.

The asphalt roof on this building was in poor condition at the time of the survey. There were sections of shingles missing. This project would provide for removal of existing roof and underlayment and installation of a 25 year asphalt composition roof with new underlayment.

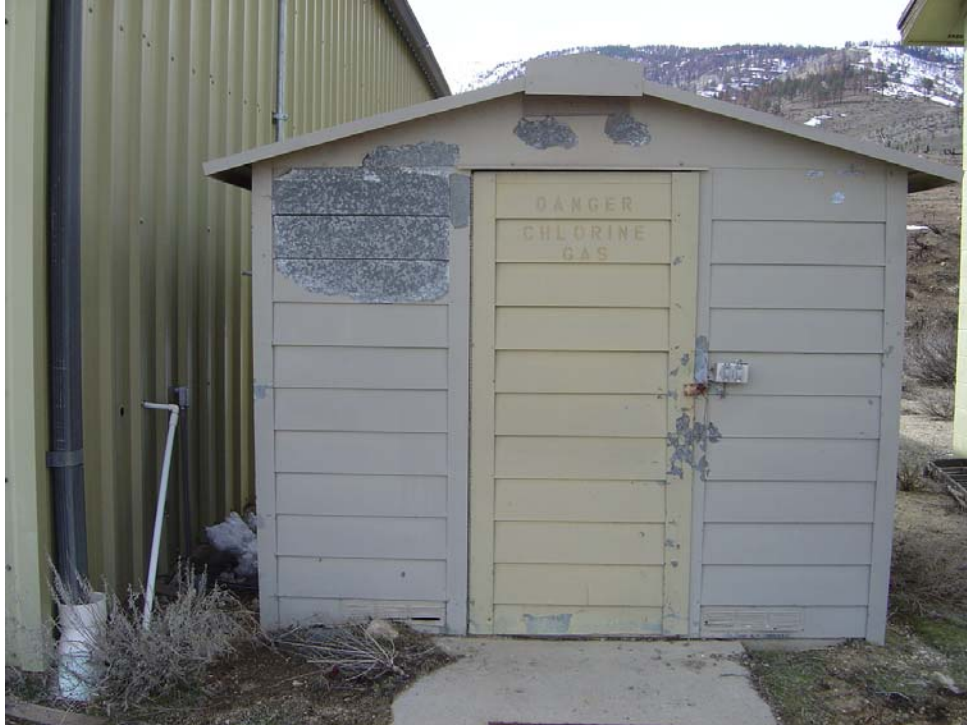
Marlette Lake / Ash Canyon- Building Index # 2503
Description: Marlette Storage Shed Exterior

It is important to maintain the finish, weather resistance and appearance of the building. This project includes items to protect the exterior building envelope other than the roof, including painting, staining, or other applied finishes, and caulking around doors, flashing, fixtures, and other penetrations to maintain the building in good, weather tight condition. This will reduce possible accelerated deterioration due to non-use of the building.

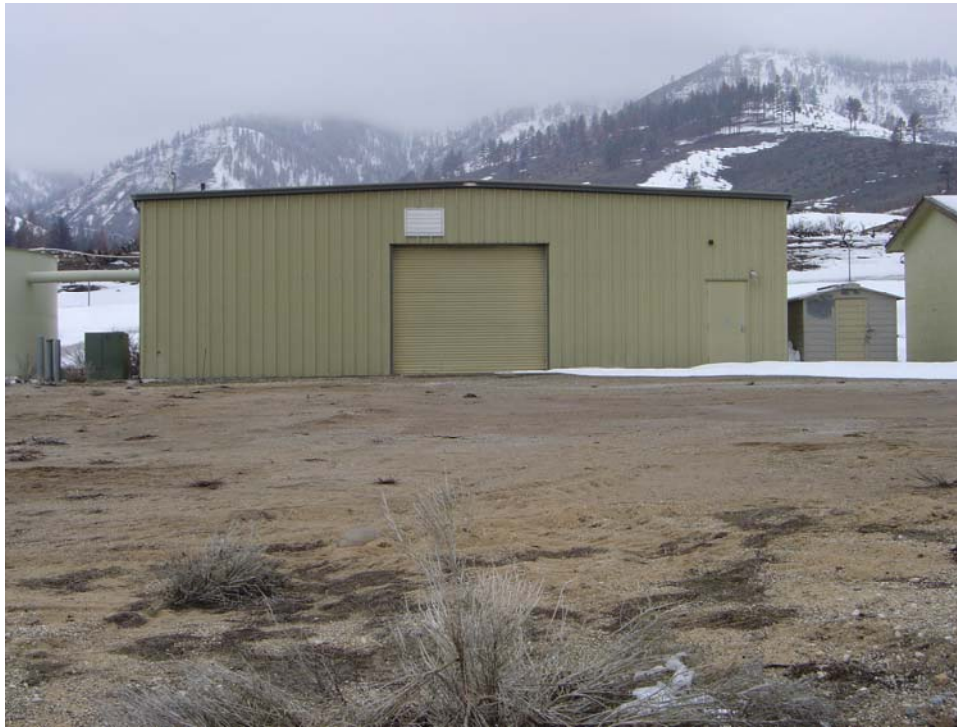
Marlette Lake / Ash Canyon- Building Index # 2487
Description: Marlette Lake Water Treatment Building

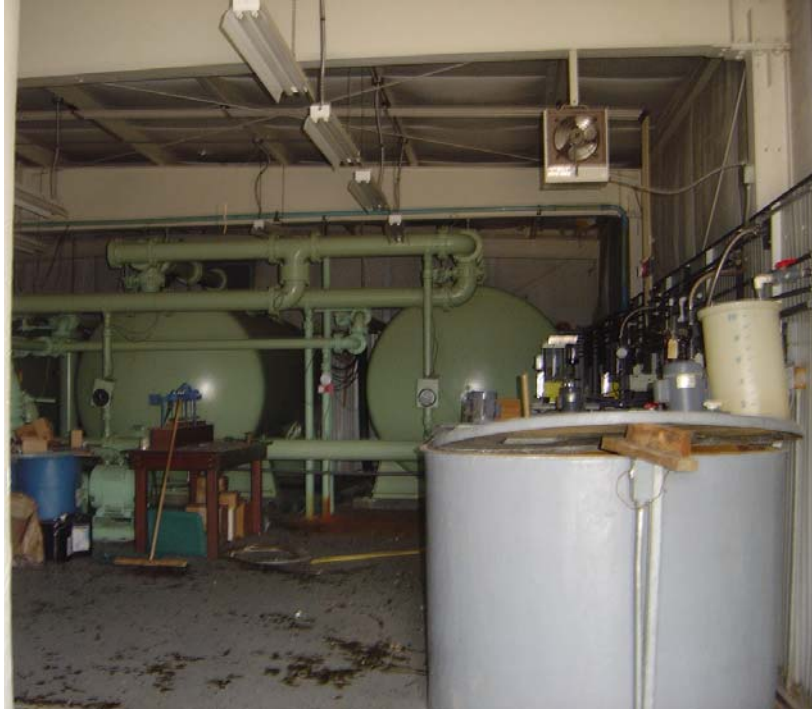
There are numerous rodent droppings throughout the storage building. Due to the potential risk of disease and Hantavirus, a project is recommended to assess the building for infestation and contamination by rodents by a licensed professional. Any future projects would come from report recommendations. This project should be completed prior to occupancy or usage by employees.

Marlette Lake / Ash Canyon – Building Index #2487
Description: Interior of Water Treatment Building; Rodent Droppings on Floor

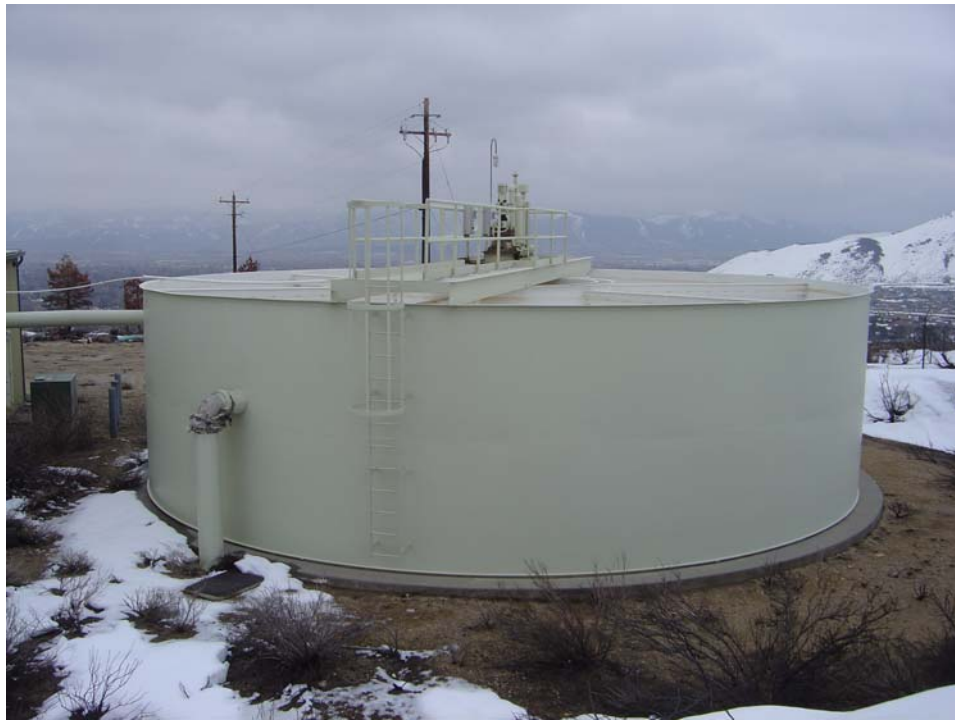
Marlette Lake / Ash Canyon- Building Index # 2504
Description: 1.5 Million Gallon Storage Tank / Waste Separator

Projects in this category address long term needs of the facility. The cyclical treatment of the building exterior is very important to maintain the finish integrity and appearance of the building. This treatment includes painting, sealing, repair and cleaning where applicable.

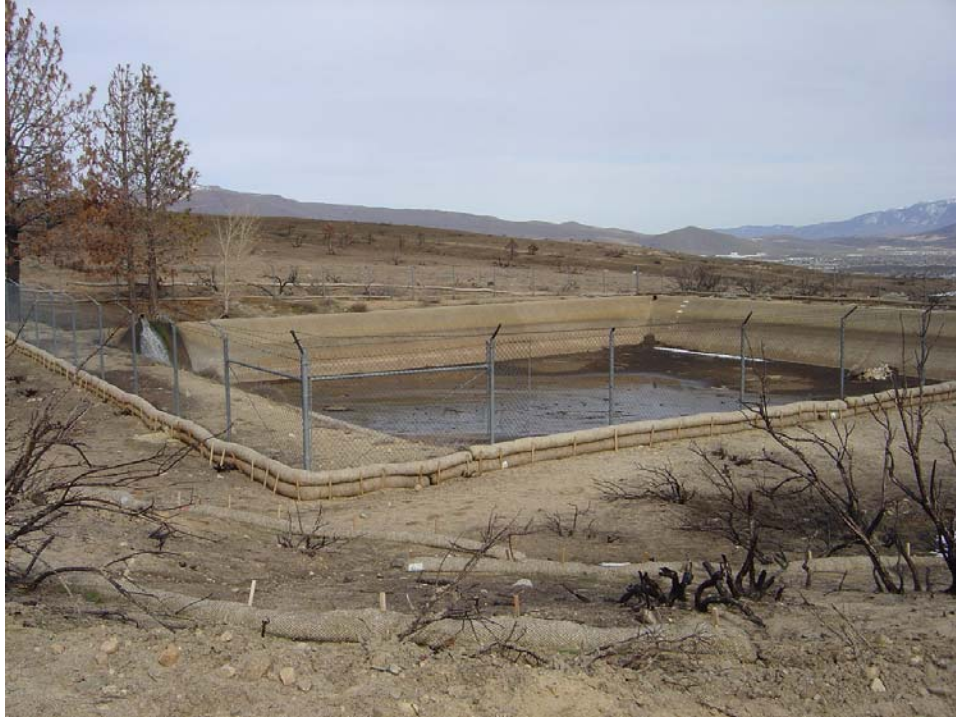
Marlette Lake / Ash Canyon - Building Index # 2486
Description: 1 Million Gallon Storage Reservoir

LONG TERM NEEDS	Project cost:	\$5,000
It is important to maintain the concrete reservoir. This project would provide for routine cleaning, sweeping, sealing and clearance of debris in the reservoir.

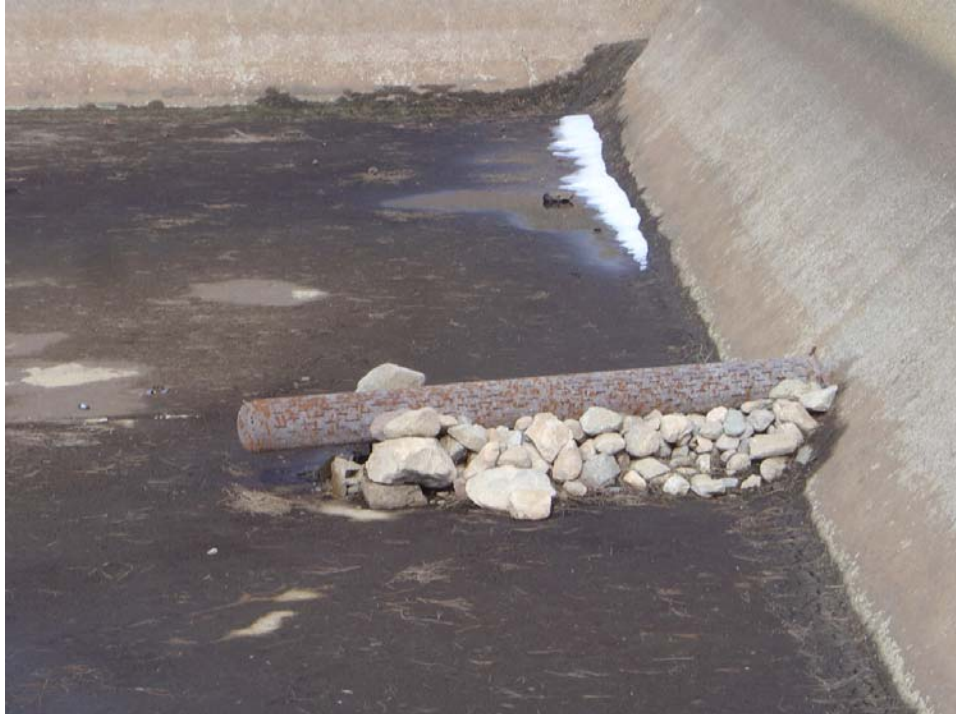
The 1 million gallon water storage tank also known as the Concrete Reservoir (V&T) is a concrete reservoir that is located 500 feet west of the Marlette Lake/Ash Canyon Site, West of Carson City, Nevada. It is surrounded with a 6 foot chain link fence with barbed wire across the top. Water currently enters through a pipeline at the northwest end and flows towards the drain outlet at the south side continuing on to the storage tanks below owned by Carson City.

Marlette Lake / Ash Canyon – Building Index #2486
Description: Drain Outlet of 1 Million Gallon Storage Reservoir
