State of Nevada  
Nevada Office of Veterans Services  
Northern Nevada Veterans Memorial Cemetery  
Facility Condition Analysis

# NORTHERN NEVADA VETERANS MEMORIAL CEMETERY

**Site Number: 9898**  
**STATE OF NEVADA PUBLIC WORKS DIVISION**  
**FACILITY CONDITION ANALYSIS**

Report Printed in February 2012

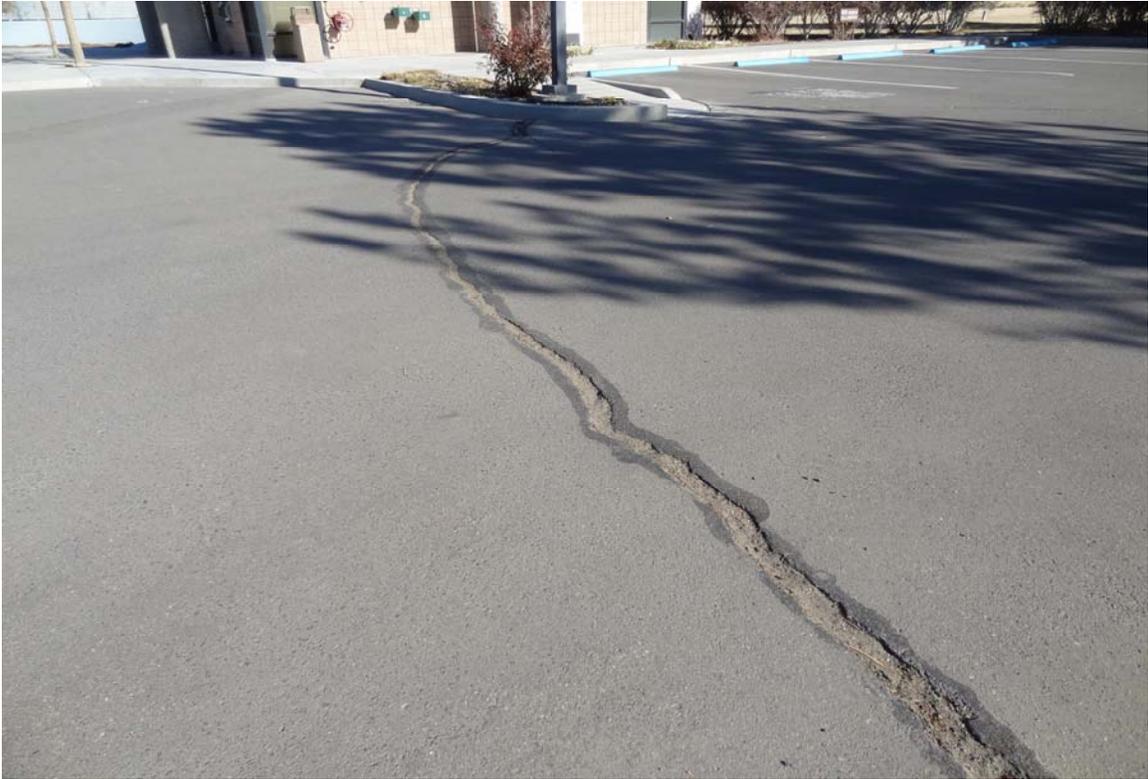
Northern Nevada Veterans Memorial Cemetery Site - Site #9898  
Description: AC paving in need of crack filling and sealing.

It is important to maintain the asphalt concrete paving for the site. This project would provide for minor crack filling and slurry sealing of the paving . Striping is included in this estimate. This project should be scheduled on a 5 year cyclical basis to maintain the integrity of the paving and prevent premature failure. 65,000 square feet of asphalt area was used to generate this estimate. This project also recommends that the parking and loading area at the Pavilion and Information Office be scheduled for sealing and striping within the next one to two years as this area is heavily used and some area are showing signs of failure.

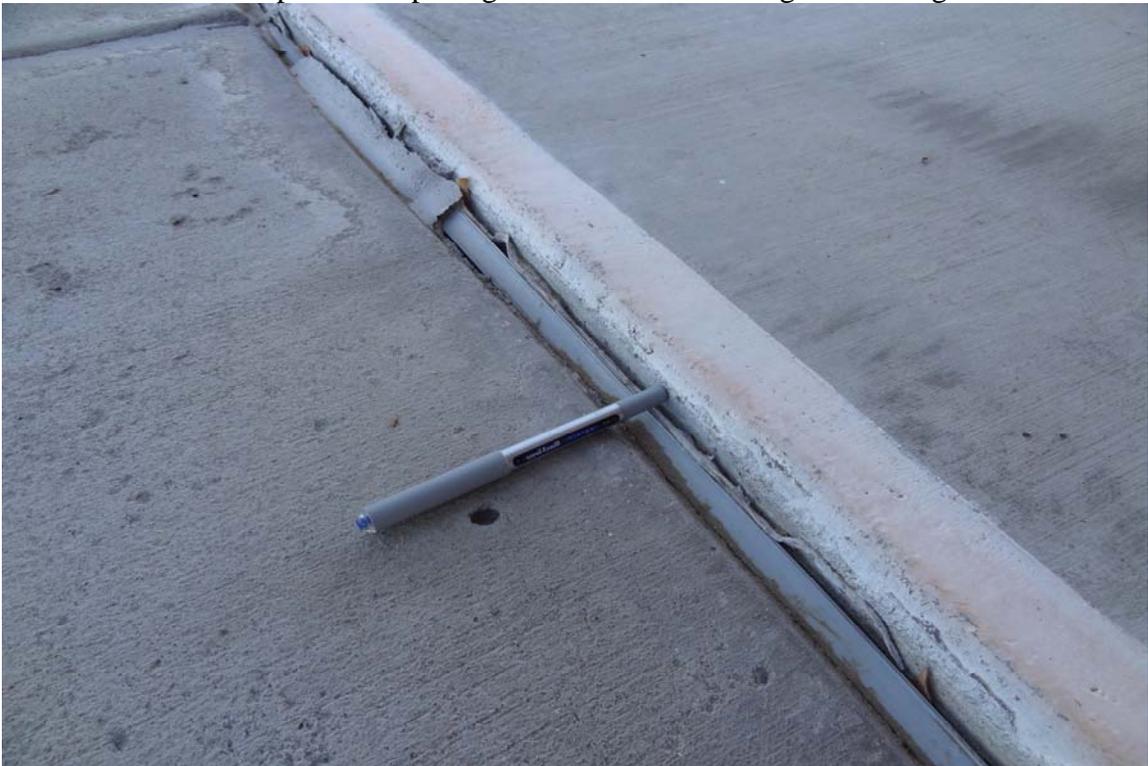
The concrete sections and expansion joints in the concrete patio between the Pavilion and the Public Information Building have become tripping hazards due to heaving, frost freeze cycles and possibly from roots of the trees in the planters. This project would provide for the replacement of the damaged sections and affected expansion joints with new concrete.

Northern Nevada Veterans Memorial Cemetery Site - Site #9898  
Description: Concrete tripping hazard at pavilion area.

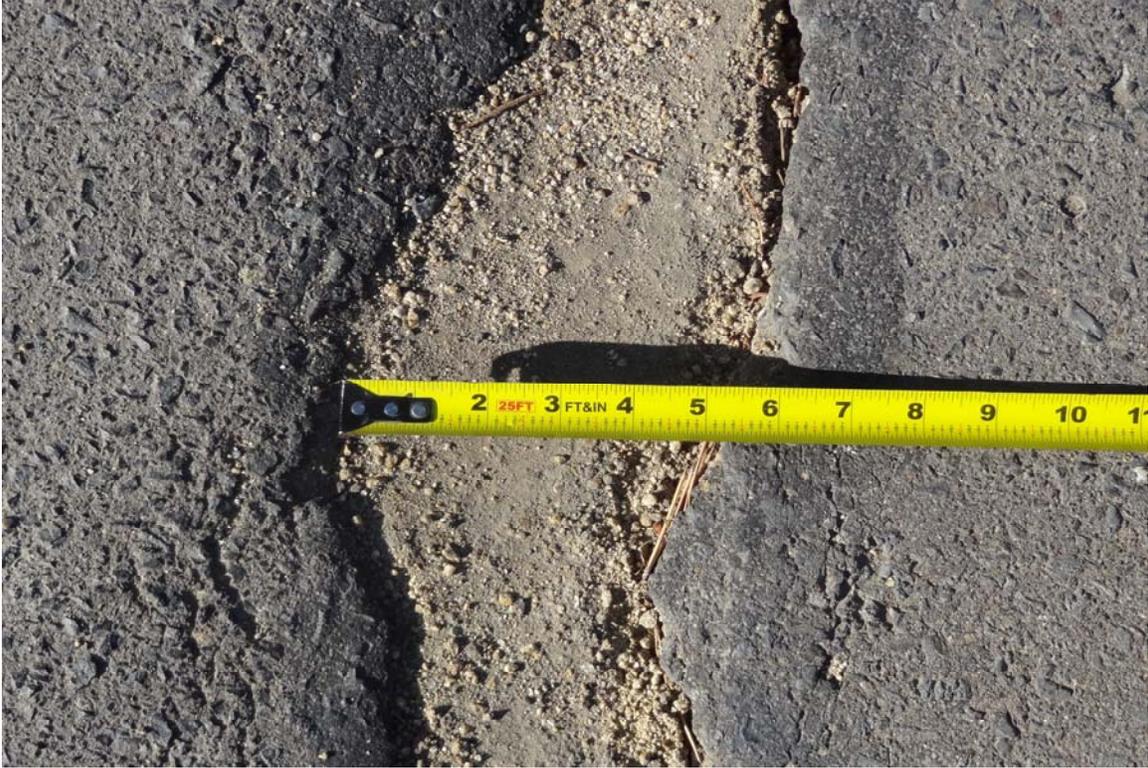
Northern Nevada Veterans Memorial Cemetery Site - Site #9898  
Description: AC paving in need of crack filling.

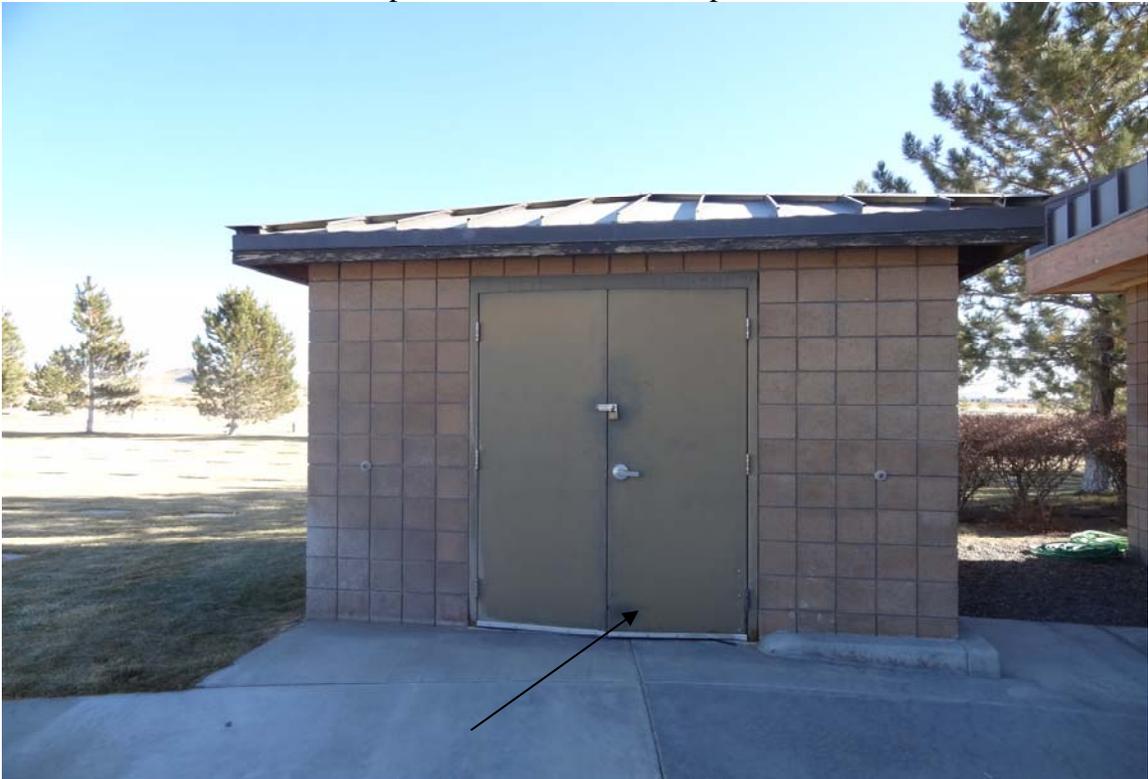
The existing double door assembly is damaged from heavy use and age. This project would provide for a new 6'-0"x7'-0" metal double door assembly including hardware, door stops and painting of door and frame. Included in this package price is the removal of a portion of the 6" concrete curb that interferes with the door operation on the south side. This project or a portion thereof was previously recommended in the FCA report dated 02/23/2005. It has been amended accordingly to reflect conditions observed during the most recent survey date of 12/08/2011.

Cemetery Storage 2 - Building #2036  
Description: Exterior of the building, note damaged door.

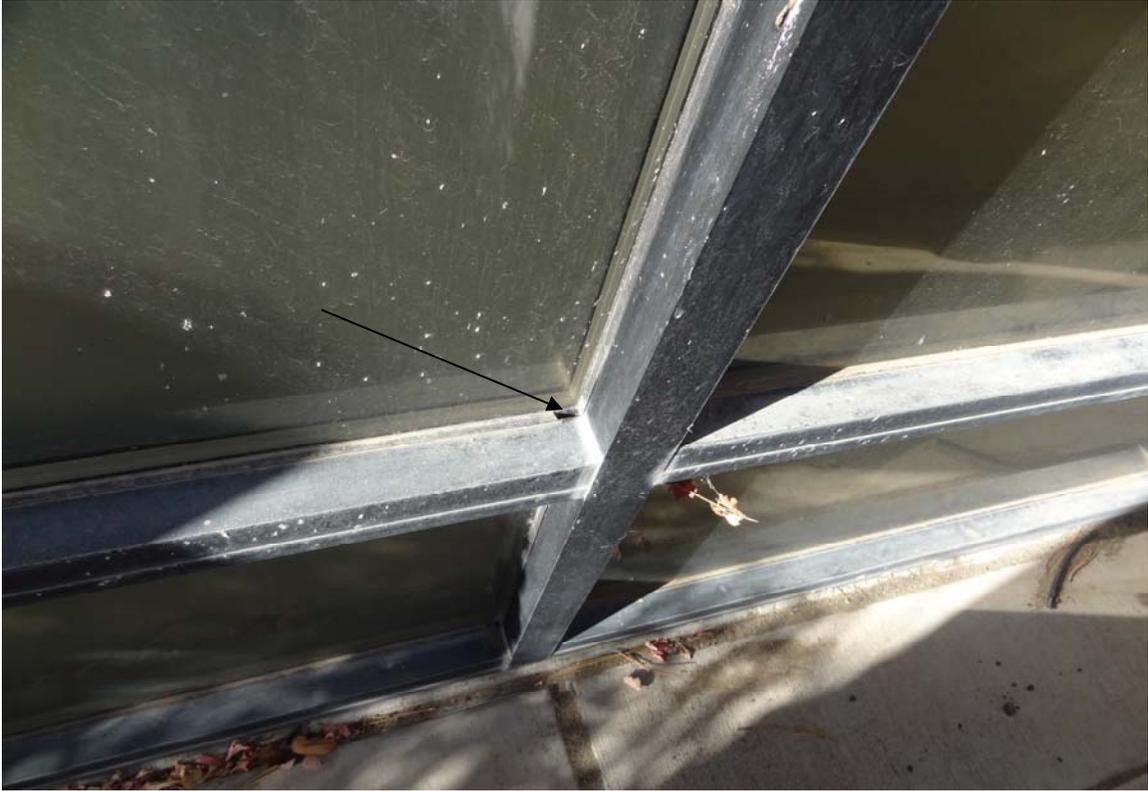
Cemetery Public Information Office - Building #1944  
Description: Failing seals in glazing panels.

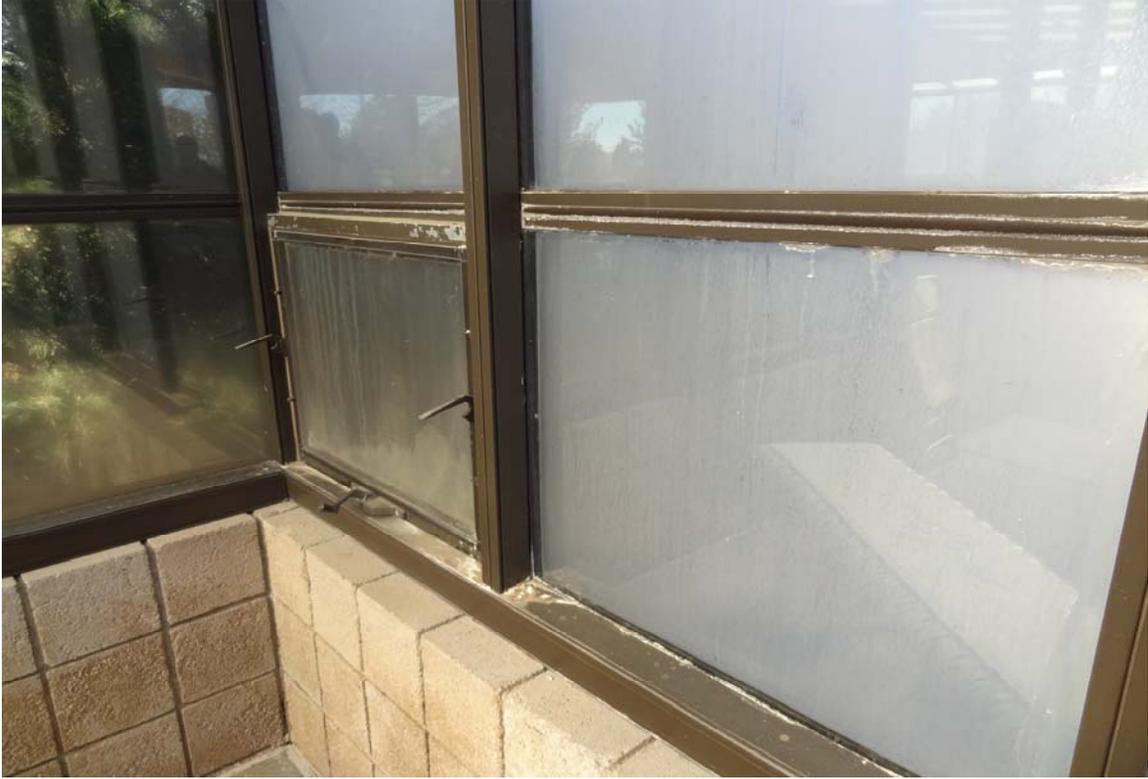
The storefront glazing system shows signs of failure due to age, exposure, broken seals around the glazing panels and water infiltration. This project would provide for new tempered glazing panels to be installed. Removal and disposal of the existing system is included in this estimate.

Cemetery Pavilion - Building #1943  
Description: Moisture damage to glazing panels.

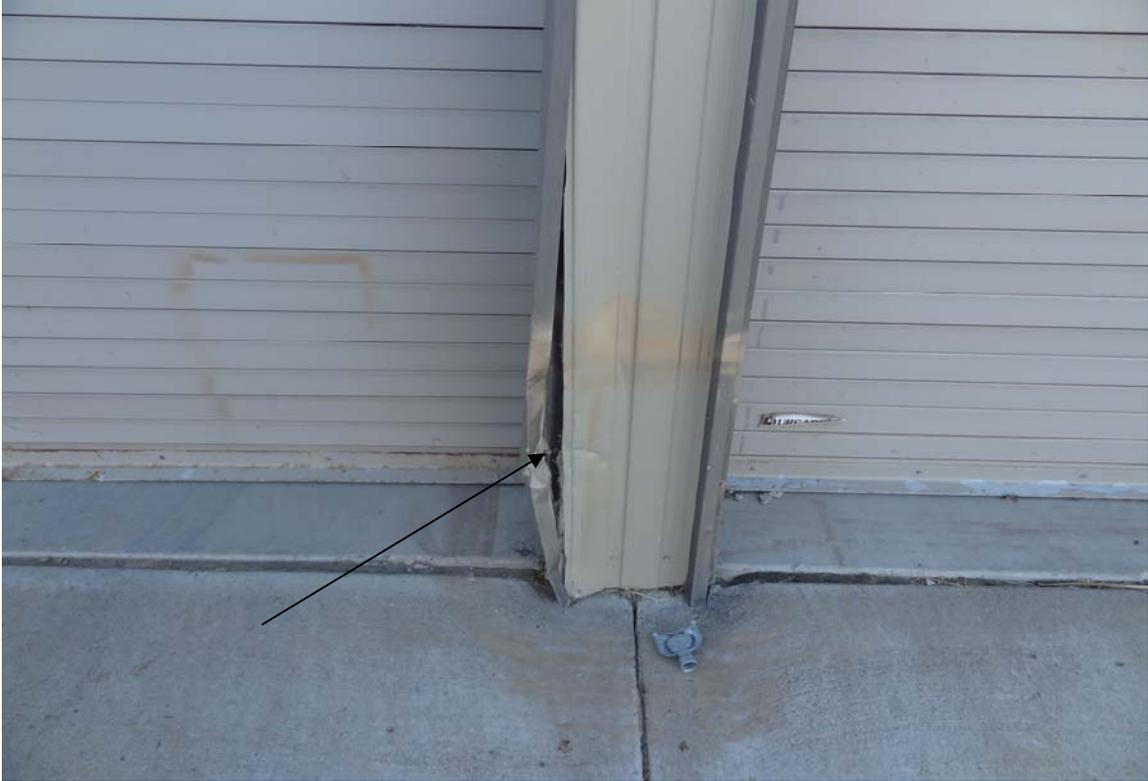
Cemetery Welding / Storage Shop - Building #1942  
Description: Damage to metal siding.
