State of Nevada
Department of the Public Safety
NDI Site in Las Vegas
Facility Condition Analysis

NDI SITE

Las Vegas, NV

SITE NUMBER: 9911
FACILITY CONDITION ANALYSIS

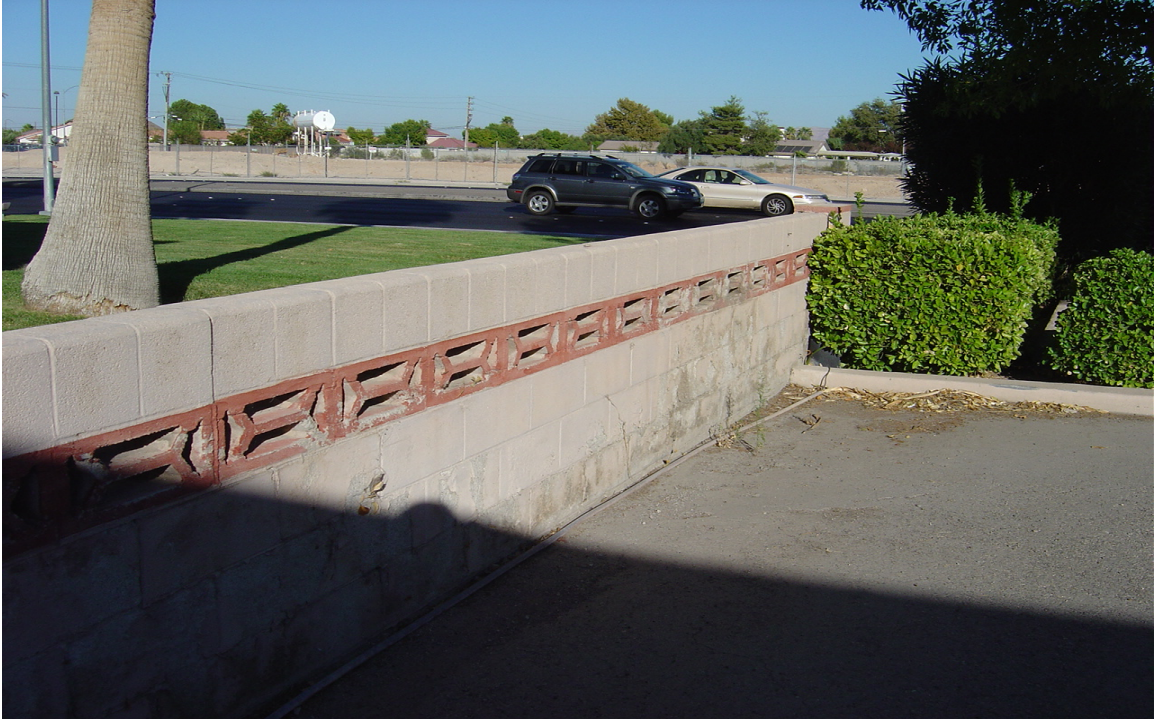
NDI in Las Vegas Site #9911

The exterior property retaining wall has water damage to the walls in several locations due to moisture infiltration. A repair is recommended. The masonry should be removed and replaced. After the repair, the affected areas should be sealed and painted.

Description: View of retaining wall.

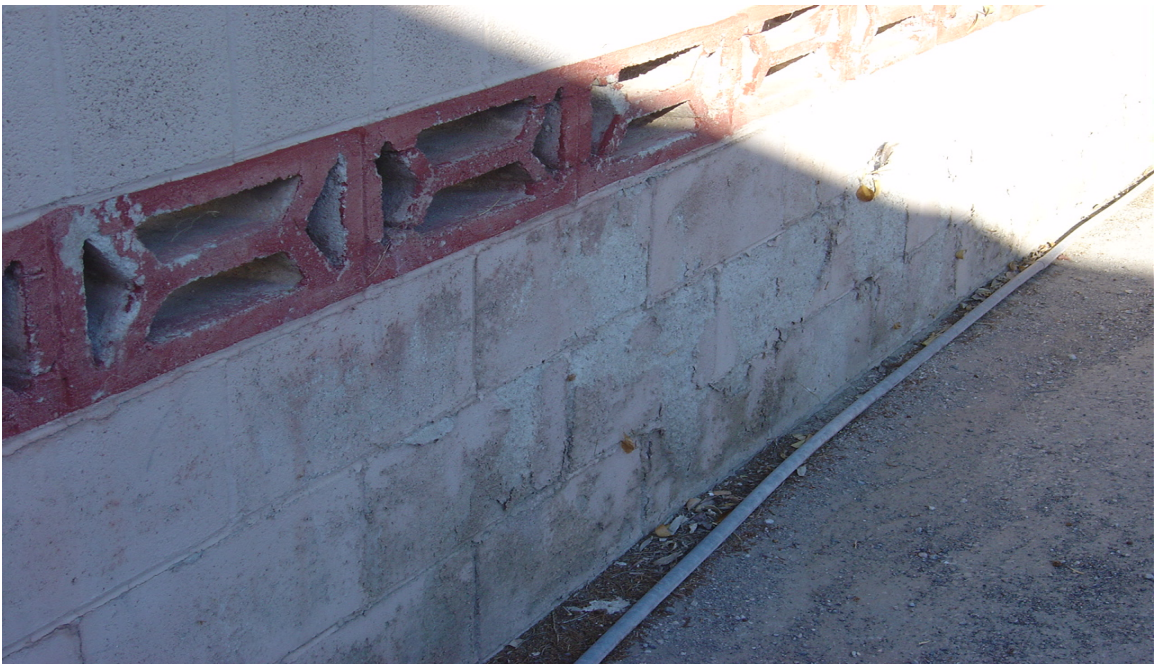
NDI in Las Vegas Site #9911

Description: Moisture issue on the retaining wall.

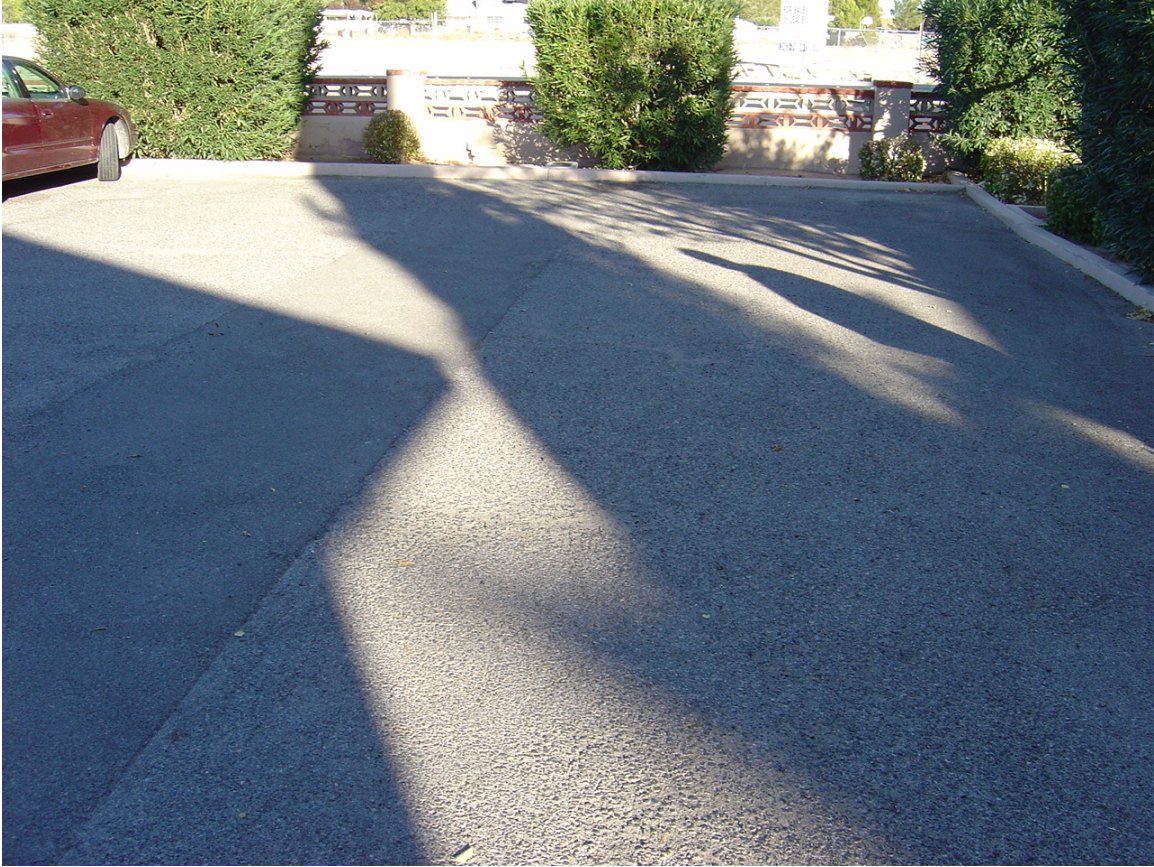
NDI in Las Vegas Site #9911

The existing paving is in fair condition. Climate and constant use will accelerate deterioration. For proper maintenance, it is recommended the parking areas and roadways be resealed and re-stripped. This type of maintenance will extend the life of the asphalt.

Description: View of asphalt condition throughout the site.

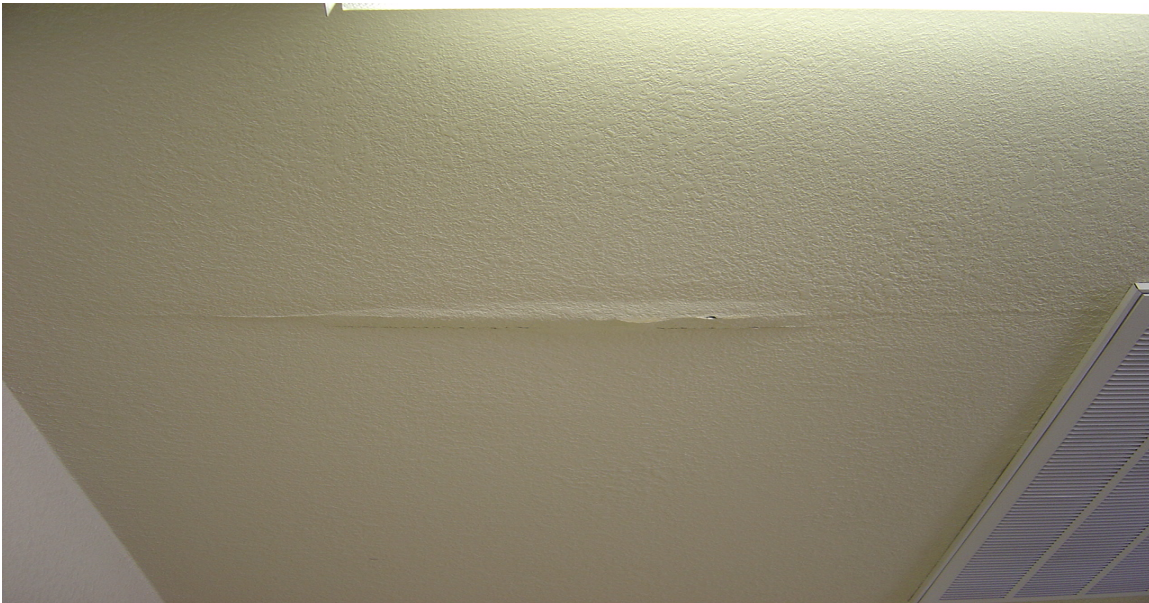
The roof was reported in average condition at the time of the survey. The statewide roofing program has set the useful life of an average roof at 15 years. The roof warranty expires at the end of the same time frame.

NDI in Las Vegas Site/NDI Office #2 - Building #2400
Description: Evidence of past roof leak.

It is recommended that this building be re-roofed within the next two to four years to be consistent with roofing program guidelines.

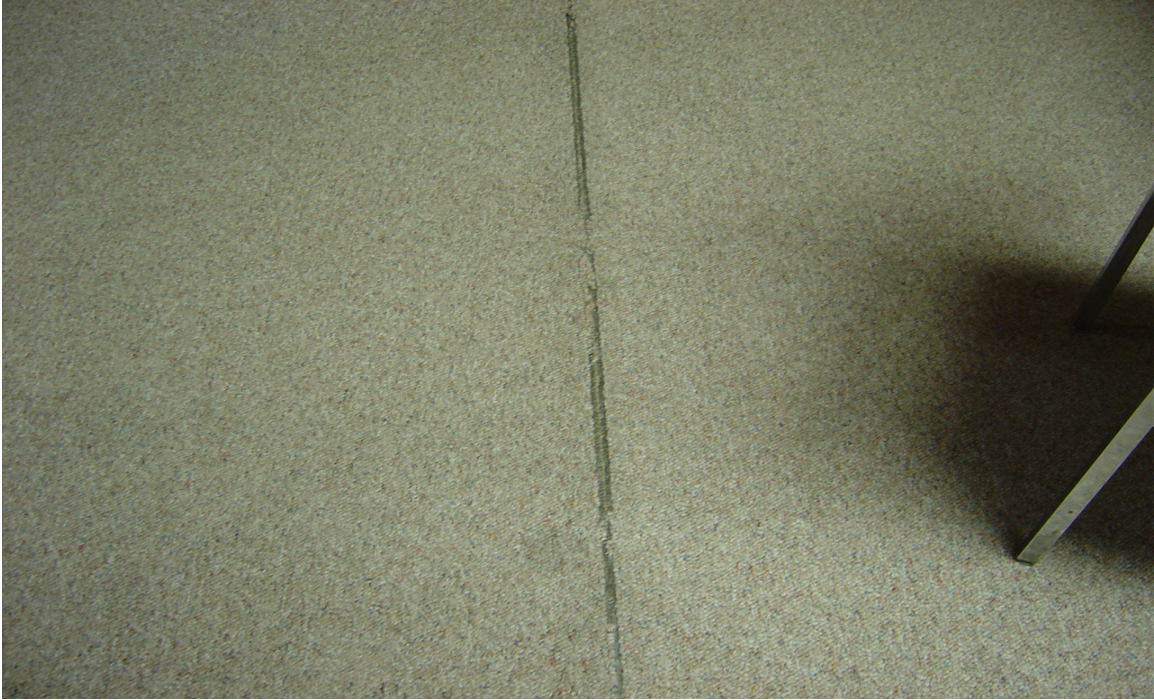
The carpeted areas on the stairs and in the offices are reaching the end of their useful life. It is recommended the carpet be replaced.

NDI in Las Vegas Site/NDI Main Office - Building #0262
Description: View of carpet failure throughout the building.

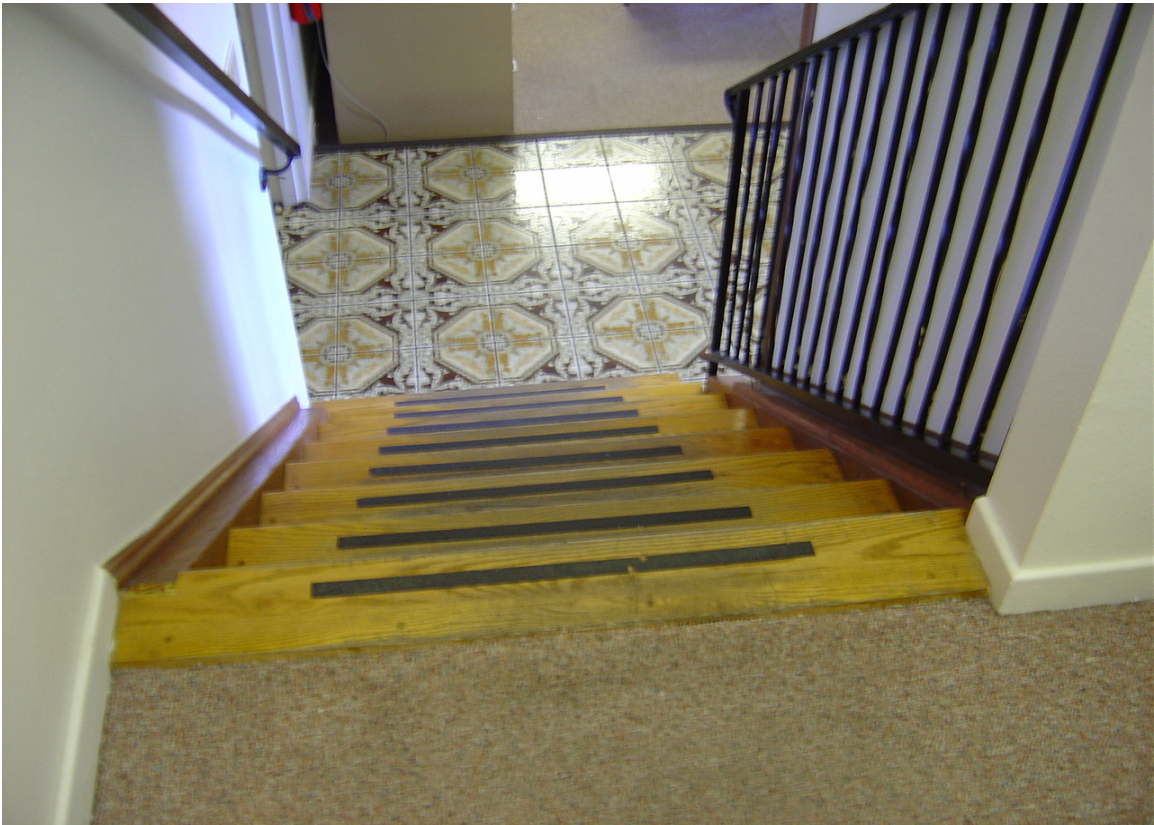
The stair handrails appear to be original to the building, and do not meet code for safety or accessibility. The gripping surfaces are incorrect, the handrails are flimsy, do not have proper returns and they are not continuous from the top to bottom of the stairs. This project recommends the installation of handrails on both sides of both stairwells, with proper returns and supports.

NDI in Las Vegas Site/NDI Main Office - Building #0262
Description: View of stairs in the building.

This project includes monies for some repairs or replacement of stair treads.

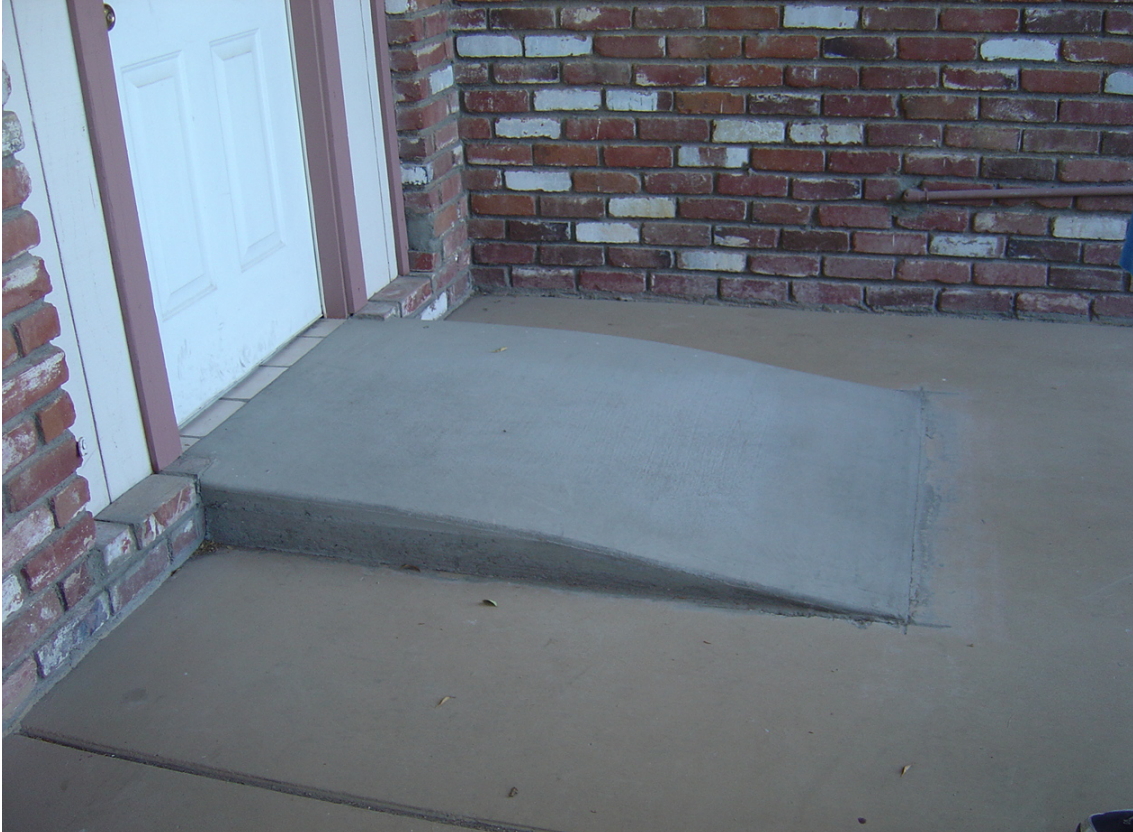
The building has steps and a ramp leading to the main entrances. Both are in poor condition, and should be replaced.

NDI in Las Vegas Site/NDI Main Office - Building #0262
Description: Ramp at the entrance to the visitor area.

This project would provide for an accessible concrete ramp, including upper and lower landing areas, handrails, and curbing.
