State of Nevada  
Department of the Military  
Nevada National Guard  
Plumb Lane Readiness Center  
Facility Condition Analysis

# PLUMB LANE READINESS CENTER

**Site Number: 9919**  
**STATE OF NEVADA PUBLIC WORKS BOARD**  
**FACILITY CONDITION ANALYSIS**

Report Printed in September 2010

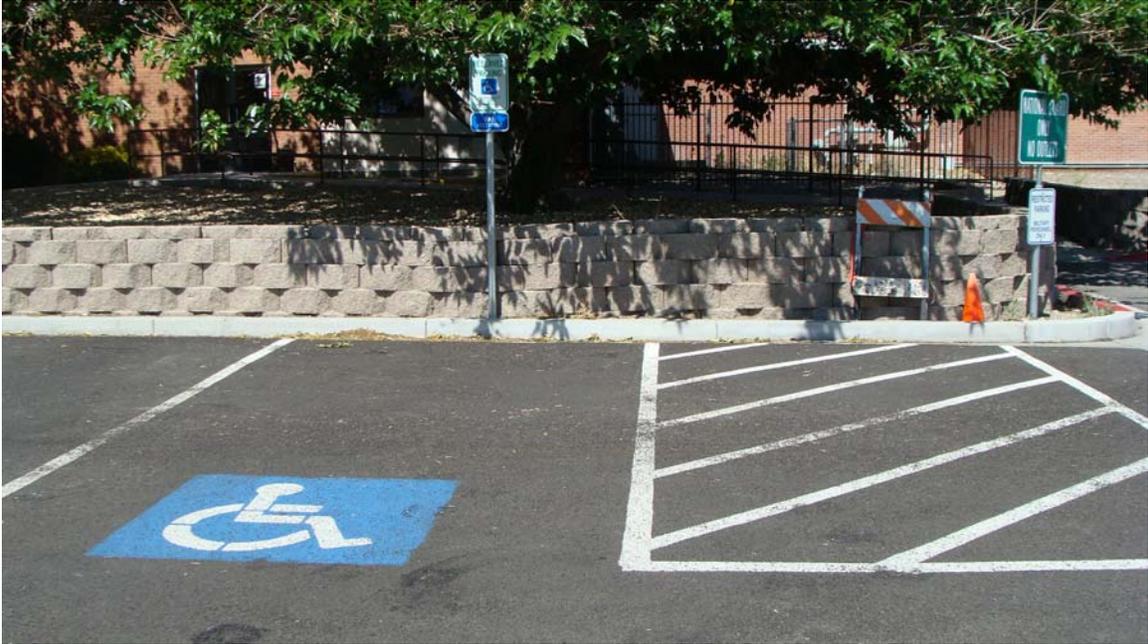
Plumb Lane Readiness Center Site - Site #9919  
Description: ADA accessible parking.

This facility has an ADA accessible ramp on the east side of the Readiness Center. This ramp is on the accessible path of travel from the accessible parking spaces to the Readiness Center. The ramp does not have proper landings, the handrails are not compliant, and it is missing edge protection. This project would provide for an upgrade to the ramp to make it fully ADA compliant. NRS 338.180, IBC - 2006, ICC/ANSI A117.1 - 2003 and the most current version of the Americans with Disabilities Act Accessible Guidelines (ADAAG) was used as a reference for this project.

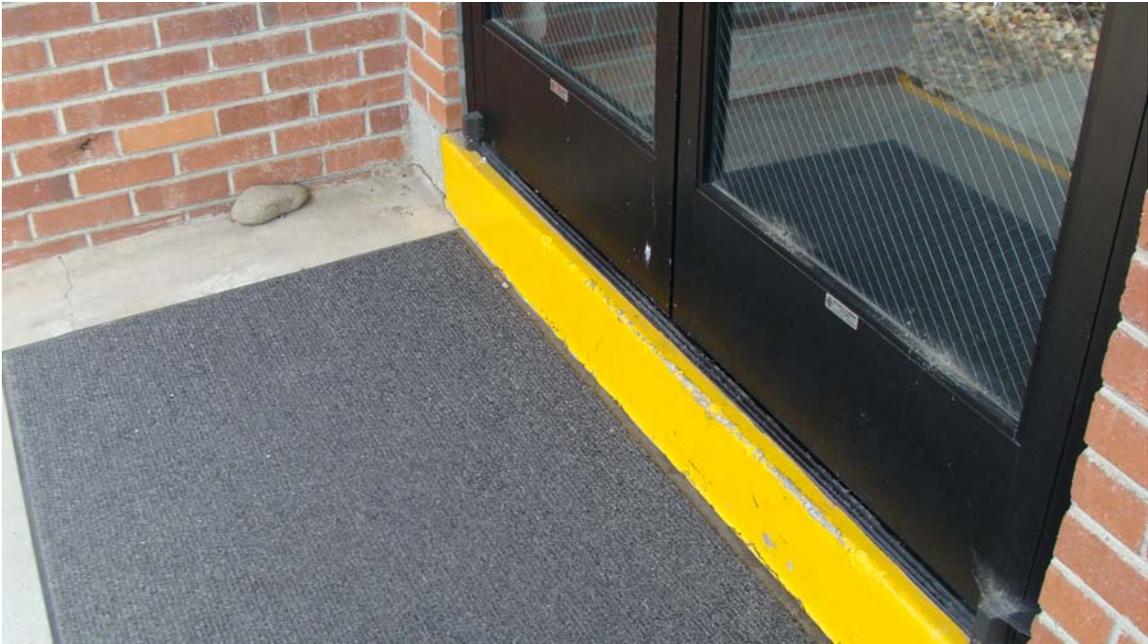
Plumb Lane Readiness Center - Building #2042  
Description: Door swing over step.

The entrance on the south side of the building does not have a proper exterior landing, stairway, and is missing handrails as required by the 2006 IBC, Chapter 10, Section 1008, 1009 and 1012. Also the exit door from the drill hall area swings out over a step. This project would provide for the reworking of the exterior landing and steps to provide a proper landing and stairs including handrails at the south entrance, and adding a new concrete landing at the drill hall exit door.

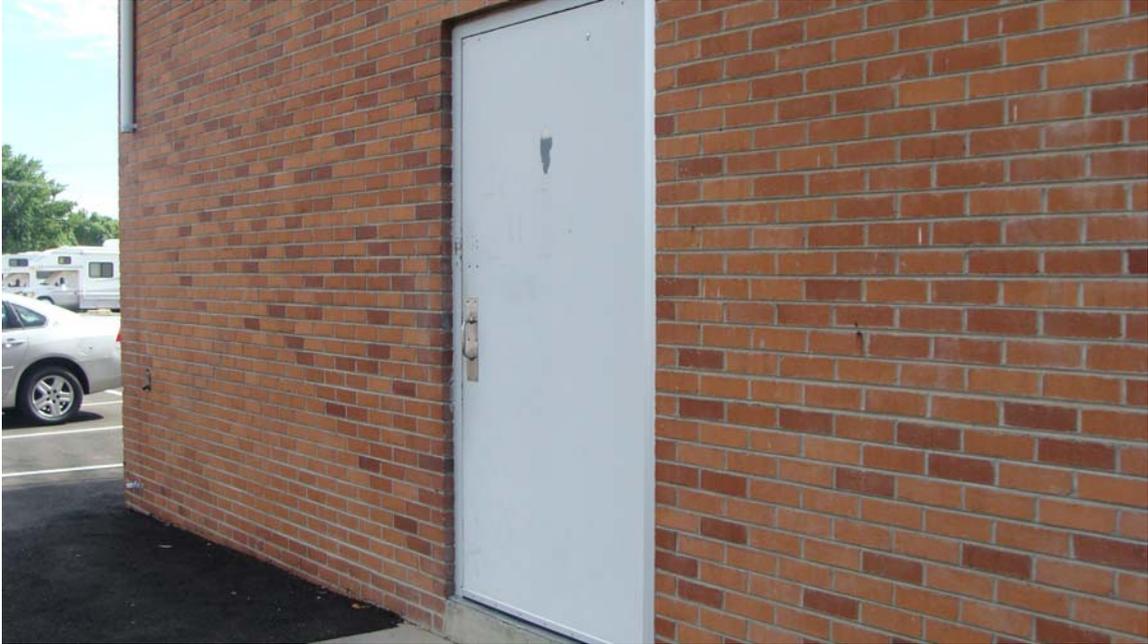
Plumb Lane Readiness Center - Building #2042  
Description: Door swing over step at Drill Hall.

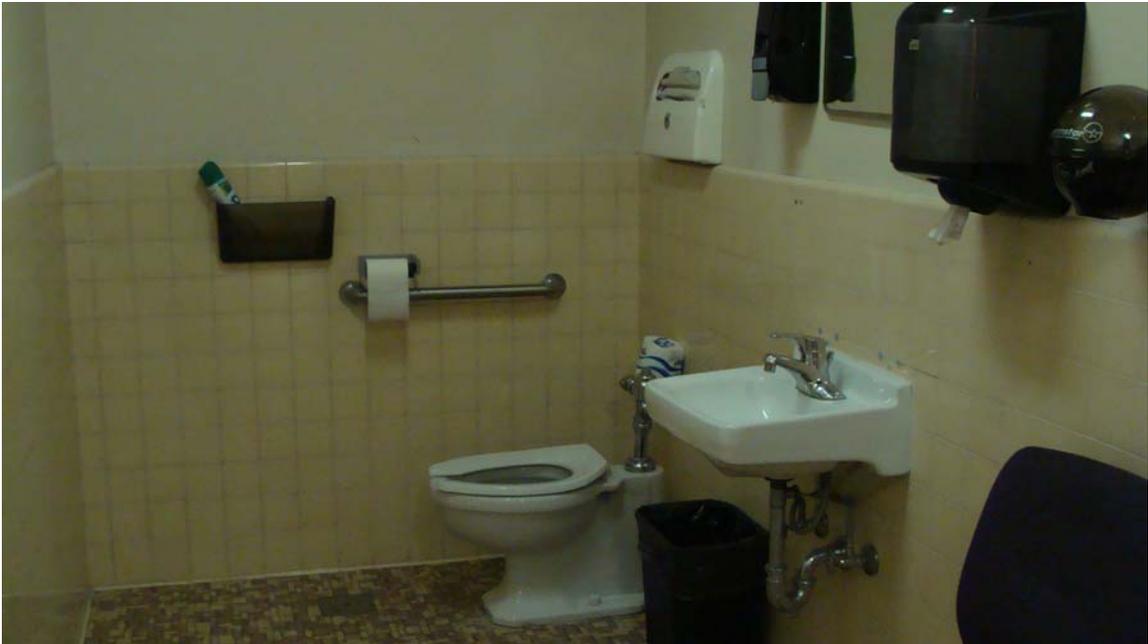
The designated unisex ADA accessible restroom is not fully compliant. There is no pipe protection, the toilet paper dispenser is not in the correct location, and it is missing a grab bar. A partial retrofit is necessary. This project would provide funding to bring the restroom into full ADA compliance. NRS 338.180, IBC - 2006, ICC/ANSI A117.1 - 2003 and the most current version of the Americans with Disabilities Act Accessible Guidelines (ADAAG) was used as a reference for this project.

Plumb Lane Readiness Center - Building #2042  
Description: Restroom in need of an ADA upgrade.

The existing Men's and Women's restrooms are original to building and are in need of upgrades. This project would provide for the remodeling of both restrooms including but not limited to new toilets, shower modifications, sinks, fixtures, hardware, and floor and wall finishes. It is also recommended that these restrooms become ADA accessible but there already is a unisex ADA restroom present in the building which would provide minimum ADA restroom facilities after the proposed project for upgrading that restroom is complete. This cost estimate does not include an ADA upgrade which may increase the construction cost.

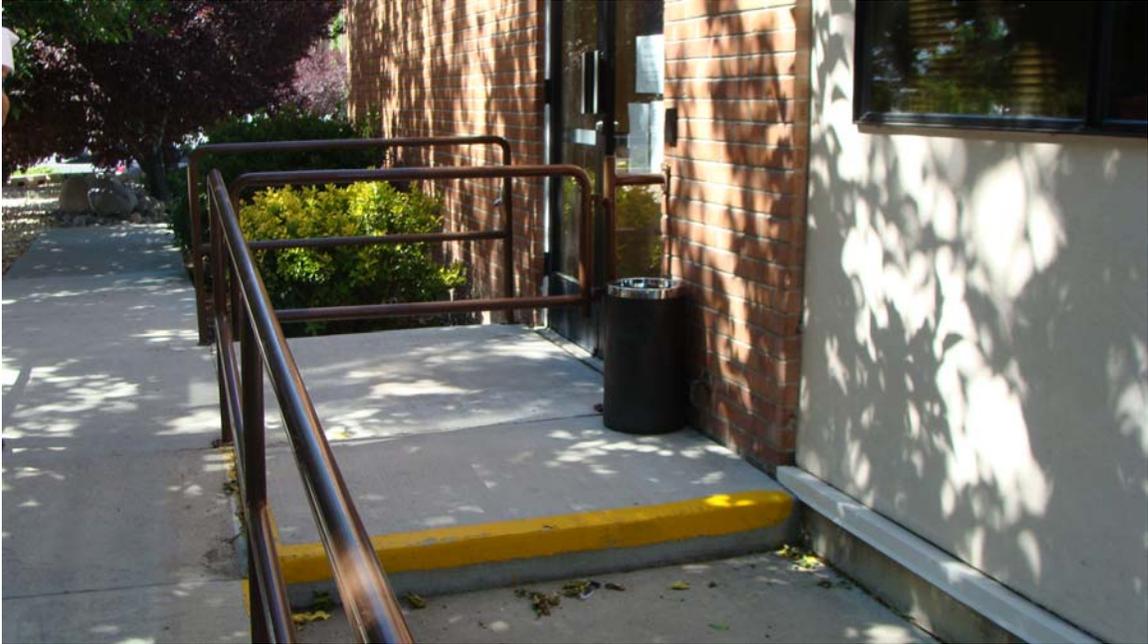
The exterior entrance door on the east side of the building is on an accessible path of travel. It has a power door opener installed on it which has been disabled for security reasons. Without the power door opener, the entrance is not accessible. This project would provide for replacement of the doors to provide an accessible entrance including new ADA compliant door hardware, threshold, signage and space requirements. NRS 338.180, IBC - 2006, ICC/ANSI A117.1 - 2003 and the most current version of the Americans with Disabilities Act Accessible Guidelines (ADAAG) was used as a reference for this project. The other option would be to activate the power door opener which must open both door leaves along with signage identifying ADA access which may cost less than door replacement.

Plumb Lane Readiness Center - Building #2042  
Description: Designated ADA accessible entrance.

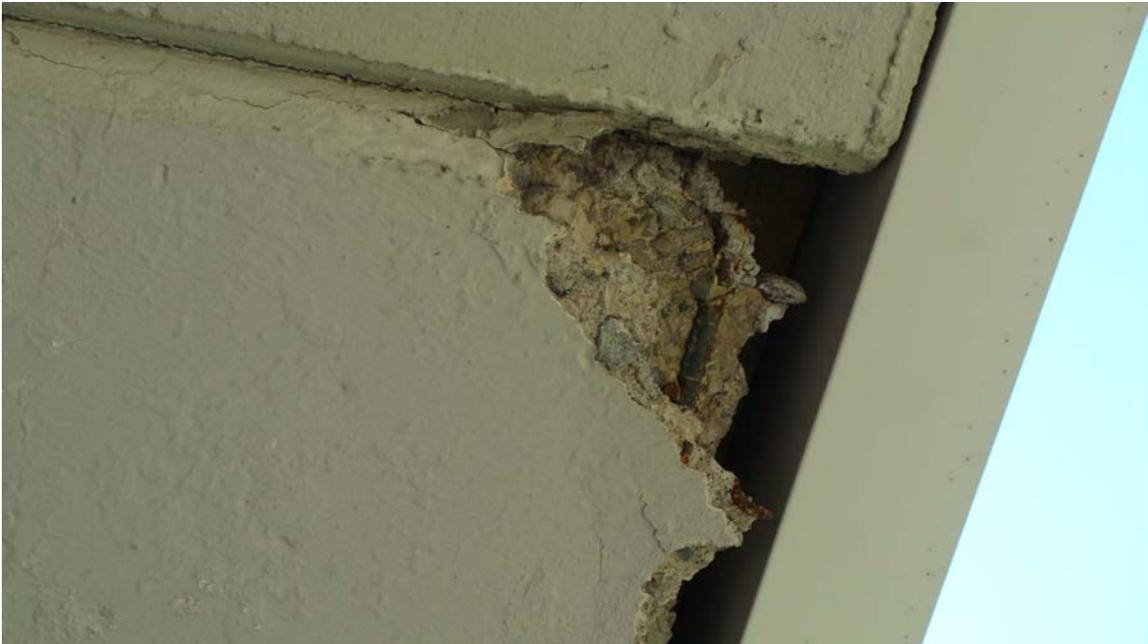
Plumb Lane Readiness Center - Building #2042  
Description: Concrete roof deck damage.

It is important to maintain the finish, weather resistance, and appearance of the building. This project would provide funding to protect the exterior of the building excluding the roof. Included in the cost are cleaning and sealing the masonry, priming and painting the stucco, and caulking of the windows, flashing, fixtures and all other penetrations. It is recommended that the building be sealed and caulked in the next 2-3 years and that this project be scheduled on a cyclical basis to maintain the integrity of the structure. Also included is the repairing of the concrete roof deck overhang at the damaged areas.

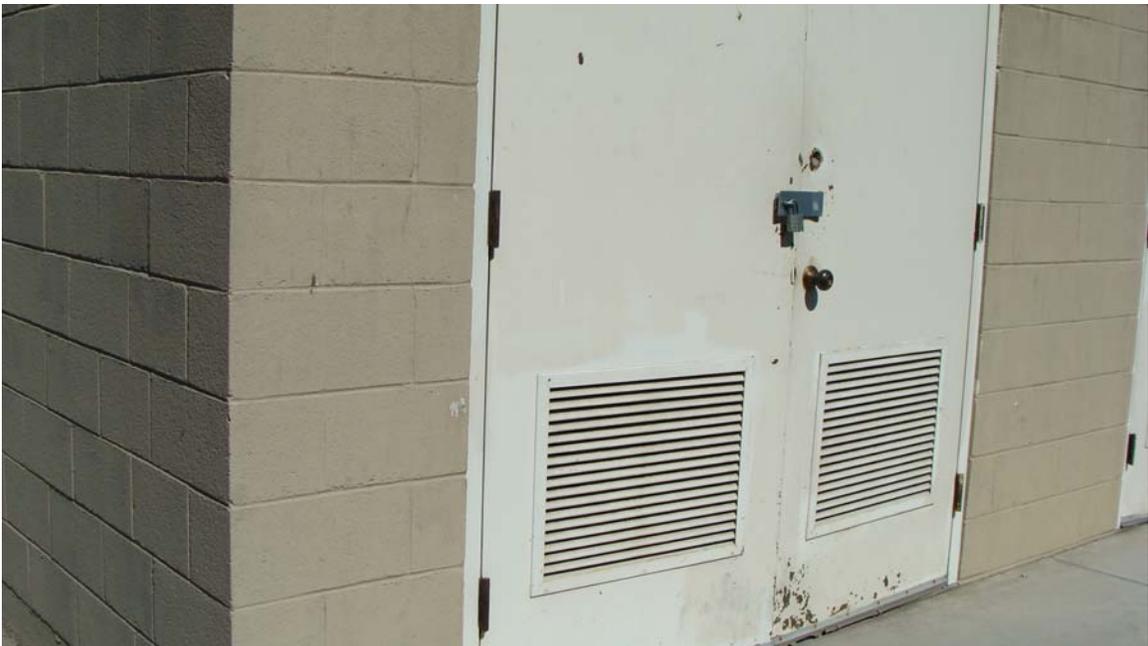
The exterior metal doors are damaged from age and general wear and tear and have reached the end of their expected life. This project would provide for the replacement of the three double door assemblies with new metal doors, frames, and hardware. Removal and disposal of the existing doors is included in this estimate.

Storage Building 1 - Building #2044  
Description: Doors in need of replacement.
