State of Nevada
Department of Corrections
Three Lakes Valley Conservation Camp
Facility Condition Analysis

THREE LAKES VALLEY CONSERVATION CAMP

**STATE OF NEVADA PUBLIC WORKS DIVISION
FACILITY CONDITION ANALYSIS**

Survey Date: 5/1/2013

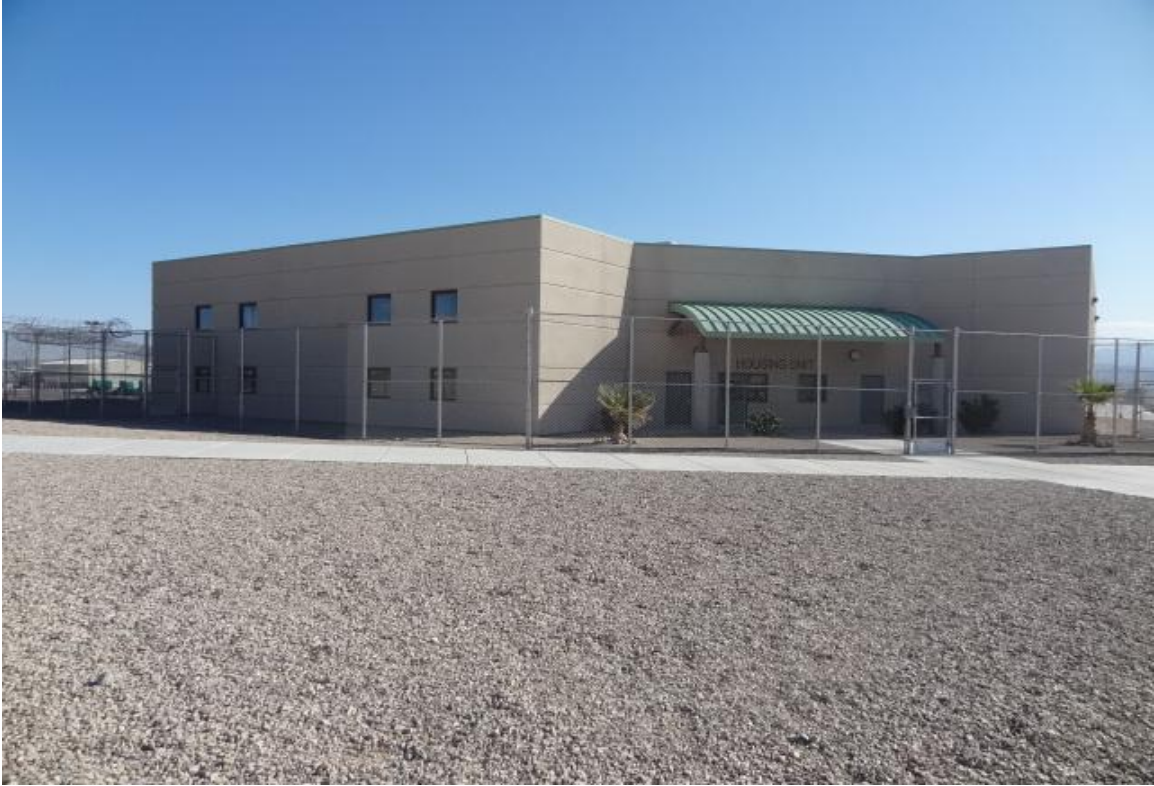
Housing Unit A1 – FCA Building #3088
Description: Exterior of the building.

It is important to maintain the finish, weather resistance and appearance of the building. This project would provide funding to protect the exterior of the building excluding the roof. Included in the cost is power washing, priming and painting and caulking of the windows, flashing, fixtures and all other penetrations. It is recommended that the building be painted in the next 5-7 years and that this project be scheduled on a cyclical basis to maintain the integrity of the structure.

The interior finishes are in fair condition. It is recommended that the interior walls and ceilings be painted at least once in the next 4-5 years and that this project be scheduled on a cyclical basis to maintain the integrity of the structure. Prior to painting, all surfaces should be repaired and prepped. An epoxy-based paint should be utilized in wet areas for durability.

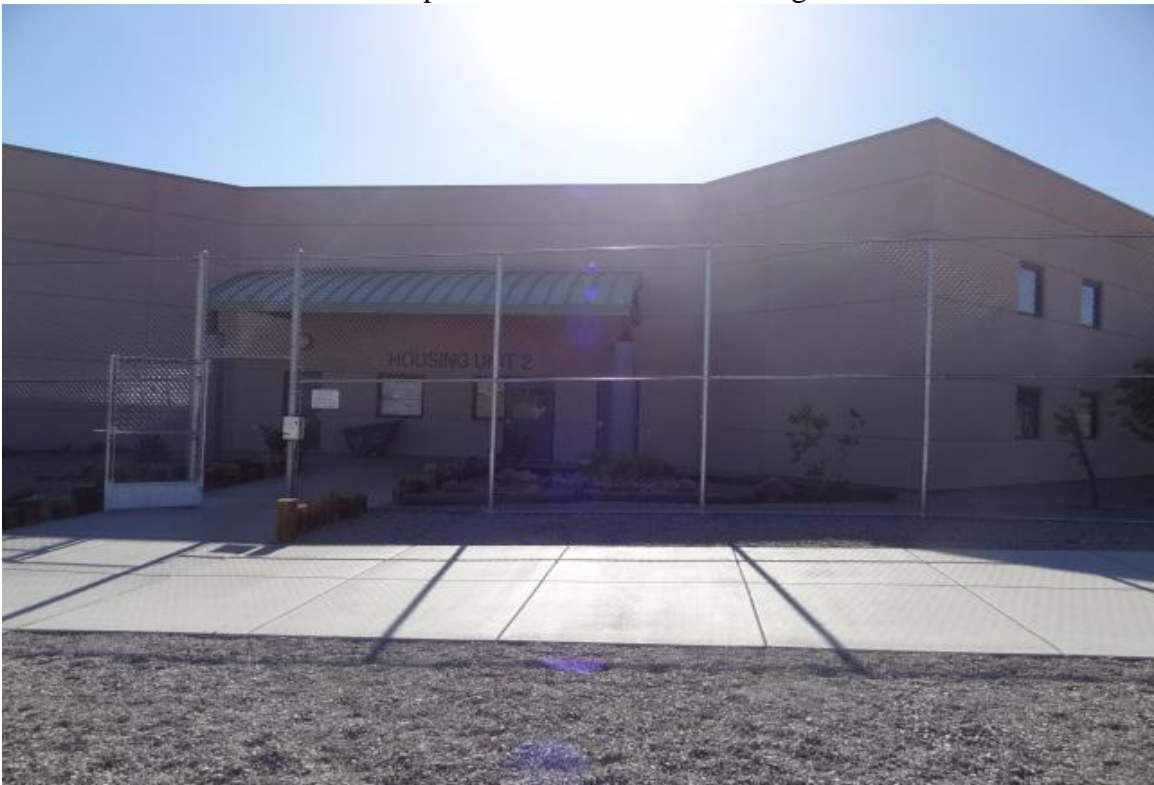
Housing Unit A2 – FCA Building #3089
Description: Exterior of the building.

It is important to maintain the finish, weather resistance and appearance of the building. This project would provide funding to protect the exterior of the building excluding the roof. Included in the cost is power washing, priming and painting and caulking of the windows, flashing, fixtures and all other penetrations. It is recommended that the building be painted in the next 5-7 years and that this project be scheduled on a cyclical basis to maintain the integrity of the structure.

The interior finishes are in fair condition. It is recommended that the interior walls and ceilings be painted at least once in the next 4-5 years and that this project be scheduled on a cyclical basis to maintain the integrity of the structure. Prior to painting, all surfaces should be repaired and prepped. An epoxy-based paint should be utilized in wet areas for durability.

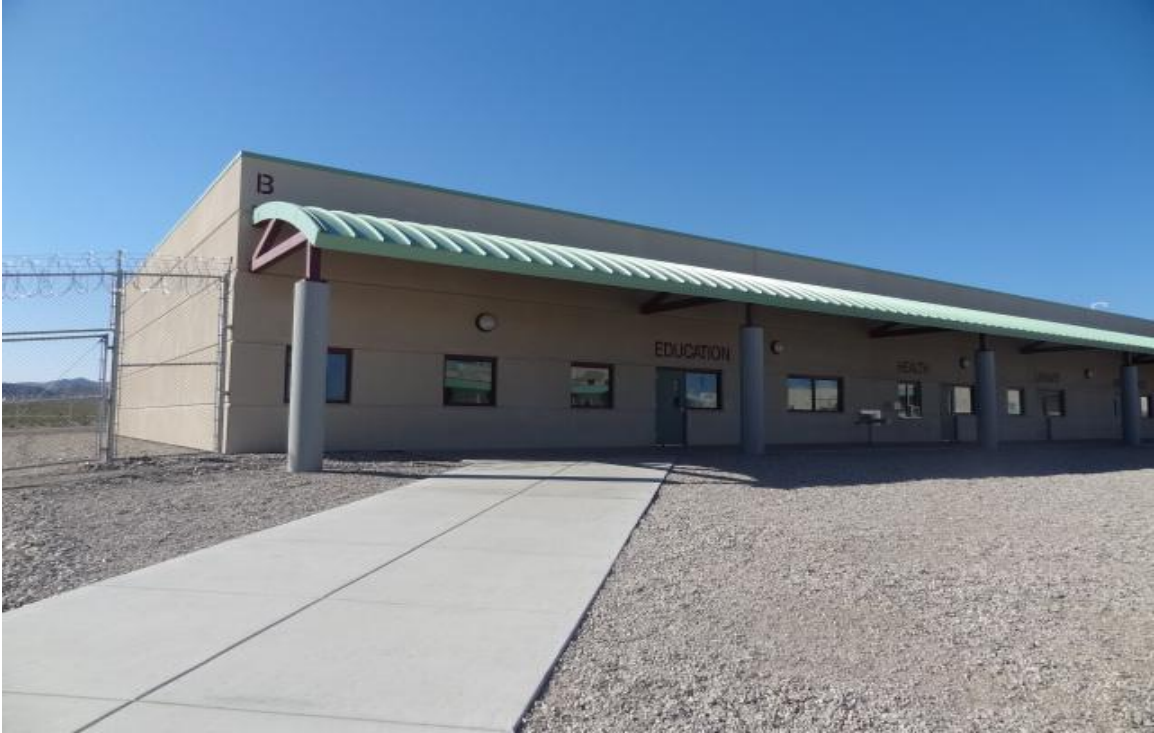
Inmate Services B – FCA Building #3090
Description: Exterior of the building.

It is important to maintain the finish, weather resistance and appearance of the building. This project would provide funding to protect the exterior of the building excluding the roof. Included in the cost is power washing, priming and painting and caulking of the windows, flashing, fixtures and all other penetrations. It is recommended that the building be painted in the next 5-7 years and that this project be scheduled on a cyclical basis to maintain the integrity of the structure.

The interior finishes are in fair condition. It is recommended that the interior walls and ceilings be painted at least once in the next 4-5 years and that this project be scheduled on a cyclical basis to maintain the integrity of the structure. Prior to painting, all surfaces should be repaired and prepped. An epoxy-based paint should be utilized in wet areas for durability.

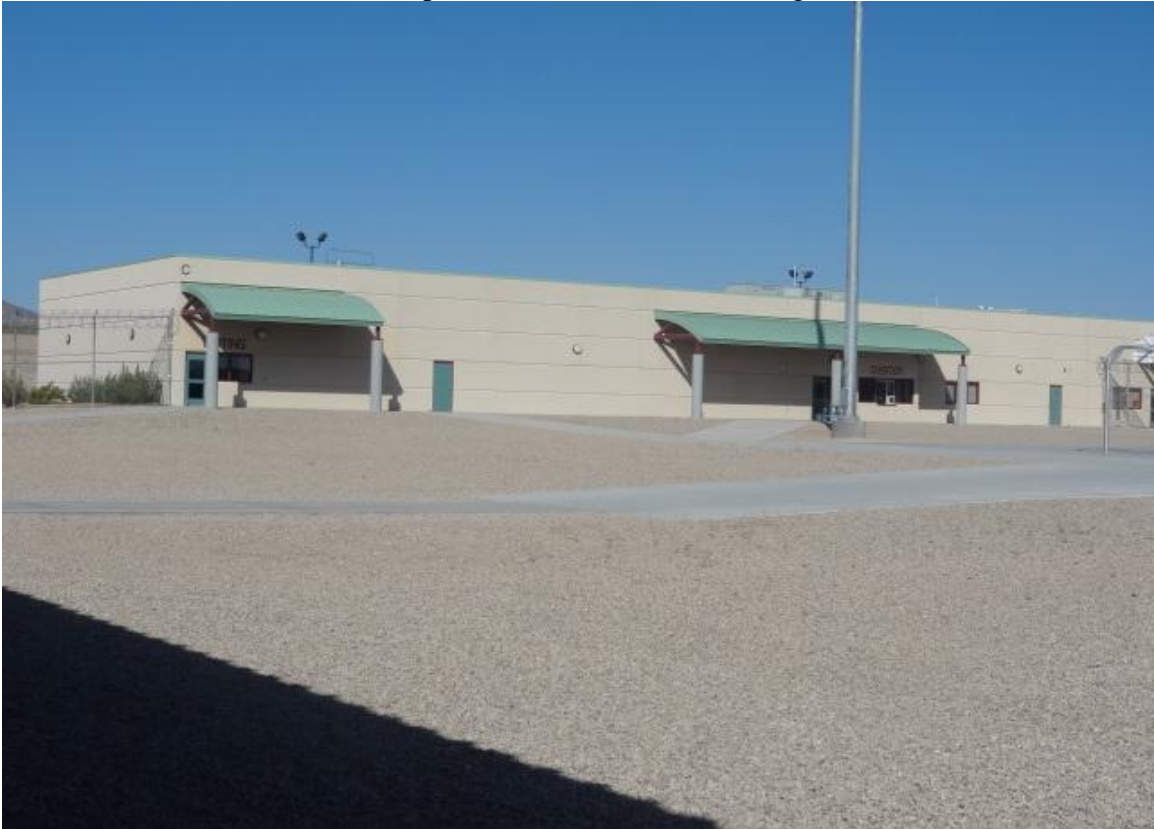
NDOC / NDF Administration C – FCA Building #3091
Description: Exterior of the building.

It is important to maintain the finish, weather resistance and appearance of the building. This project would provide funding to protect the exterior of the building excluding the roof. Included in the cost is power washing, priming and painting and caulking of the windows, flashing, fixtures and all other penetrations. It is recommended that the building be painted in the next 5-7 years and that this project be scheduled on a cyclical basis to maintain the integrity of the structure.

The interior finishes are in fair condition. It is recommended that the interior walls and ceilings be painted at least once in the next 4-5 years and that this project be scheduled on a cyclical basis to maintain the integrity of the structure. Prior to painting, all surfaces should be repaired and prepped. An epoxy-based paint should be utilized in wet areas for durability.

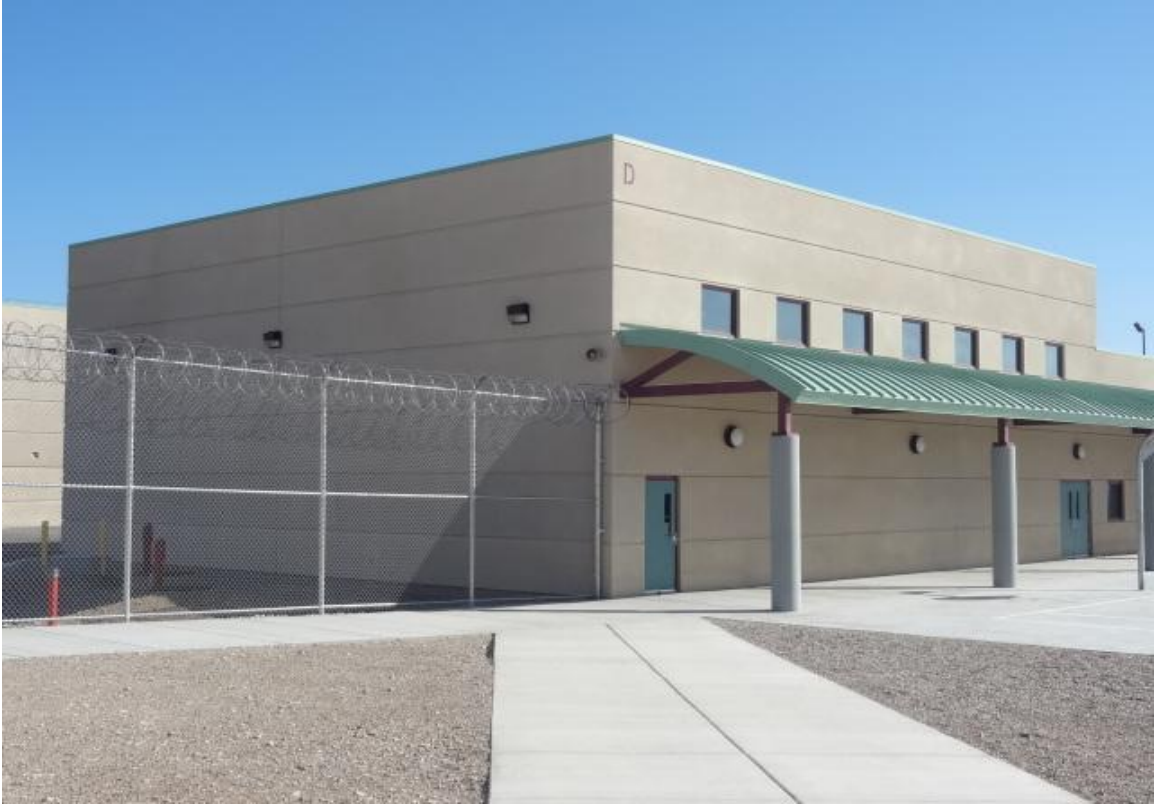
Inmate Programs D – FCA Building #3092
Description: Exterior of the building.

It is important to maintain the finish, weather resistance and appearance of the building. This project would provide funding to protect the exterior of the building excluding the roof. Included in the cost is power washing, priming and painting and caulking of the windows, flashing, fixtures and all other penetrations. It is recommended that the building be painted in the next 5-7 years and that this project be scheduled on a cyclical basis to maintain the integrity of the structure.

The interior finishes are in fair condition. It is recommended that the interior walls and ceilings be painted at least once in the next 4-5 years and that this project be scheduled on a cyclical basis to maintain the integrity of the structure. Prior to painting, all surfaces should be repaired and prepped. An epoxy-based paint should be utilized in wet areas for durability.
