STATE OF NEVADA
STATE PUBLIC WORKS DIVISION

FACILITY CONDITION ASSESSMENT REPORT FOR:

STATE BOARD OF MEDICAL EXAMINERS

SITE #: 9748 BOARD OF MEDICAL EXAMINERS OFFICE SITE
9600 GATEWAY DR
RENO, NV 89521-8953

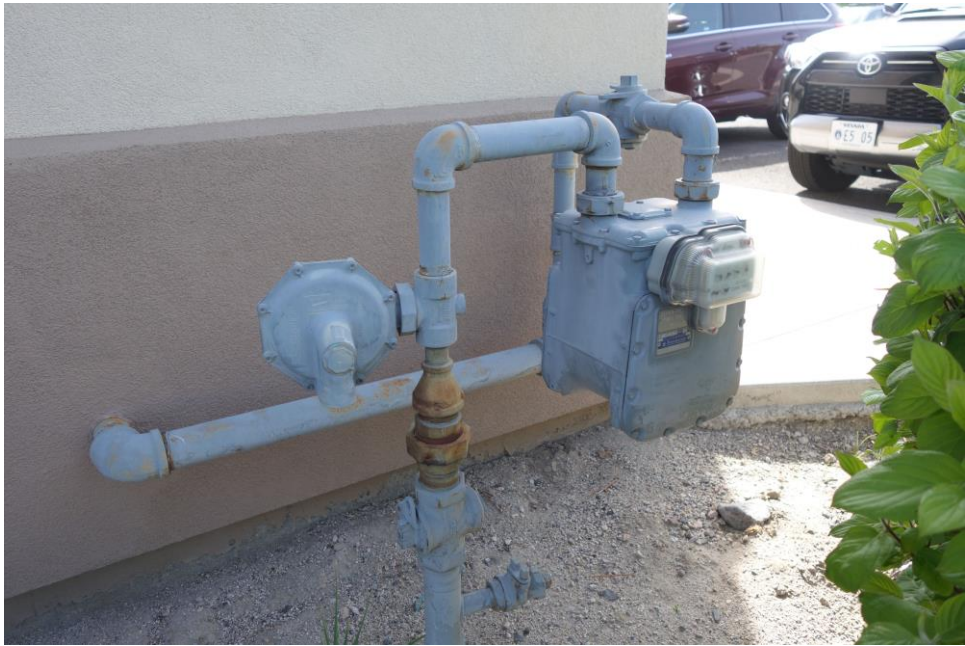
PRIORITY	1 - Immediate to Two Years	
PROJECT #	9748SFT1 - SAFETY ISSUES	STATUS	9/9/2024	NEW

SEISMIC GAS SHUT-OFF VALVE INSTALLATION

QUANTITY	UNITS	TOTAL	SF COST
<p>This project would provide for the installation of a seismic gas shut-off valve on the main gas service piping prior to entering the building. Alternately, for propane services or a site gas services with a single site metering station, consider installation at the tank or main meter service if it feeds multiple buildings. This estimate is based on the manufacturer Pacific Seismic Products or approved equal, equipped with the optional Model MS remote monitoring switch (to be interfaced with the direct digital control system and/or with an audible alarm). The gas piping immediately adjacent to the seismic gas valve shall be secured to the building utilizing unistrut channel bracing.</p>	1	Package	\$ 9,400.00	-

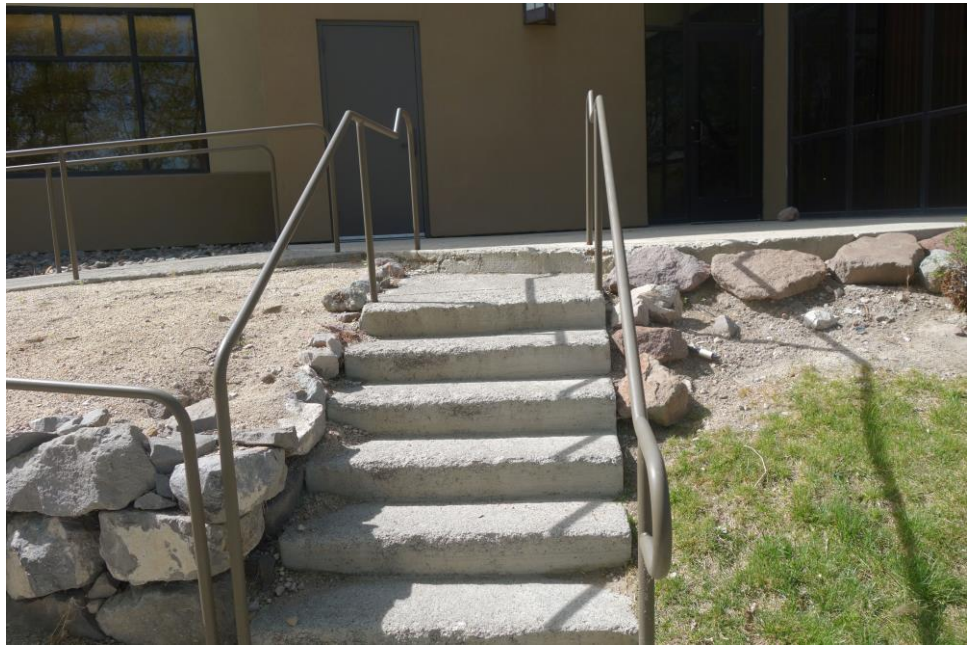
PRIORITY	2 - Two to Four Years	
PROJECT #	9748SIT1 - SITE ISSUES	STATUS	9/9/2024	NEW

CONCRETE REPLACEMENT

QUANTITY	UNITS	TOTAL	SF COST
The concrete surfaces of the two patios, stair and ramp on the north side of the building are failing creating an uneven walking surface. In addition, the guard rails are structurally mounted to the concrete. As the concrete continues to degrade, it will affect the mounting support for the guard rails creating an additional safety hazard. This project recommends the complete replacement of flatwork, stairs, ramp and guard rails.	600	Square Foot	\$45,000.00	-

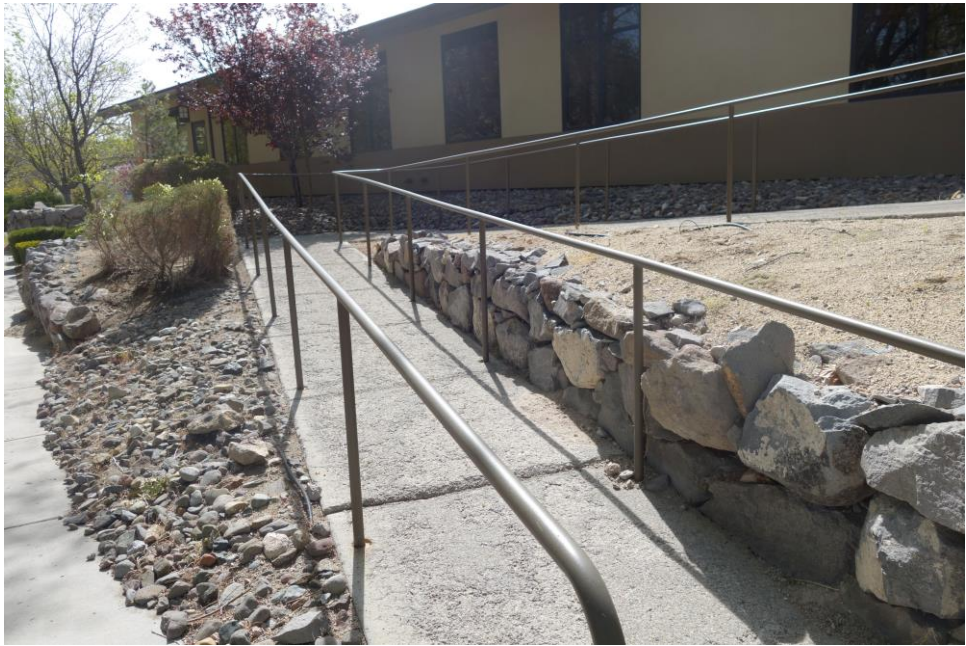
PRIORITY	2 - Two to Four Years	
PROJECT #	9748SIT2 - SITE ISSUES	STATUS	9/9/2024	NEW

LANDSCAPE REFURBISHMENT

QUANTITY	UNITS	TOTAL	SF COST
<p>The landscaping surrounding the building is aging and appears to be in poor condition. The rock retaining walls appear to be bulging over the sidewalks, possibly due to movement of the soil behind the retaining walls. The stone hardscape is sluffing onto the sidewalks and some of the shrubbery may be lacking adequate irrigation. This project recommends a complete review by a qualified landscape contractor to conduct the proper repairs.</p>	1	Package	\$50,000.00	-

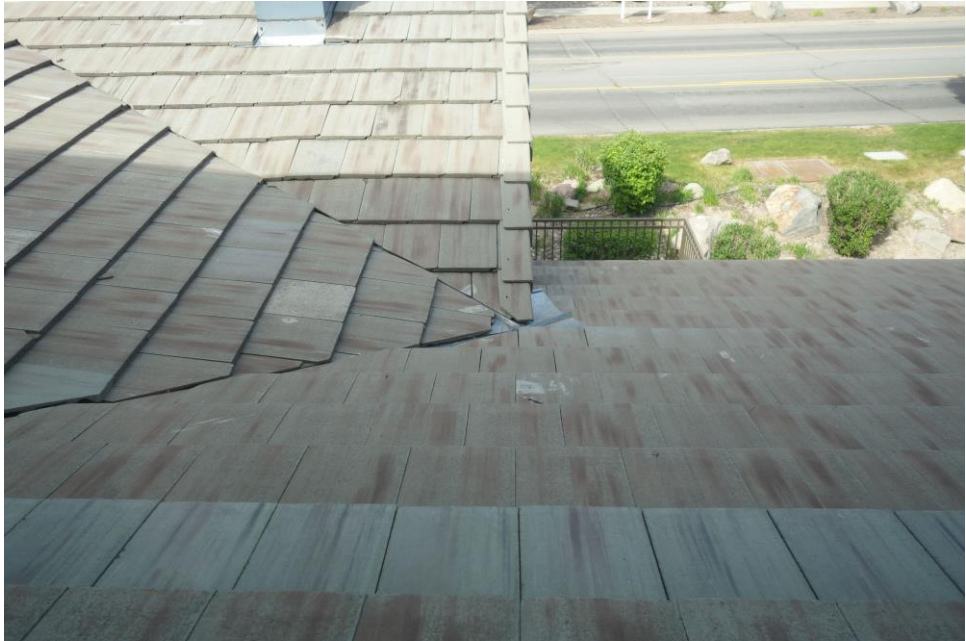
PRIORITY	2 - Two to Four Years	
PROJECT #	3876EXT2 - BUILDING EXTERIOR	STATUS	9/9/2024	NEW

ROOF REPAIR

QUANTITY	UNITS	TOTAL	SF COST
<p>The underlayment in a double valley on the west side of the roof appears to have been installed incorrectly. During severe weather conditions ice builds up under the roofing tiles causing leaks in the spaces below. This project recommends the removal of the roofing tiles and underlayment and re-application of ice & water shield over the entire area. Consulting with the Statewide Roofing Project Manager is recommended in development of the project scope.</p>	1	Package	\$15,000.00	\$ 1.00

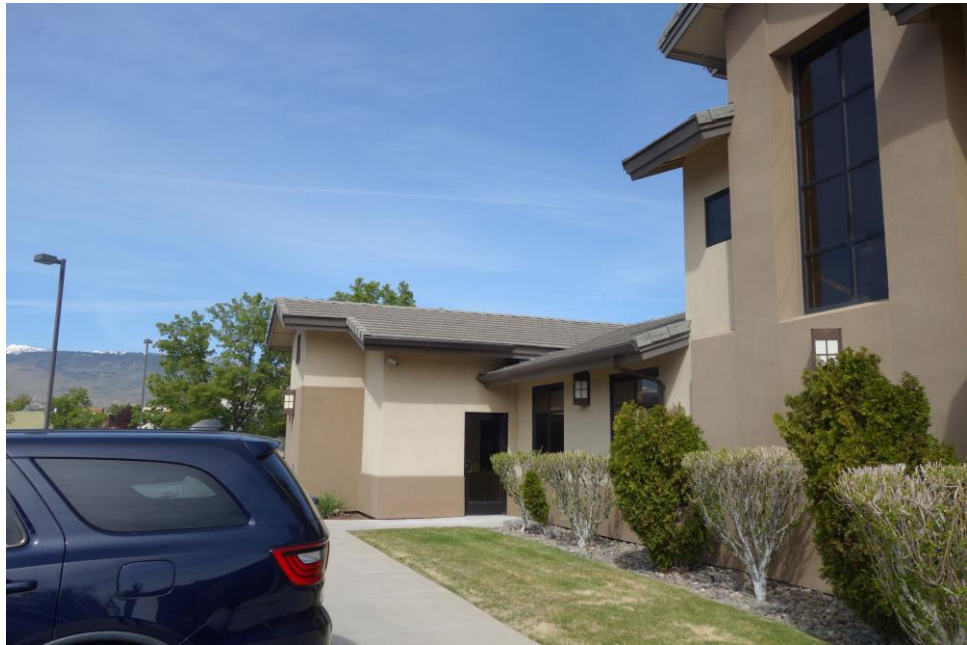
PRIORITY	3 - Four to Ten Years	
PROJECT #	3876EXT1 - BUILDING EXTERIOR	STATUS	9/9/2024	NEW

EXTERIOR FINISHES

QUANTITY	UNITS	TOTAL	SF COST
The exterior finishes were in good condition. It is important to maintain the finish, weather resistance and appearance of the building. This project would provide funding to protect the exterior of the building excluding the roof. Included in the cost is repairing damaged areas of stucco, power washing, priming, painting and caulking the windows, flashing, fixtures and all other penetrations. It is recommended that the building be repaired and painted in the next 7 - 9 years and that this project be scheduled on a cyclical basis to maintain the integrity of the structure.	15672	Square Foot	\$78,400.00	\$ 5.00

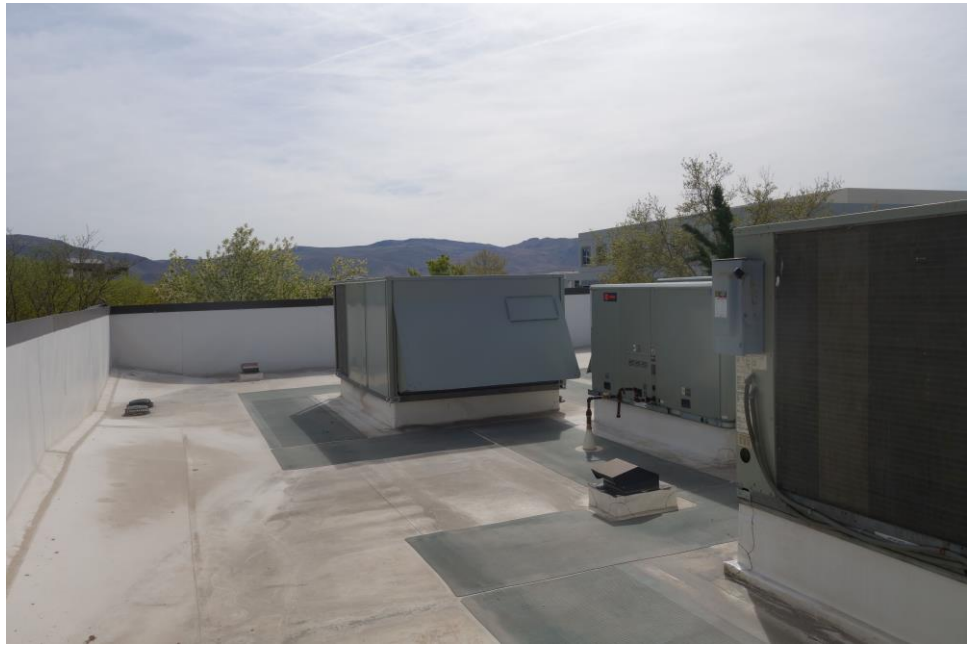
PRIORITY	3 - Four to Ten Years	
PROJECT #	3876EXT3 - BUILDING EXTERIOR	STATUS	9/10/2024	NEW

ROOF REPLACEMENT

QUANTITY	UNITS	TOTAL	SF COST
The single ply roofing in the HVAC roof well was in fair condition at the time of the survey. The statewide roofing program has set the useful life of an average roof at 20 - 25 years. The roof warranty expires during that time frame. Temperature fluctuations throughout the year, consistent wind which blows sand and dirt on to the roof membrane, and constant exposure to the sun are contributing factors to wear and deterioration. The current roofing system was installed in 2006. Based on the expected roofing lifespan, it is recommended that this building be re-roofed in the next 6 - 8 years to be consistent with the roofing program.	1600	Square Foot	\$35,200.00	\$ 2.00

The single ply roofing in the HVAC roof well was in fair condition at the time of the survey. The statewide roofing program has set the useful life of an average roof at 20 - 25 years. The roof warranty expires during that time frame. Temperature fluctuations throughout the year, consistent wind which blows sand and dirt on to the roof membrane, and constant exposure to the sun are contributing factors to wear and deterioration. The current roofing system was installed in 2006. Based on the expected roofing lifespan, it is recommended that this building be re-roofed in the next 6 - 8 years to be consistent with the roofing program.

This project should be implemented concurrently with the HVAC ROOFTOP REPLACEMENT project in order to provide an integrated, water tight roofing solution.

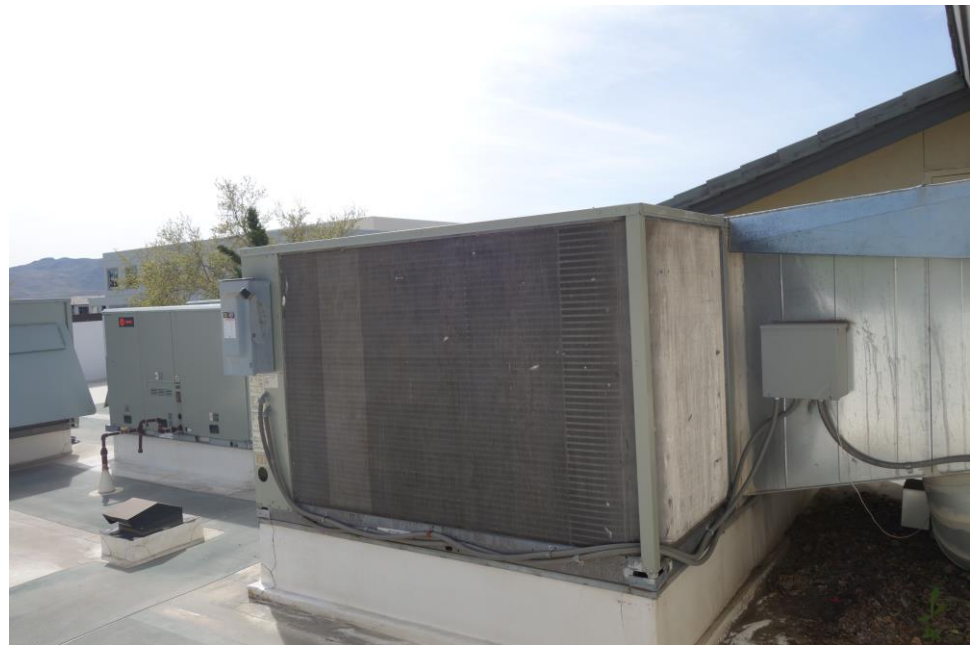
PRIORITY	3 - Four to Ten Years
PROJECT #	3876HVA1 - HVAC	STATUS	9/10/2024 NEW

HVAC ROOFTOP REPLACEMENT

QUANTITY	UNITS	TOTAL	SF COST
There are 4 rooftop packaged HVAC units that are original to the building and approaching 20 years in operation. The packaged HVAC units are reaching the end of their expected and useful life. The R-22 refrigerant in the cooling system is no longer EPA compliant and its production was phased out completely January 1, 2020. This project would provide for the installation of 4 new packaged HVAC units. Also included in this estimate is new curb adapters, roofing modifications, 100 feet of new condensate line, crane and rigging removal and installation and all required connections to utilities. Additional features to include direct drive, economizer and direct digital (DDC) controls.	4	Each	\$100,000.00	\$ 6.00

This project should be implemented concurrently with the ROOF REPLACEMENT project in order to provide an integrated, water tight roofing solution.

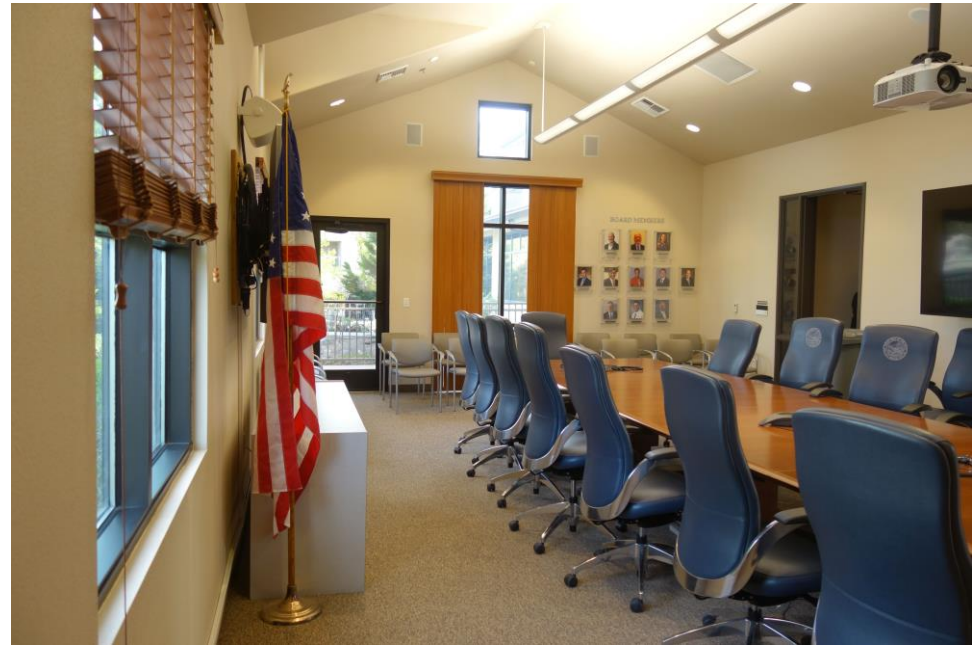
PRIORITY	3 - Four to Ten Years	
PROJECT #	3876INT1 - BUILDING INTERIOR	STATUS	9/9/2024	NEW

INTERIOR FINISHES

QUANTITY	UNITS	TOTAL	SF COST
The interior finishes were in good condition. It is recommended the interior walls and ceilings be painted in the next 7 - 9 years. All surfaces should be repaired and prepped prior to painting. For durability in wet areas, an epoxy-based paint should be used. Building maintenance should be scheduled on a cyclical basis to maintain the integrity of the structure	15672	Square Foot	\$156,700.00	\$ 10.00

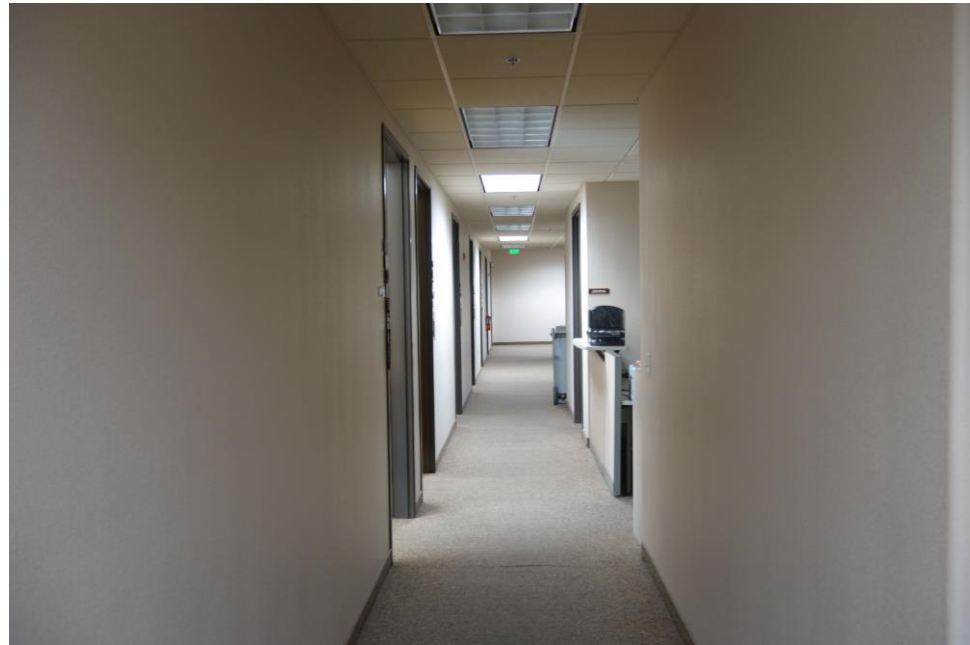
PRIORITY	3 - Four to Ten Years	
PROJECT #	3876INT2 - BUILDING INTERIOR	STATUS	9/10/2024	NEW

FLOORING REPLACEMENT

QUANTITY	UNITS	TOTAL	SF COST
The carpet in 1st floor circulation corridors of the building are reaching the end of their useful life. It is recommended that the flooring be replaced. This project would provide for removal and disposal of the existing flooring and installation of new heavy duty commercial grade carpet in the next 4 - 5 years.	3500	Square Foot	\$49,800.00	\$ 3.00
