STATE OF NEVADA STATE PUBLIC WORKS DIVISION

FACILITY CONDITION ASSESSMENT REPORT FOR:

DEPT OF CONSERVATION AND NATURAL RESOURCES
DIVISION OF FORESTRY

SITE #: 9770 SPRING CREEK NDF FIRE STATION - ENGLE SITE
607 ENGLE DR

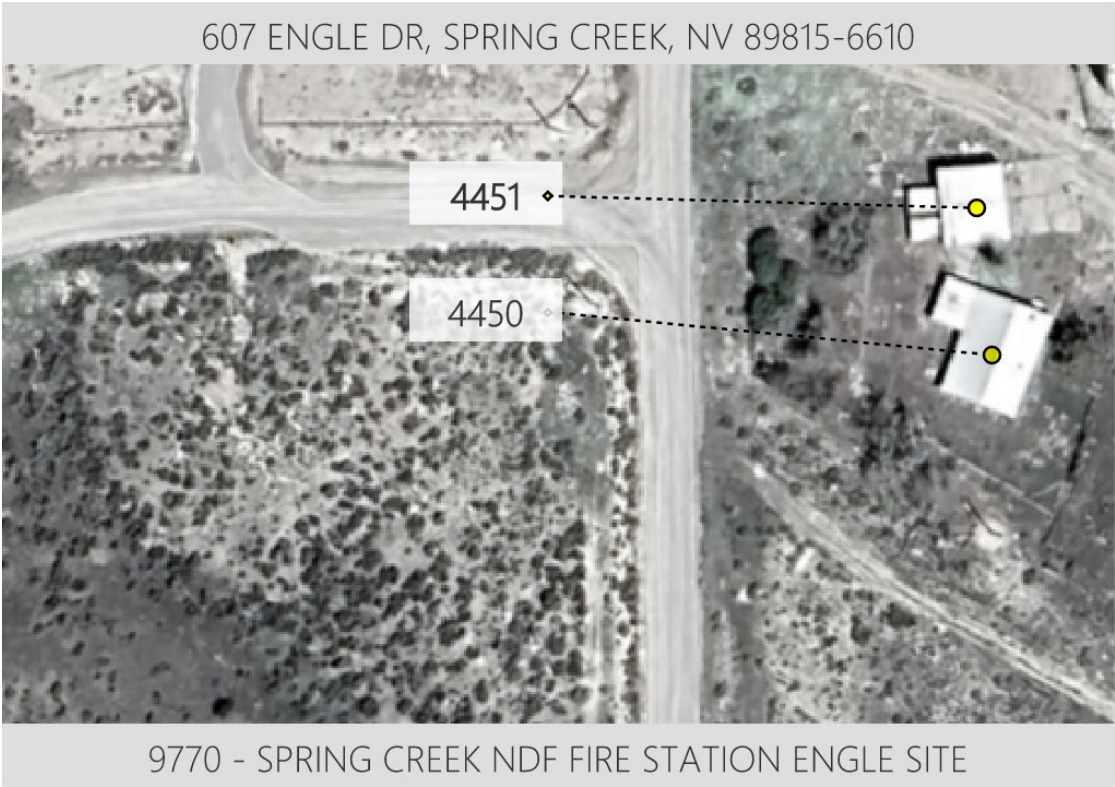
SITE MAP

BLDG #	NAME	YR BUILT	SQ FT	STATUS
4450	NDF FIRE STATION RESIDENCE	1973	1,400	VACANT
4451	APPARATUS GARAGE	1973	780	VACANT
9770	SPRING CREEK NDF FIRE STATION - ENGLE SITE	1973		UNOCCUPIED
03	TOTAL # OF BLDGS

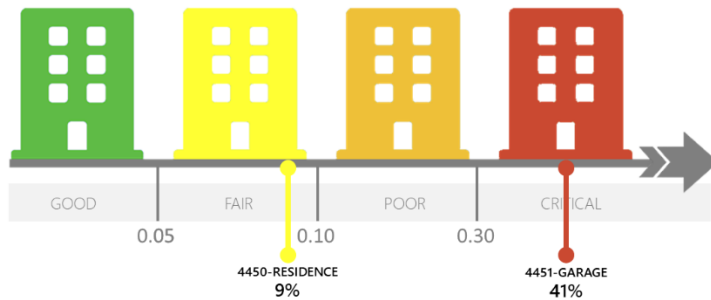
GRAPH

FCI is the total cost of necessary building repairs and renewal divided by the current cost of replacing the building. Each building's FCI score reflects the current condition of the building: *good*, *fair*, *poor*, or *critical*. It is normal to see buildings in all stages of condition.

The graph on the left shows the FCI for each building at the SPRING CREEK NDF FIRE STATION - ENGLE SITE.

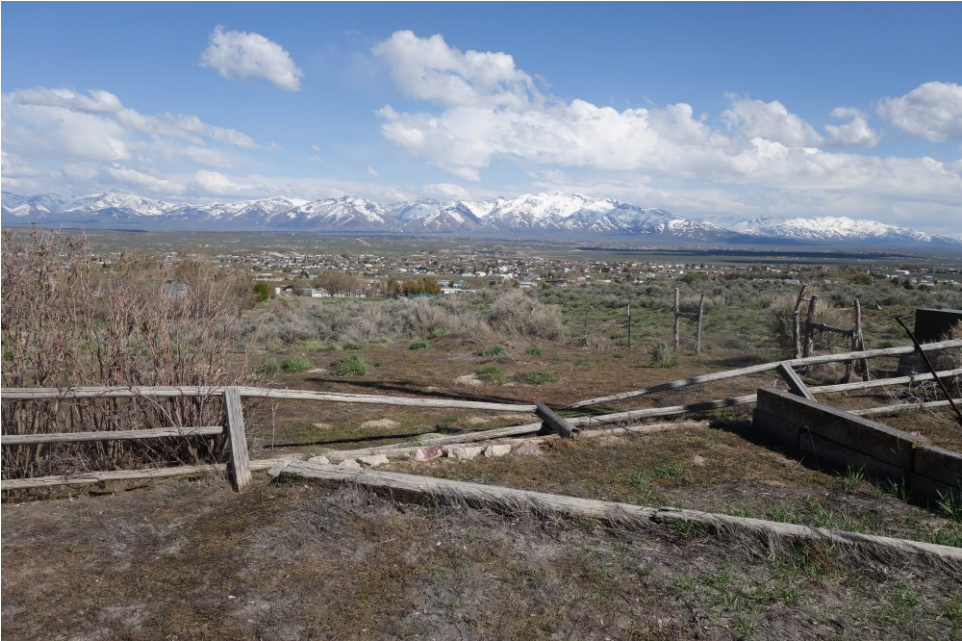
PRIORITY	2 - Two to Four Years	
PROJECT #	9770EXT1 - BUILDING EXTERIOR	STATUS	6/3/2024	NEW

QUANTITY	UNITS	TOTAL	SF COST
<p>The site has been abandoned for some years with extensive evidence of vandalism. A split rail fence surrounding the lawn area is broken. This project recommends a general cleanup of the site, removal of the fencing and removal of dead trees and shrubs.</p> <p>This project is in design under CIP 23-C08 and the estimate is based off that project.</p>	1	PKG	\$15,000.00	-

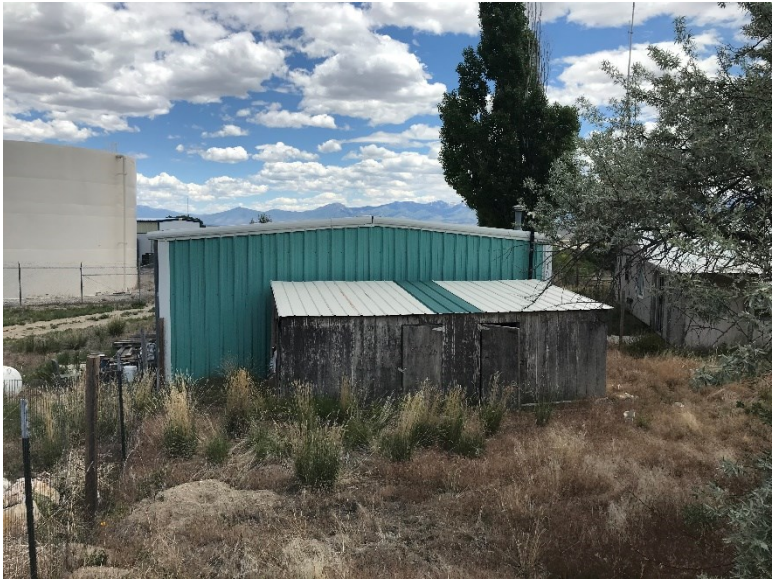
PRIORITY	2 - Two to Four Years	
PROJECT #	9770SFT1 - SAFETY ISSUES	STATUS	6/4/2024	NEW

QUANTITY	UNITS	TOTAL	SF COST
There is a small wooden structure located on the north side of the Apparatus Garage that is dilapidated and beyond its useful life. In addition, a wooden deck connecting the Apparatus Garage to the residence is in the same condition. This project recommends the demolition of these structures.	1	PKG	\$10,000.00	-

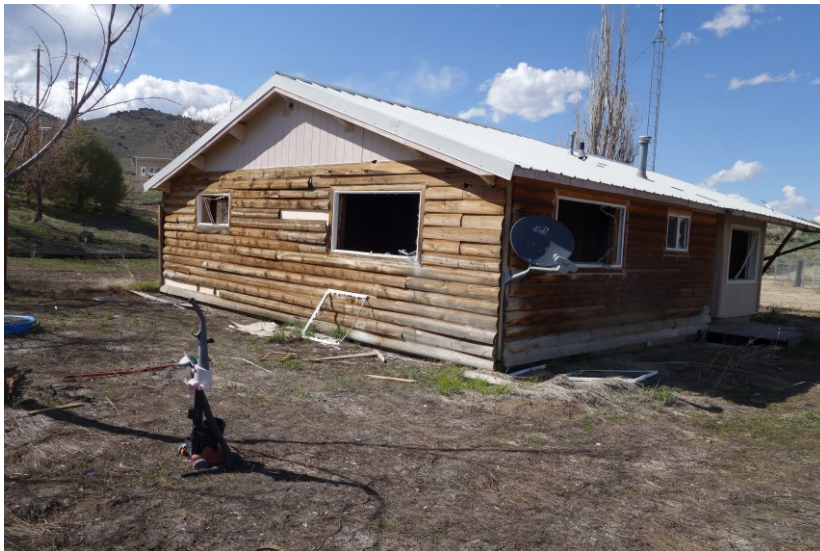
4450 – NDF FIRE STATION RESIDENCE **VACANT**

The NDF Fire Station Residence is a dimensionally shaped log framed structure on a concrete foundation. The exterior is wrapped in T1-11 siding with a metal roofing system. The structure is in extremely poor condition.

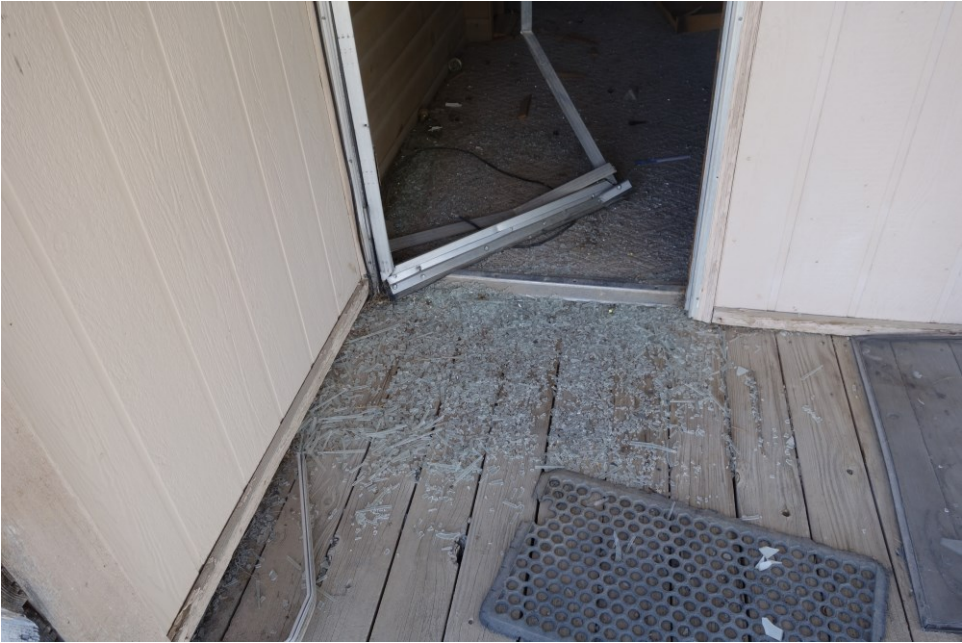
PRIORITY	2 - Two to Four Years	
PROJECT #	4450SFT1 - SAFETY ISSUES	STATUS	6/4/2024	NEW

QUANTITY	UNITS	TOTAL	SF COST
<p>The Fire Station Residence 2 contains numerous safety issues including but not limited to rodent infestation, broken windows, broken or missing electrical fixtures, dry rot and possible structural damage due to the age. The building is dilapidated and deteriorating and has reached the end of its useful life. This project would provide funding for the demolition of the building, debris removal, and site grading.</p> <p>This project is in design under CIP 23-C08 and the estimate is based off that project.</p>	1	PKG	\$50,000.00	\$ 36.00

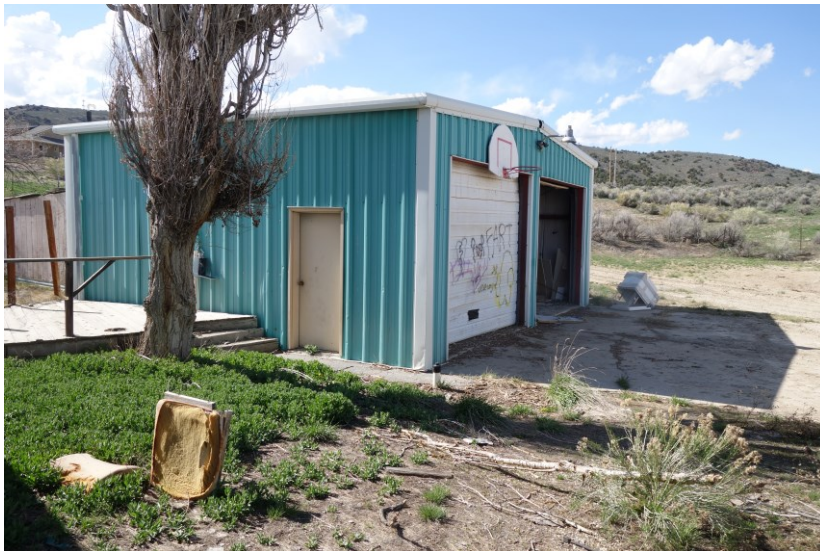
4451 – APPARATUS GARAGE **VACANT**

The Apparatus Garage is a pre-engineered insulated structural steel building with metal siding and roof. The building has a single man door entrance on the west side and two 12' x 10' insulated rollup doors on the south side. The interior of the structure is in poor condition while the structure and exterior metal is in good condition.

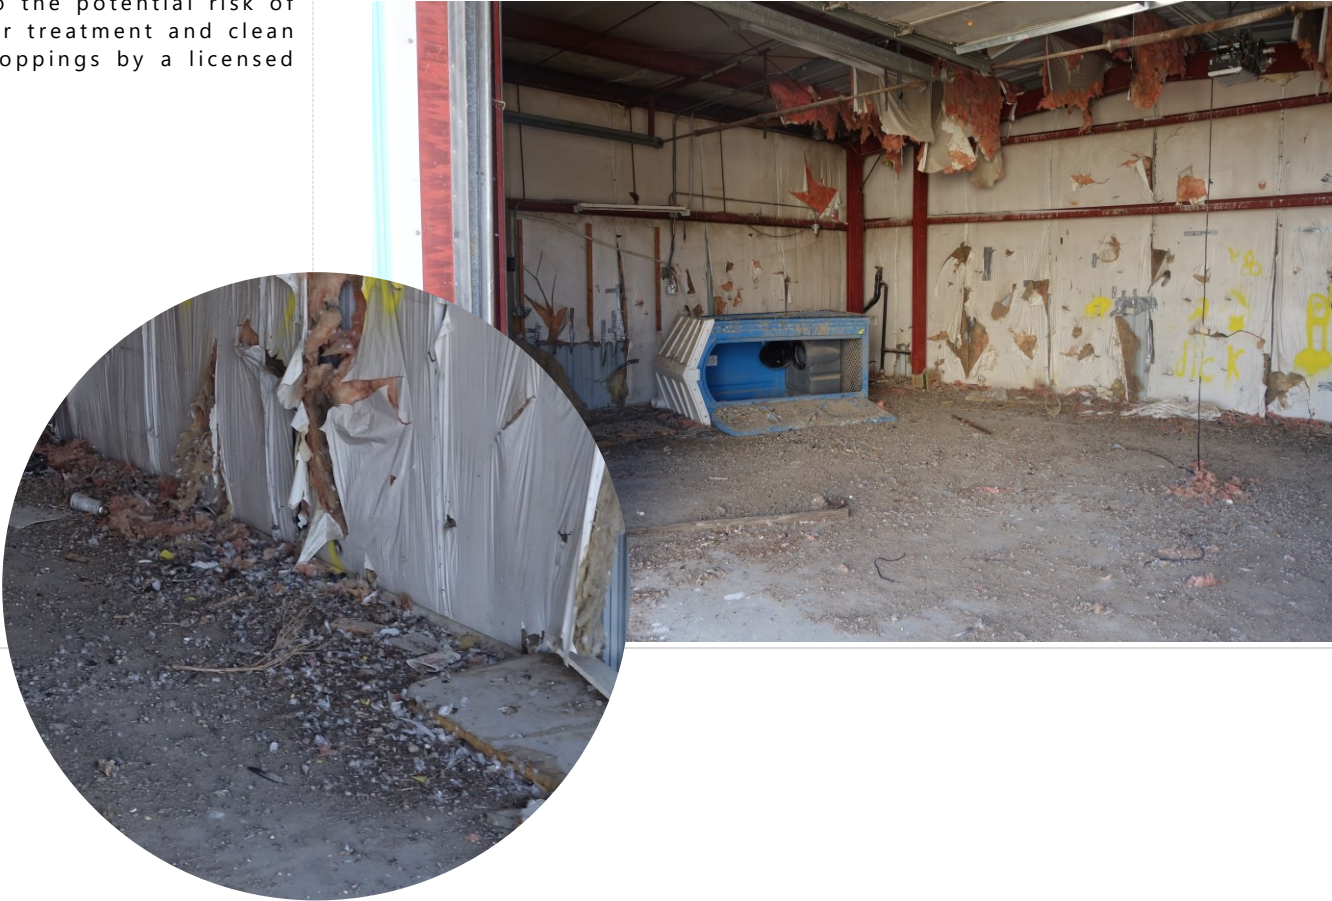
PRIORITY	1 - Immediate to Two Years	
PROJECT #	4451ENV1 - ENVIRONMENTAL	STATUS	6/3/2024	NEW

QUANTITY	UNITS	TOTAL	SF COST
There are numerous pigeon and rodent droppings throughout this building. Due to the potential risk of disease, this project provides for treatment and clean up of the pigeon and rodent droppings by a licensed pest control business.	1	PKG	\$ 5,000.00	\$ 6.00

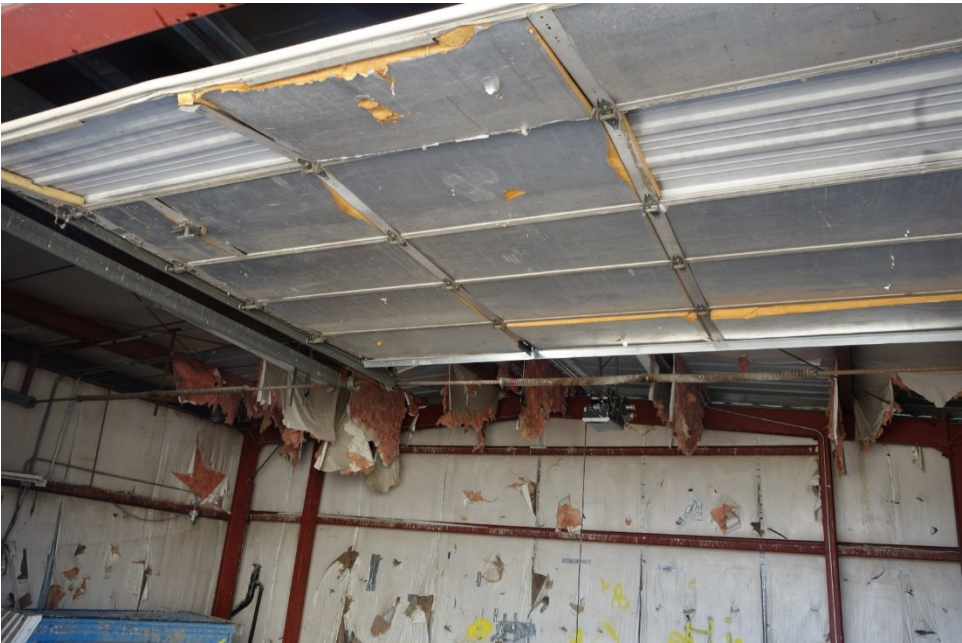
PRIORITY	2 - Two to Four Years	
PROJECT #	4451ELE1 - ELECTRICAL	STATUS	6/3/2024	NEW

QUANTITY	UNITS	TOTAL	SF COST
The existing light fixtures are T-12 fluorescent, in addition they are damaged and appear inoperable. This project recommends a complete removal and replacement with LED lighting, wiring and switches.	780	SF	\$11,700.00	\$ 15.00
