WALKER RIVER SRA

9 MILE SITE

Site Number: 9782
STATE OF NEVADA PUBLIC WORKS DIVISION
FACILITY CONDITION ANALYSIS

Report distributed in November 2021

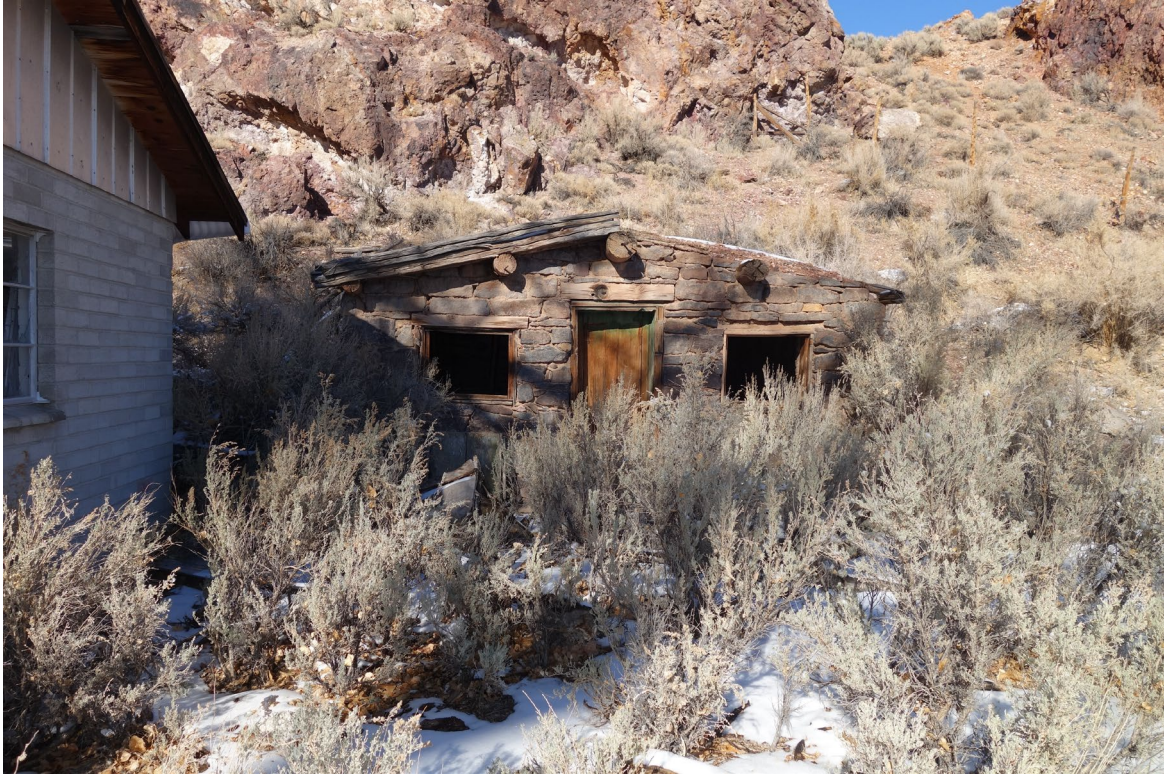
Historic stone & sod dugout.

Ravenelle Trapper Cabin - FCA Building #4148
Description: Exterior of the Building.

Until the planning phase for this site is complete and a determination of demolition or rehabilitation is reached, preservation of the structure is recommended. This project recommends mothballing it in accordance with the U. S. Department of Interior Recommended Guidelines in Preservation Brief 31. Costs related to providing drainage away from the building to prevent future water accumulation, pest control and removal of accumulated waste are included. Also included is securing the exterior envelope against water penetration. Roof, windows and doors will be secured or covered, and some will include louvers to permit ventilation of the structure.

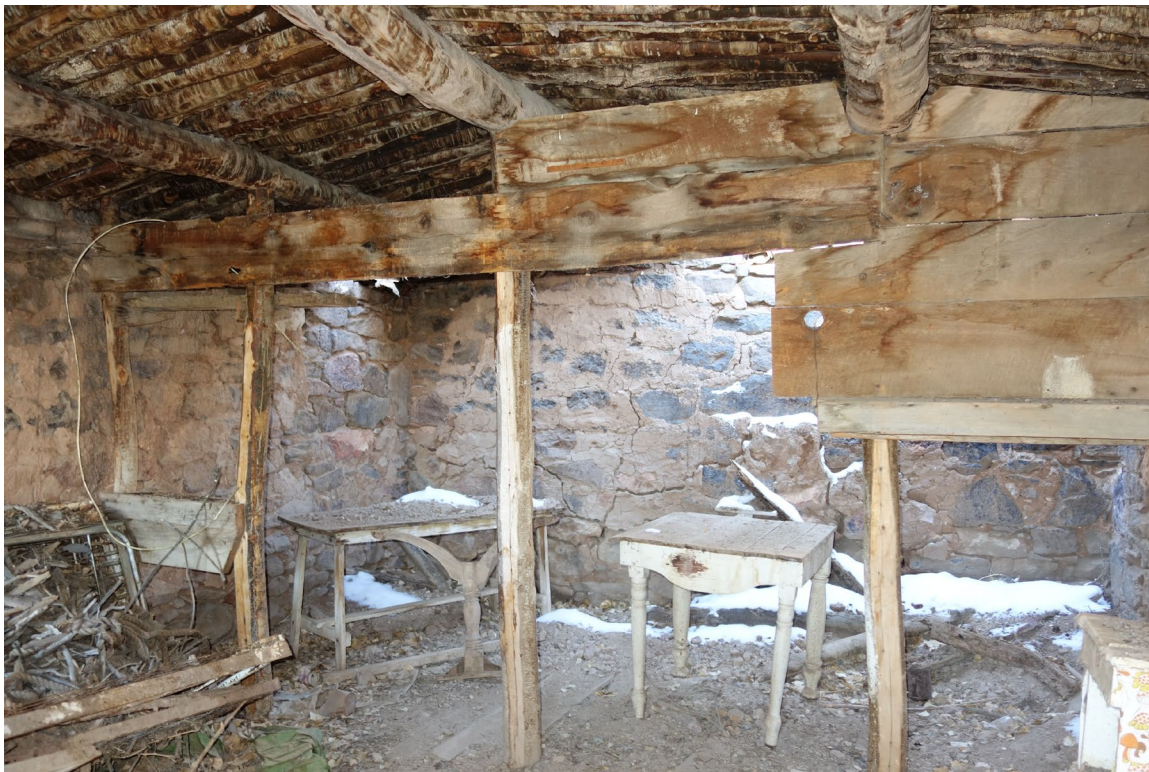
Ravenelle Trapper Cabin - FCA Building #4148
Description: Interior of the Building.

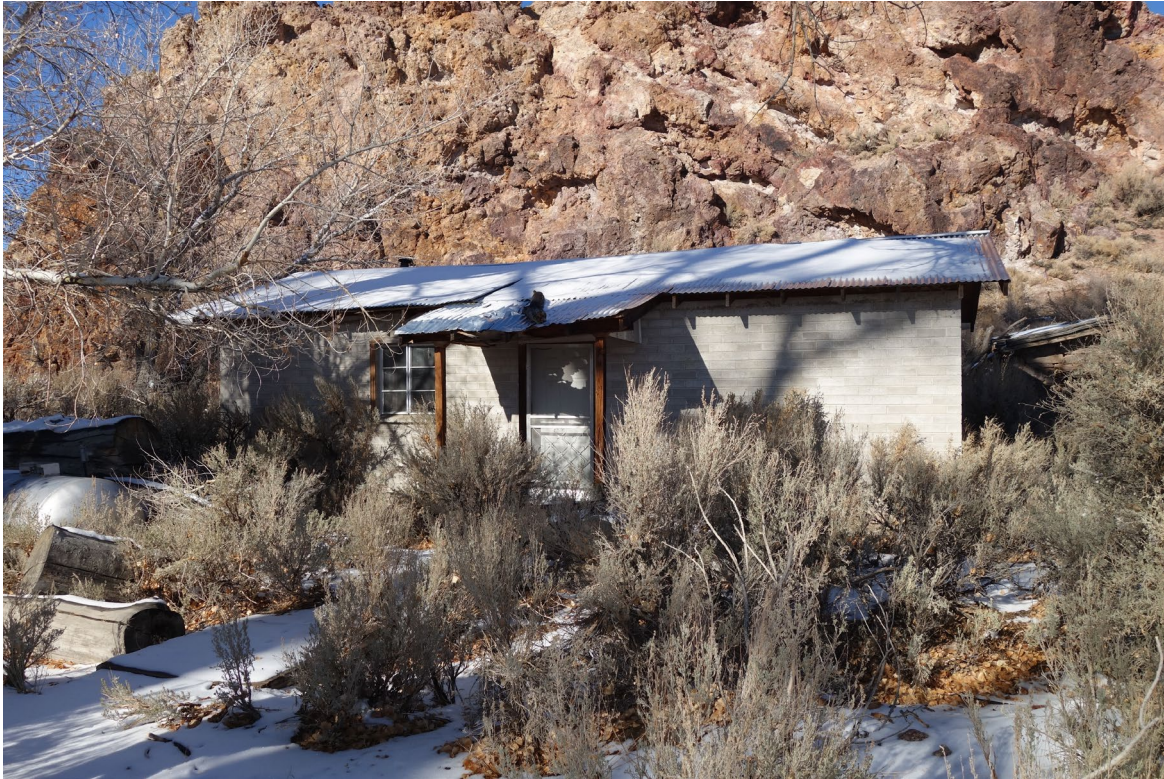
2 room cinderblock house. Vacant and not habitable.

Ravenelle Fish Cabin - FCA Building #4147
Description: Exterior of the Building.

Until the planning phase for this site is complete and a determination of demolition or rehabilitation is reached, preservation of the structure is recommended. This project recommends mothballing it in accordance with the U. S. Department of Interior Recommended Guidelines in Preservation Brief 31. Costs related to providing drainage away from the building to prevent future water accumulation, pest control and removal of accumulated waste are included. Also included is securing the exterior envelope against water penetration. Roof, windows and doors will be secured or covered, and some will include louvers to permit ventilation of the structure.

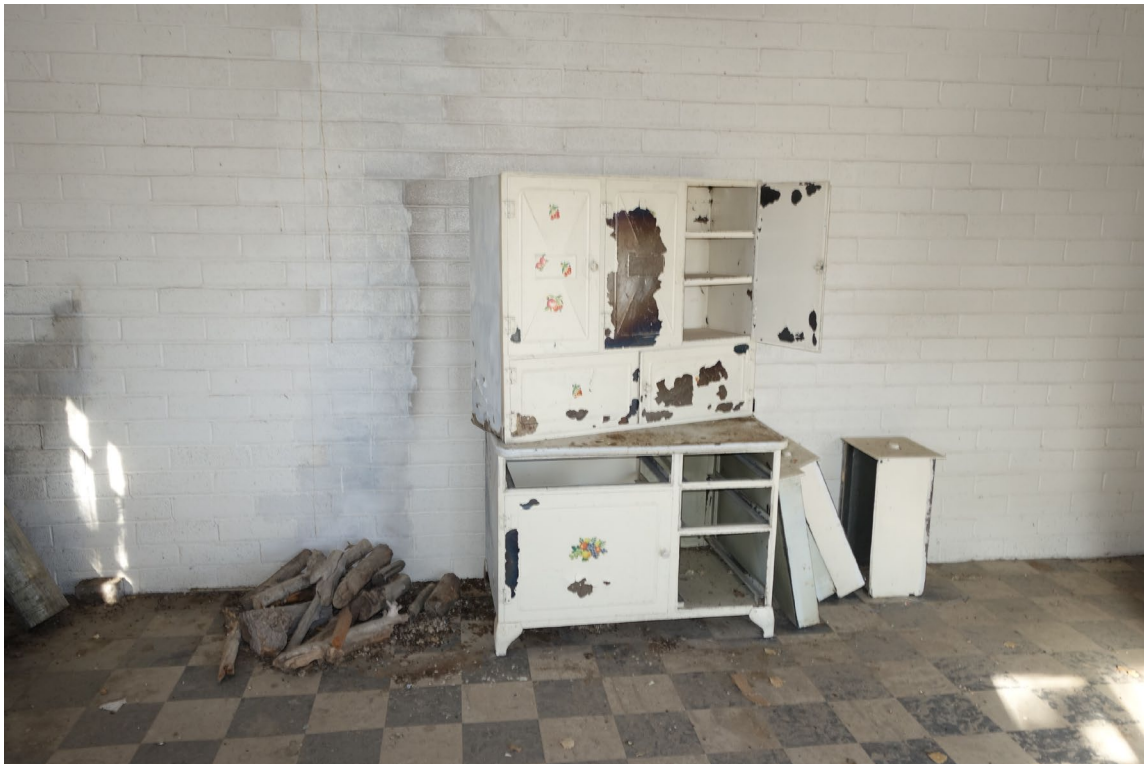
Ravenelle Fish Cabin - FCA Building #4147
Description: Interior of the Building.

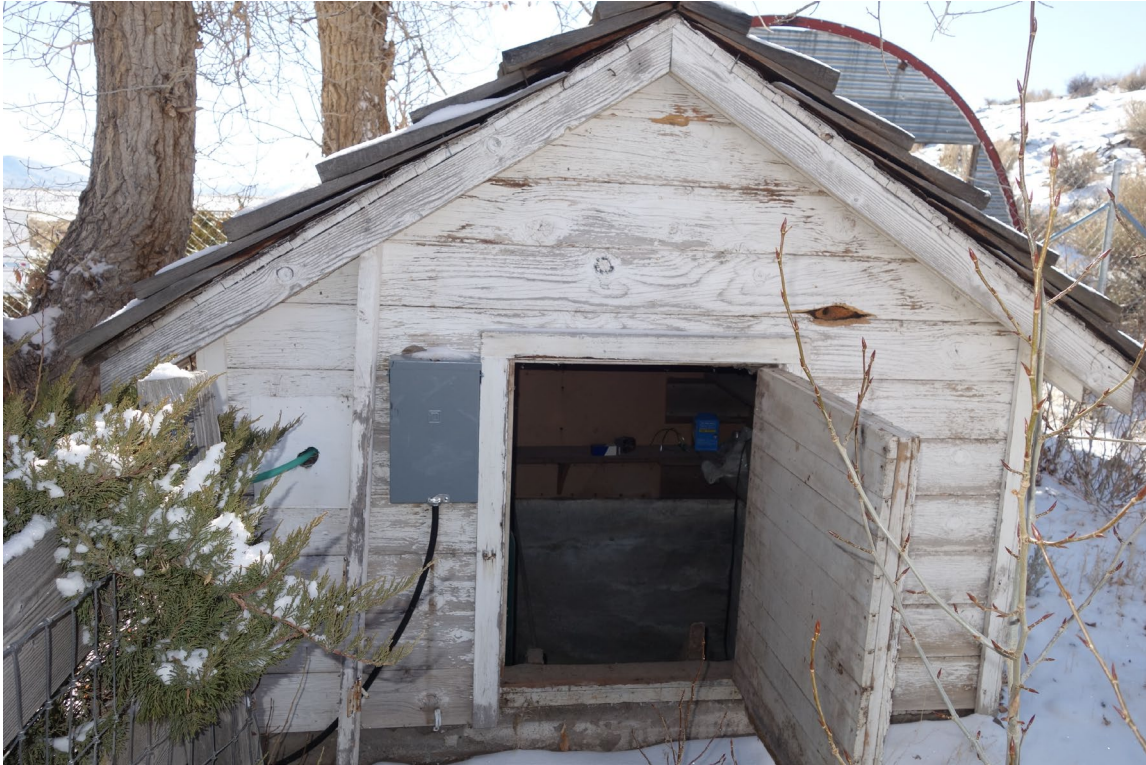
The exterior finishes were in poor condition. It is important to maintain the finish, weather resistance and appearance of the building. This project would provide funding to protect the exterior of the building excluding the roof. Included in the cost is sanding, priming and painting and caulking of the windows, flashing, fixtures and all other penetrations. It is recommended that the building be painted in the next 2 - 3 years and that this project be scheduled on a cyclical basis to maintain the integrity of the structure.

Stone House Pump Bldg - FCA Building #4146
Description: Exterior of the Building.

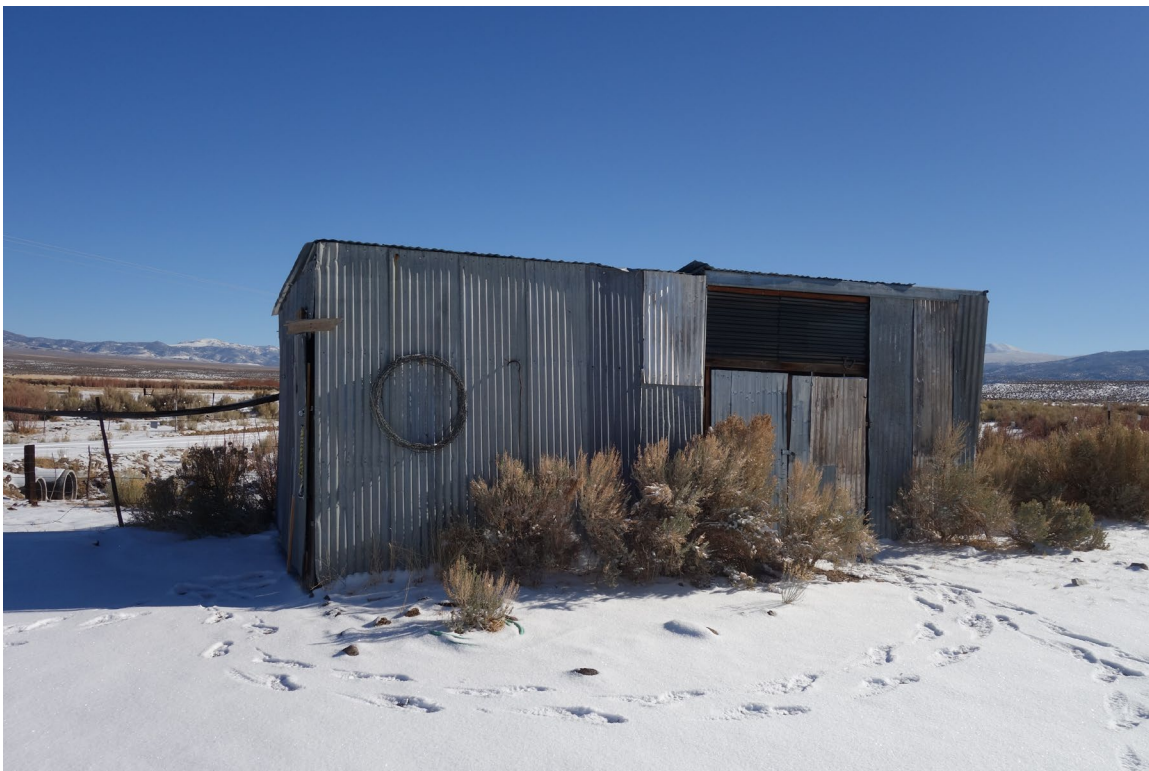
The exterior finishes were in poor condition including missing sheet metal panels. It is important to maintain the finish, weather resistance and appearance of the building. This project would provide funding to protect the exterior of the building excluding the roof. Included in the cost is the caulking and sealing of the windows, flashing, fixtures and all other penetrations. It is recommended that the building be caulked and sealed in the next 5 - 7 years and that this project be scheduled on a cyclical basis to maintain the integrity of the structure.

Storage Shed 2 - FCA Building #4145
Description: Exterior of the Building.

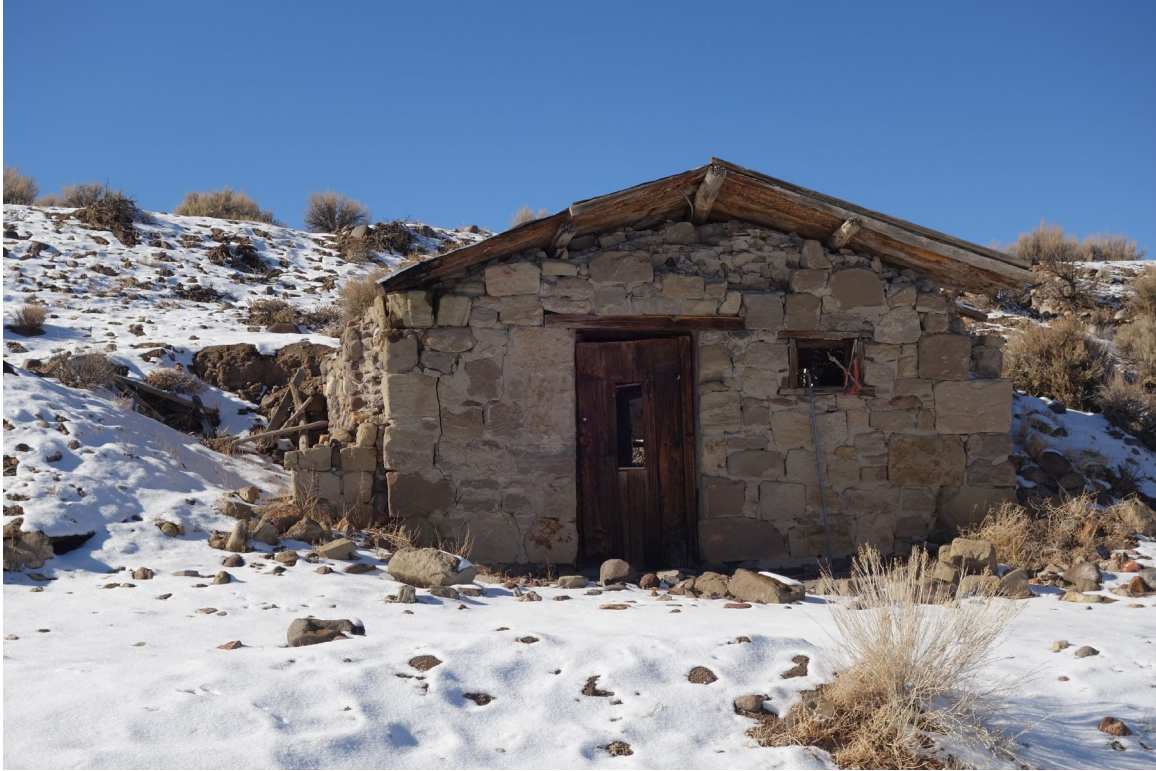
Single story dugout cabin made of stone.

Trapper Cabin - FCA Building #4144
Description: Exterior of the Building.

Until the planning phase for this site is complete and a determination of demolition or rehabilitation is reached, preservation of the structure is recommended. This project recommends mothballing it in accordance with the U. S. Department of Interior Recommended Guidelines in Preservation Brief 31. Costs related to providing drainage away from the building to prevent future water accumulation, pest control and removal of accumulated waste are included. Also included is securing the exterior envelope against water penetration. Roof, windows and doors will be secured or covered, and some will include louvers to permit ventilation of the structure.

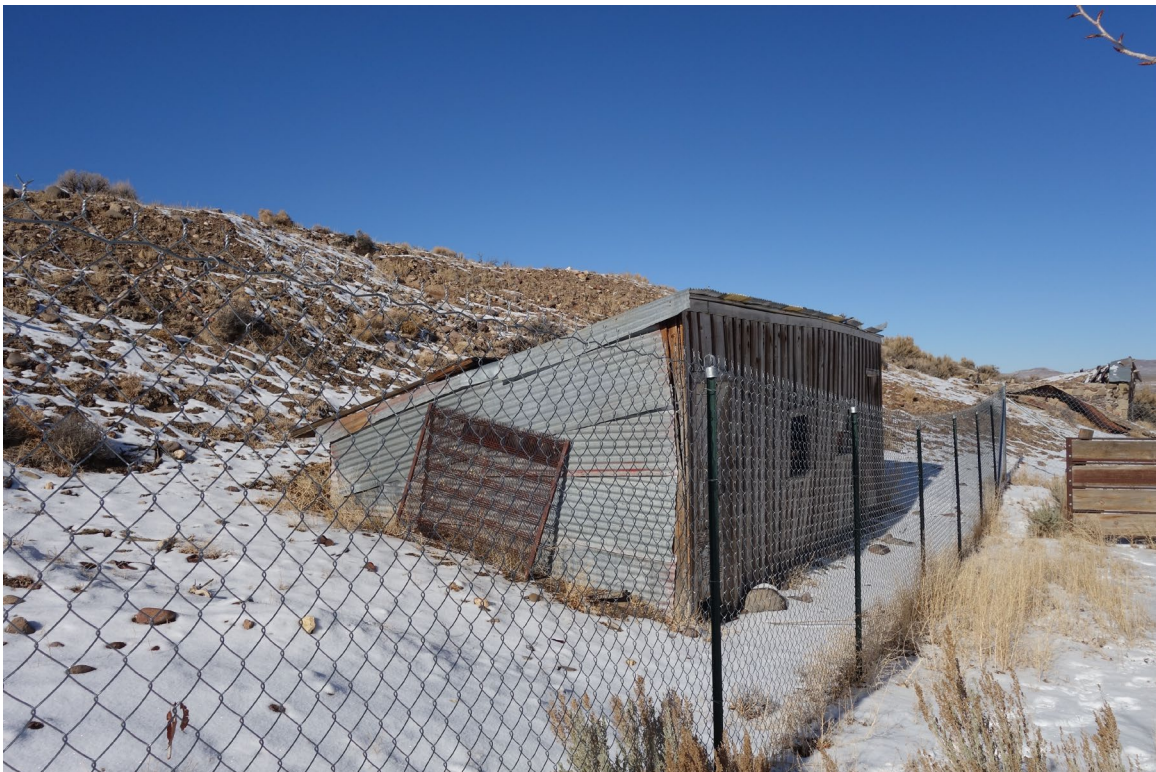
Stone house storage shed is a one story painted wood structure.

Stone House Storage Shed - FCA Building #4143
Description: Exterior of the Building.

Until the planning phase for this site is complete and a determination of demolition or rehabilitation is reached, preservation of the structure is recommended. This project recommends mothballing it in accordance with the U. S. Department of Interior Recommended Guidelines in Preservation Brief 31. Costs related to providing drainage away from the building to prevent future water accumulation, pest control and removal of accumulated waste are included. Also included is securing the exterior envelope against water penetration. Roof, windows and doors will be secured or covered, and some will include louvers to permit ventilation of the structure.

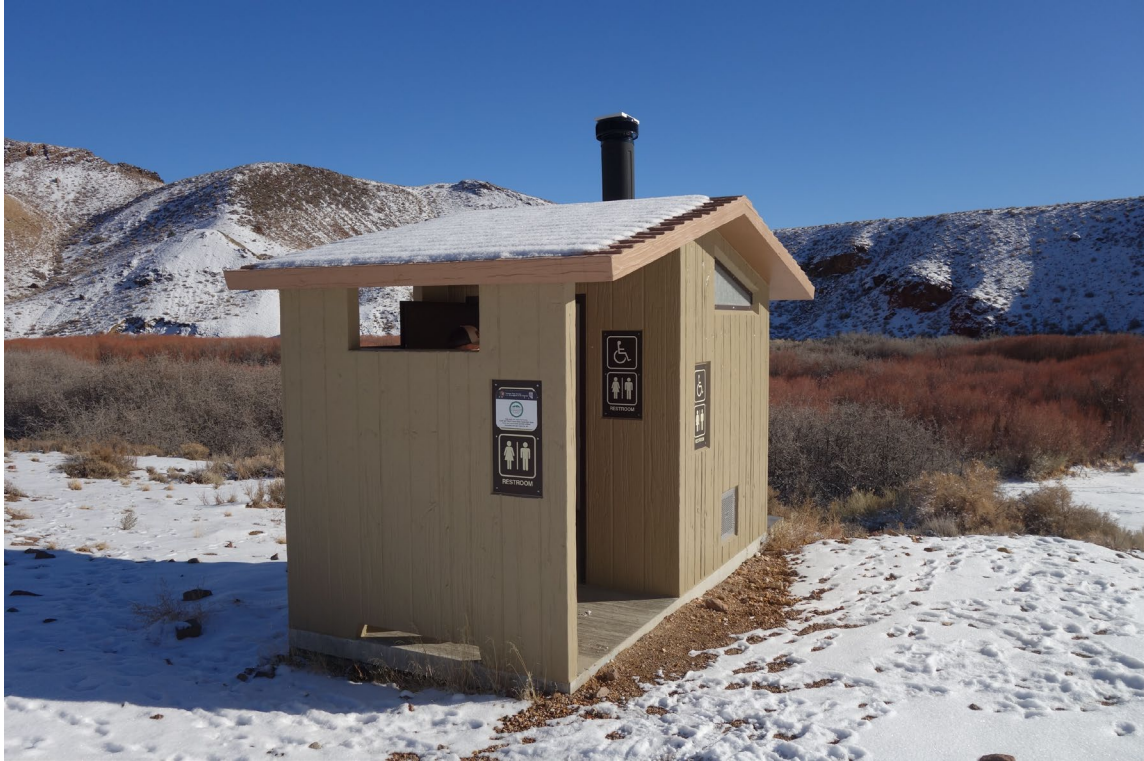
The exterior finishes were in good condition. It is important to maintain the finish, weather resistance and appearance of the building. This project would provide funding to protect the exterior of the building excluding the roof. Included in the cost is painting the concrete walls and caulking of the windows, flashing, fixtures and all other penetrations. It is recommended that the building be painted and caulked in the next 7 - 9 years and that this project be scheduled on a cyclical basis to maintain the integrity of the structure.

Elbow Comfort Station 3 - FCA Building #4142
Description: Exterior of the Building.

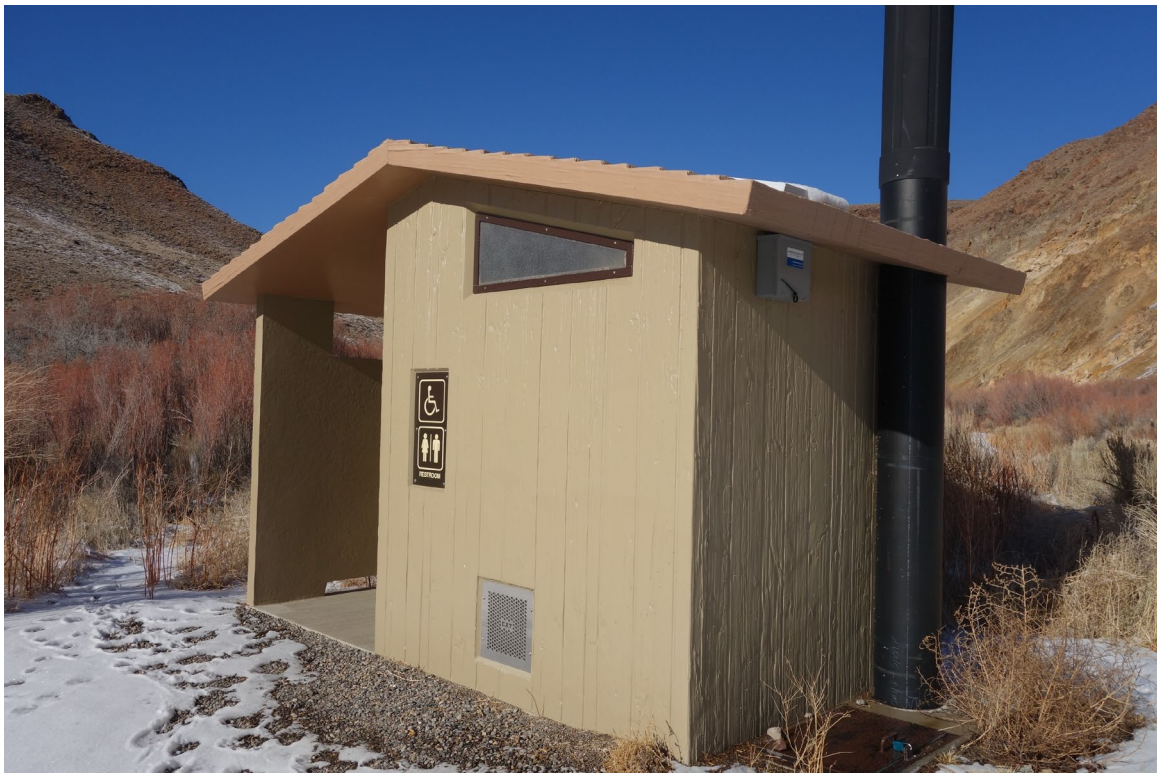
The exterior finishes were in good condition. It is important to maintain the finish, weather resistance and appearance of the building. This project would provide funding to protect the exterior of the building excluding the roof. Included in the cost is painting the concrete walls and caulking of the windows, flashing, fixtures and all other penetrations. It is recommended that the building be painted and caulked in the next 7 - 9 years and that this project be scheduled on a cyclical basis to maintain the integrity of the structure.

Elbow Comfort Station 2 - FCA Building #4141
Description: Exterior of the Building.

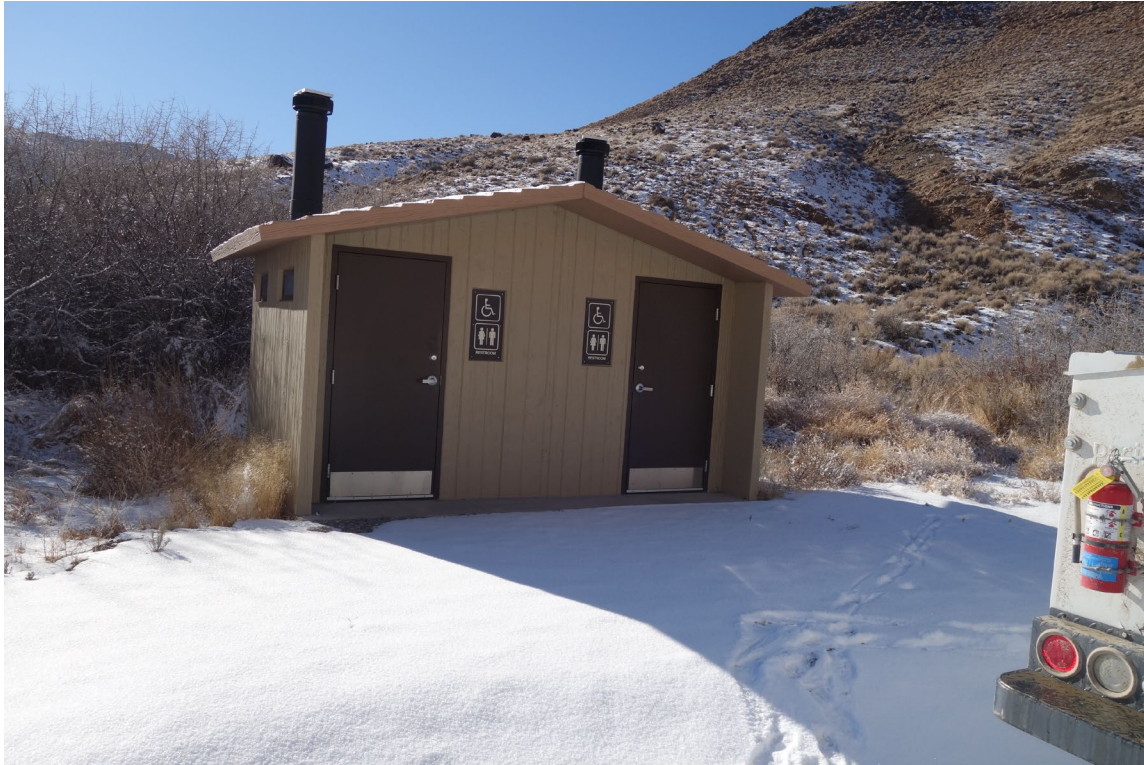
The exterior finishes were in good condition. It is important to maintain the finish, weather resistance and appearance of the building. This project would provide funding to protect the exterior of the building excluding the roof. Included in the cost is painting the concrete walls and caulking of the windows, flashing, fixtures and all other penetrations. It is recommended that the building be painted and caulked in the next 7 - 9 years and that this project be scheduled on a cyclical basis to maintain the integrity of the structure.

Elbow Comfort Station 1 - FCA Building #4140
Description: Exterior of the Building.

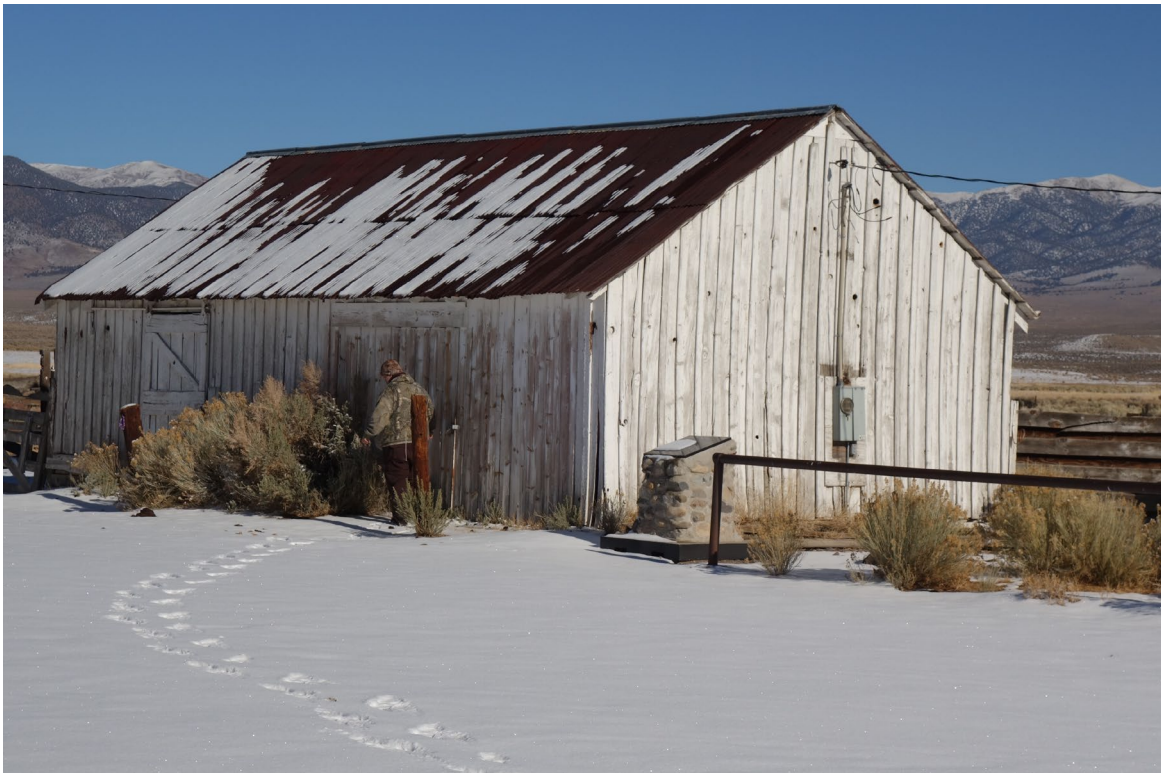
The exterior finishes were in poor condition. It is important to maintain the finish, weather resistance and appearance of the building. This project would provide funding to protect the exterior of the building excluding the roof. Included in the cost is sanding, priming and painting and caulking of the windows, flashing, fixtures and all other penetrations. It is recommended that the building be painted in the next 2 - 3 years and that this project be scheduled on a cyclical basis to maintain the integrity of the structure.

9 Mile Barn #2 - FCA Building #3874
Description: Exterior of the Building.

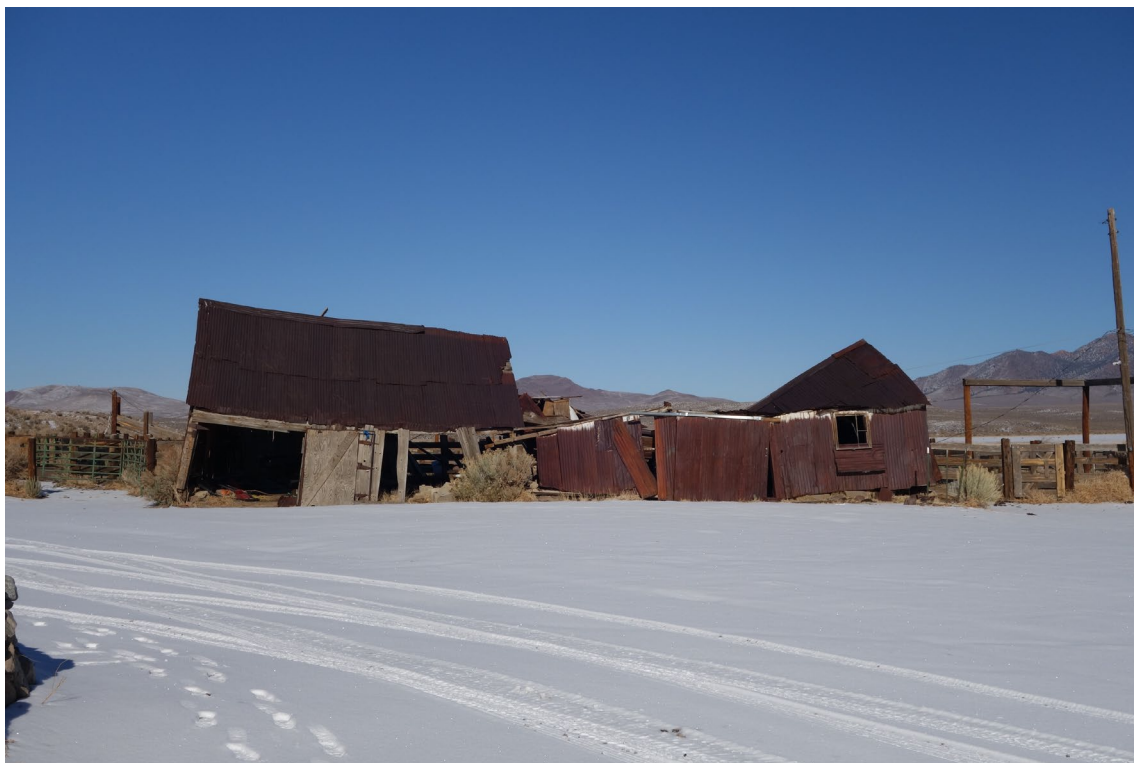
The structure has failed and is a safety hazard. This project would provide funding for the demolition and disposal of the building. Due to the historical nature of the building, this project is subject to review and approval from the State Historical Preservation Office.

9 Mile Barn #1 - FCA Building #3873
Description: Exterior of the Building.

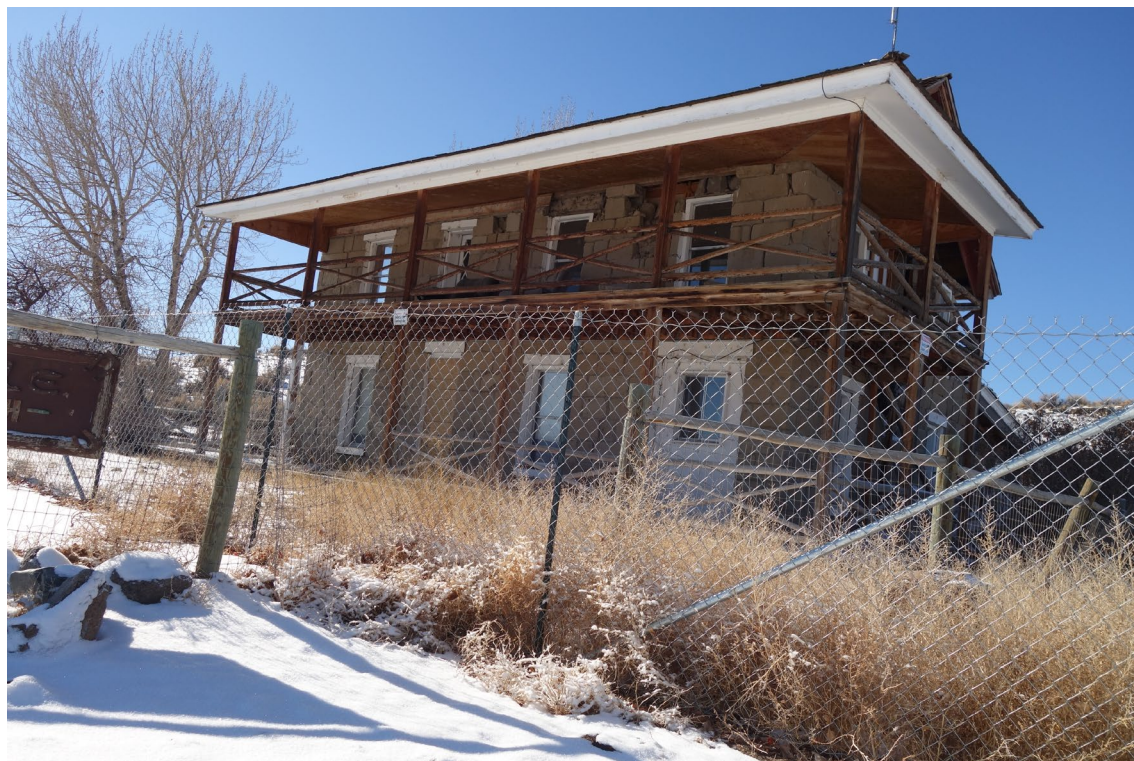
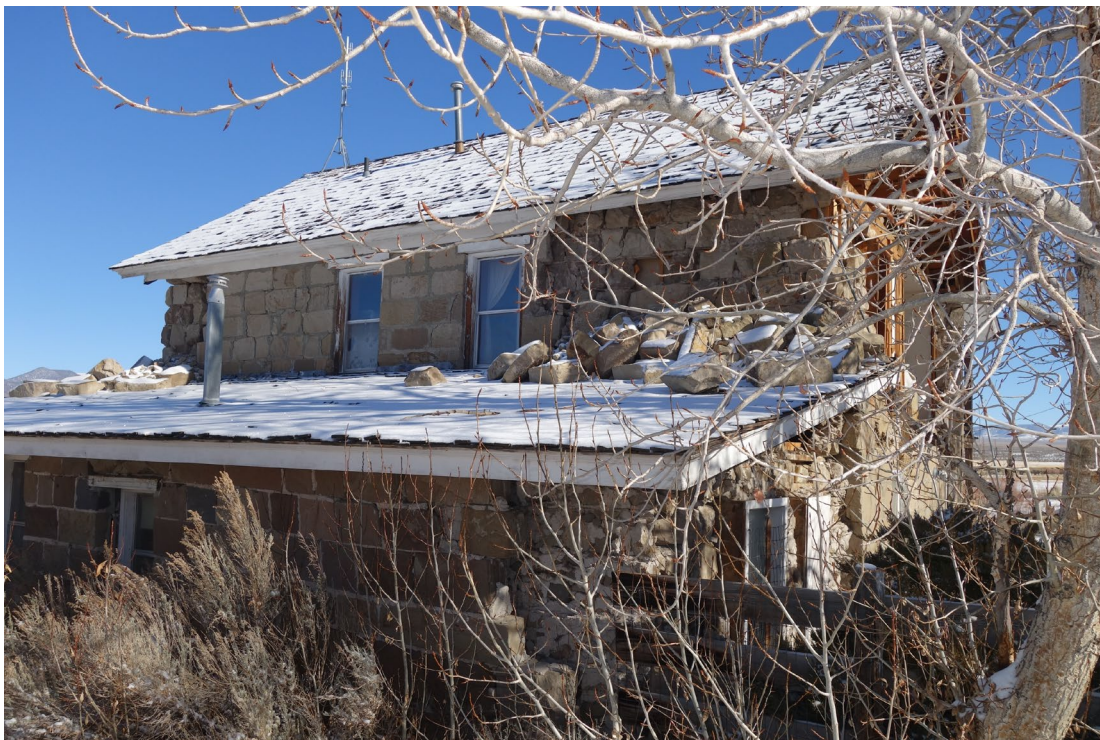
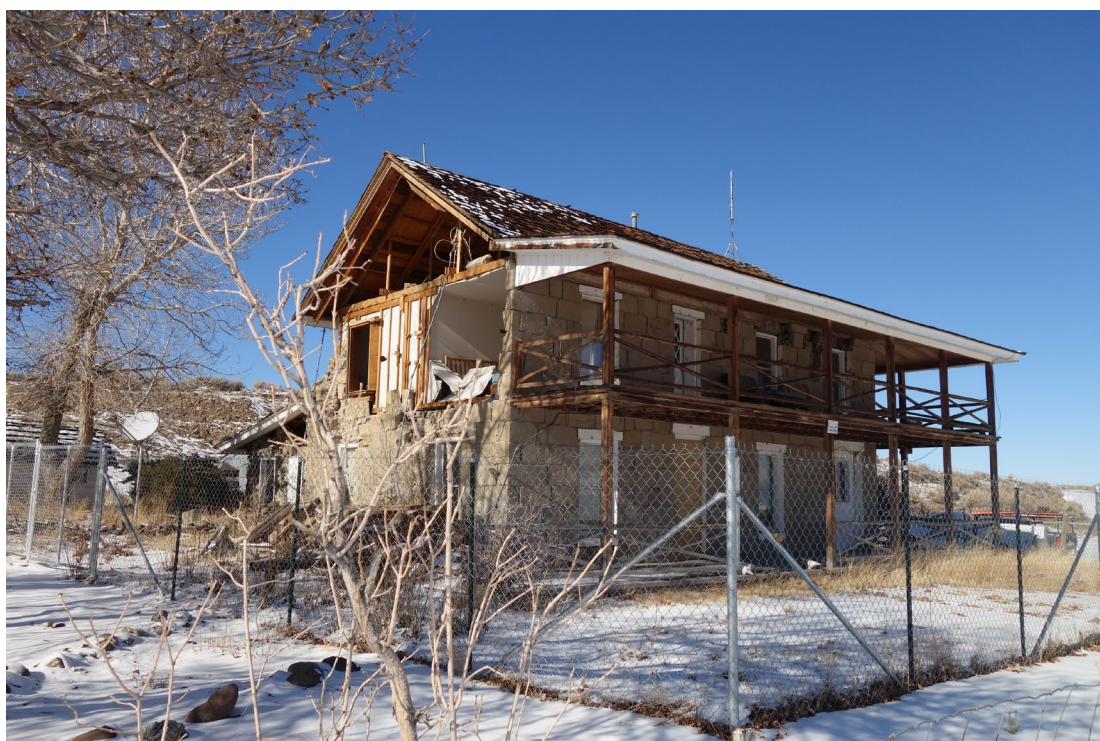
The structure was damaged in December 2016 and the State took ownership of it in July 2017. Programming, structural, and historical assessments were completed by H+K Architects, Nevada State Parks, and State Public Works in 2018 via project number 18-A005. This project will rehabilitate, restore, and seismically strengthen the 9 Mile Ranch Stone House at Walker River State Recreation Area. The project will include design and construction resulting in a publicly accessible interpretative center. The site development will include utilities, parking, and accessible access to the building. This project was estimated and recommended under CIP Estimate 21236.

9 Mile Stone House - FCA Building #3872
Description: East & North Elevations of Building.

9 Mile Stone House - FCA Building #3872
Description: West Elevation of Building.

9 Mile Stone House - FCA Building #3872
Description: South & West Elevations of Building.

Until the planning phase for this site is complete and a determination of demolition or rehabilitation is reached, preservation of the structure is recommended. This project recommends mothballing it in accordance with the U. S. Department of Interior Recommended Guidelines in Preservation Brief 31. Costs related to removing water in the basement or crawlspace, providing drainage away from the building to prevent future water accumulation, pest control and removal of accumulated waste are included. Also included is securing the exterior envelope against water penetration. Roof, windows and doors will be secured or covered, and some will include louvers to permit ventilation of the structure.
