STATE OF NEVADA STATE PUBLIC WORKS DIVISION

FACILITY CONDITION ASSESSMENT REPORT FOR:

DEPT OF CORRECTIONS

SITE #: 9789 NORTHERN NV TRANSITIONAL HOUSING SITE
225 SUNSHINE LN
RENO, NV 89502-1221

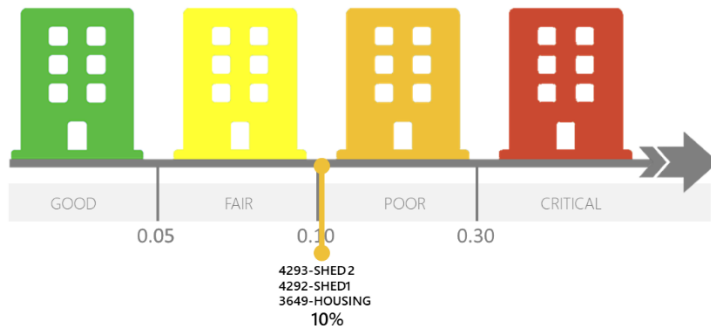
GRAPH

FCI is the total cost of necessary building repairs and renewal divided by the current cost of replacing the building. Each building's FCI score reflects the current condition of the building: *good*, *fair*, *poor*, or *critical*. It is normal to see buildings in all stages of condition.

The graph on the left shows the FCI for each building at the NORTHERN NV TRANSITIONAL HOUSING SITE.

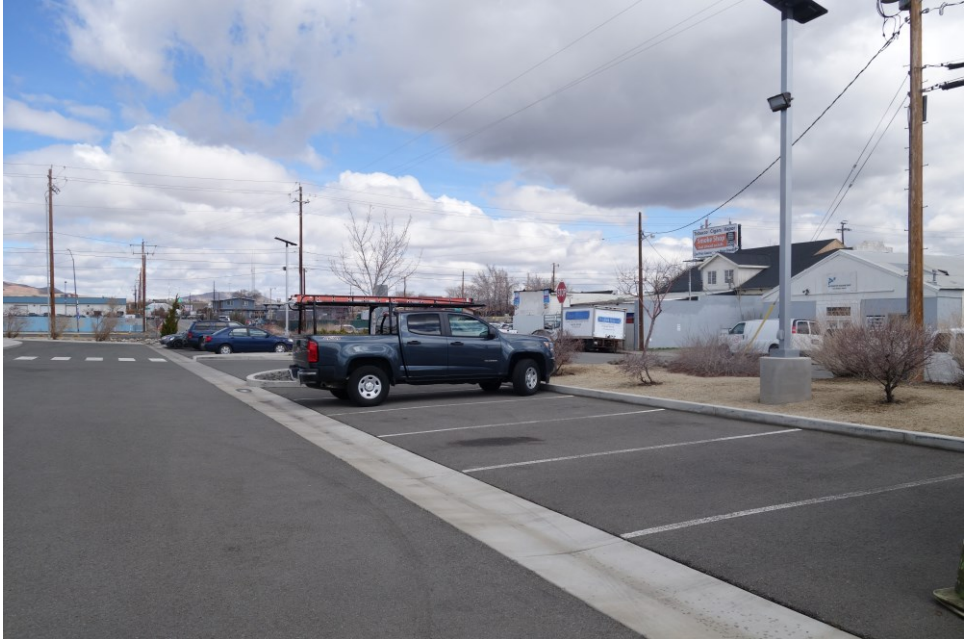
CRACK FILL & SEAL ASPHALT PAVING

QUANTITY	UNITS	TOTAL	SF COST
It is important to maintain the asphalt concrete paving on the site. This project would provide for minor crack filling and sealing of the paving site wide including access roads, parking areas and driving test areas. Striping is included in this estimate. This project should be scheduled on a 5 year cyclical basis to maintain the integrity of the paving and prevent premature failure. 14,000 square feet of asphalt area was used to generate this estimate.	14000	SF	\$15,100.00	-

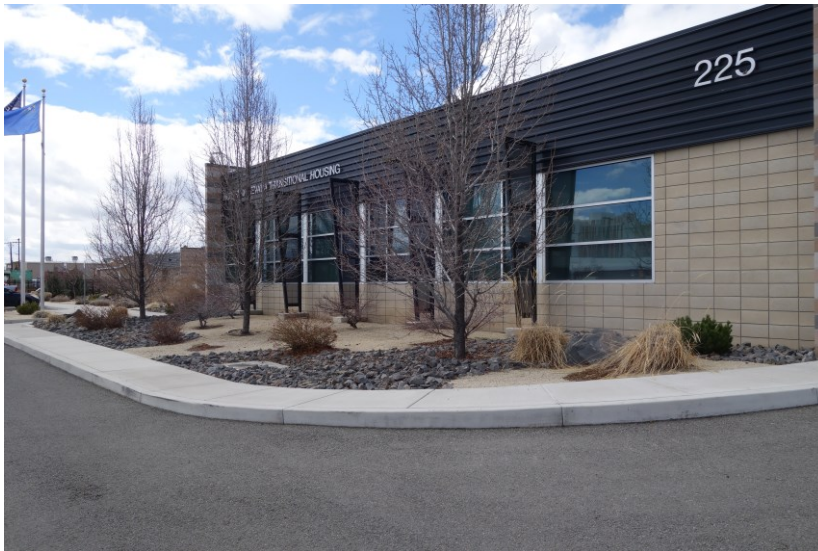
The Northern Nevada Transitional Housing building is an insulated CMU structure with a single ply roofing system on a concrete foundation. Interior walls are furred out with R-13 insulation and the roof deck is insulated with R-30 rigid insulation below the roofing membrane. The HVAC system consists of natural gas fired Rooftop Units (RTU's). Domestic hot water is generated by boilers and storage tanks in each of the dormitory areas and Culinary. The building is protected by both a fire alarm and sprinkler system. The facility is a NDOCs transitional housing facility with administrative offices, conference / training rooms, counseling rooms for transitional housing occupants, ADA accessible restrooms, a large kitchen and dining area, dry and cold storage.

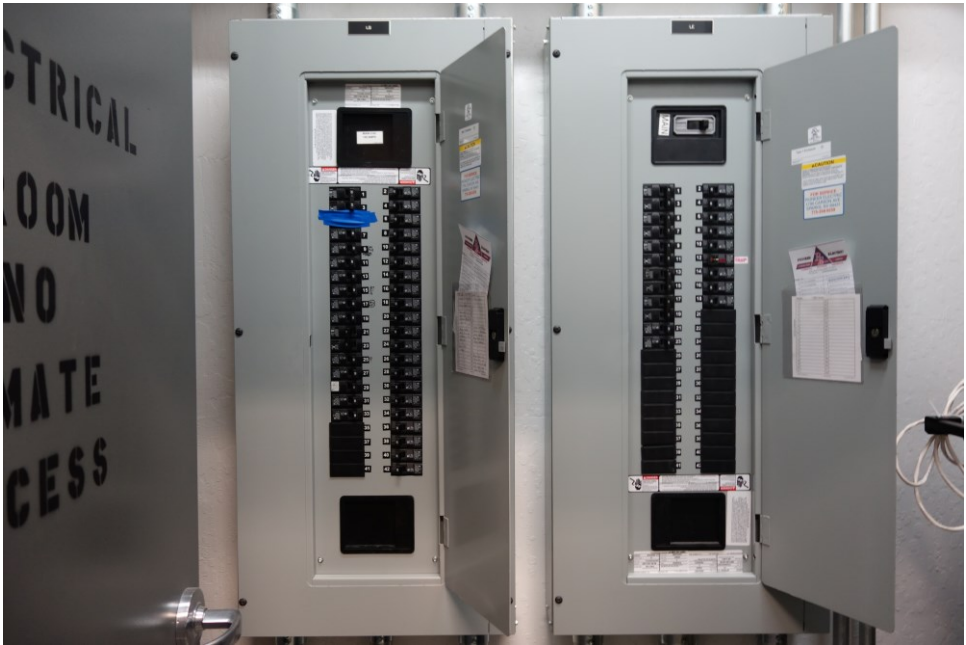
ARC FLASH and ELECTRICAL COORDINATION STUDY

QUANTITY	UNITS	TOTAL	SF COST
Arc flash and electrical breaker coordination studies have not been performed or it has been more than 5 years since the last coordination study. Safety requirements for maintenance personnel and the latest electrical code require coordination studies to be verified and performed every 5 years, along with arc flash labeling on all electrical panels. This project will perform the required coordination study, evaluation, adjustments and labeling for the building's electrical distribution system.	1	PKG	\$18,000.00	\$ 1.00

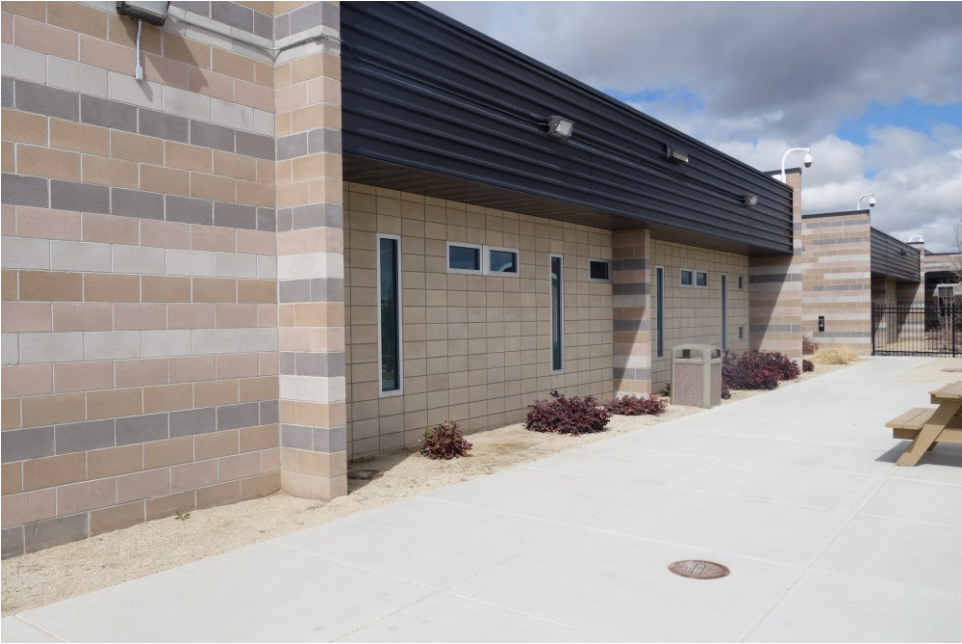
EXTERIOR FINISHES

QUANTITY	UNITS	TOTAL	SF COST
The exterior finishes were in good condition. It is important to maintain the finish, weather resistance and appearance of the building. This project would provide funding to protect the exterior of the building excluding the roof. Included in the cost are cleaning and sealing the concrete masonry units (CMU), caulking the windows, flashing, fixtures and all other penetrations. Sealing the exterior brick masonry will help in preventing efflorescence. It is recommended that the building be sealed and caulked in the next 8 - 10 years and that this project be scheduled on a cyclical basis to maintain the integrity of the structure.	21536	SF	\$215,600.00	\$ 10.00

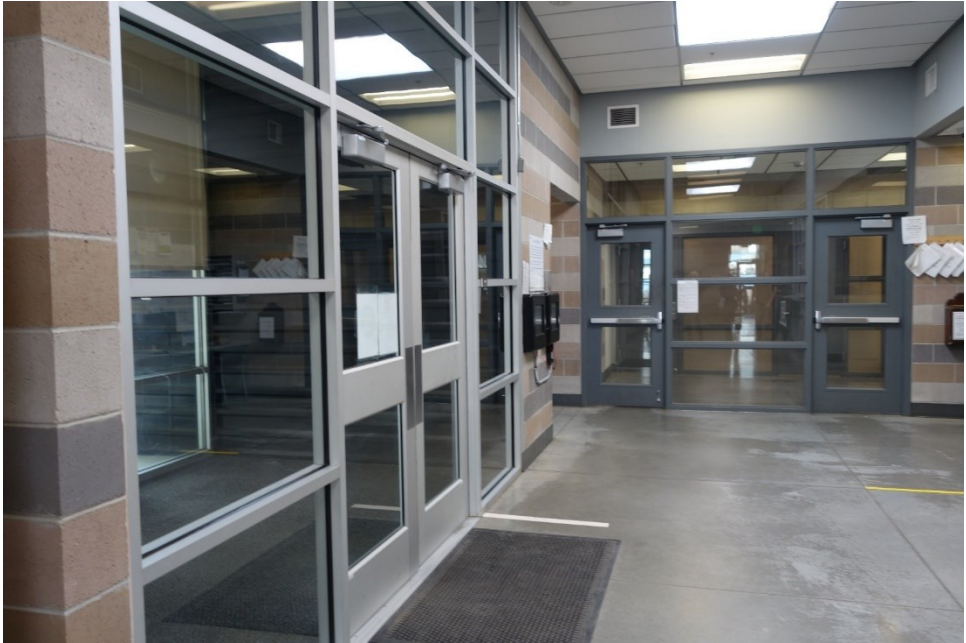
INTERIOR FINISHES

QUANTITY	UNITS	TOTAL	SF COST
The interior finishes were in good condition. It is recommended that the interior walls, ceilings, doors, frames, steel stairs and exposed steel framing be painted at least once in the next 7 - 9 years. Prior to painting, all surfaces should be repaired and prepped. An epoxy-based paint should be utilized in wet areas for durability.	21536	SF	\$215,600.00	\$ 10.00

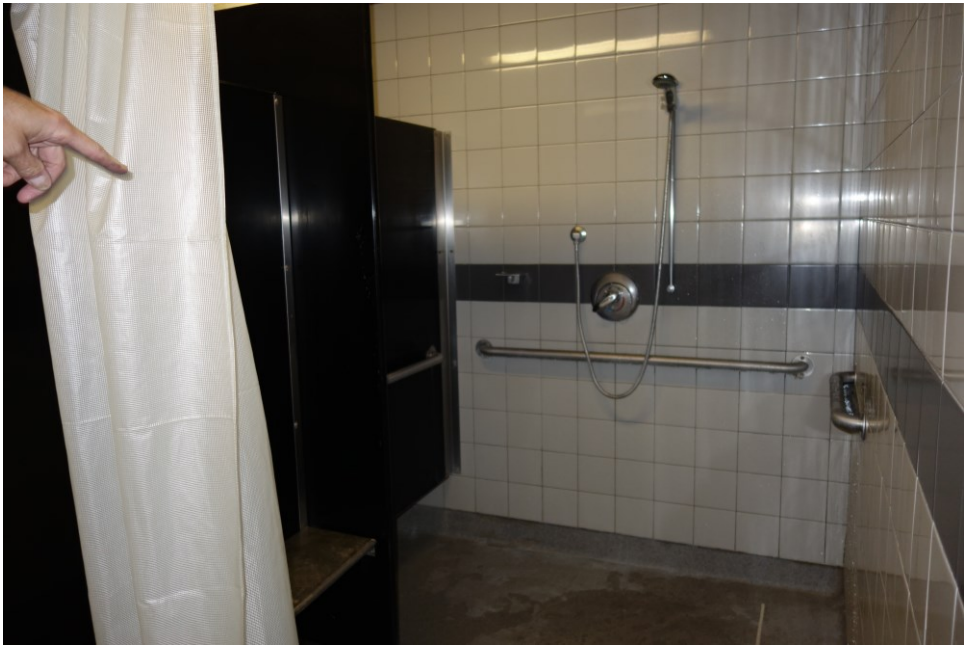
SHOWER ROOM RENOVATION

QUANTITY	UNITS	TOTAL	SF COST
<p>The shower stalls in the building were in fair condition at the time of the survey, however, they are starting to deteriorate due to heavy usage and materials that are not intended for this application. The shower partitions are standard coated metal toilet partitions and the bases are beginning to corrode. This project recommends the complete removal of the shower tile, partitions & fixtures and replacing them with solid surface surrounds, new plumbing fixtures, epoxy overlay of the shower floors and solid plastic partitions with manufacture approved base mounts suitable for the application.</p>	1	PKG	\$253,500.00	\$ 12.00

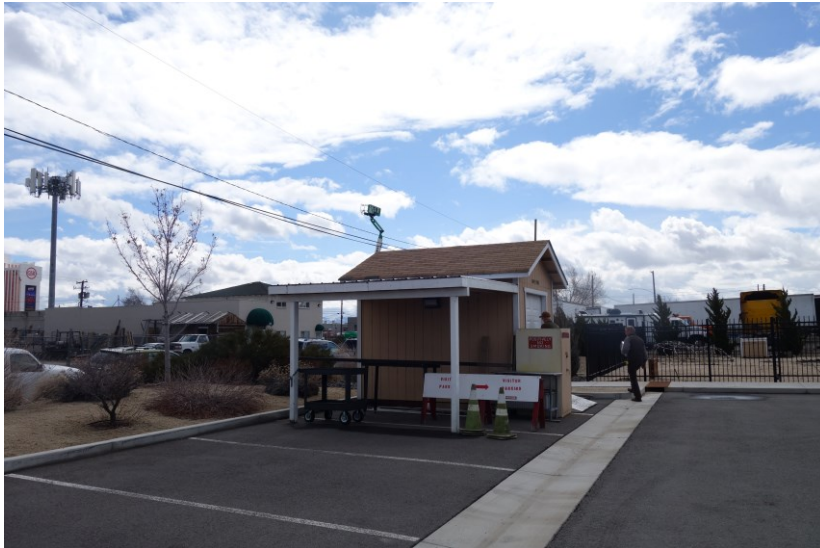
12'X10' Wood shed used by NNTH for storage (i.e. tools). This shed is located in the parking lot and does not have power.

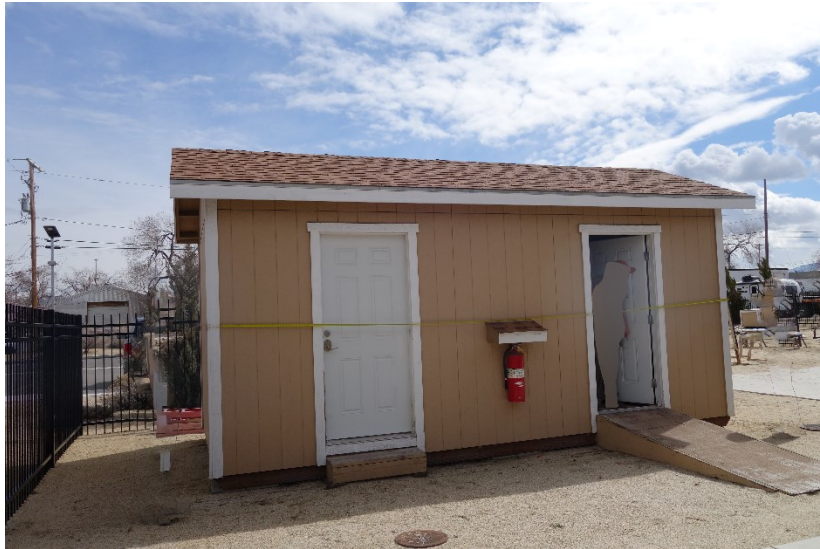
12'X20' Wood shed used by NNTH for storage. This shed is located inside the fenced area and has power to it.

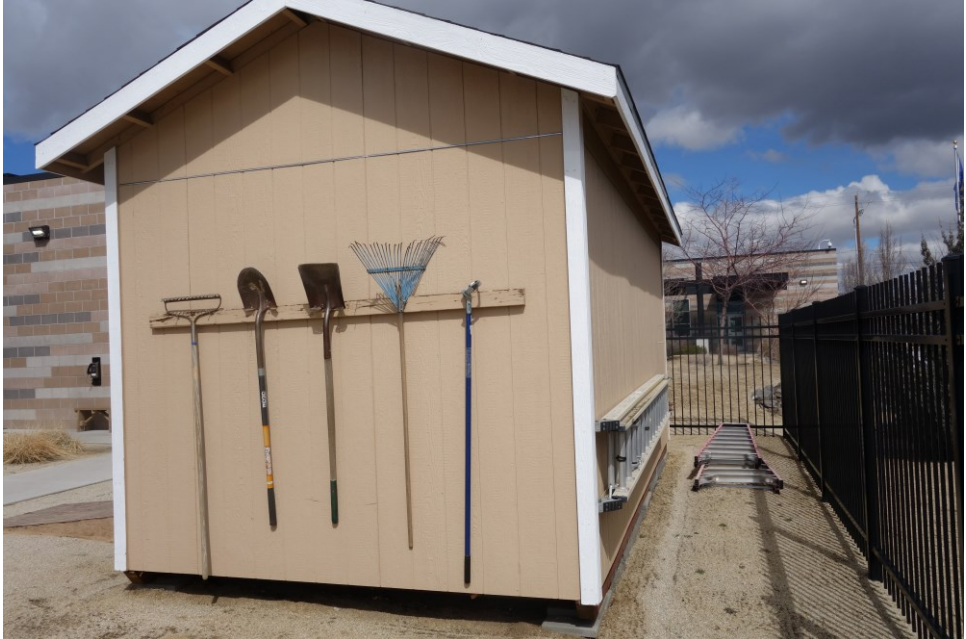
EXTERIOR FINISHES

QUANTITY	UNITS	TOTAL	SF COST
The exterior finishes were in good condition. It is important to maintain the finish, weather resistance and appearance of the building. This project would provide funding to protect the exterior of the building excluding the roof. Included in the cost is power washing and painting the wood and caulking the windows, flashing, fixtures and all other penetrations. It is recommended that the building be stained and caulked in the next 6 - 8 years and that this project be scheduled on a cyclical basis to maintain the integrity of the structure.	200	SF	\$ 2,000.00	\$ 10.00
