STATE OF NEVADA STATE PUBLIC WORKS DIVISION

FACILITY CONDITION ASSESSMENT REPORT FOR:

STEWART CAMPUS
NONSTATE ENTITY(S)

SITE #: 9820 STEWART IRRIGATION DIVERSION BLDG SITE
CLEAR CREEK RD
CARSON CITY, NV 89701-6601

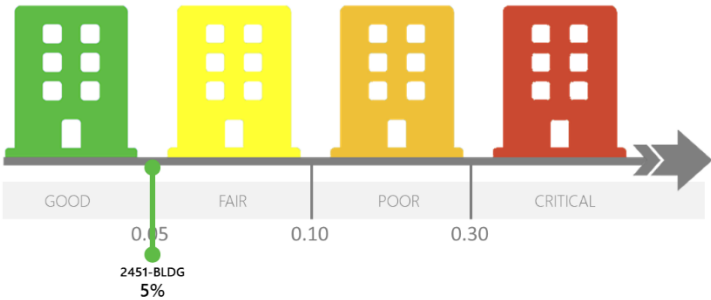
FCI is the total cost of necessary building repairs and renewal divided by the current cost of replacing the building. Each building’s FCI score reflects the current condition of the building: *good*, *fair*, *poor*, or *critical*. It is normal to see buildings in all stages of condition.

The graph on the left shows the FCI for each building at the STEWART IRRIGATION DIVERSION BLDG SITE.

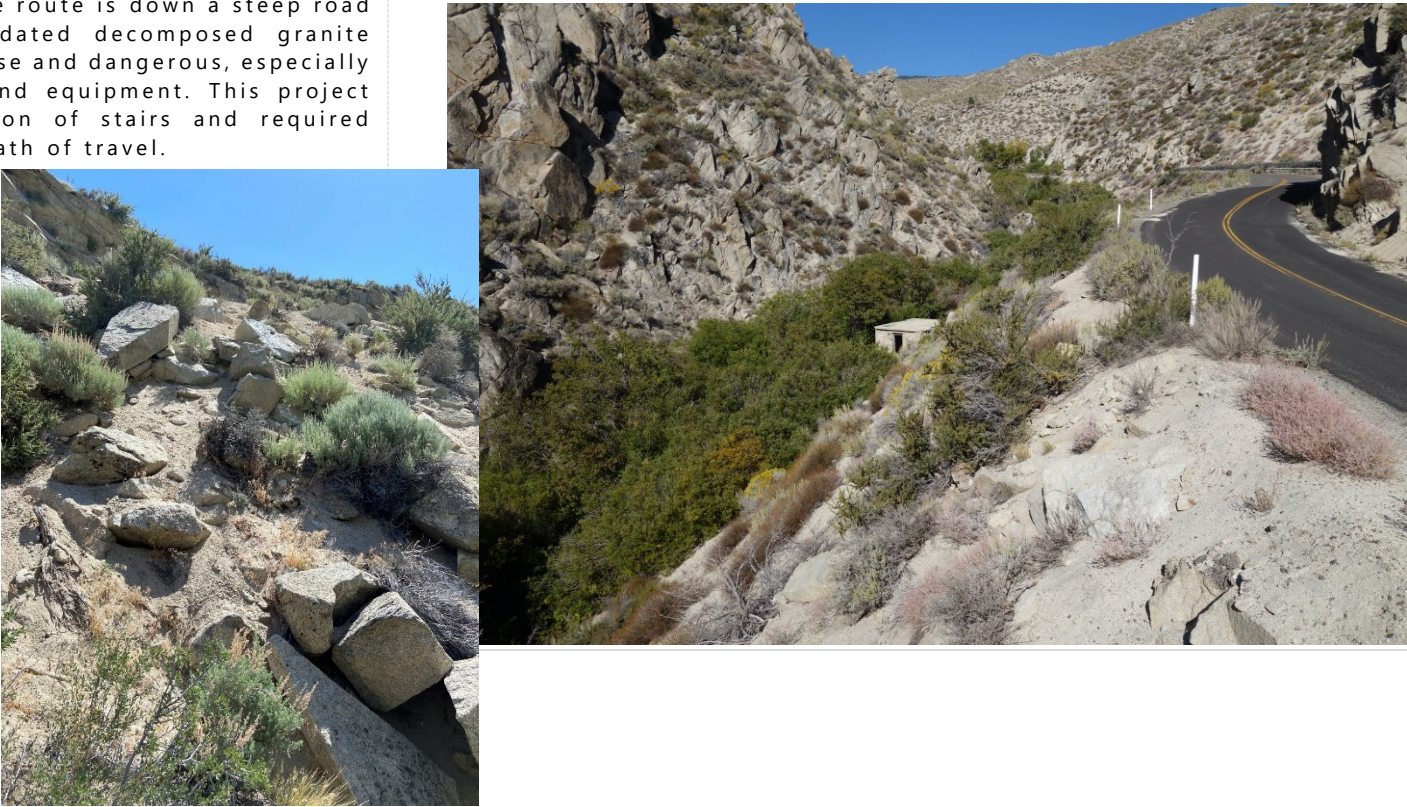
QUANTITY	UNITS	TOTAL	SF COST
There is no path of travel from Old Clear Creek Road to the diversion structure. The route is down a steep road embankment of unconsolidated decomposed granite material. The footing is loose and dangerous, especially when transporting tools and equipment. This project recommends the installation of stairs and required landings to create a safe path of travel.	1	Package	\$75,000.00

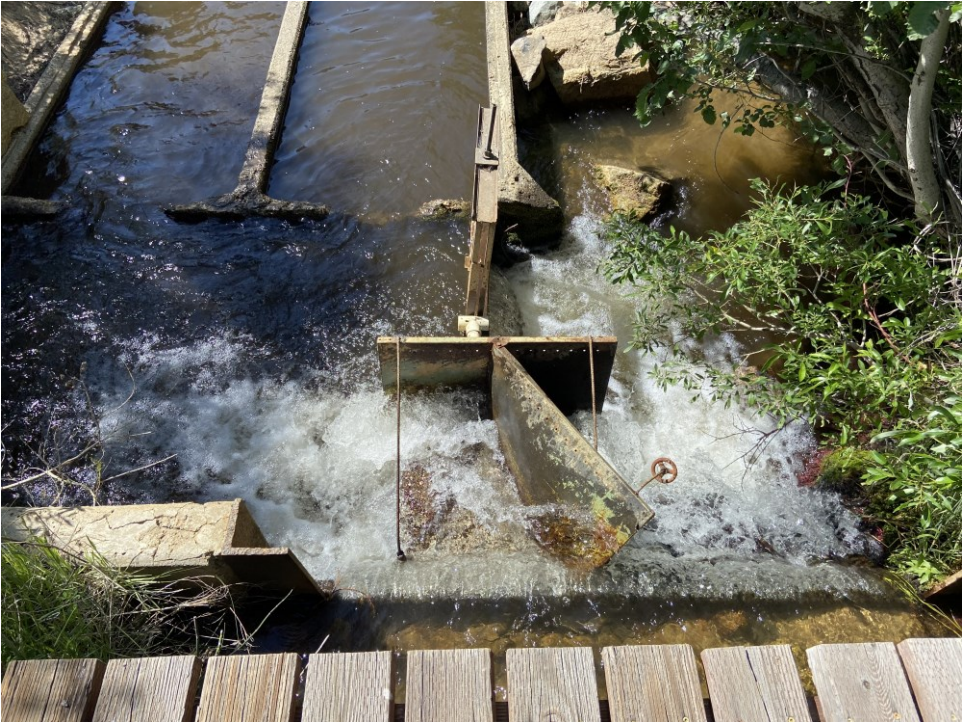
CONCRETE WIER REHABILITATION

QUANTITY	UNITS	TOTAL	SF COST
The existing concrete weir structure is in need of rehabilitation. The concrete wall structure appears to have some structural damage (cracking) and the old diversion head gate (age unknown) has failed. A complete rehabilitation is recommended including diversion gate replacement, structural repairs to the concrete structure, re-coating or re-surfacing the concrete weir structure and adding filtration devices to the two outgoing pipes.	1	Package	\$130,000.00

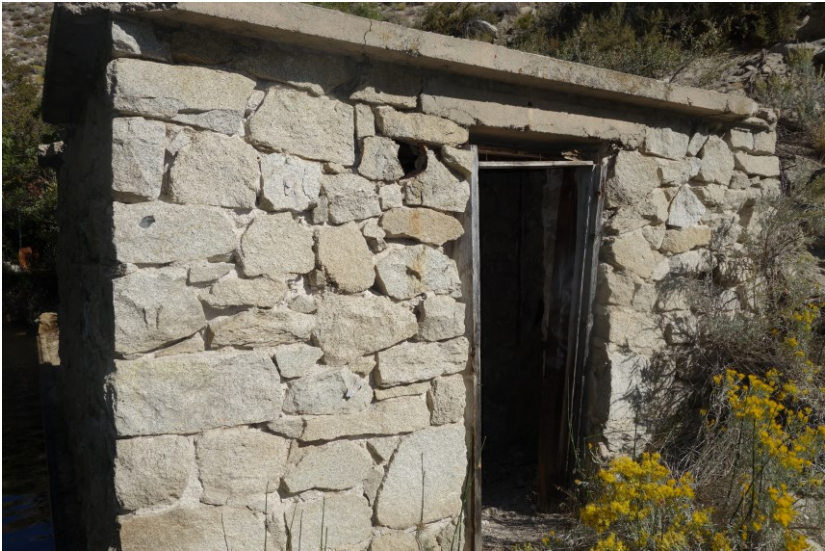
The historic Stewart Irrigation Diversion Building is an unreinforced native stone structure with a dirt floor built in the late 1800's. It has a concrete roof which probably replaced the original wood framed roof. The building does not serve any purpose at this time.

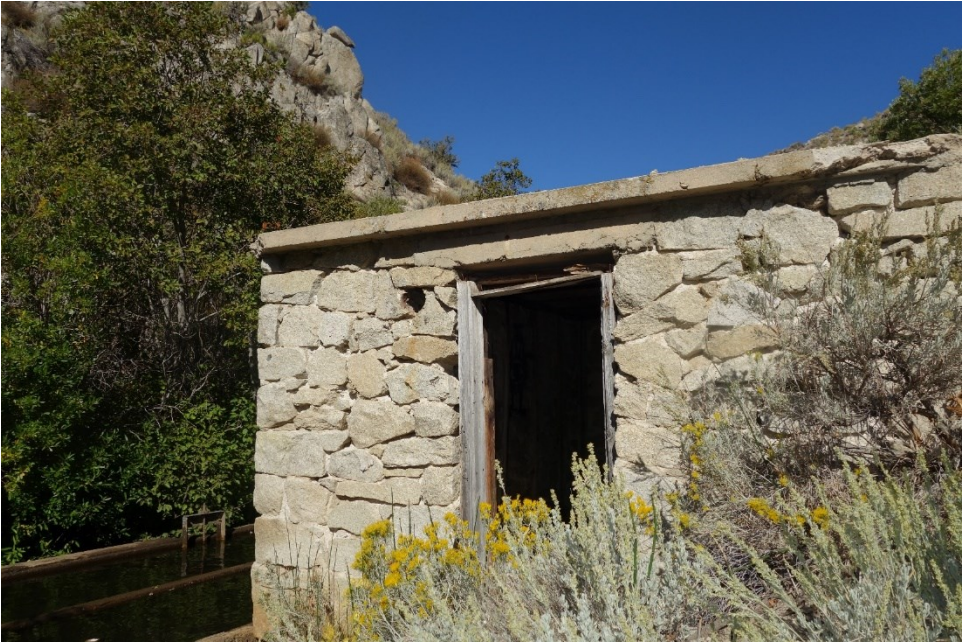
STRUCTURE DEMOLITION ASSESSMENT

QUANTITY	UNITS	TOTAL	SF COST
The building does not appear to have been assessed for its historic significance. Per NRS 383 and the National Historic Preservation Act (Section 106), an agency must take into account the effects of their project upon historic resources. If a building or structure is over 50 years of age, the agency must have qualified personnel assess the property and submit their findings to the Nevada State Historic Preservation Office, for their review, prior the start of a project. This project recommends the assessment of the structure for historical significance to determine whether it can be demolished.	1	Package	\$ 2,500.00	\$ 12.00
