DEPARTMENT OF ADMINISTRATION
STATE PUBLIC WORKS DIVISION
FACILITY CONDITION ASSESSMENT

PROPERTY PORTFOLIO REVIEW PROJECT ADDENDUM

-
9827 - FALLON ETR SITE
121 INDUSTRIAL WAY
FALLON, NV 89406-3116
CHURCHILL COUNTY

SURVEY DATE: 05/29/2024

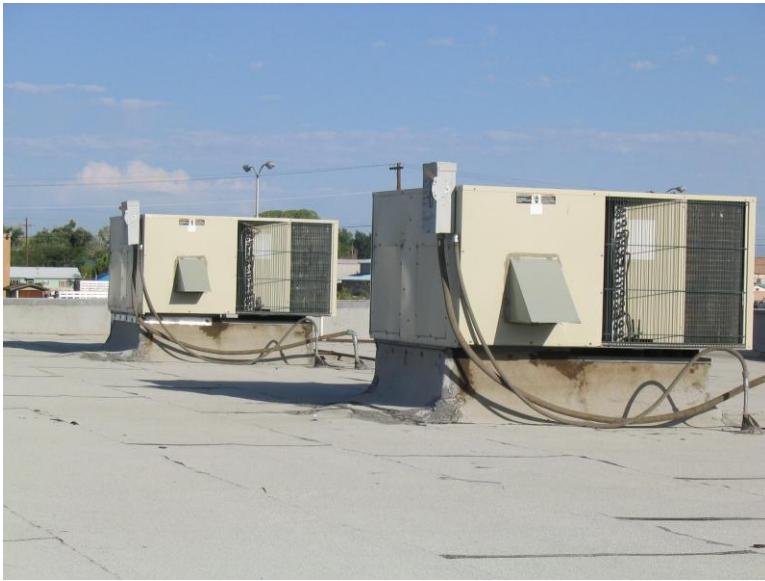
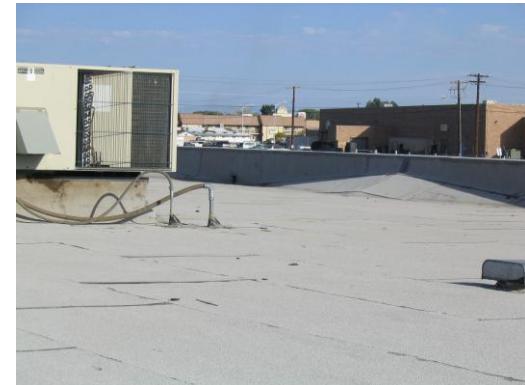
1935-HVA-0: REPLACE HVAC SYSTEM AND CONTROLS

The existing HVAC system is not able to effectively heat and cool the restrooms and the phone/server room. New electric supplemental heating should be added to the two bathrooms, which are on exterior walls. An exhaust fan should be installed in the store room (phone and server room) to remove heat from the server. One of the rooftop a/c units was replaced in 2024 while the other unit is original to the building and should be replaced.

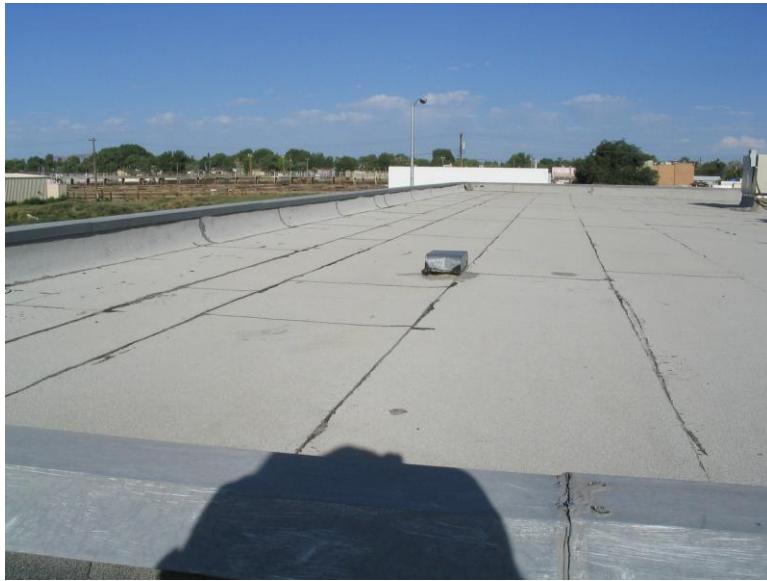
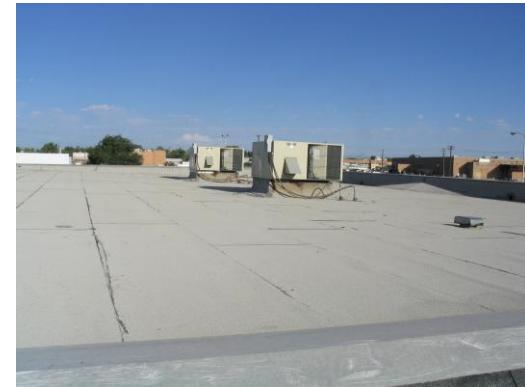
1935-EXT-2: ROOF REPLACEMENT

The existing roof was replaced approximately 18 years ago and is in fair condition. Budget planning for replacement should be done for replacement in the next 8 - 10 years. It is recommended that any current leaks or necessary repairs are done immediately to ensure the structural integrity of the roof and the ceiling below.

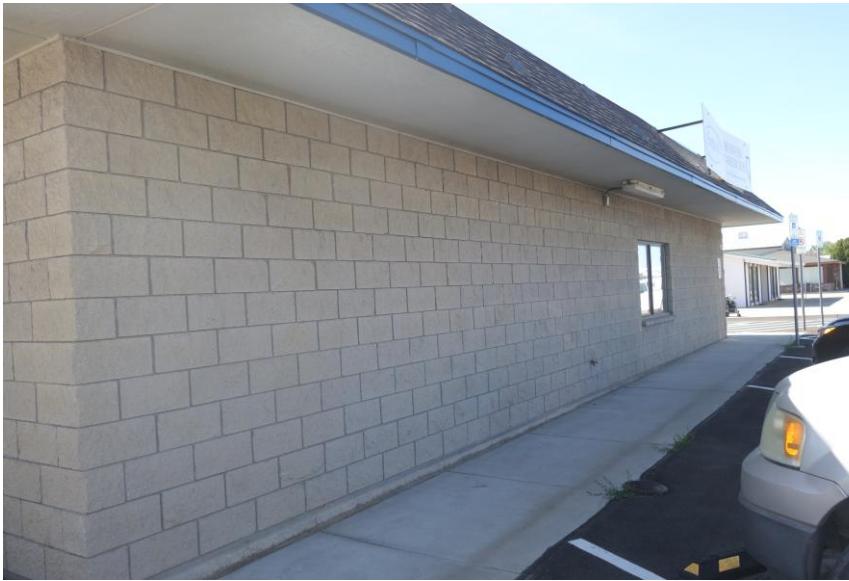
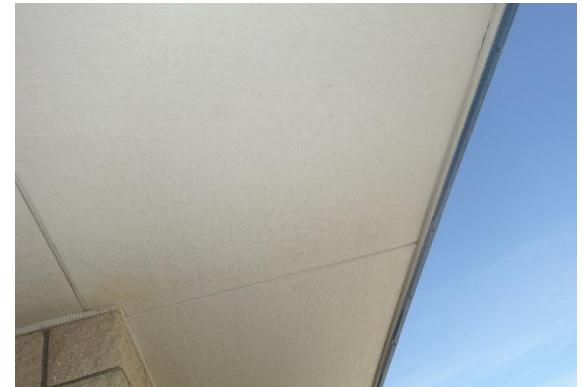
1935-EXT-3: EXTERIOR FINISHES

The exterior finishes of the building are in good condition. Maintaining the building's finish, weather resistance, and appearance is essential. This project will fund improvements to protect the exterior envelope of the building, excluding the roof. The scope includes painting, staining, or sealing the exterior walls, along with caulking around windows, flashing, fixtures, and all other exterior penetrations. It is recommended that this work be completed within the next 7 to 10 years and scheduled on a recurring

maintenance cycle to preserve the structural integrity and visual condition of the facility.

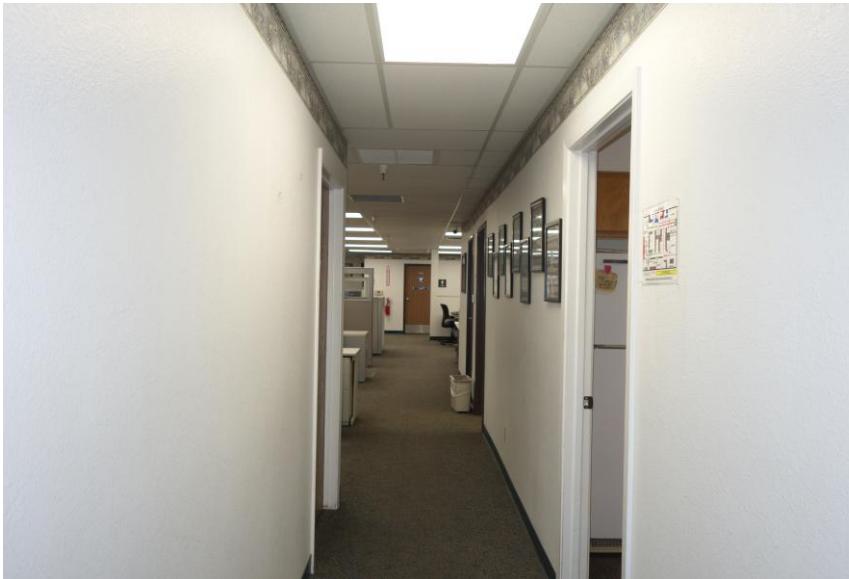
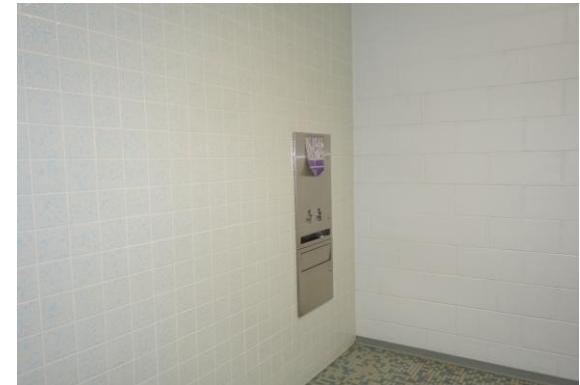
1935-INT-2: INTERIOR FINISHES

The interior finishes are in good condition. It is recommended that the interior walls and ceilings be repainted within the next 7 - 10 years. Prior to painting, all surfaces should be properly repaired and prepared to ensure a durable and uniform finish. In wet or high humidity areas, the use of an epoxy-based paint is recommended to enhance moisture resistance and durability. To preserve the quality of interior finishes and support the longevity of the structure, ongoing building maintenance should be scheduled on a regular, cyclical basis.

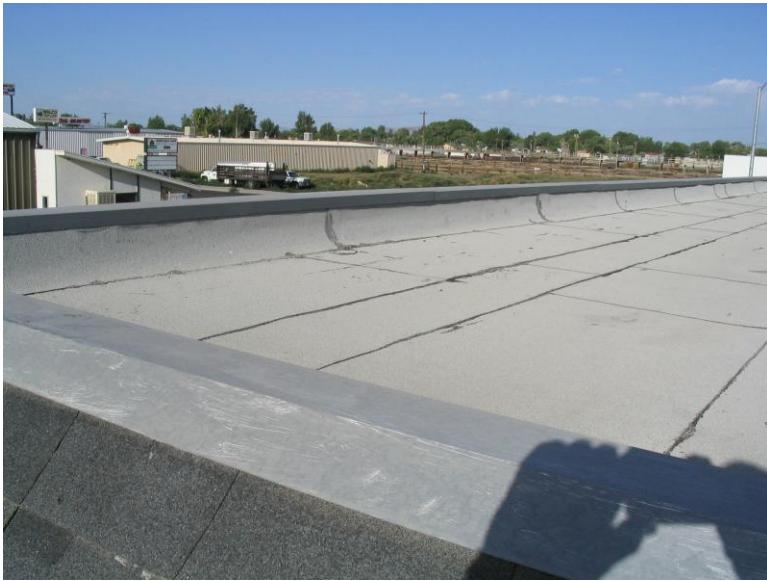
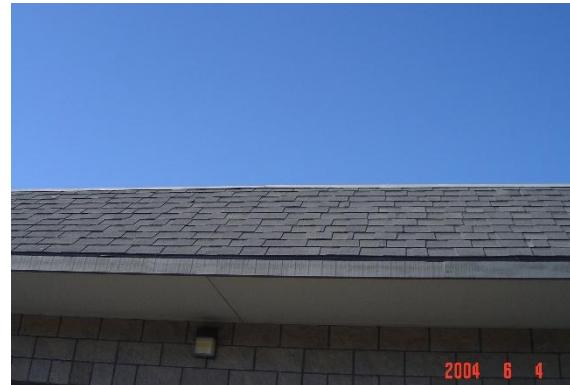
1935-HVA-2: INSTALL ROOF ACCESS HATCH AND LADDER

The existing building has no permanent access to the rooftop equipment. The shape of the Mansard roof makes using a ladder to access the roof unsafe. This project would install a lockable roof access hatch and permanent fixed ladder in the Janitor's Closet or Store Room.

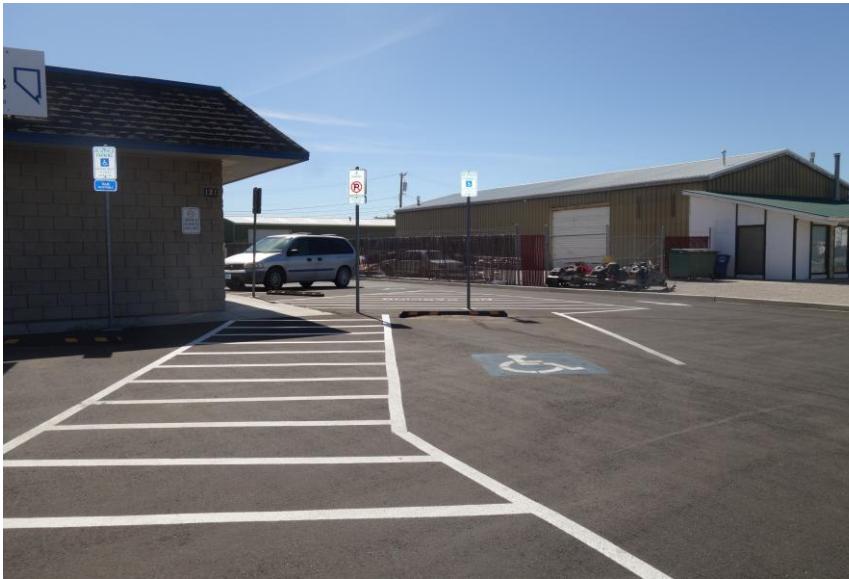
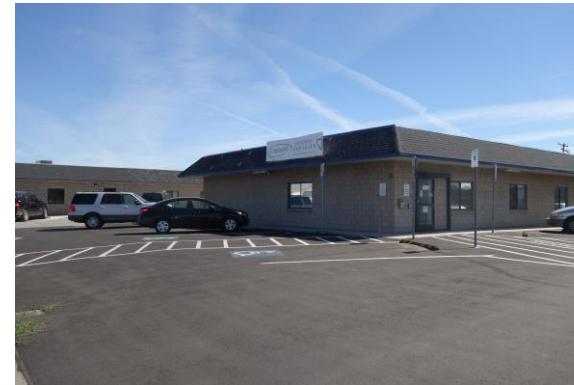
9827-SIT-1: SEAL AND STRIPE PARKING LOT

The existing parking lot has numerous cracks, in which weeds are growing. This project would seal the cracks, seal the entire lot, restripe, and relocate the handicapped parking sign.
