# LAUGHLIN WILDLIFE FIELD OFFICE

Site Number: 9838

## STATE OF NEVADA PUBLIC WORKS DIVISION FACILITY CONDITION ANALYSIS

Report distributed in January 2023

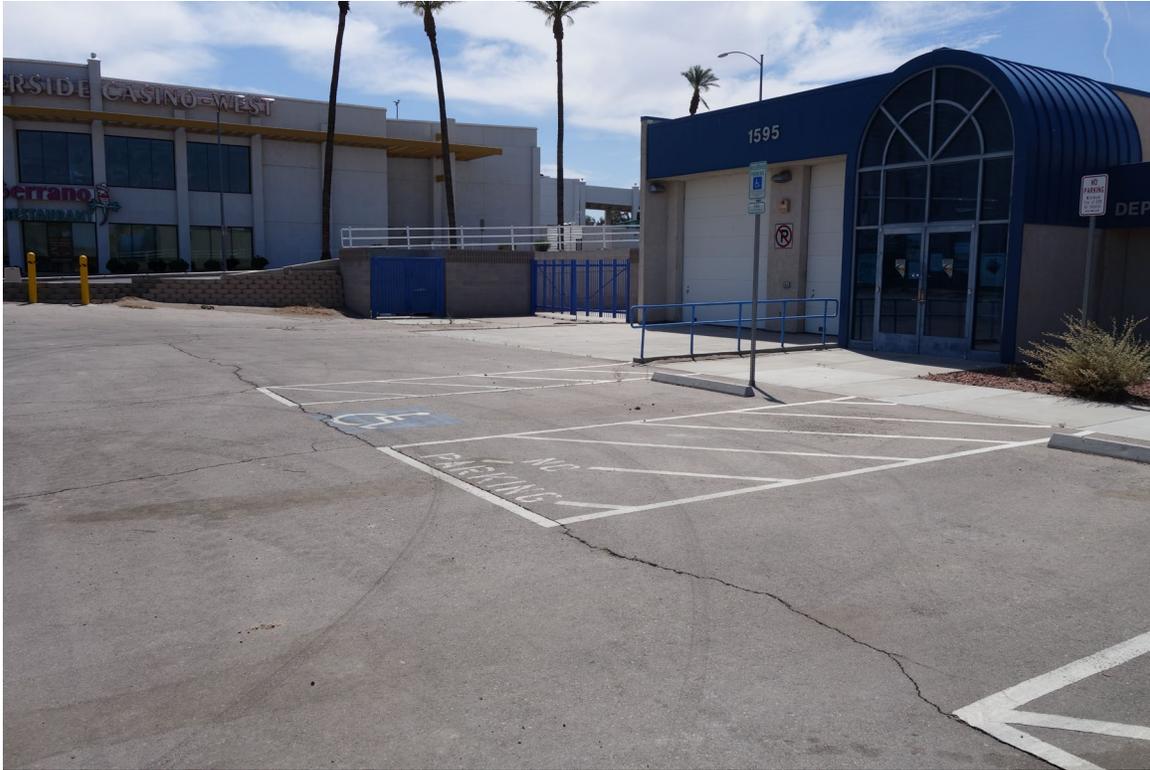
Laughlin Wildlife Field Office Site – FCA Site #9838  
Description: Accessible Paved Parking and Public Entrance.

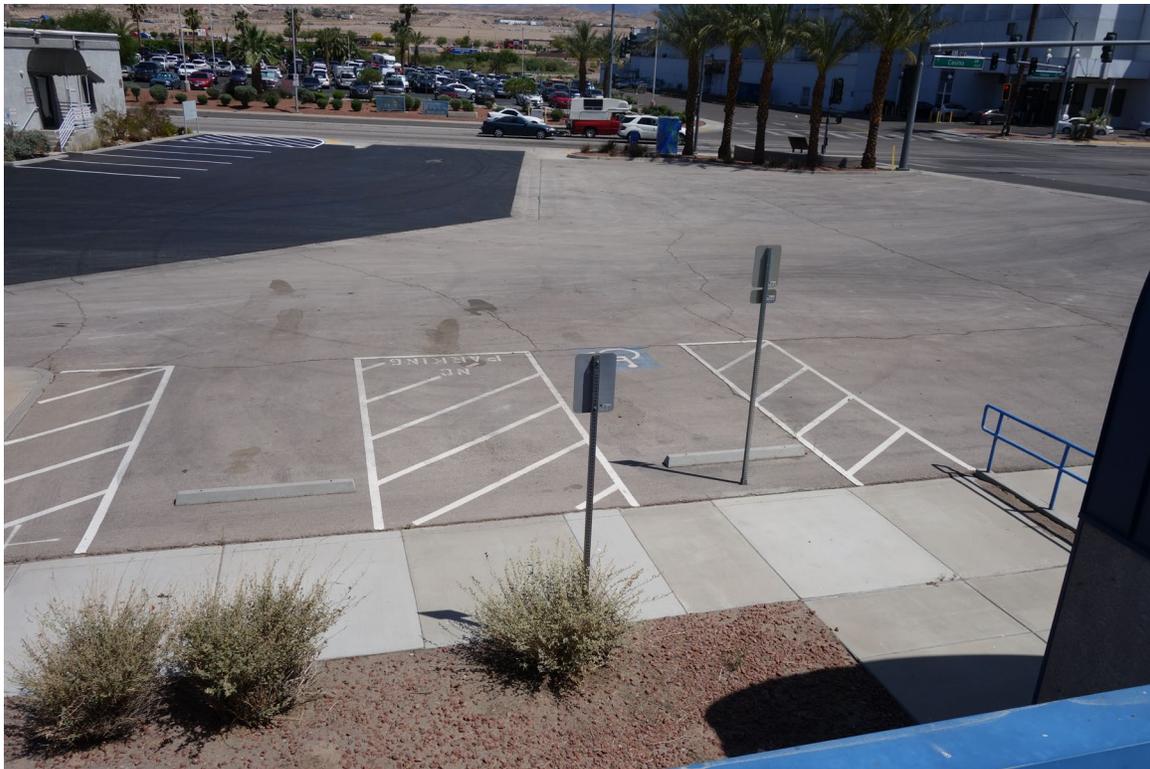
Laughlin Wildlife Field Office Site – FCA Site #9838  
Description: Public Parking Pavement Sealing Needed.

It is important to maintain the asphalt concrete paving on the site. This project would provide for minor crack filling and sealing of the paving site wide including access roads, parking areas, and vehicle storage areas. Striping is included in this estimate. This project should be scheduled on a 5 year cyclical basis to maintain the integrity of the paving and prevent premature failure. 32,000 square feet of asphalt area was used to generate this estimate.

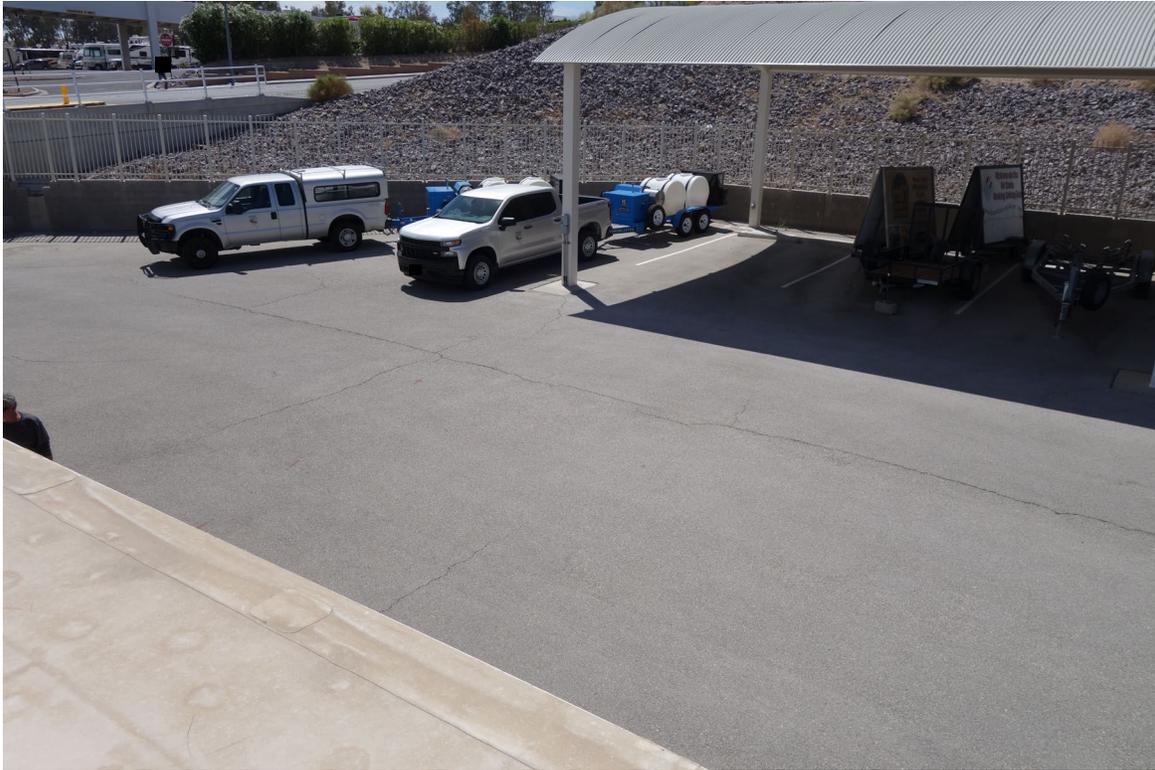
Laughlin Wildlife Field Office Site – FCA Site #9838  
Description: Rear Parking Lot Pavement and Shade Structure.

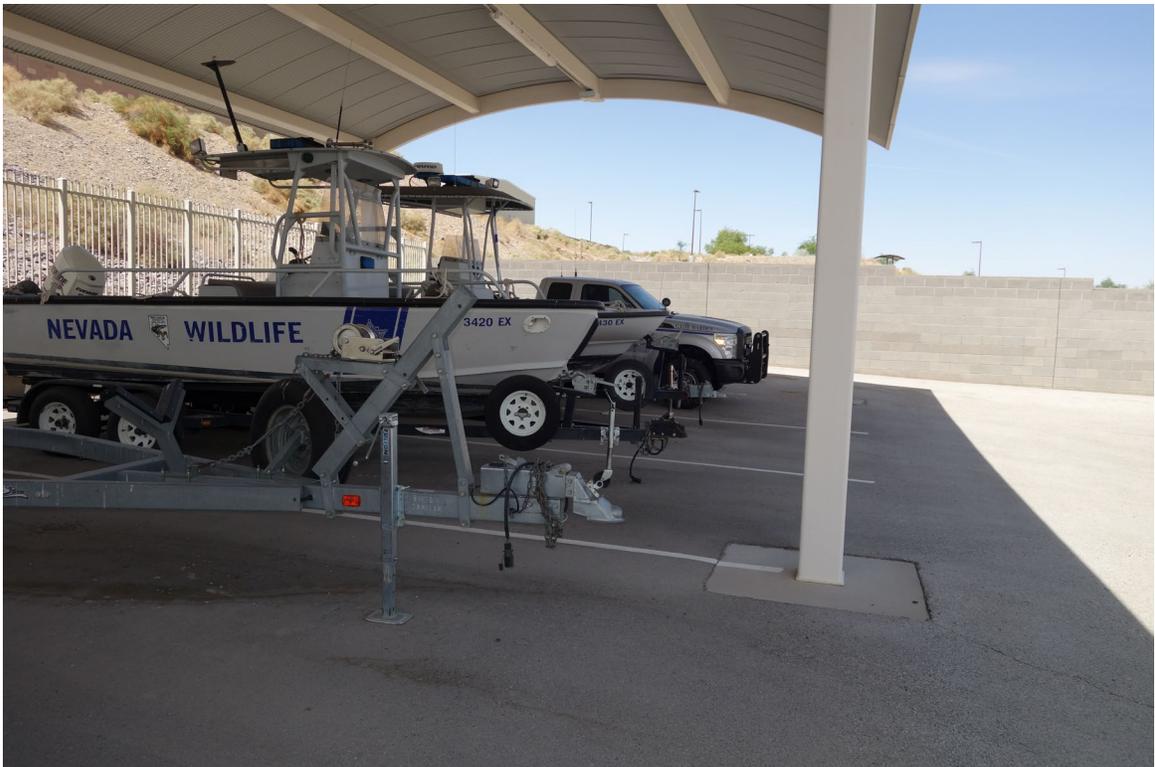
Shade Structure – FCA Building #4278  
Description: View of the Structure.

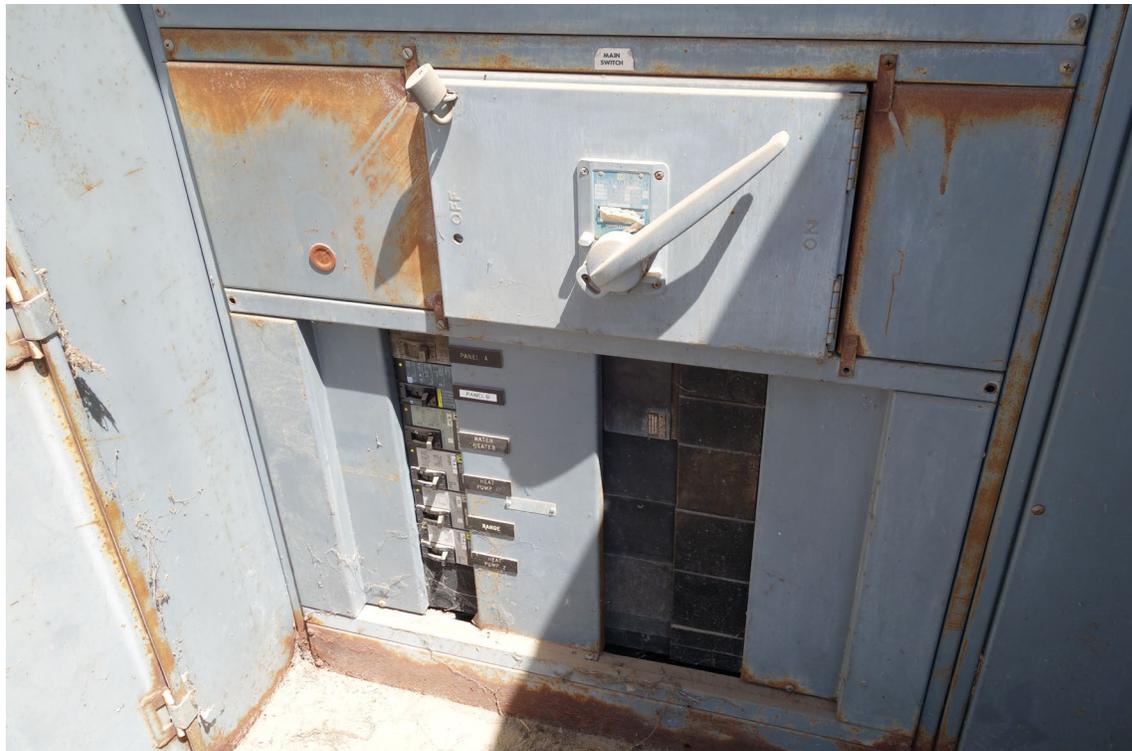
Arc flash and electrical breaker coordination studies have not been performed or it has been more than 5 years since the last coordination study. Safety requirements for maintenance personnel and the latest electrical code require coordination studies to be verified and performed every 5 years, along with arc flash labeling on all electrical panels. Additionally, the exterior main service panel show evidence of recent breaker installation. This study will ensure that the new breakers are properly rated for the main service panel. This project will perform the required coordination study, evaluation, adjustments and labeling for the building's electrical distribution system.

Laughlin Wildlife Field Office – FCA Building #2470  
Description: Arc Flash Labeling & Breaker Coordination Study Needed.

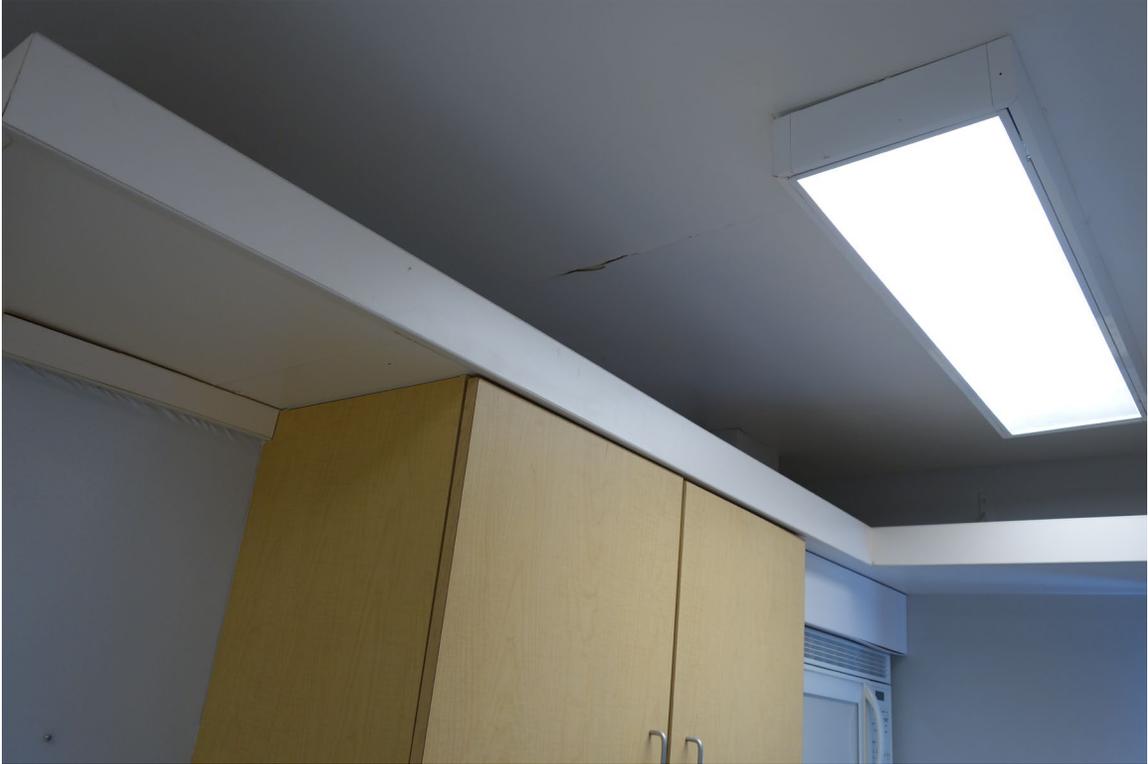
Two locations on the interior drywall ceiling were damaged and should be scheduled for repair. It appears that old roof leaks were the cause based on pictures taken of the same damage during the previous FCA Survey in 2012. The roofing was replaced in 2010 prior to the 2012 Survey and the ceiling damage has not worsened since then. This project would provide for repair of the gypsum board ceiling and include tape, mud, texture and paint.

Laughlin Wildlife Field Office – FCA Building #2470  
Description: Ceiling Repairs Needed.

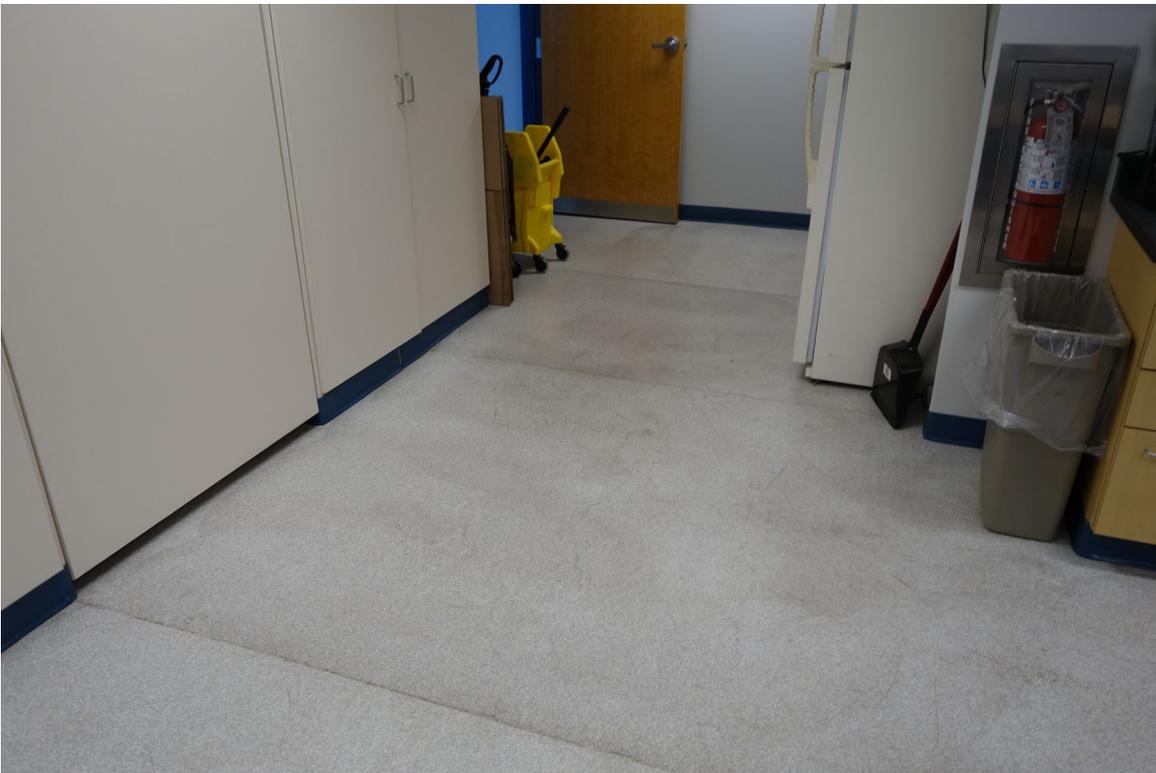
The vinyl floor coverings in this building were generally in poor condition and have reached the end of their serviceable lives. This project would provide funding to completely remove the existing flooring and replace with durable sheet vinyl.

Laughlin Wildlife Field Office – FCA Building #2470  
Description: Vinyl Flooring Replacement Needed.
