# FACILITY CONDITION ASSESSMENT REPORT FOR:

CAPITAL COMPLEX MASTER PLAN DEPT OF ADMINISTRATION STATE PUBLIC WORKS DIVISION B&G

SITE #: 9854 CAPITOL COMPLEX STREETS/PARKING SITE

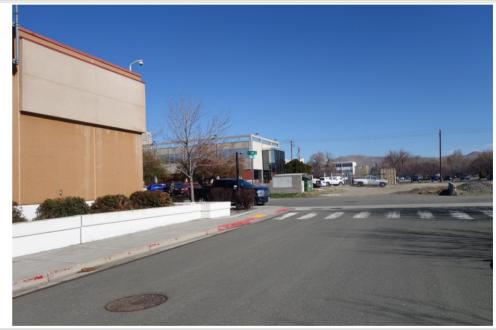
#### SEAL ASPHALT PAVING

S Anderson St is a north / south oriented roadway bounded by the dead end of E 4th St on the south and 3rd St on the north. The condition of the street is good and only needs a maintenance seal and striping which will be addressed in this report.

It is important to maintain the asphalt concrete street paving. This project will provide for minor crack filling and sealing the roadway. Microsurface sealing process is recommended to account for street deformations, subsidence or other minor anomalies. Striping is included in this estimate. This project should be scheduled on a 5 year cyclical basis to maintain the integrity of the paving and prevent premature failure.

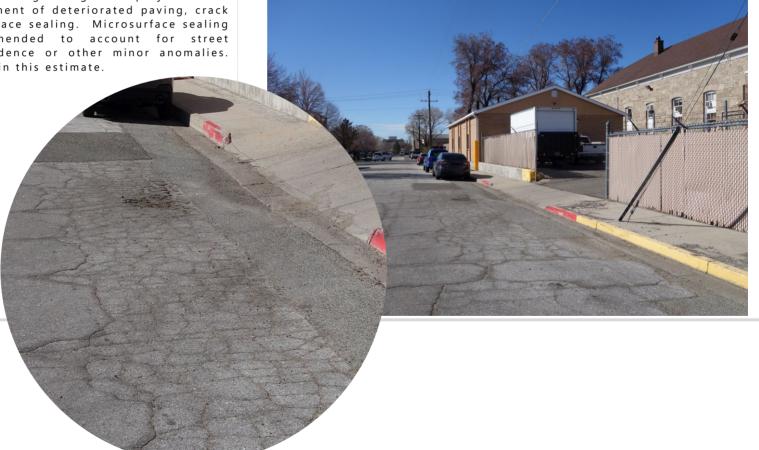
#### PATCH, CRACK & MICROSURFACE SEAL ASPHALT PAVING

N & S Valley St is a north / south oriented roadway which changes from North to South Valley at King St. The state responsibility for maintenance is bounded on the north by E Musser St and terminates at E 4th St on the south. The condition of Valley St is in poor condition partially due to existing saw cutting for utility trenches, legacy patching, lack of maintence and general use. All of these conditions will be addressed in this report.

The street paving is severely deteriorated with large cracks and areas of allegatoring. This project would provide for replacement of deteriorated paving, crack filling and microsurface sealing. Microsurface sealing process is recommended to account for street deformations, subsidence or other minor anomalies. Striping is included in this estimate.

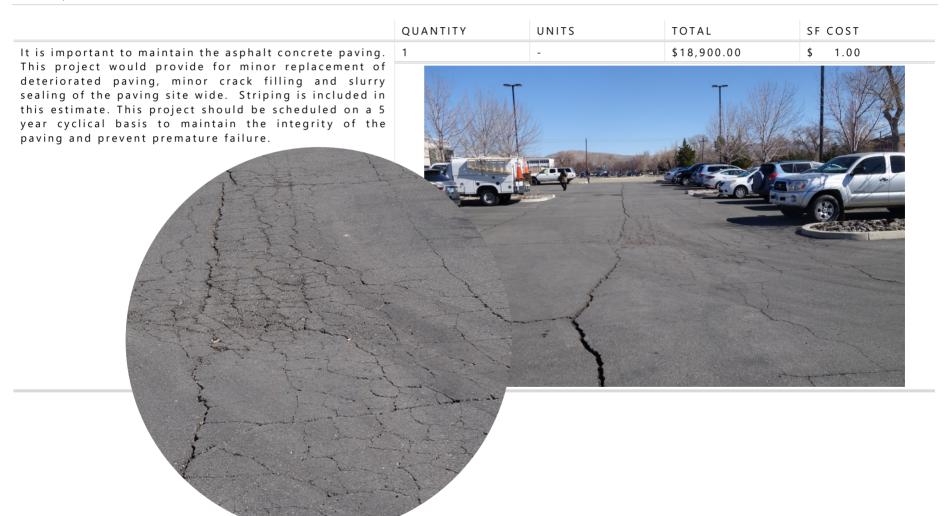
#### PATCH, CRACK & SLURRY SEAL ASPHALT PAVING

The Parking Lot is located across S Anderson St to the east of the OCIO Building. The vehicle entrance points are on the north side from 3rd Street. ADA parking and ramp exits are on the west side of the lot to the sidewalk on S Anderson St. The parking lot is in fair condition but is in need of repairs prior to a maintenance seal and striping which will be addressed in the report.

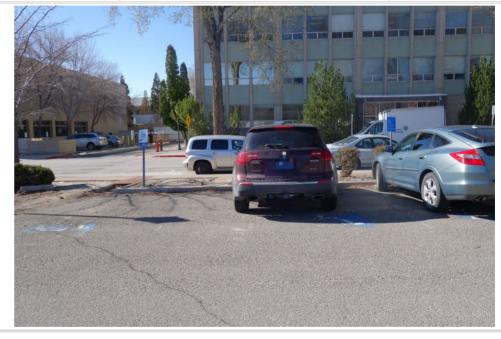
#### ADA PARKING SPACE UPGRADES

The ADA provides for accessibility to sites and services for people with physical limitations. The existing ADA parking spaces are no longer compliant and deteriorated. This project would provide for 5 ADA parking spaces and Path of Travel to the existing sidewalk. This will require regrading, installing concrete, striping, signage and any other necessary upgrades. The 2018 IBC, ICC/ANSI A117.1, NRS 338.180 and the most current version of the ADA Standards for Accessible Design were used as a reference for this project.

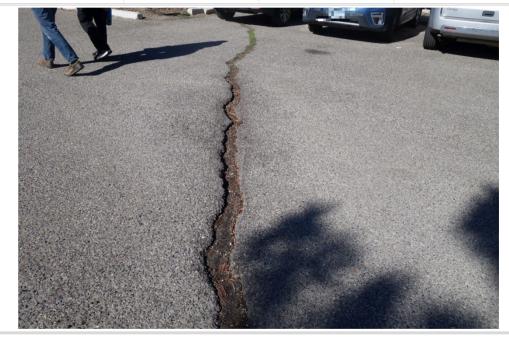
#### PATCH, CRACK & SLURRY SEAL ASPHALT PAVING

It is important to maintain the asphalt concrete paving. This project would provide for minor replacement of deteriorated paving, minor crack filling and slurry sealing of the paving site wide. Striping is included in this estimate. This project should be scheduled on a 5 year cyclical basis to maintain the integrity of the paving and prevent premature failure.

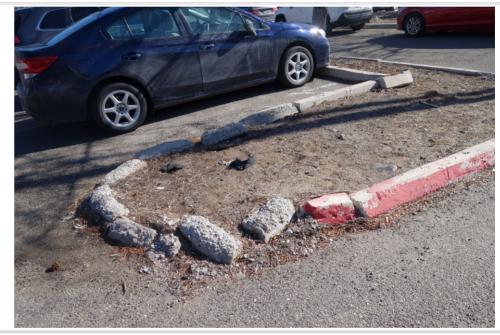
#### CURB REPLACEMENT

The parking lot curbs on this site are deteriorated and failing. This project addresses removal and replacement of existing curbs. 200 lineal feet of curb was used for this estimate.

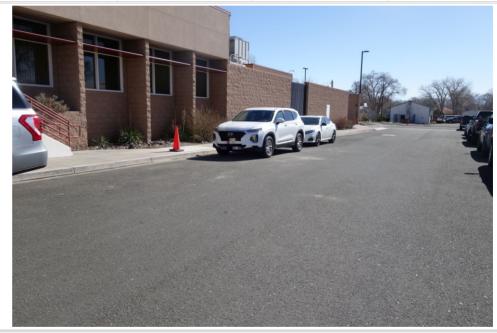
#### SEAL ASPHALT PAVING

E 4TH ST is an east / west oriented roadway bounded by S Valley St on the west and S Anderson St on the east. The condition of the street is good and only needs a maintenance seal and striping which will be addressed in this report.

It is important to maintain the asphalt concrete street paving. This project will provide for minor crack filling and sealing the roadway. Microsurface sealing process is recommended to account for street deformations, subsidence or other minor anomalies. Striping is included in this estimate. This project should be scheduled on a 5 year cyclical basis to maintain the integrity of the paving and prevent premature failure.

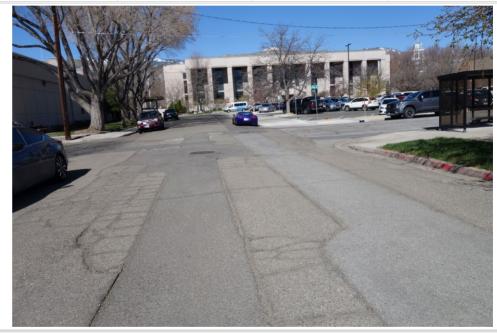
#### PATCH, CRACK & MICROSURFACE SEAL ASPHALT PAVING

E 3rd St is an east / west oriented roadway. The state responsibility for street maintenance is bounded on the west by S Stewart St and dead ends on the east end at the EITS parking lot. The condition of E King St is fair to poor partially due to existing saw cutting for utility trenches, lack of maintence and general use. All of these conditions will be addressed in this report.

The street paving is deteriorated with large cracks and areas of allegatoring. This project would provide for replacement of deteriorated paving, crack filling and microsurface sealing. Microsurface sealing process is recommended to account for street deformations, subsidence or other minor anomalies. Striping is included in this estimate.

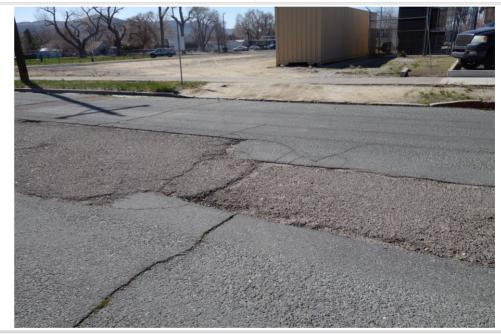
#### PATCH, CRACK & MICROSURFACE SEAL ASPHALT PAVING

E 2nd St is an east / west oriented roadway. The state responsibility for street maintenance is bounded on the west by S Stewart St and S Roop St on the east. The condition of E King St is fair to poor partially due to existing saw cutting for utility trenches, lack of maintence and general use. All of these conditions will be addressed in this report.

The street paving is deteriorated with large cracks and areas of allegatoring. This project would provide for replacement of deteriorated paving, crack filling and microsurface sealing. Microsurface sealing process is recommended to account for street deformations, subsidence or other minor anomalies. Striping is included in this estimate.

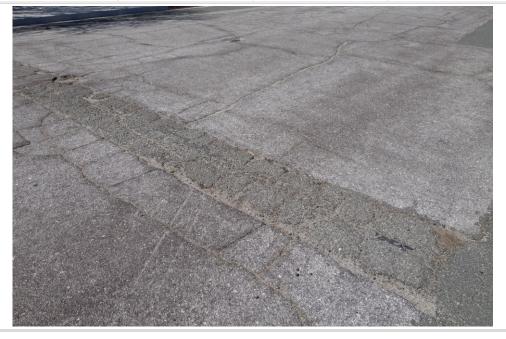
#### PATCH, CRACK & MICROSURFACE SEAL ASPHALT PAVING

E King St is an east / west oriented roadway. The state responsibility for street maintenance is bounded on the west by S Stewart St and S Roop St on the east. The condition of E King St is fair to poor condition partially due to existing saw cutting for utility trenches, lack of maintence and general use. All of these conditions will be addressed in this report.

The street paving is deteriorated with large cracks and areas of allegatoring. This project would provide for replacement of deteriorated paving, crack filling and microsurface sealing. Microsurface sealing process is recommended to account for street deformations, subsidence or other minor anomalies. Striping is included in this estimate.
