CARSON CITY MOTOR POOL SITE

Site Number: 9862

STATE OF NEVADA PUBLIC WORKS DIVISION FACILITY CONDITION ANALYSIS

Report distributed in November 2021

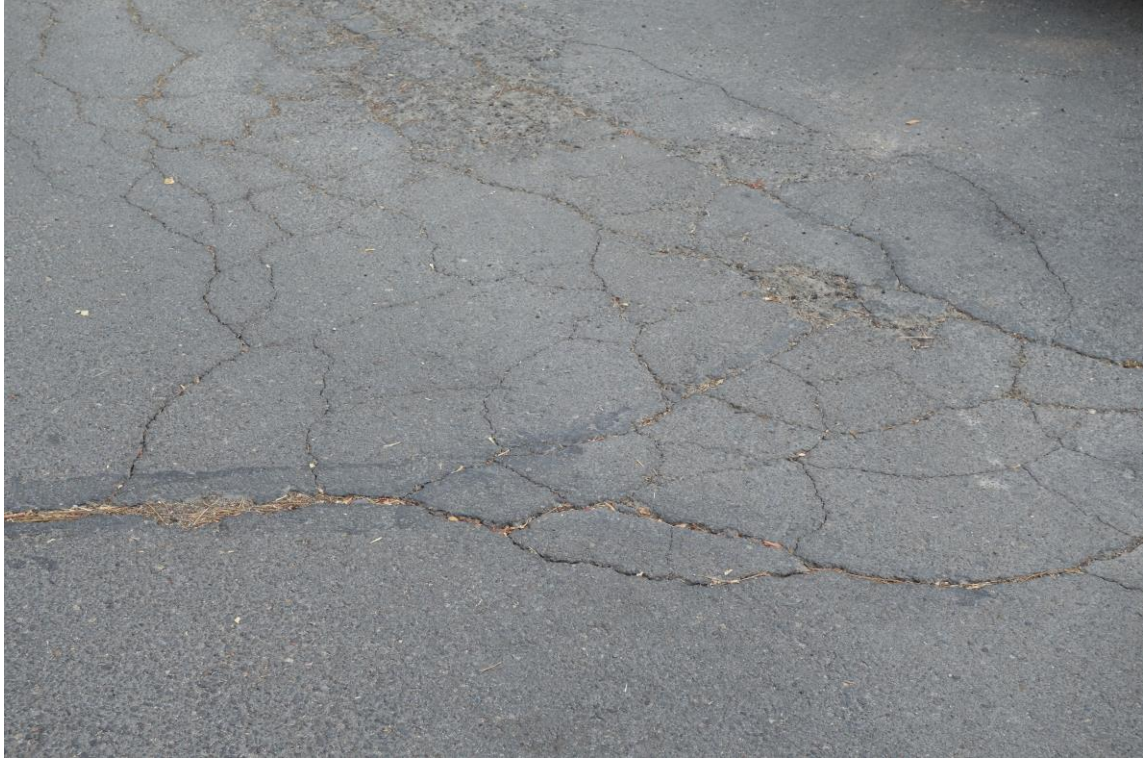
Carson City Motor Pool Site - Site #9862
Description: Failing Parking Pavement.

It is important to maintain the asphalt concrete paving on the site. This project would provide for minor replacement of deteriorated paving, minor crack filling, and slurry sealing of the paving site wide. Striping is included in this estimate. Slurry seal should be scheduled on a 5 year cyclical basis to maintain the integrity of the paving and prevent premature failure. 22,789 square feet of asphalt area was used to generate this estimate.

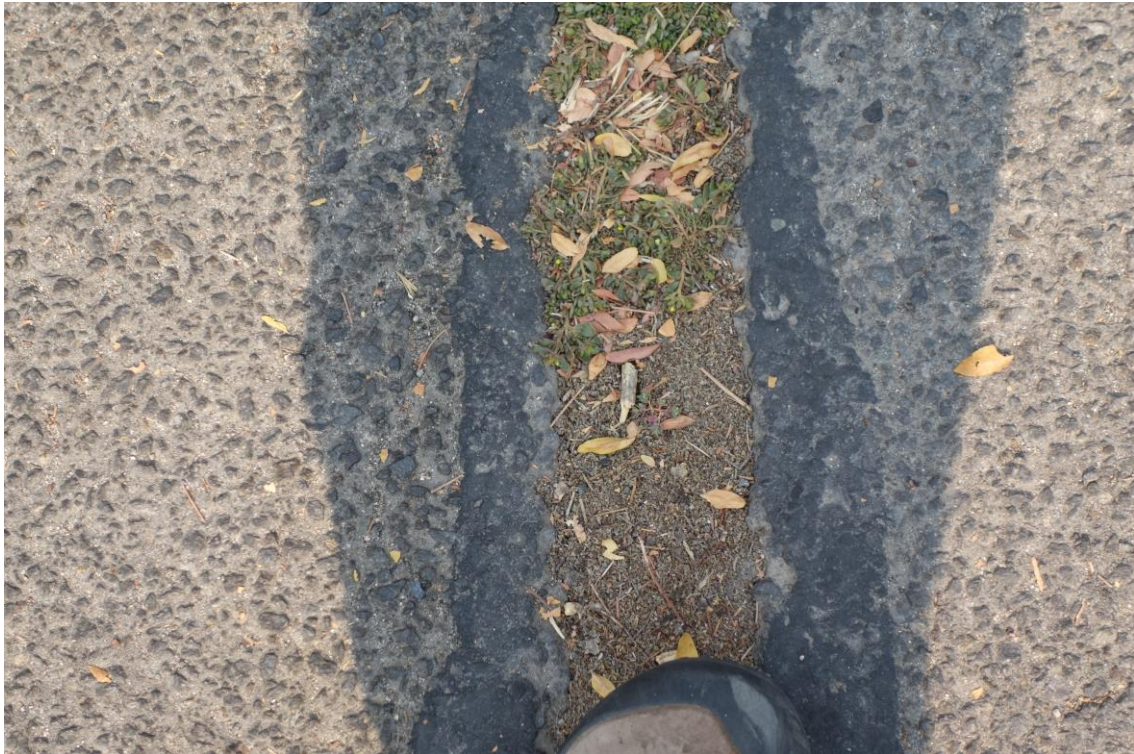
Carson City Motor Pool Site - Site #9862
Description: Parking Pavement Patch, Crack, and Surry Seal.

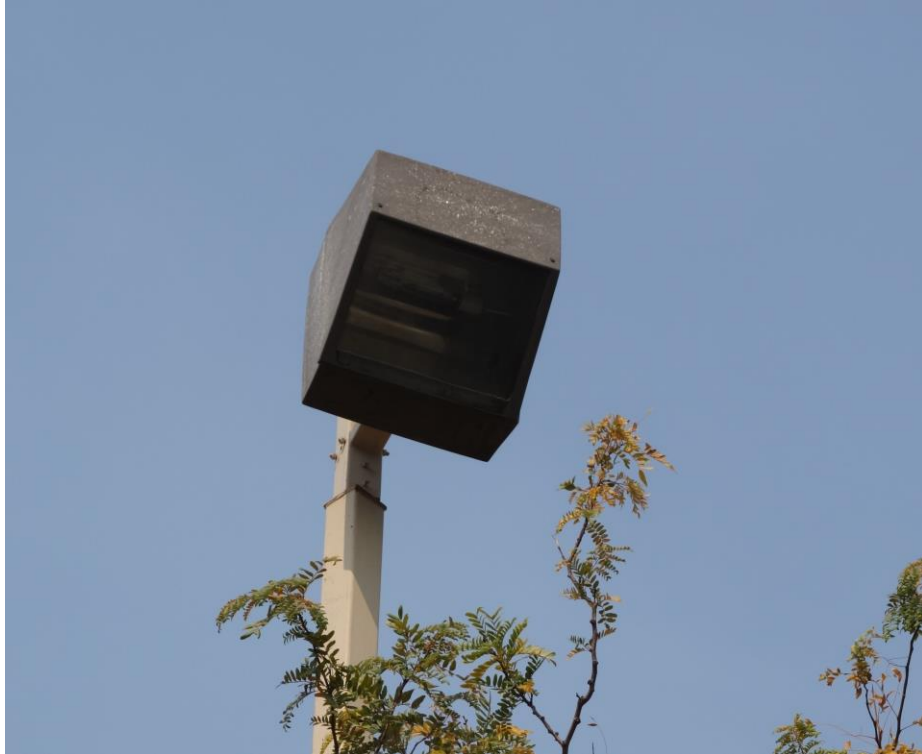
Carson City Motor Pool Site - Site #9862
Description: Exterior Lighting Replacement.

There are five lighting poles on the site. Three have been upgraded with LED fixtures. Two are non-LED fixtures, possibly HPS (high pressure sodium). This project would provide for the replacement of the two fixtures with new LED light fixtures using existing wiring and poles.

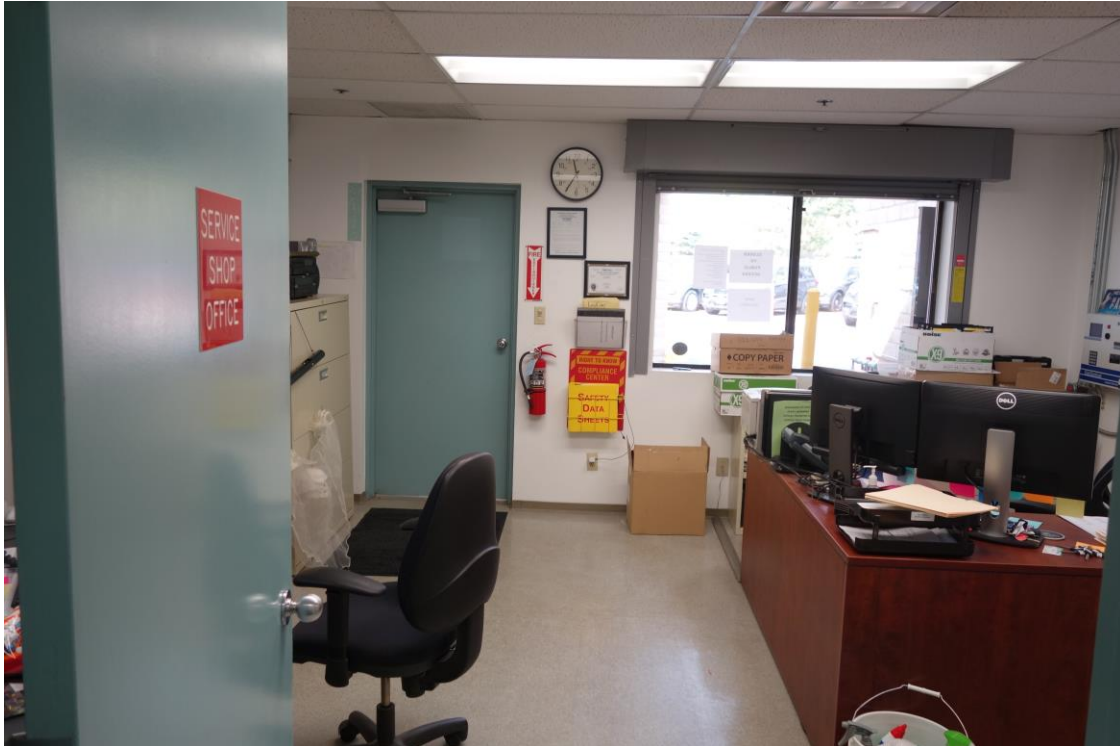
Carson City Motor Pool - Building #0204
Description: Door Lever Hardware Recommendation.

Section 4.13.9 of the Americans with Disabilities Act Accessibility Guidelines (ADAAG) states that handles, pulls, latches, locks and other operating devices on accessible doors shall have a shape that is easy to grasp with one hand and does not require tight grasping, tight pinching, or twisting of the wrist to operate. It is recommended that compliant hardware be installed on all doors in this building to meet these guidelines. The estimate is based on purchase and installation of hardware for 12 doors.

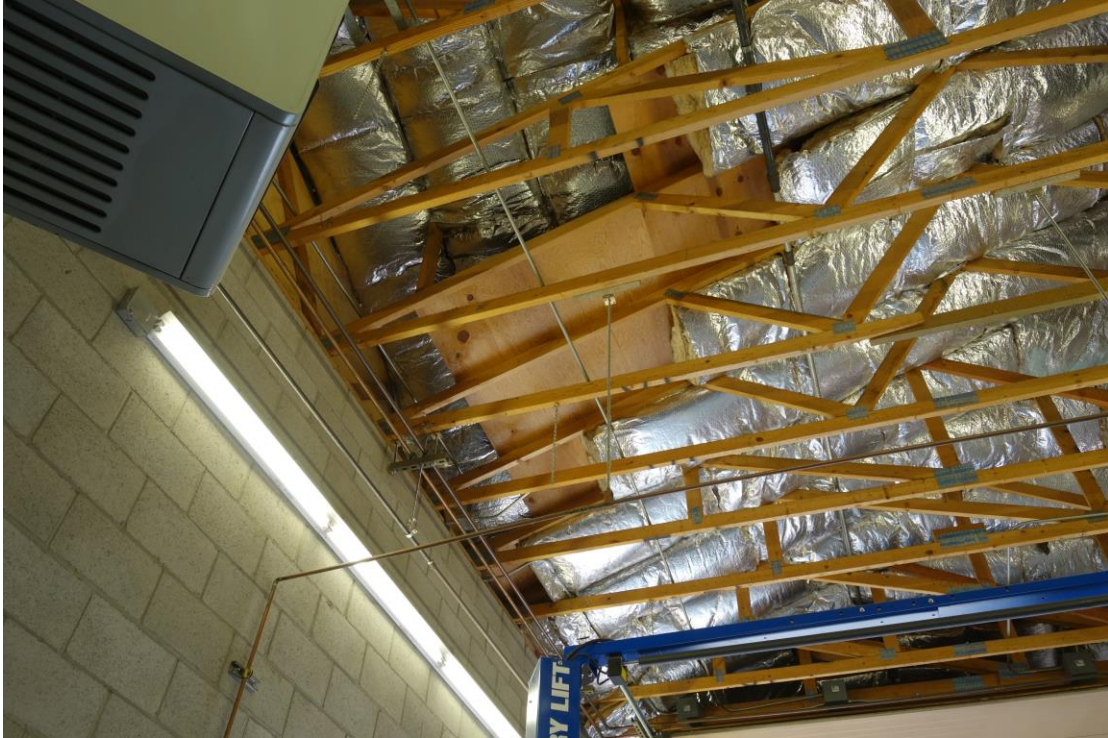
Carson City Motor Pool - Building #0204
Description: Insulation Replacement.

The ceiling in the vehicle bays have insulation bats that have fallen or been removed. Other insulation bats are resting on the head of the fire sprinklers and are a safety issue. This project recommends the missing insulation bats be replaced with R-30 and the installed insulation be repaired, as required, to prevent them from falling or resting on the fire sprinklers.

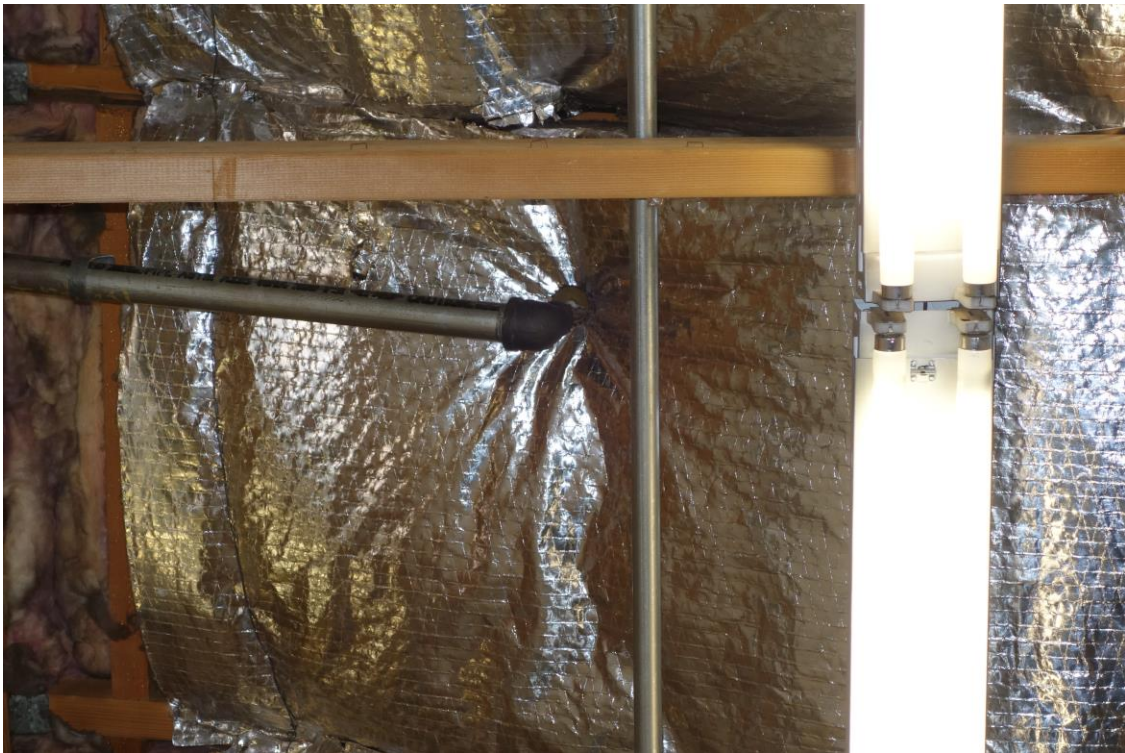
Carson City Motor Pool - Building #0204
Description: Insulation Repairs and Fire Sprinkler Clearance.

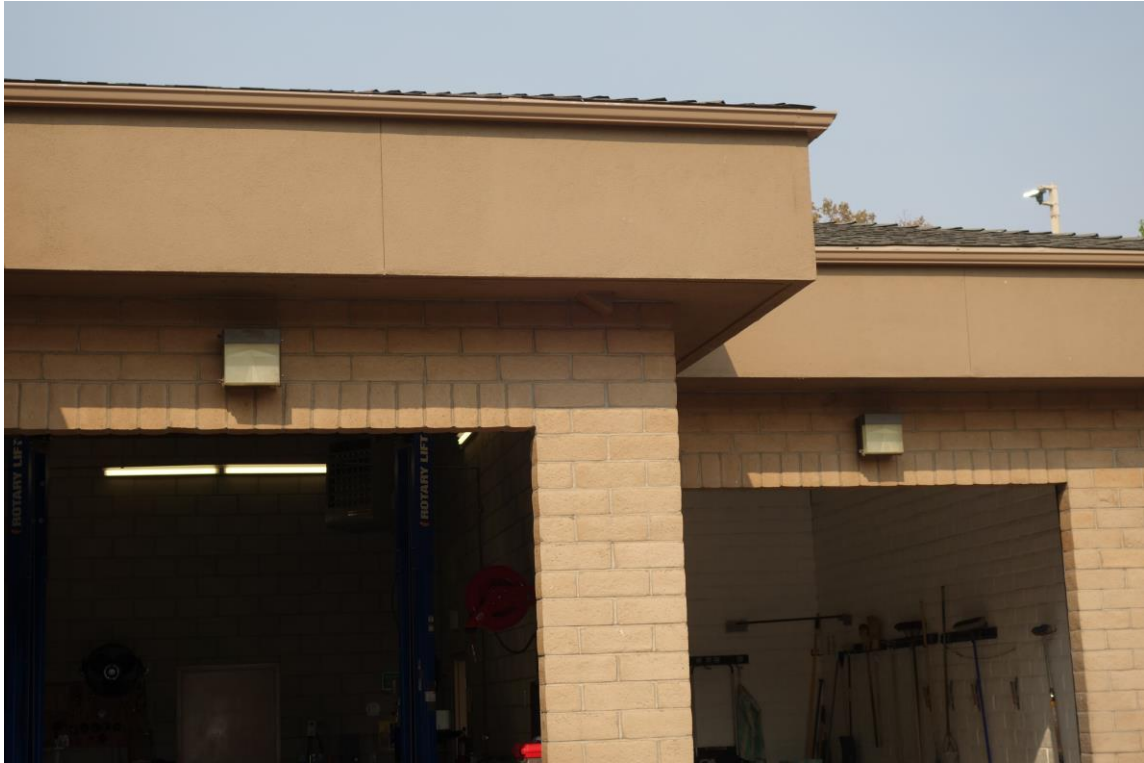
Carson City Motor Pool - Building #0204
Description: Exterior Lighting Replacement.

The building has perimeter lighting on the exterior of the building, but the light fixtures are HPS (high pressure sodium) and not energy efficient. This project would provide for the replacement of the exterior lighting fixtures with new LED light fixtures using existing wiring.

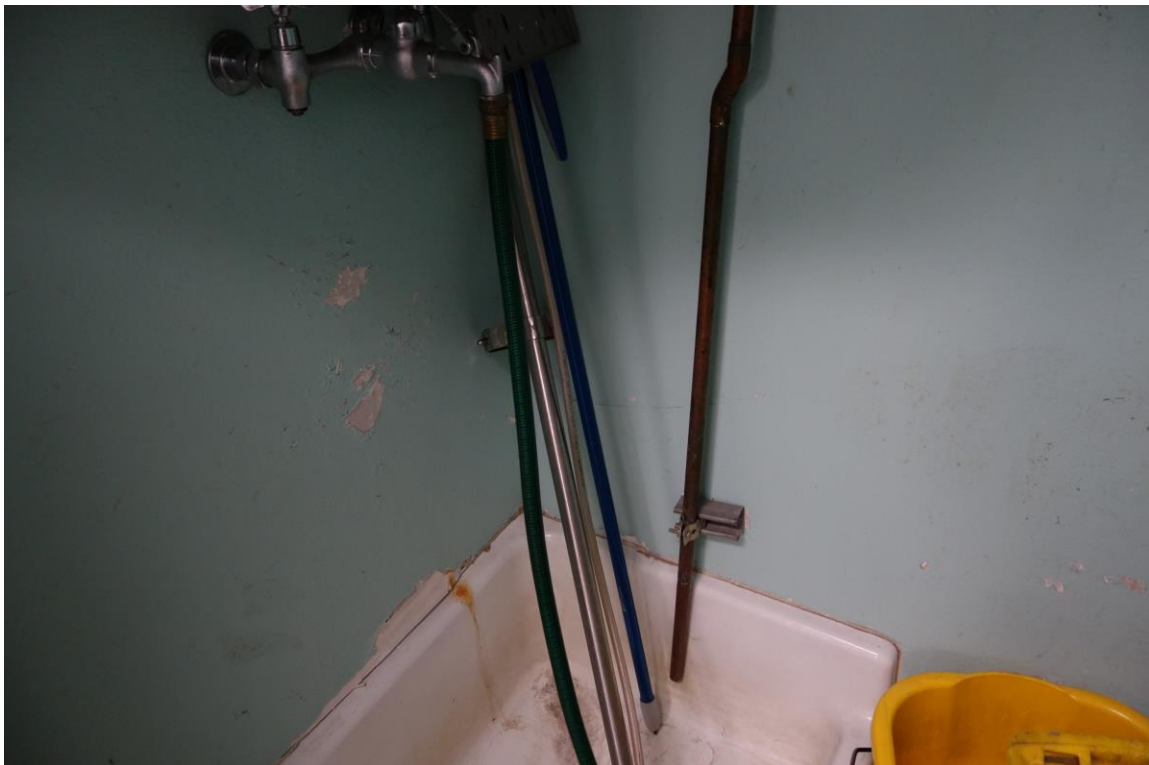
Carson City Motor Pool - Building #0204
Description: Janitors Closet Repairs.

The mop sink in the Janitors Closet is mounted adjacent to gypsum board and is showing signs of water damage. This project would provide fiberglass reinforced panels (FRP) to be installed on the walls adjacent to the mop sink. The FRP shall extend two feet beyond the edge of the sink and a minimum of 54" above the floor finish.
