SUPREME COURT OF NEVADA SITE

201 South Carson Street
Carson City, Nevada 89701

Site Number: 9865
STATE OF NEVADA PUBLIC WORKS DIVISION
FACILITY CONDITION ANALYSIS

Report distributed in December 2021

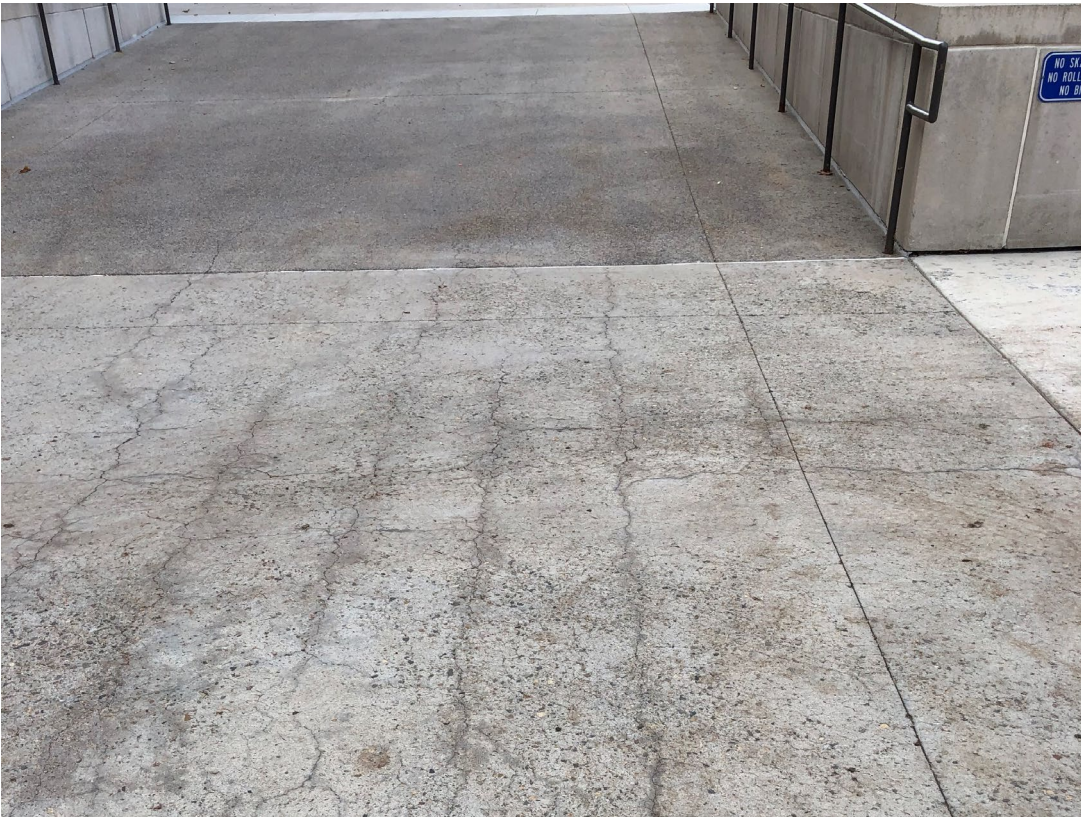
Some of the sidewalks serving the site and building entrances are deteriorated and beginning to fail in several areas. Most of the work needs to be done on the west side of the site where there is extensive spalling and some settling. A few sections have deteriorated enough to expose the reinforcing metal and the settling has created a tripping hazard. This project addresses removal and replacement of existing sidewalks as needed. 5,000 SF of 4" thick concrete sidewalk was used for this estimate.

Supreme Court of Nevada - Site #9865
Description: Sidewalk Replacement Needed.

This project or a portion thereof was previously recommended in the FCA report dated 04/14/2011. It has been amended accordingly to reflect conditions observed during the most recent survey date of 01/26/2021.

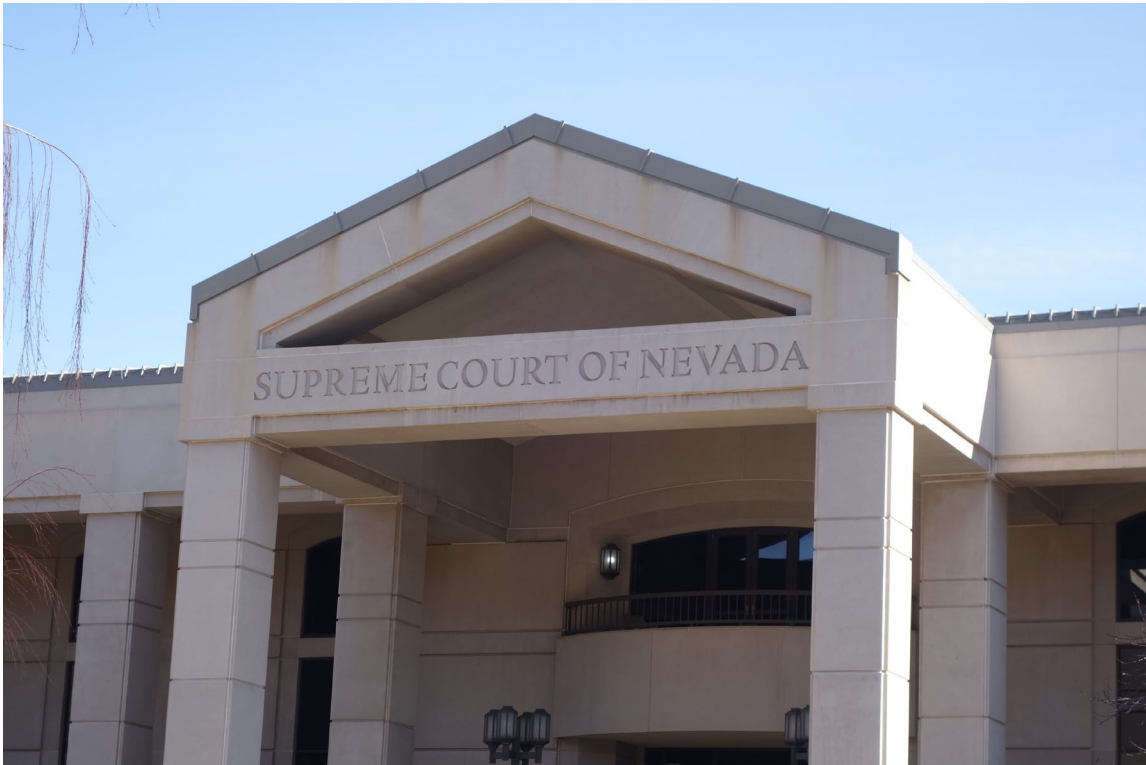
The exterior finishes were in fair condition; however, the exterior metal finishes require attention. These include exterior handrails, roof to wall flashings and intake/exhaust louvers. It is important to maintain the finish, weather resistance, and appearance of the building. This project recommends work to protect the exterior building envelope other than the roof, including sealing the concrete precast panels, and caulking around windows, flashing, fixtures, and other penetrations to maintain the building in good, weather tight condition. It is recommended that the building envelope, including the metal surfaces be repainted or sealed in the next 2 - 3 years and that this project be scheduled on a cyclical basis to maintain the integrity of the structure.

Supreme Court of Nevada - Building #1478
Description: View of Exterior Metal Finishes.

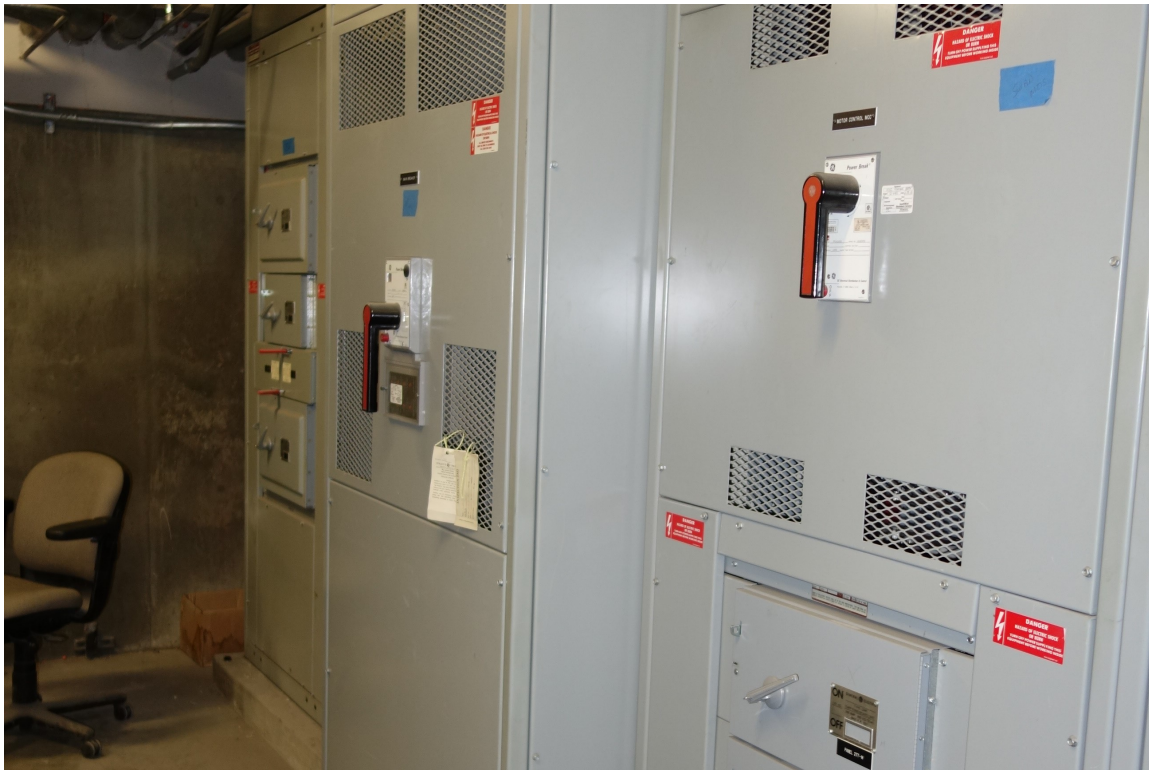
An arc flash and electrical coordination study has not been performed or is more than 5 years since the last coordination study. The latest electrical code requires coordination studies be verified and performed every 5 years and arc flash labeling on all electrical panels to provide the safety requirements for maintenance personnel. This project will perform the required coordination study, evaluation, adjustments and labeling for the building electrical distribution system.

Supreme Court of Nevada - Building #1478
Description: Arc Flash & Breaker Coordination Needed.

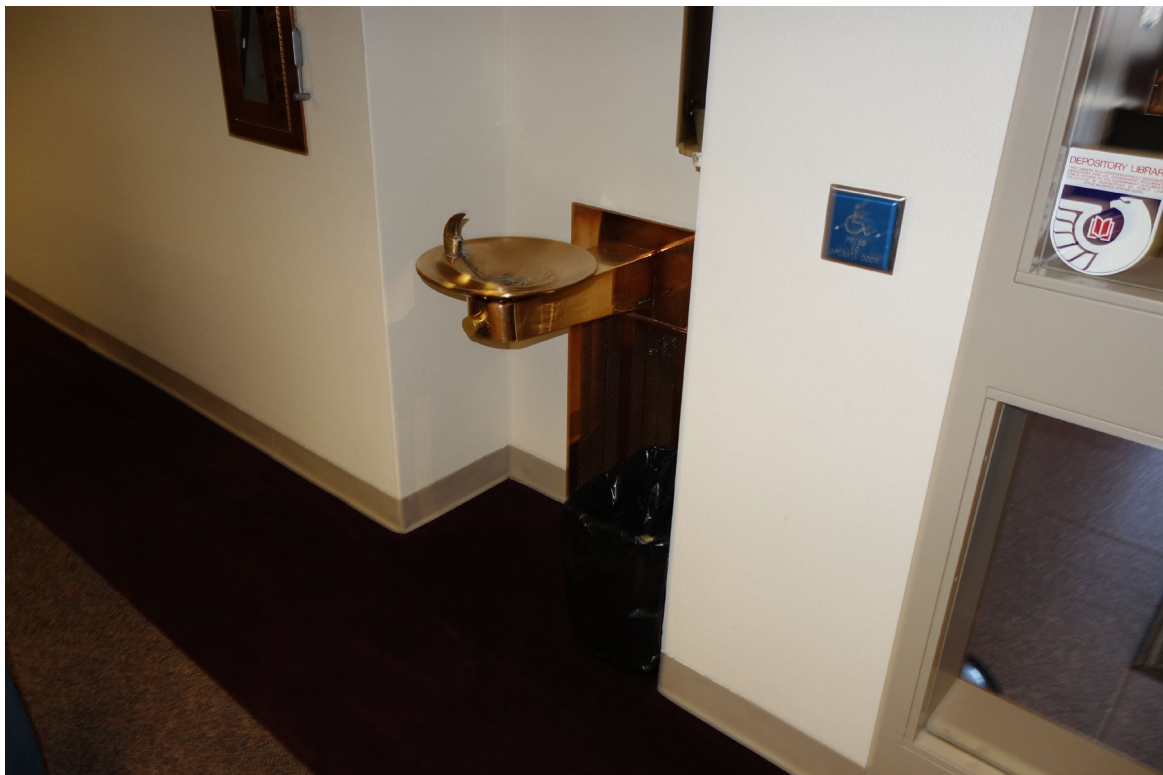
This building contains water fountains on each floor that are not ADA compliant. The 2018 IBC Section 1109.5 states where drinking fountains are provided on an exterior site, on a floor or within a secured area, no fewer than two drinking fountains shall be provided. One shall comply with the requirements for people who use a wheelchair and one shall comply with the requirements for standing persons. This project would provide funding for the purchase and installation of four drinking fountains to meet the ADA requirements, two on each floor. If drinking fountains are located in an exit access, it is recommended to review exit access requirements for projections into exit access width.

Supreme Court of Nevada - Building #1478
Description: Dual Level Drinking Fountains Needed.

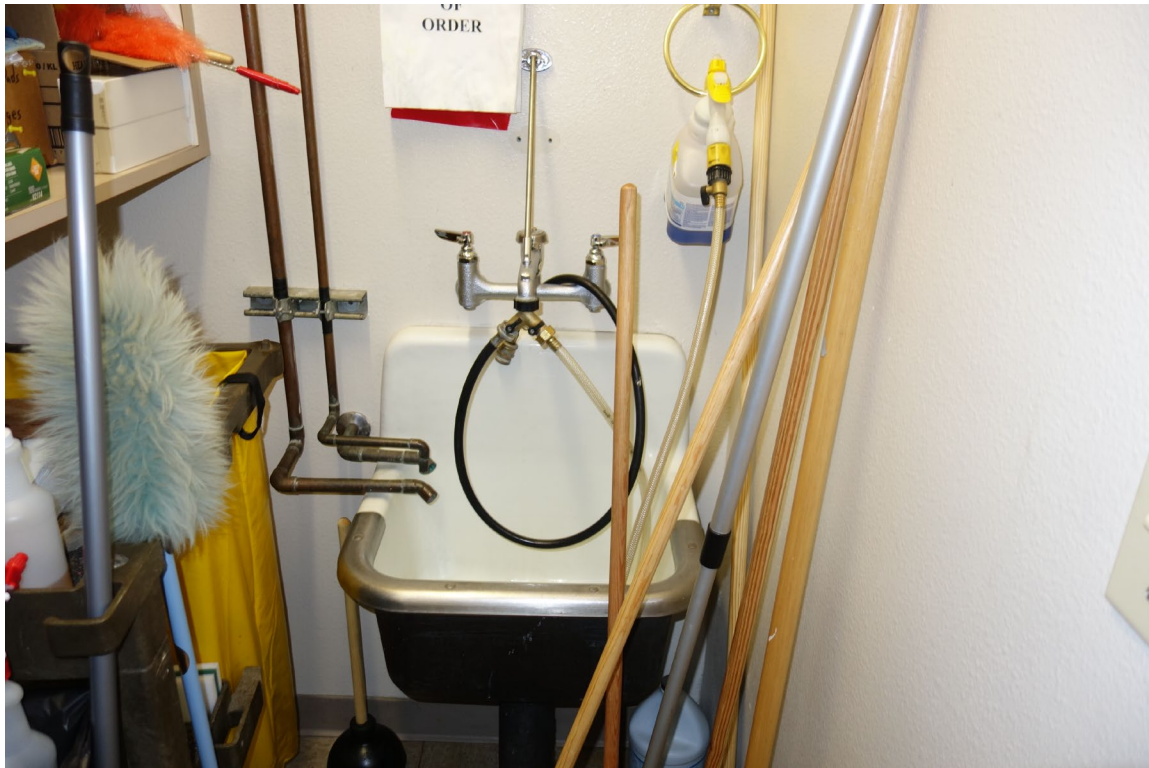
The mop sink in the Janitor's Closet is mounted adjacent to gypsum board that may cause water damage. This project would provide fiberglass reinforced panels (FRP) to be installed on the walls adjacent to the mop sink. The FRP shall extend two feet beyond the edge of the sink and a minimum of 54" above the floor finish.

Supreme Court of Nevada - Building #1478
Description: Wall Protection at Janitor Sinks Needed.

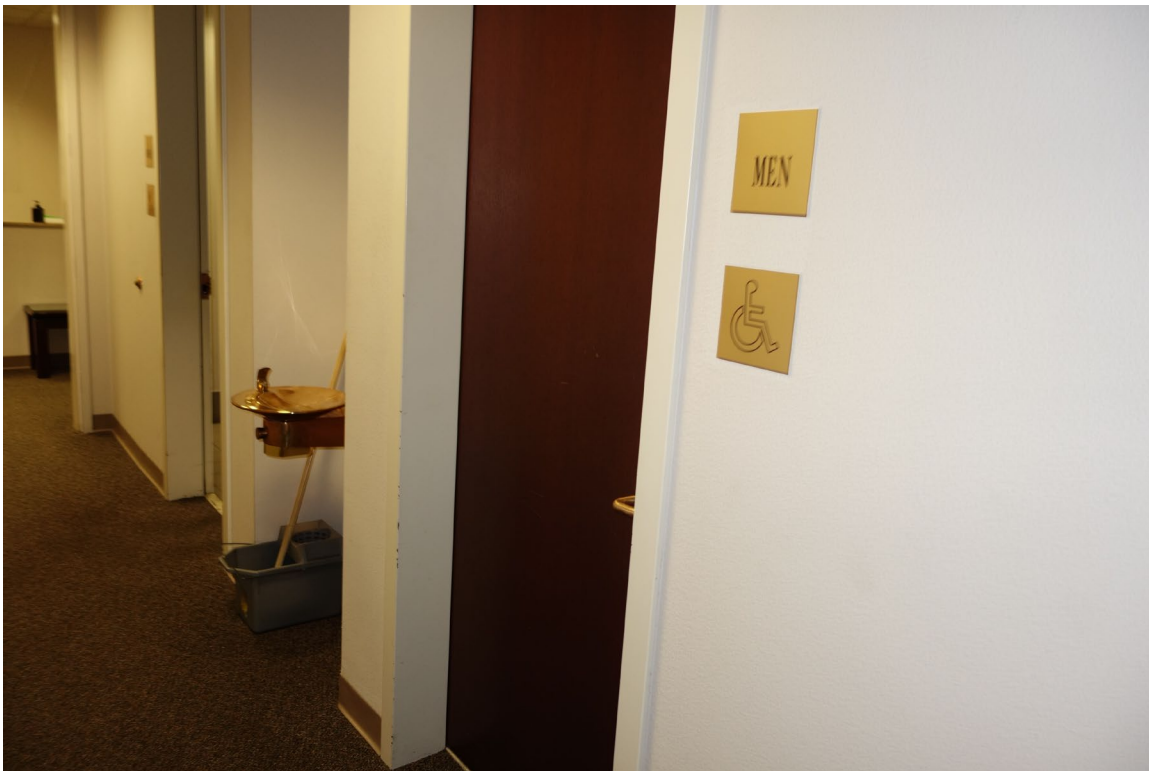
Americans with Disabilities Act (ADA) regulations pertaining to building access has established building signage criteria for permanent spaces in buildings. The criteria includes: sign mounting heights and locations; character heights and proportions; raised and Braille characters/pictograms; and sign contrast and finish. The signage in this facility does not comply with this criteria. It is recommended that applicable signage be installed where required. NRS 338.180, IBC - 2018, ICC/ANSI A117.1 and the most current version of the Americans with Disabilities Act Accessible Guidelines (ADAAG) were used as a reference for this project.

Supreme Court of Nevada - Building #1478
Description: ADA Signage Upgrade Needed.
