Supreme Court of Nevada
Division of Buildings and Grounds
Supreme Court of Nevada
Facility Condition Analysis

SUPREME COURT OF NEVADA

201 South Carson Street
Carson City, Nevada 89701

Site Number: 9865
STATE OF NEVADA PUBLIC WORKS BOARD
FACILITY CONDITION ANALYSIS

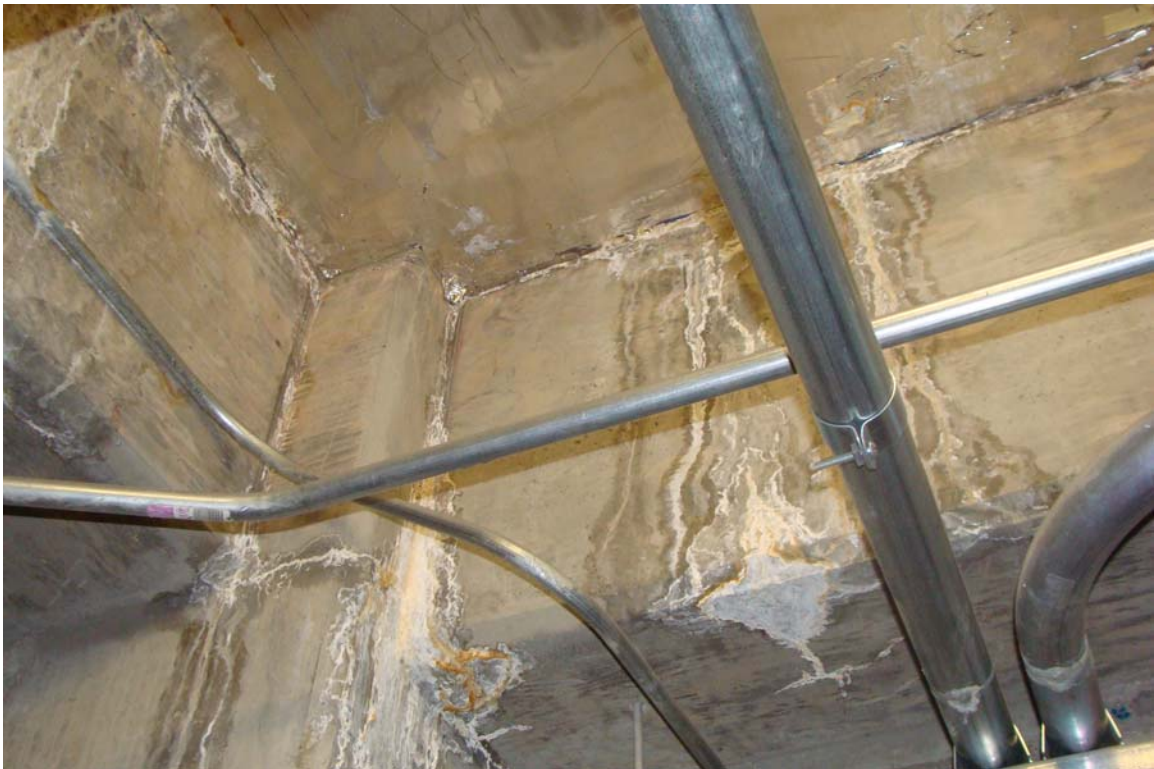
Supreme Court of Nevada - Building #1478
Description: Water infiltration in basement electrical switchgear room.

The terrace on the southwest side of the site has a damaged waterproof membrane. Water is penetrating the membrane and leaking into the basement of the building below. Evidence of leaking can be seen in the mechanical room which may damage the walls, floor, and equipment. This project would provide for a general refurbishment of the terrace waterproof membrane including removing the existing stone tiles, repairing the substrate, caulking all penetrations, and reinstalling the tile.

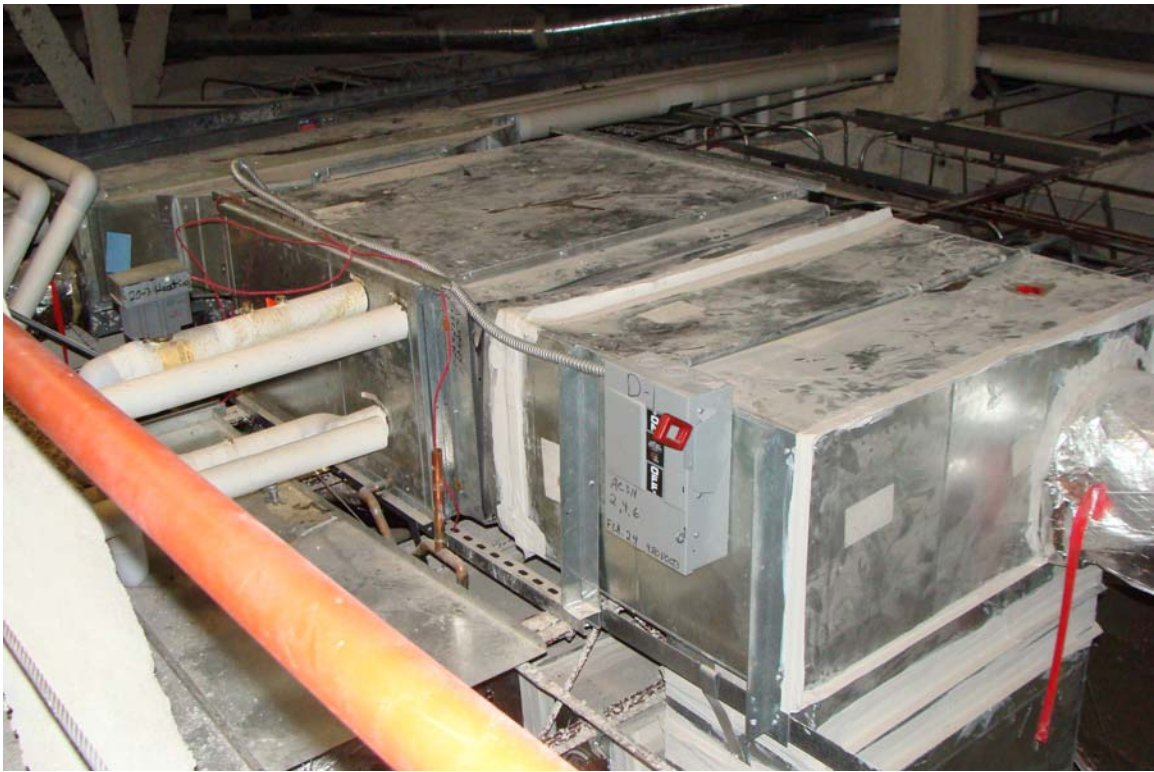
Supreme Court of Nevada - Building #1478
Description: Typical fan coil unit.

The central HVAC system in the building was installed in 1991. The equipment is not energy efficient and will be reaching the end of its expected and useful life within the next 10 years. This project would provide for installation of a new HVAC system including boilers, chillers, air handlers, fan coil units, water treatment, all associated equipment and cleaning of the existing duct work and grilles. This project includes removal and disposal of the existing HVAC units and all required connections to utilities.

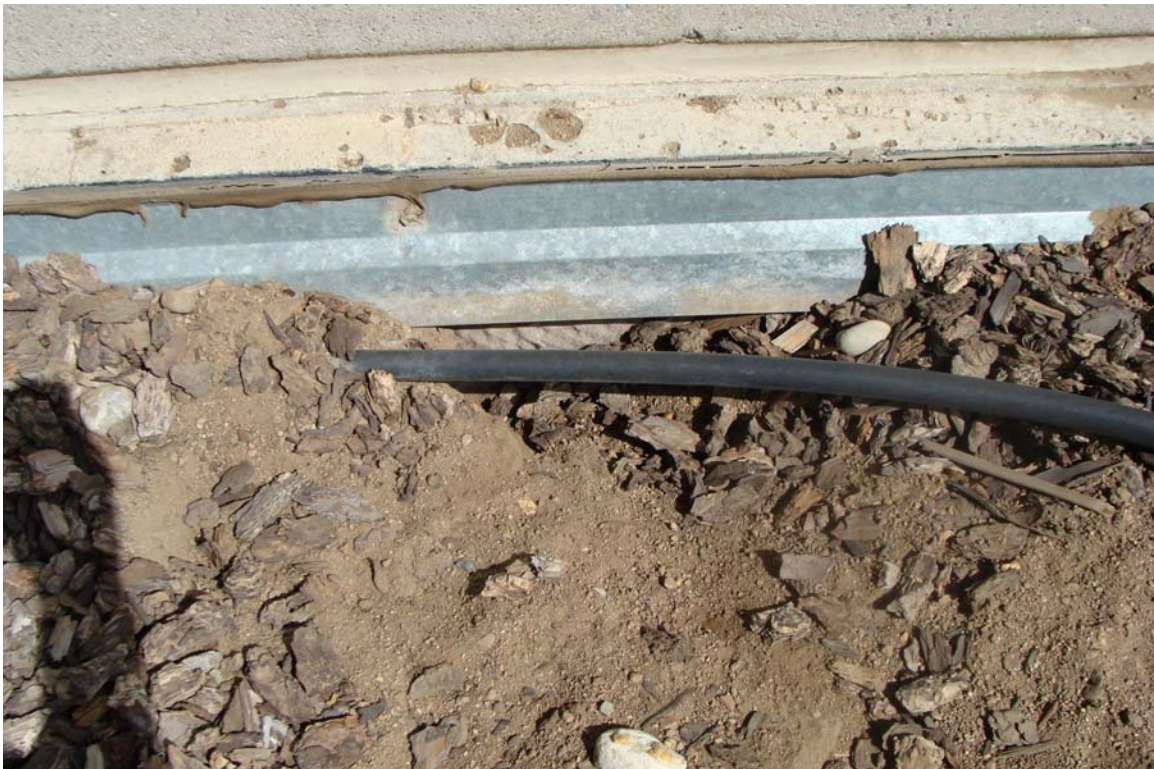
Supreme Court of Nevada - Building #1478
Description: Terrace planter in need of waterproof membrane repairs.

There are many built-in planters around the building. Several of them leak due to failed waterproof membranes and cracks in the concrete. There are also broken irrigation lines and areas with no vegetation. This project would provide for a general refurbishment of the planters including removing the existing dirt, fixing the cracks and irrigation lines, installing new waterproof membranes, filling the dirt back in and installing new plantings if desired.

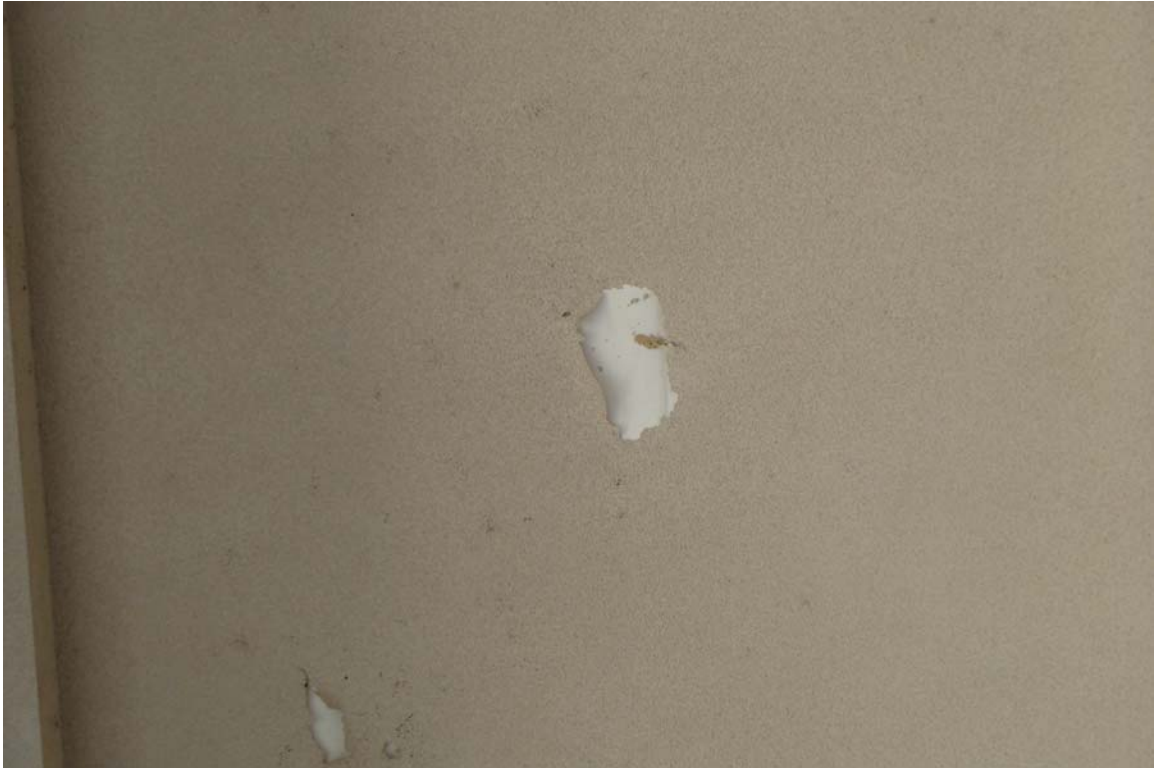
Supreme Court of Nevada - Building #1478
Description: Damage to EIFS at east entrance soffit.

It is important to maintain the finish, weather resistance, and appearance of the building. This project recommends work to protect the exterior building envelope other than the roof, including sealing the concrete precast panels, and caulking around windows, flashing, fixtures, and other penetrations to maintain the building in good, weather tight condition. It is recommended that the building be painted in the next 5-7 years and that this project be scheduled on a cyclical basis to maintain the integrity of the structure.

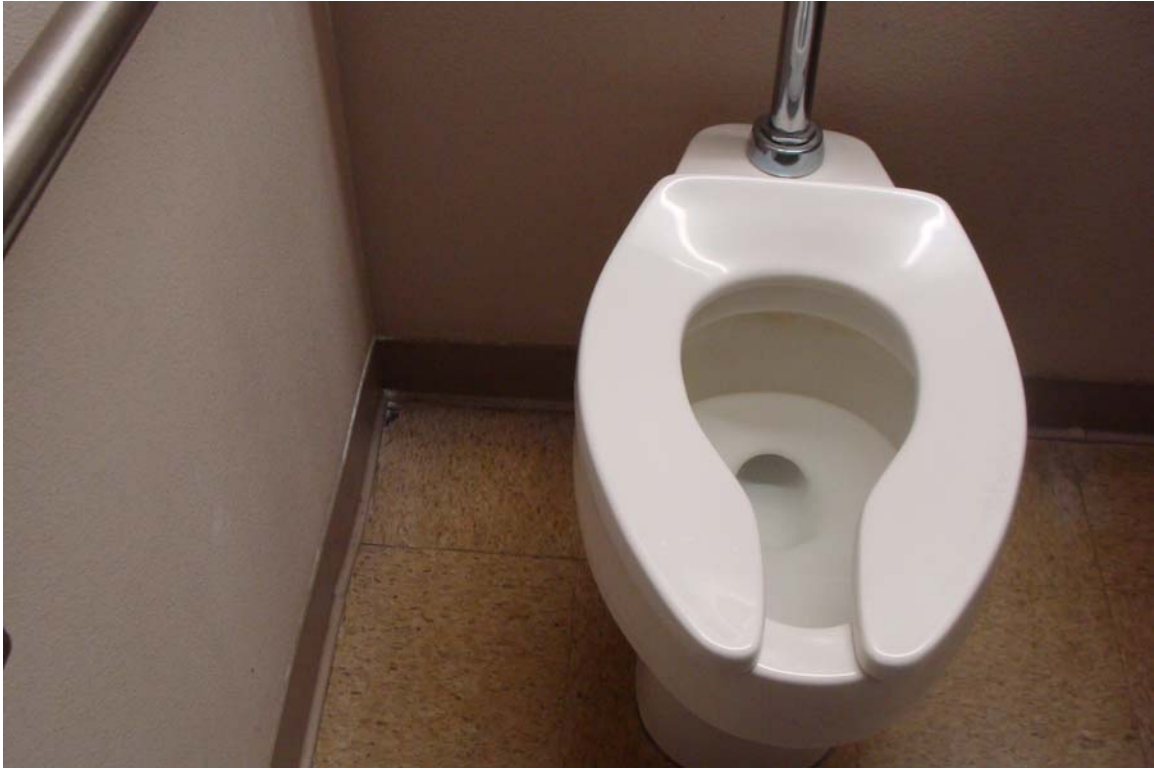
One of the ADA accessible restrooms on the second floor is damaged. This project would provide for the removal of the existing vinyl composition tile (VCT) and replacement with a new VCT floor in one restroom.

Supreme Court of Nevada - Building #1478
Description: Damaged VCT in restroom.

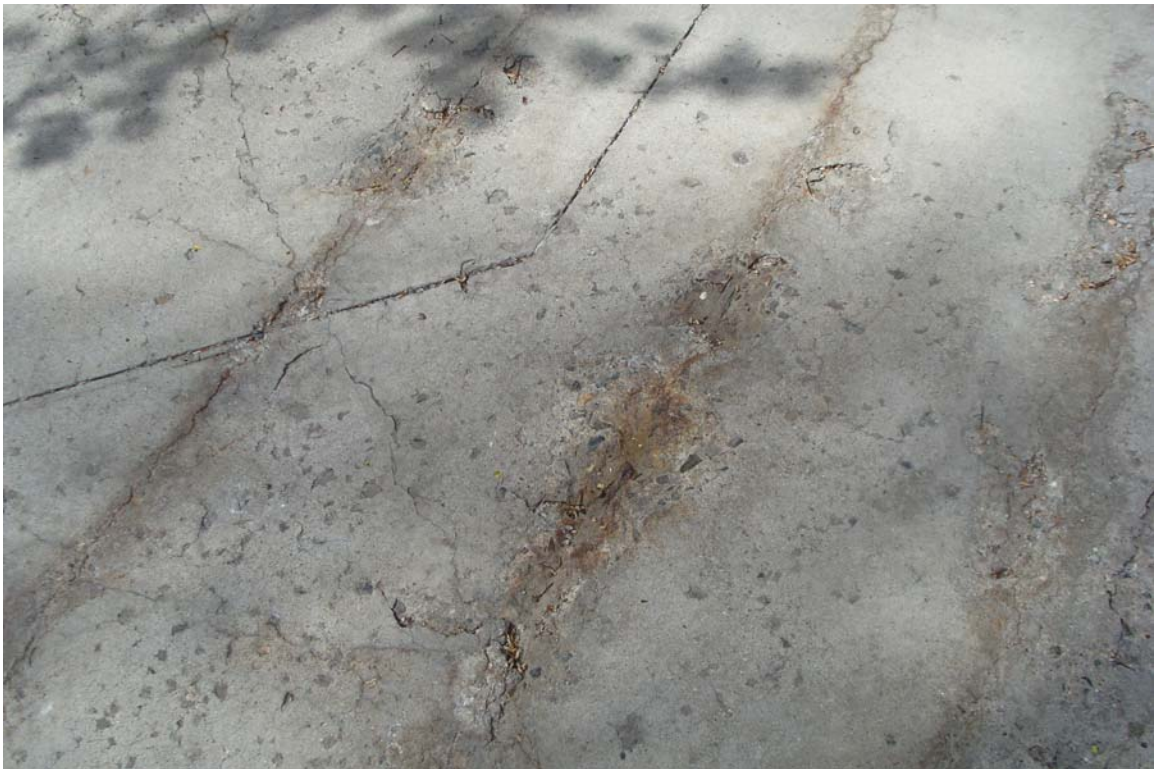
Some of the sidewalks serving the site and building entrances are deteriorated and beginning to fail in several areas. Most of the work needs to be done on the west side of the site where there is extensive spalling and some settling. A few sections have deteriorated enough to expose the reinforcing metal and the settling has created a tripping hazard. This project addresses removal and replacement of existing sidewalks as needed. 5,000 SF of 4" thick concrete sidewalk was used for this estimate.

Supreme Court of Nevada - Building #1478
Description: Damaged walkway.
