# **RICHARD H. BRYAN BUILDING**

**Site Number: 9867**  
**STATE OF NEVADA PUBLIC WORKS DIVISION**  
**FACILITY CONDITION ANALYSIS**

Report distributed in October 2021

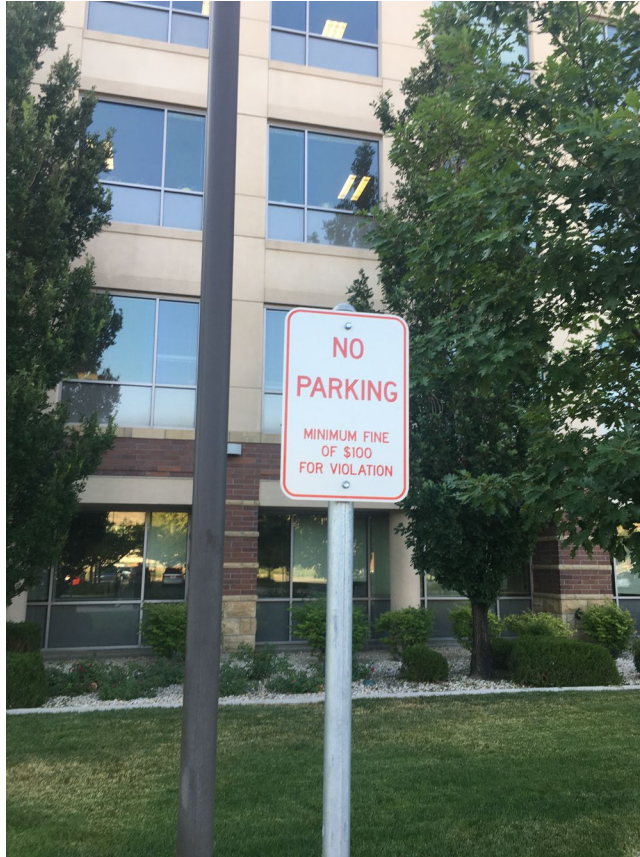
Richard H. Bryan Building - Site #9867  
Description: ADA Parking Sign Update.

The existing ADA accessible parking signage is not up to current standards. This project would provide for new stickers reflecting the most current maximum fine information to be installed on the existing signs. The 2018 IBC, ICC/ANSI A117.1, NRS 338.180 and the most current version of the ADA Standards For Accessible Design were used as a reference for this project.

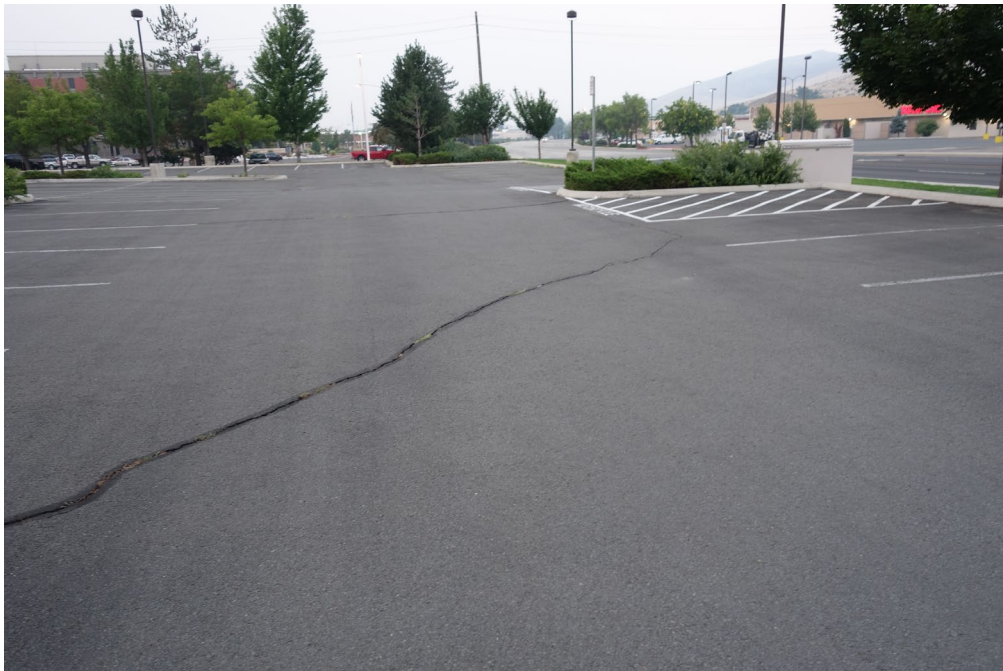
Richard H. Bryan Building - Site #9867  
Description: Crack Fill & Seal Needed.

It is important to maintain the asphalt concrete paving on the site. This project would provide for minor crack filling and slurry sealing of the East parking lot. Striping is included in this estimate. It is recommended that this project be implemented in the next 4 to 5 years and should be scheduled on a 5 year cyclical basis to maintain the integrity of the paving and prevent premature failure. 25,000 square feet of asphalt area was used to generate this estimate.

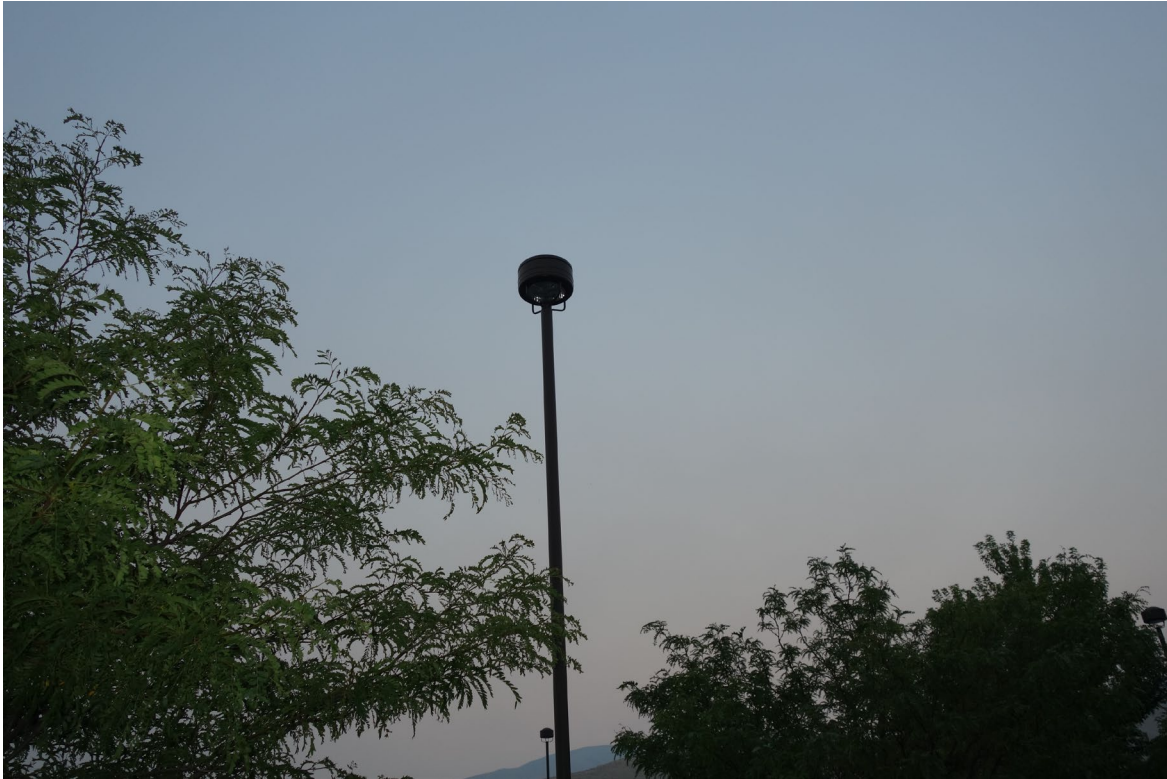
The site lighting poles and flag pole uplighting are original to the site and are not energy efficient. These fixtures have High Intensity Discharge (HID) lamps. This project would provide for the replacement of the existing light fixtures with LED fixtures using the existing wiring.

Richard H. Bryan Building - Site #9867  
Description: Site Lighting Upgrade Recommended.

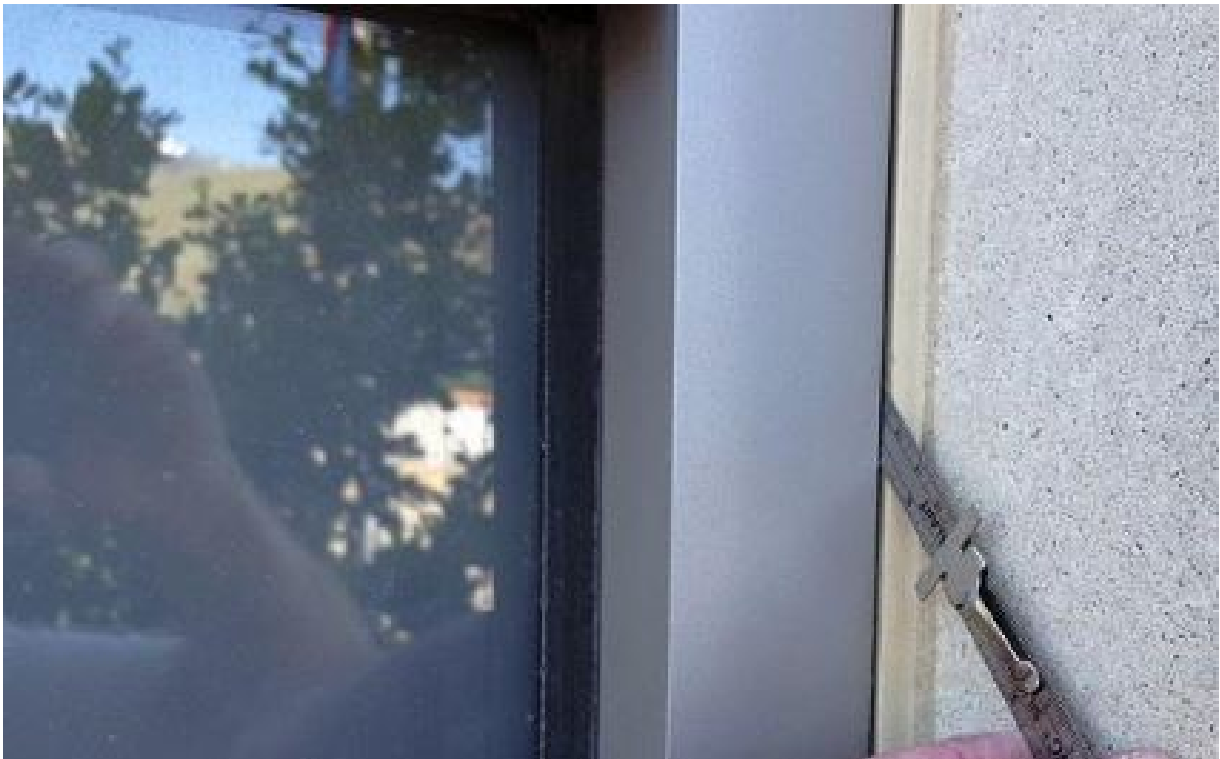
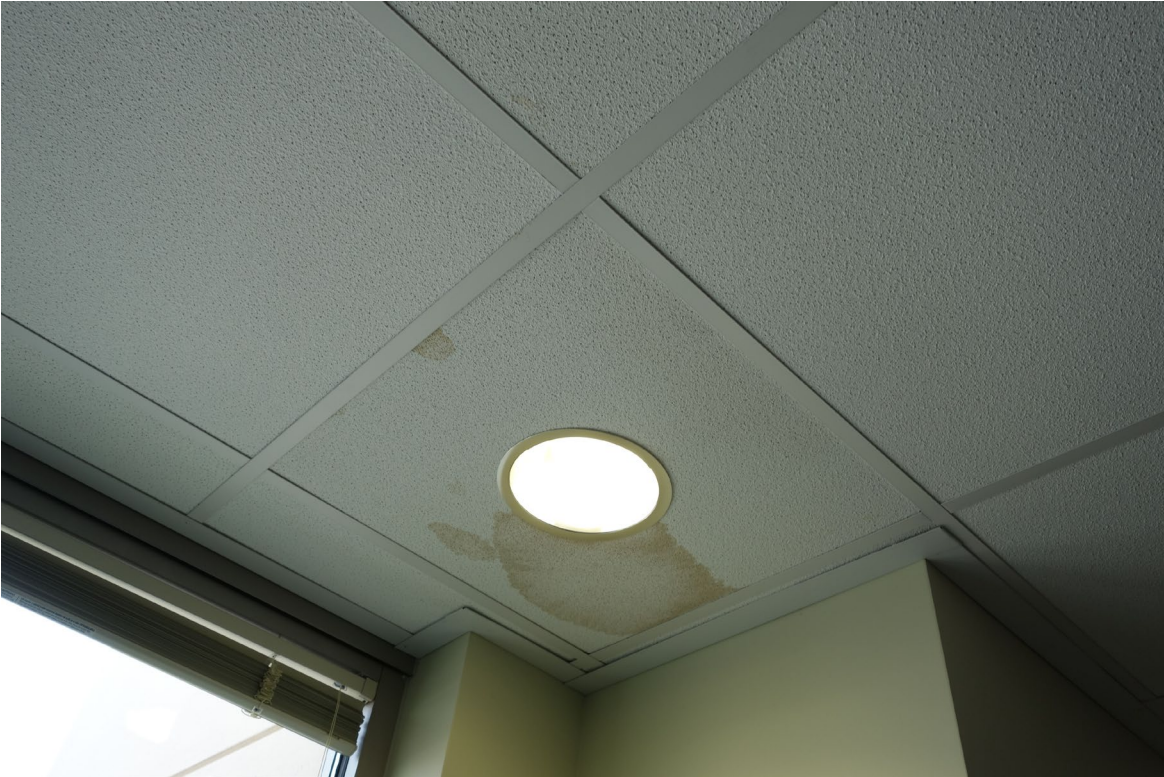
The components of the exterior walls have deteriorated from aging resulting in water infiltration into the building during rain and snow events. They are in need of repair or replacement. The building's exterior envelope has been compromised, and although there have been numerous attempts to fix water penetration, intermittent issues remain to be repaired. If this project is not funded, the building will continue to leak which could lead to the development of mold. This project includes the repair or replacement of the exterior building components including the exterior insulation finish system (EIFS), parapet coping flashing and re-caulking / re-gasketing the existing curtain wall system.

Richard H. Bryan Building - Building #2450  
Description: Building Envelope Rehabilitation.

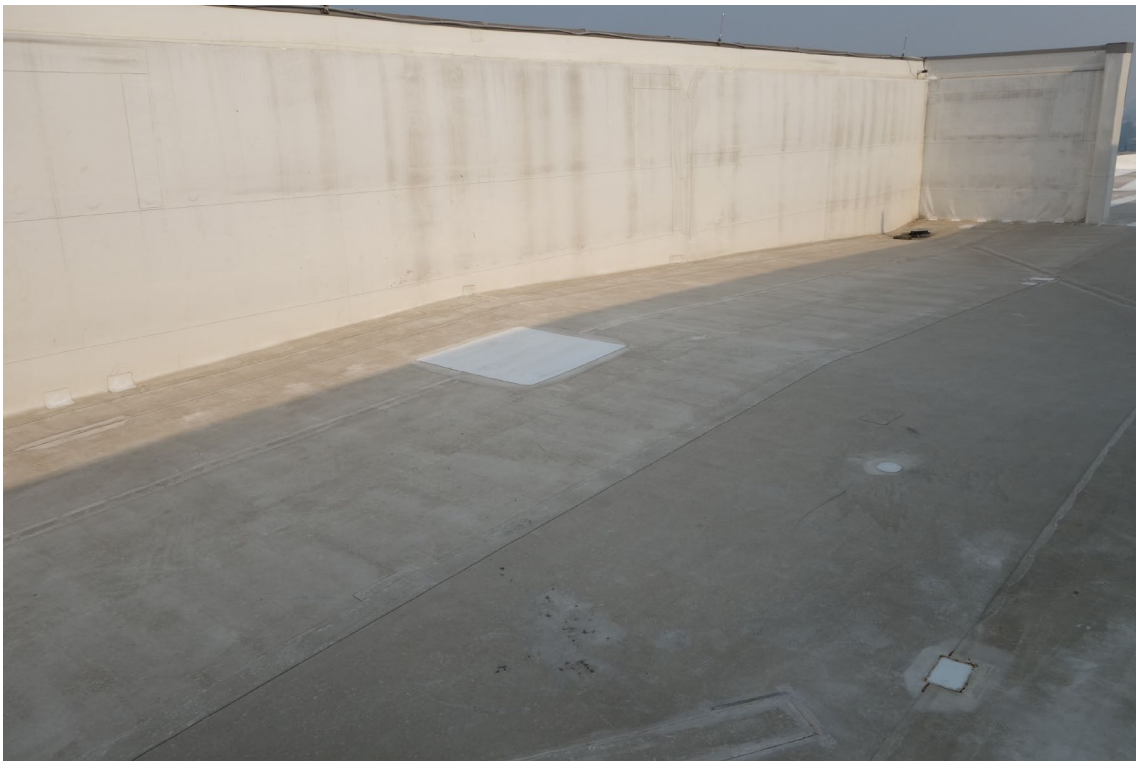
The roof on this building was installed in 2005 with a 15 year warranty and is in fair to poor condition. The statewide roofing program has set the useful life of an average roof at 20 years. The roof warranty expires at the end of the same time frame. The temperature fluctuations throughout the year, consistent wind which blows sand and dirt on to the roof membrane, and constant exposure to the sun are contributing factors to wear and deterioration. The current roofing system was installed in 2005. It is recommended that this building be re-roofed in the next 2 - 3 years to be consistent with the roofing program and the end of the warranty period.

Richard H. Bryan Building - Building #2450  
Description: Roof Replacement Needed.

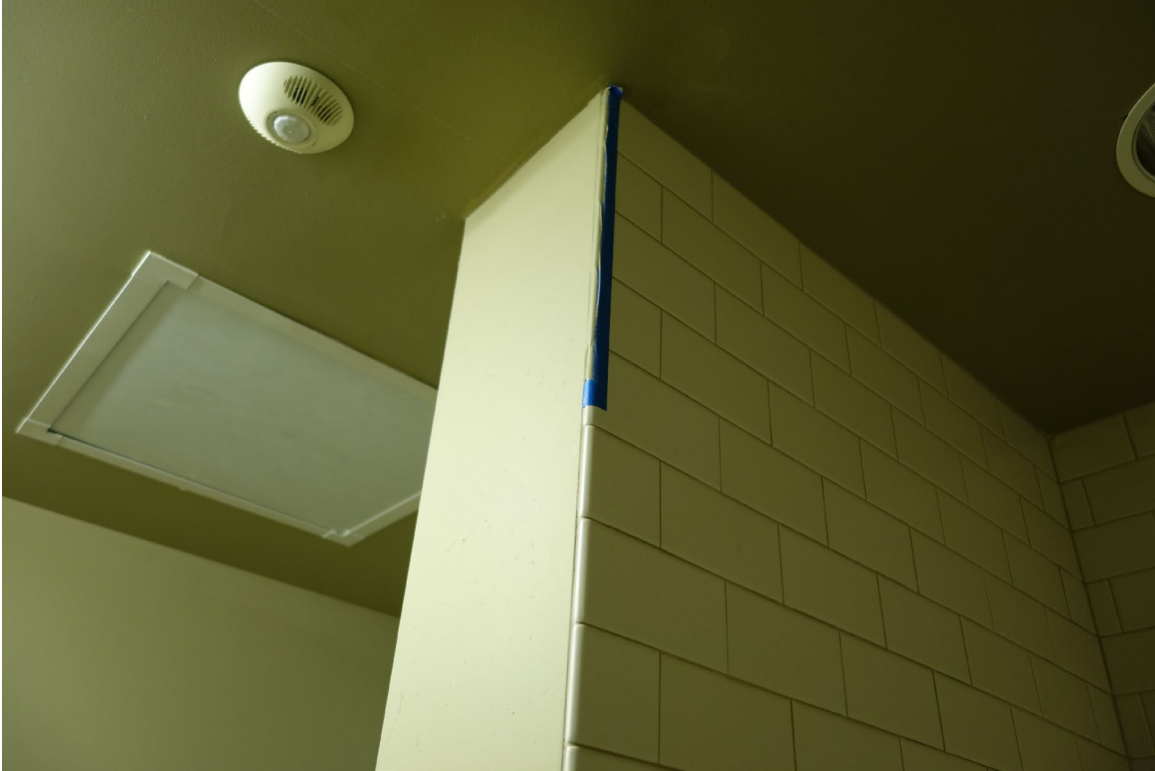
Richard H. Bryan Building - Building #2450  
Description: Restroom Tile & Grout Repair & Cleaning.

The interior finishes are in fair condition except the restrooms and conference rooms. The restrooms should have the tile and grout cleaned and repaired as required. The conference rooms should have the walls patched and repainted. It is recommended that the interior walls and ceilings be painted at least once in the next 4 - 6 years and every 7 - 9 years thereafter to maintain the integrity of the interior of the building. Prior to painting, all surfaces should be repaired and prepped. An epoxy-based paint should be utilized in wet areas for durability.

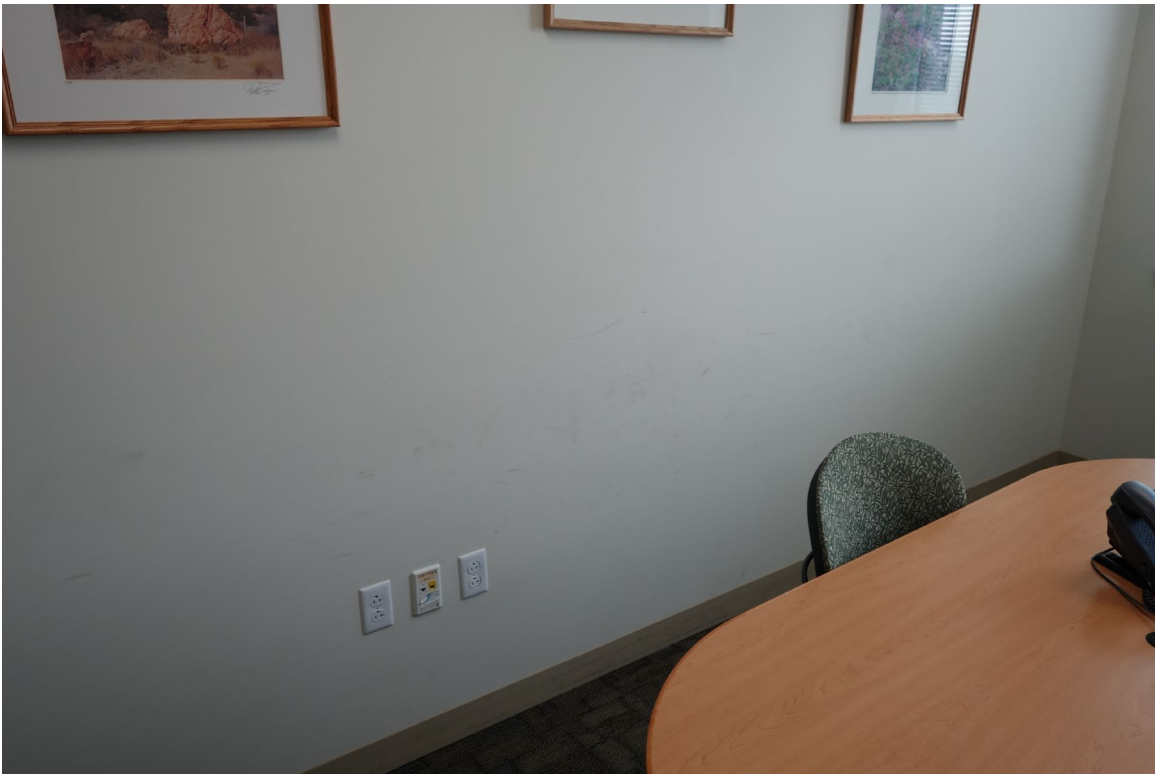
Richard H. Bryan Building - Building #2450  
Description: Interior Finishes – Conference Rooms.
