NORTHERN NEVADA VETERANS MEMORIAL CEMETERY

Site Number: 9898 STATE OF NEVADA PUBLIC WORKS DIVISION FACILITY CONDITION ANALYSIS

Report distributed in January 2022

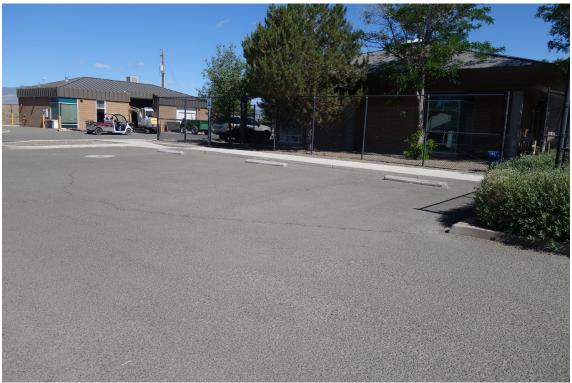
Northern Nevada Veterans Memorial Cemetery Site - Site #9898 Description: Slurry Seal Paving Project.

It is important to maintain the asphalt concrete paving for the site. This project would provide for minor crack filling and slurry sealing of the paving. Striping is included in this estimate. This project should be scheduled on a 5 year cyclical basis to maintain the integrity of the paving and prevent premature failure. 65,000 square feet of asphalt area was used to generate this estimate.

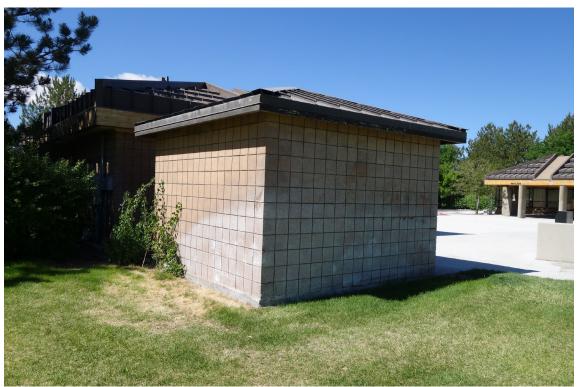
The exterior conditions are in poor condition. There is significant spalling and efflorescence on the CMU decorative block that need to be treated and the exterior surfaces need to be sealed. It is important to maintain the finish, weather resistance, and appearance of the building. This project recommends work to protect the exterior building envelope, other than the roof, including painting, staining, sealing of CMU or other applied finishes, and caulking around windows, flashing, fixtures, and other penetrations to maintain the building in good, weather tight condition. It is recommended that this project be implemented within the next 2 - 3 years and is recommended on a cyclical basis based on environmental conditions.

Cemetery Storage 2 - Building #2036 Description: Exterior Finishes of the Building.

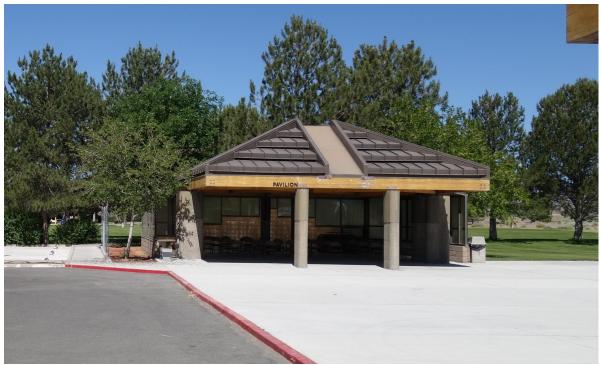
The Cemetery Pavilion is located North of the main entrance at the Veterans Memorial Cemetery in Fernley, Nevada. The facility is post and beam construction with exposed glue laminated timber beam frame and exposed aggregate columns. The roof is a sloped/stepped metal hip. There is a storefront glass/sloped glazing component on three sides and the fourth side is open. The primary use of the building is an outside meeting area and to conduct veteran memorial services. The overall condition of the pavilion is poor and should be refurbished to meet the expectations required to conduct veterans memorial services.

Cemetery Pavilion - Building #1943 Description: Exterior of the Building.

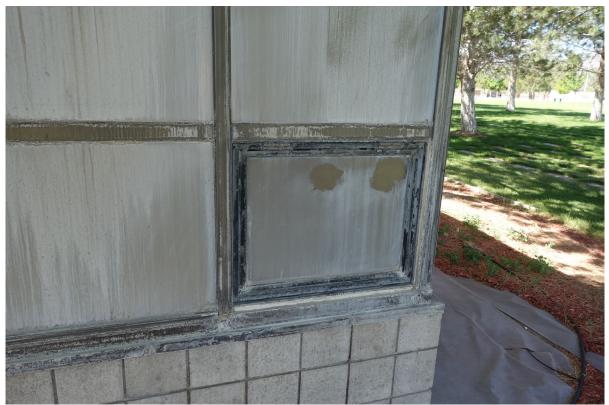
The storefront glazing system shows significant signs of failure due to age, exposure, broken seals around the glazing panels, and water infiltration. This project would provide for a complete replacement of the storefront glazing and framing. Removal and disposal of the existing system is included in this estimate.

Cemetery Pavilion - Building #1943 Description: Glazing Replacement Project.

This project should be implemented concurrently with the CMU DECORATIVE BLOCK REPLACEMENT and EXTERIOR/INTERIOR FINISHES projects.

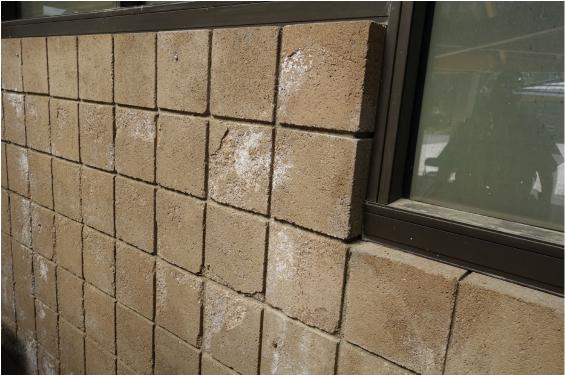
The CMU block supporting the storefront glazing system shows significant spalling and efflorescence. Visually, the appearance does not meet the expectations required to conduct veteran memorial services. This project would provide for a complete replacement of the CMU block. Removal and disposal of the existing system is included in this estimate. This project should be implemented concurrently with the STOREFRONT / SLOPED GLAZING REPLACEMENT and EXTERIOR/INTERIOR FINISHES projects.

Cemetery Pavilion - Building #1943 Description: CMU Decorative Block Replacement Project.

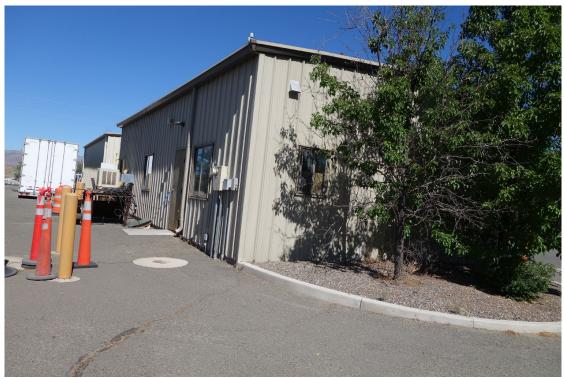
The exterior finishes on the wood siding portion of the exterior and exterior doors is in poor condition. It is important to maintain the finish, weather resistance, and appearance of the building. This project recommends work to protect the exterior building envelope other than the roof, including caulking around windows, flashing, fixtures, and other penetrations to maintain the building in good, weather tight condition. It is recommended that the building exterior be re-assessed in the next 2 - 3 years and that this project be scheduled on a cyclical basis to maintain the integrity of the structure.

Cemetery Welding / Storage Shop - Building #1942 Description: Rear Exterior of the Building.

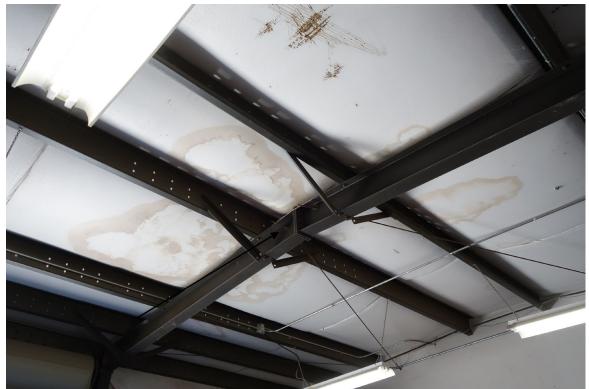
Cemetery Welding / Storage Shop - Building #1942 Description: Roof Replacement Project – Multiple Roof Leaks.

The corrugated metal roof on this building was in poor condition at the time of the survey. It is recommended that this building be re-roofed in the next 2 - 3 years with a standing seam metal roofing system and new vinyl faced insulation. This estimate includes removal and disposal of the old roofing system.
