State of Nevada
Department of Wildlife

ELY WILDLIFE OLD FIELD OFFICE SITE

Airport Road
Ely, Nevada 89301

Site Number: 9933
STATE OF NEVADA PUBLIC WORKS DIVISION
FACILITY CONDITION ANALYSIS

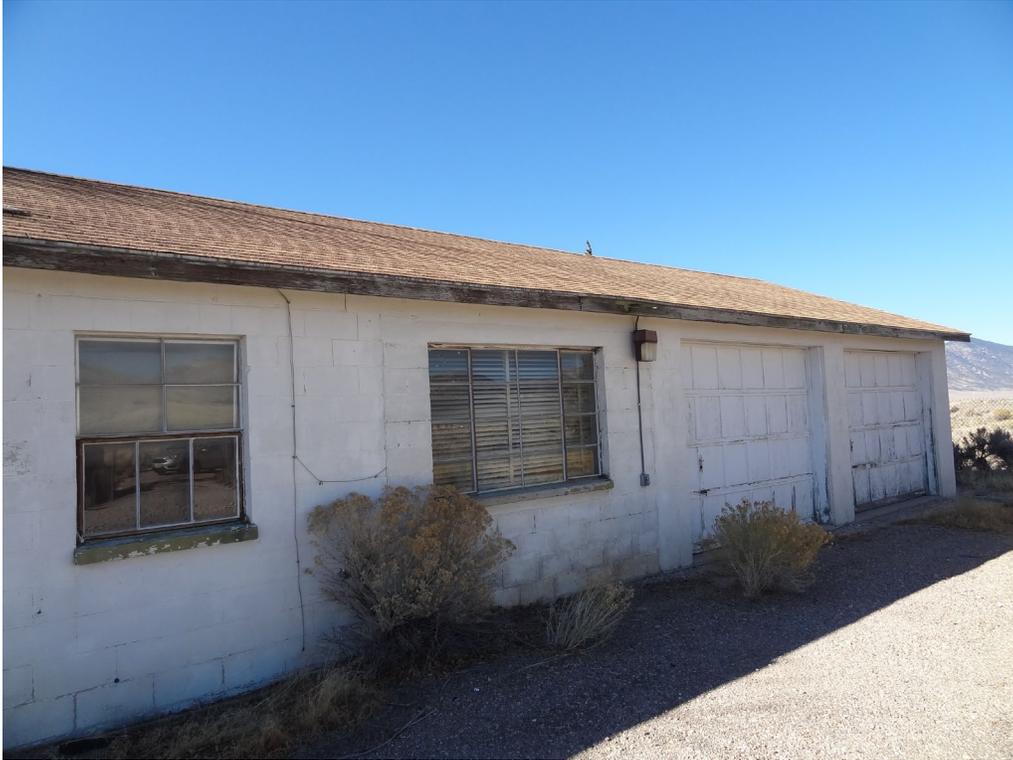
Old Wildlife Administrative Office – Building #0635
Description: East Elevation of Old Office Building.

There are two 8'x8' overhead doors on the east side of the building which are damaged and do not function properly. They are original to the building and should be scheduled for replacement. This project would provide for the removal and disposal of the manually operated overhead doors and replacement with two new manually operated overhead doors. Removal and disposal of the existing doors is included in this estimate.

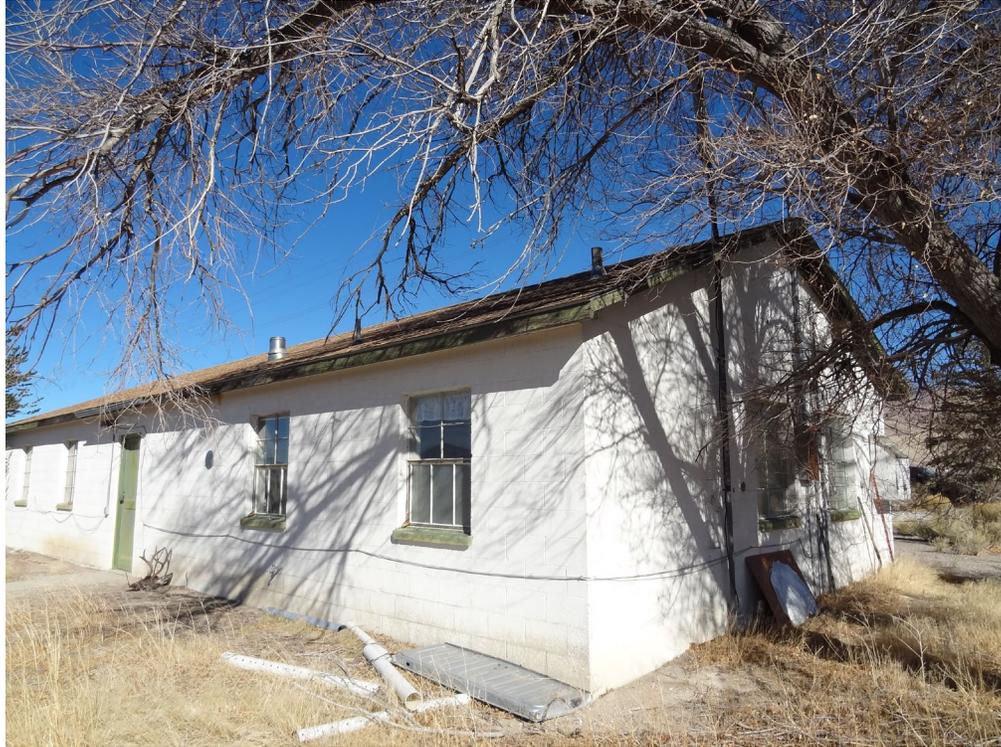
Old Wildlife Administrative Office – Building #0635
Description: West and South Elevation of the Old Office Building.

At the south exterior wall there is an underground heating oil fuel tank that is no longer needed because new propane-fired equipment will be installed. This project allows for removal of the underground tank and associated soils surrounding the installation. This project or a portion thereof was previously recommended in the FCA report dated 08/24/2011. It has been amended accordingly to reflect conditions observed during the most recent survey date of 11/07/2017.

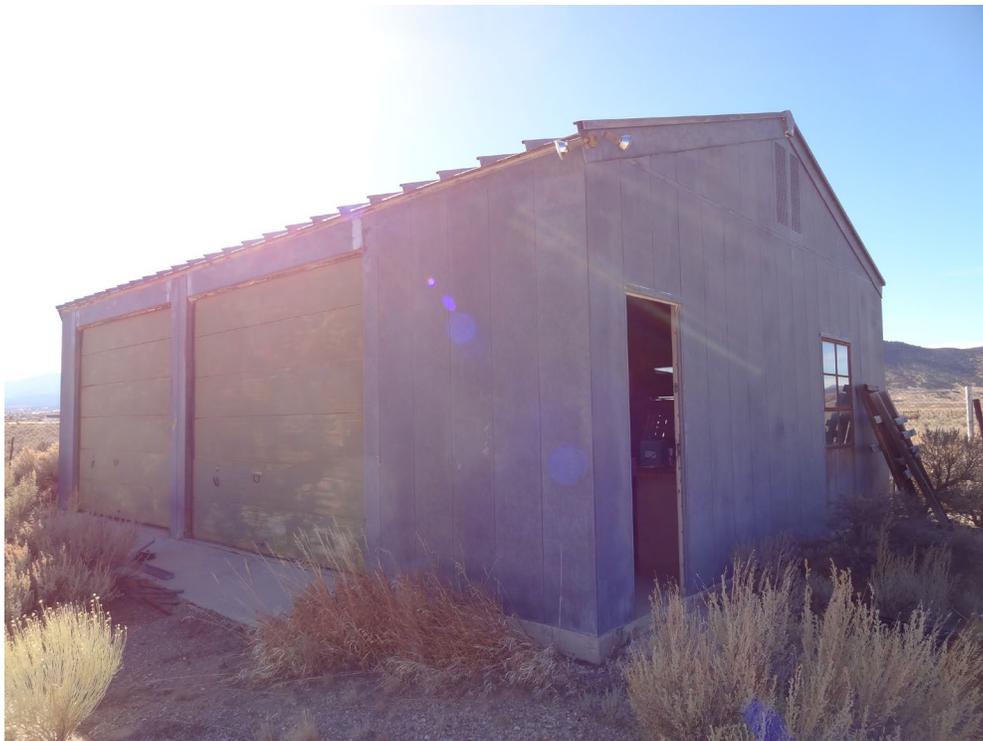
Wildlife Storage / Garage - Building #0636
Description: Exterior of the Building.

There are two 10'x10' overhead doors which are damaged and do not function properly. Exposure and wind have caused the doors to bend, crack and lose their finish. They are original to the building and should be scheduled for replacement. This project would provide for the removal and disposal of the manually operated overhead doors and replacement with new manually operated coiling doors. This project or a portion thereof was previously recommended in the FCA report dated 08/24/2011. It has been amended accordingly to reflect conditions observed during the most recent survey date of 11/07/2017.
