State of Nevada  
National Guard  
Facility Condition Analysis

# ELKO ARMORY SITE

**Site Number: 9937**

**STATE OF NEVADA PUBLIC WORKS DIVISION  
FACILITY CONDITION ANALYSIS**

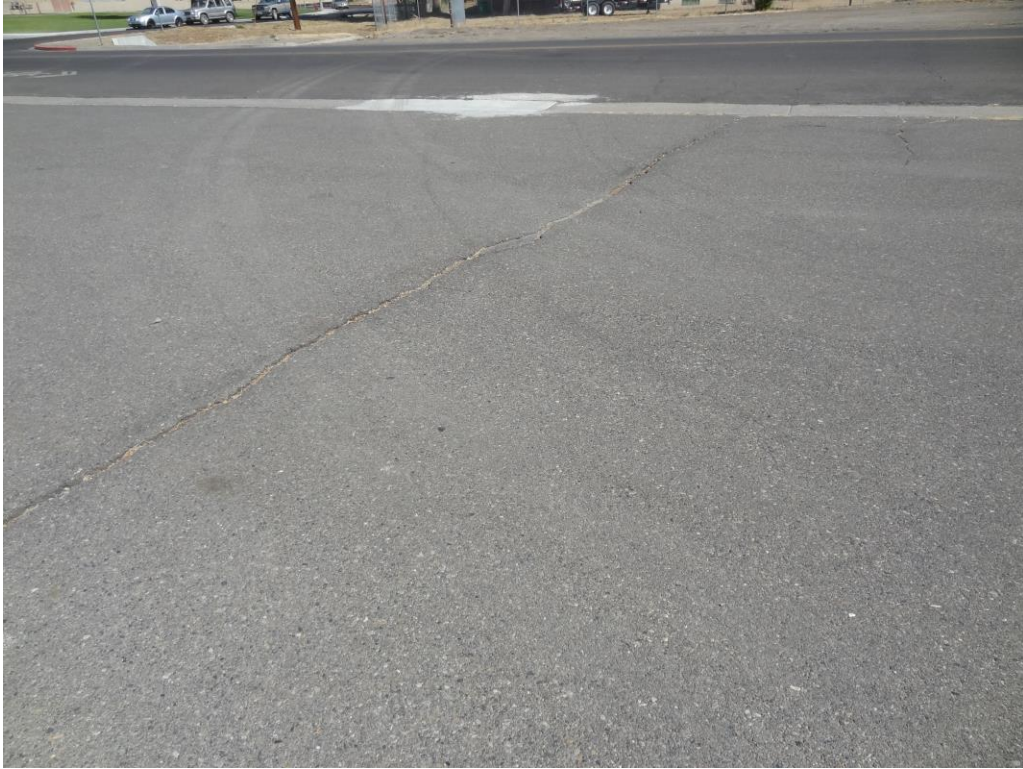
Elko Armory - Site #9937  
Description: Slurry seal asphalt paving needed.

It is important to maintain the asphalt concrete paving on the site. This project would provide for minor crack filling and slurry sealing of the paving site wide. Striping is included in this estimate. This project should be scheduled on a 5 year cyclical basis to maintain the integrity of the paving and prevent premature failure. 72,716 square feet of asphalt area was used to generate this estimate.

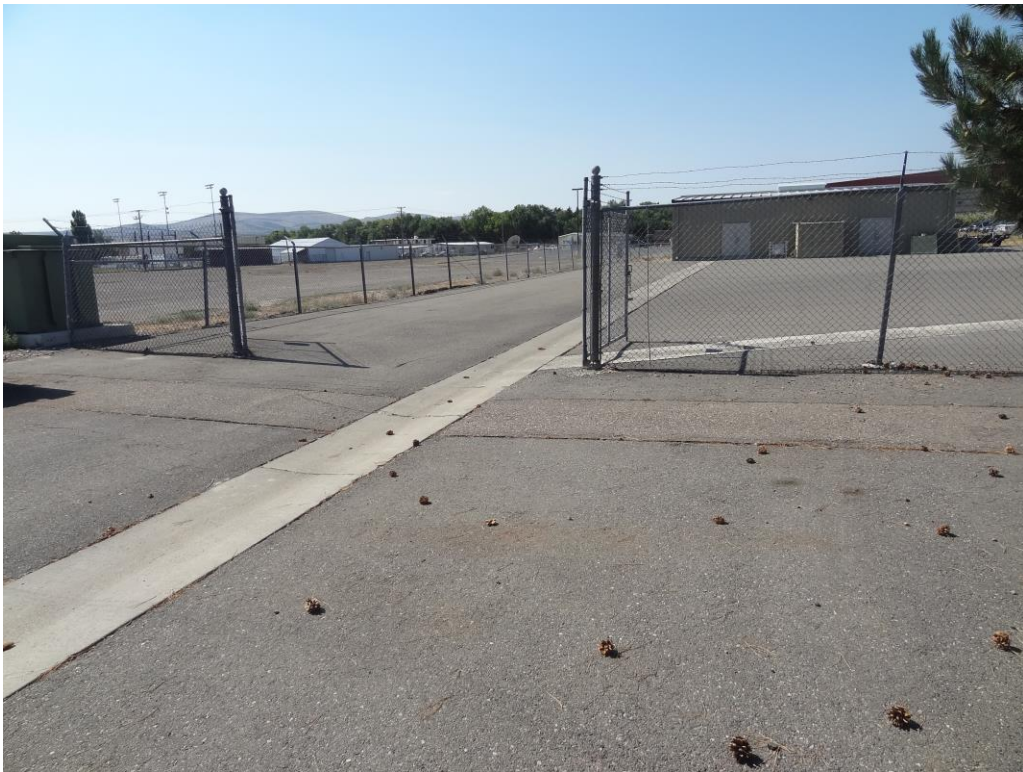
Elko Armory - Site #9937  
Description: Exterior lighting needed.

The Elko NNG site has minimal site lighting, which affects the ability to mobilize during hours of darkness and has security implications. This project would provide funding for the purchase and installation of ten LED light fixtures, 30 foot tall light poles including 30" diameter raised concrete bases, electrical trenching, conduit, wiring and connections to existing utilities.

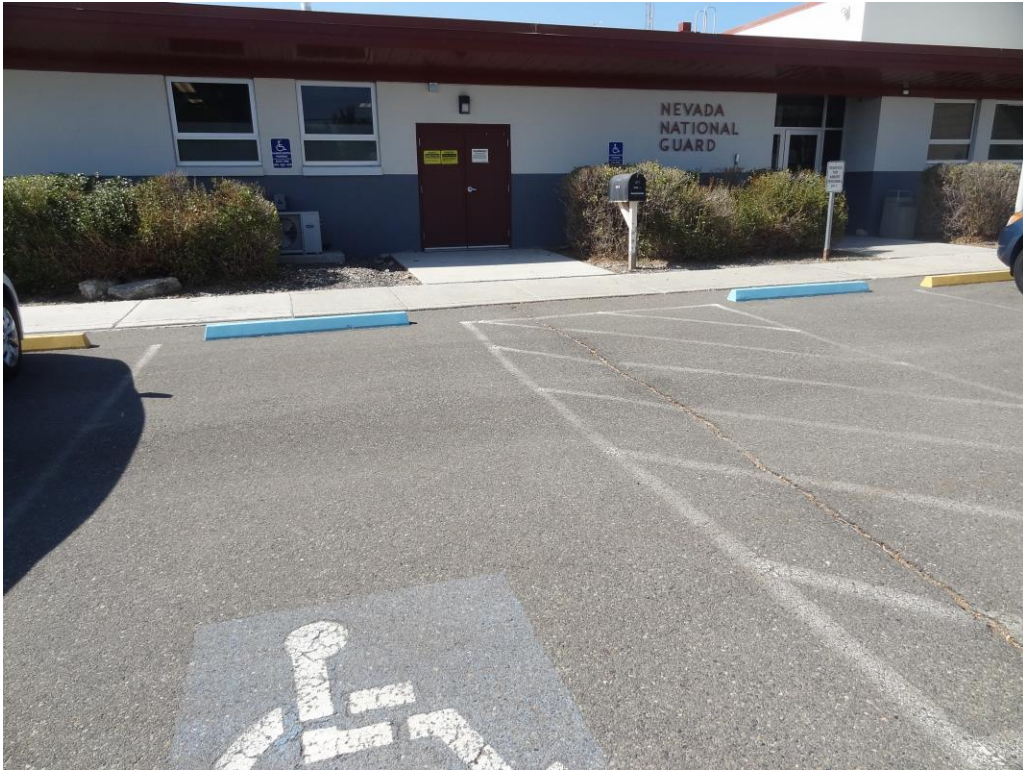
Elko Armory - Site #9937  
Description: ADA parking stall striping needed.

The ADA provides for accessibility to sites and services for people with physical limitations. A concrete parking area, passenger loading area and path of travel to the office are necessary to comply with ADA accessibility requirements. This project would provide for a concrete van accessible ADA parking and loading space and concrete walkway to the existing sidewalk. This will require regrading, placement of P.C. concrete, signage, striping and any other necessary upgrades. The 2012 IBC, ICC/ANSI A117.1 - 2009, NRS 338.180 and the most current version of the ADA Standards for Accessible Design were used as references for this project. 750 square feet of concrete was used for this estimate. It is recommended that this project coincide with the paving project.

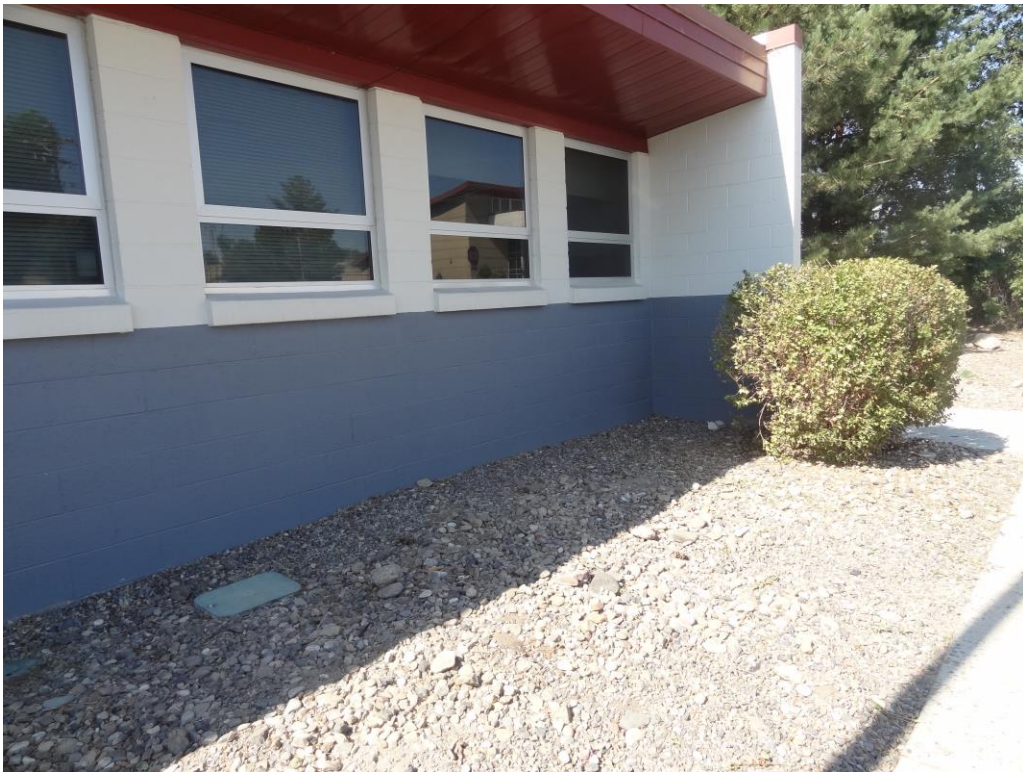
Armory – Building #0674  
Description: Window replacement needed.

The windows are original, single pane construction in metal frames. These older windows are drafty and not energy efficient. This project recommends replacing the windows with dual pane, higher efficiency units. This estimate is for the replacement of 20 units. Removal and disposal of the existing windows is included in this estimate.

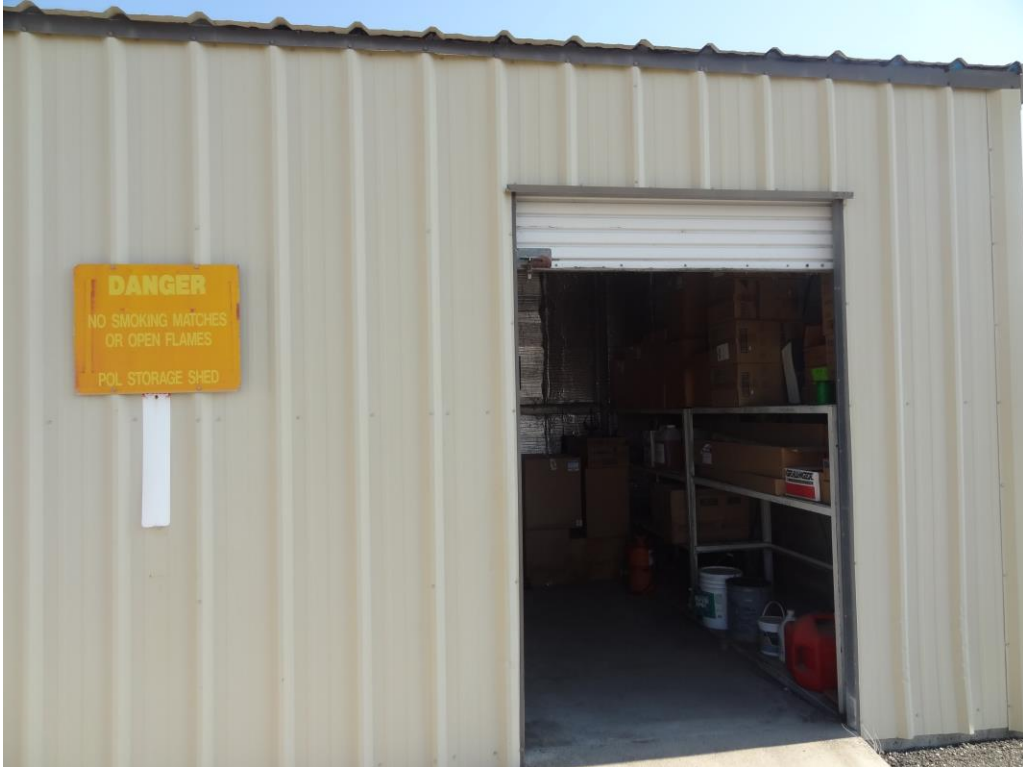
Hazardous Waste Storage #1 - Building #0677  
Description: Safety Cabinets needed.

The building contains many different paints, stains, gasoline, herbicides, pesticides and other hazardous products located on open shelves and on the floor. This does not meet OSHA standards or IFC for hazardous materials containment. This project would provide a self-closing hazardous storage container in the building and install placards on the building exterior in accordance with OSHA 1910.106 (d) and IFC Chapter 57 Section 5704.3.2.1.3.

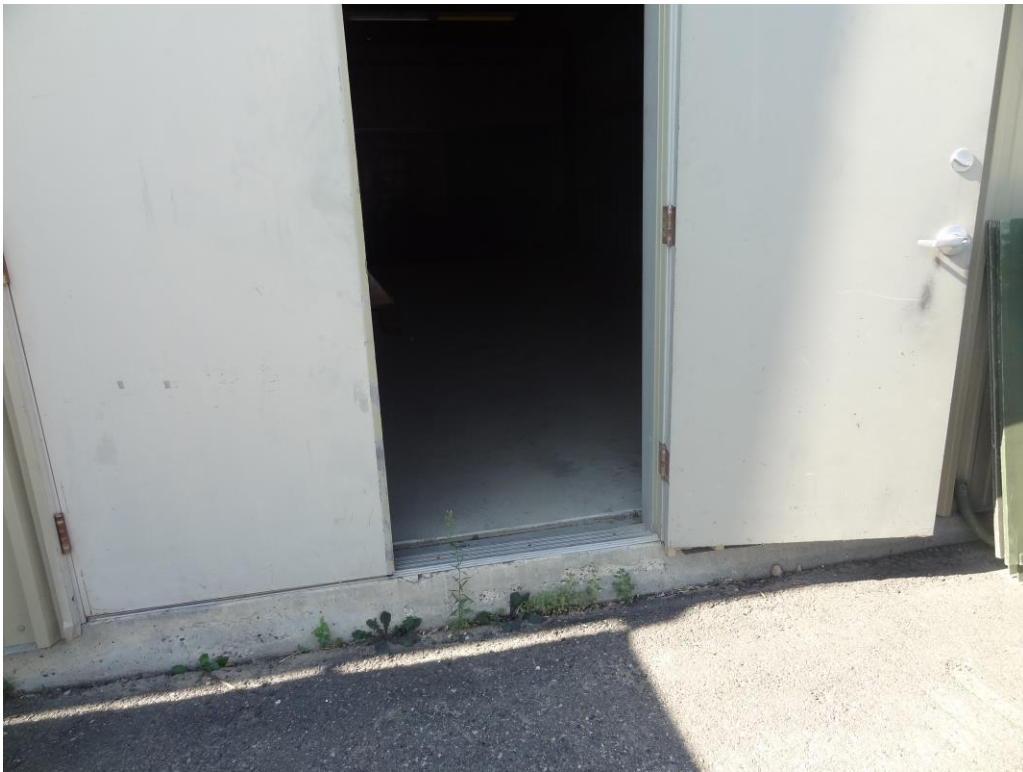
Storage Building - Building #1490  
Description: Exterior landing installation needed.

There are two out-swinging exterior doors on the building, which swing out over a step that does not have a landing. This does not comply with 2012 IBC Section 1008.1, which requires a proper landing and for the landing to not be more than 1/2" below the threshold. This project would provide for the installation of compliant landings.

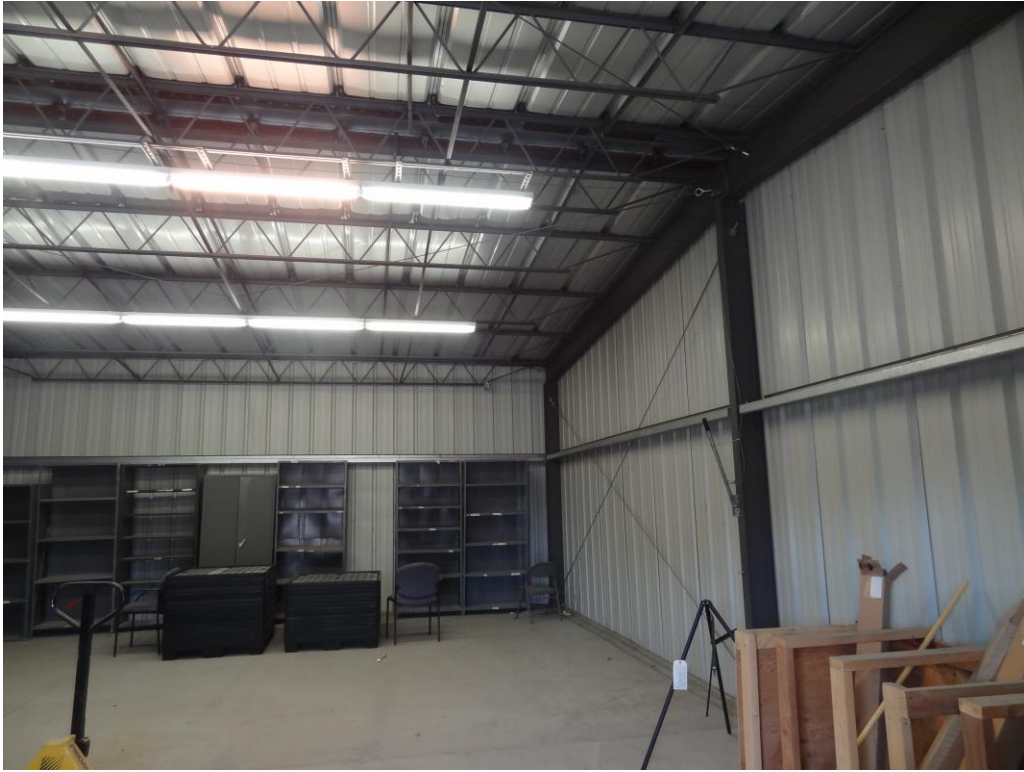
Storage Building - Building #1490  
Description: View of interior finishes.
