STATE OF NEVADA  
STATE PUBLIC WORKS DIVISION

FACILITY CONDITION ASSESSMENT REPORT FOR:

SITE #: 9979      CLEAR CREEK YOUTH CAMP SITE  
8000 OLD CLEAR CREEK RD  
CARSON CITY, NV 89705-5805

Survey Date: 10/5/2023  
Distribution Date: 6/17/2024

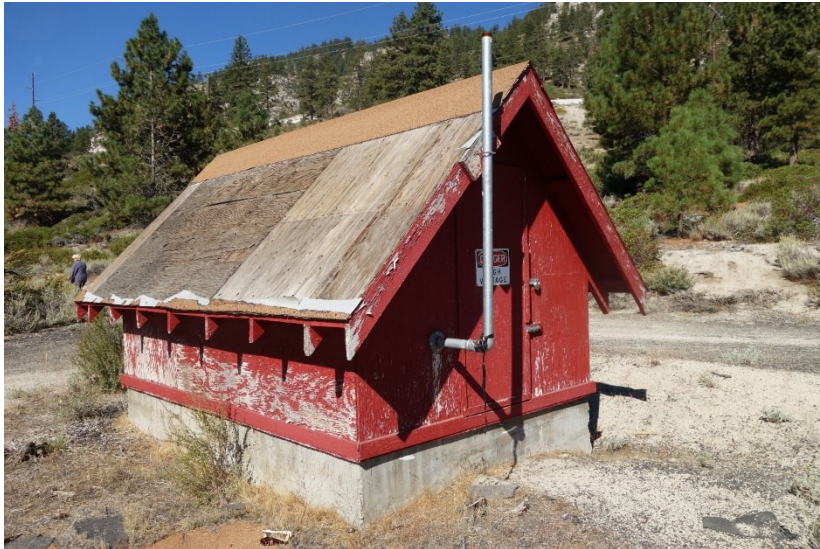
0709 – WELL HOUSE **OCCUPIED**

The well house is a wood frame structure with T-111 siding housing a well and pump. The roof is covered in roll roofing.

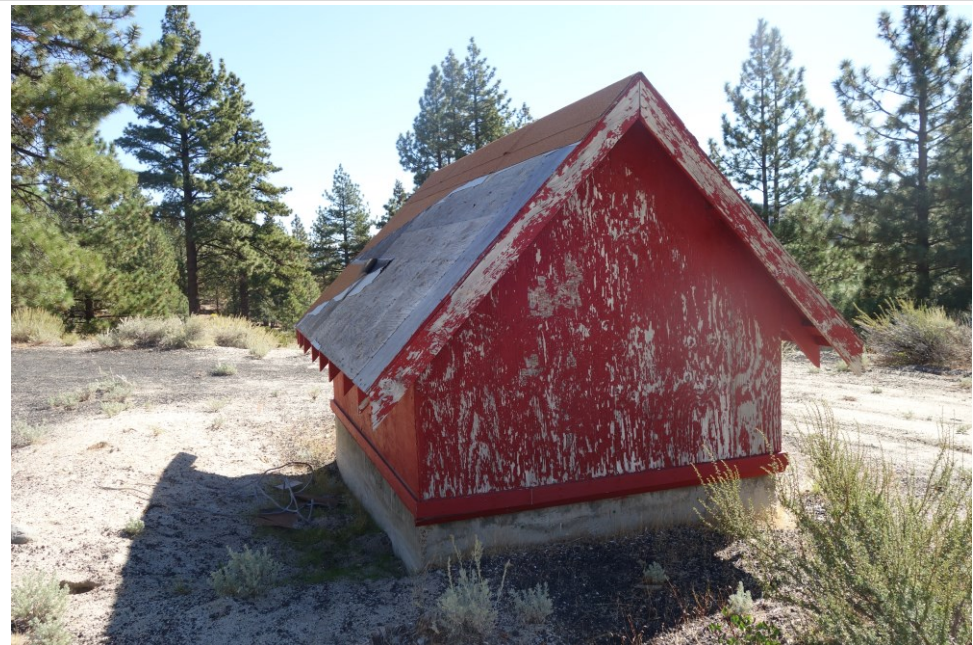
PROJECT # 0709EXT3 - BUILDING EXTERIOR

QUANTITY	UNITS	TOTAL	SF COST
Portions of the rolled asphalt composition roof on this building was missing and the balance in poor condition at the time of the survey. It is recommended that this building be re-roofed in the next 2 - 3 years with a new 50 year asphalt composition roofing shingle and new underlayment. This estimate includes removal and disposal of the old roofing system.	1	Package	\$ 5,000.00	\$ 52.00

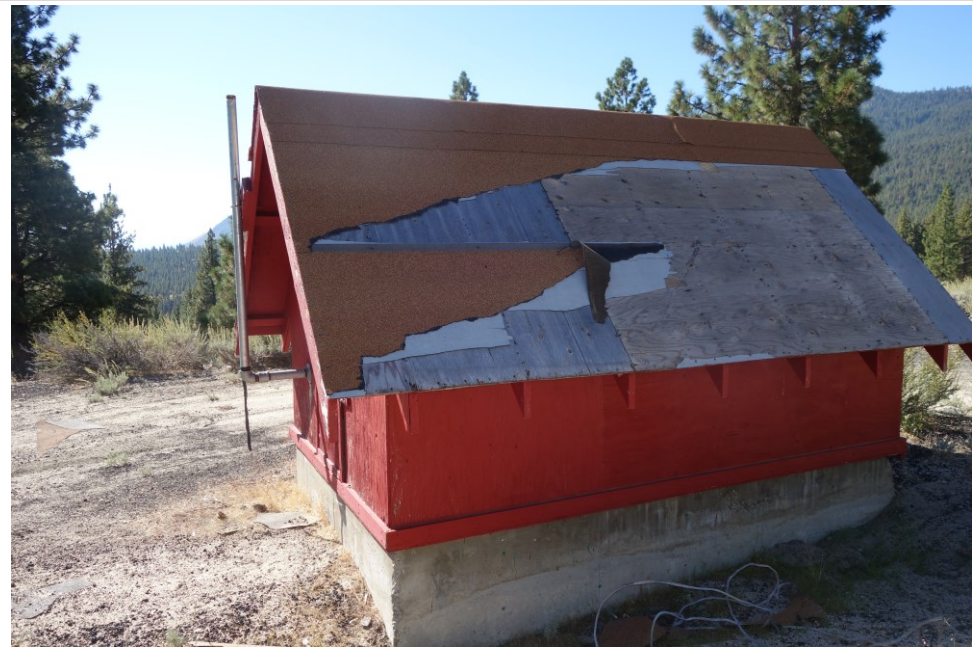
PROJECT # 1899EXT2 - BUILDING EXTERIOR

QUANTITY	UNITS	TOTAL	SF COST
The exterior finishes were in poor condition. It is important to maintain the finish, weather resistance and appearance of the building. This project recommends work to protect the exterior building envelope, other than the roof, including painting, staining, or other applied finishes, and caulking around windows, flashing, fixtures, and other penetrations to maintain the building in good, weather tight condition.	96	Square Foot	\$ 1900.00	\$ 20.00

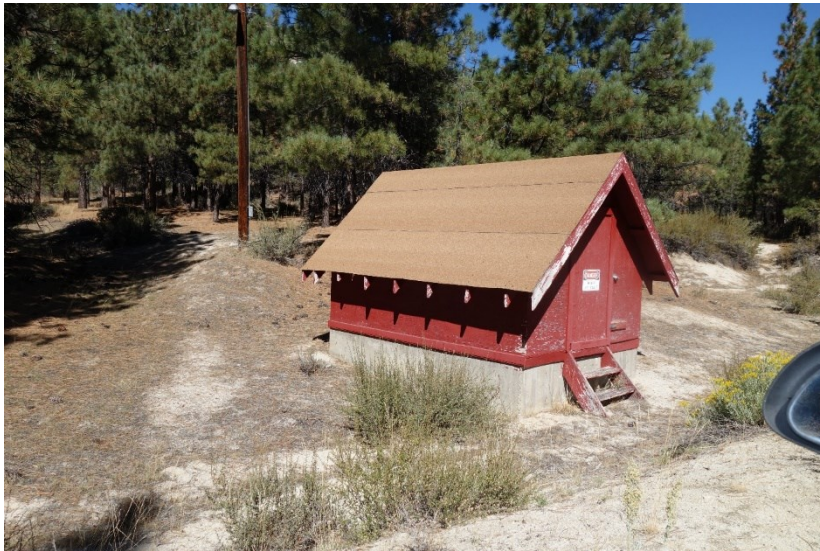
1899 – WELL HOUSE, 5700 FT. **OCCUPIED**

The building is a wood frame, T-111 sided structure housing a well and pump. The roof is covered with roll roofing.

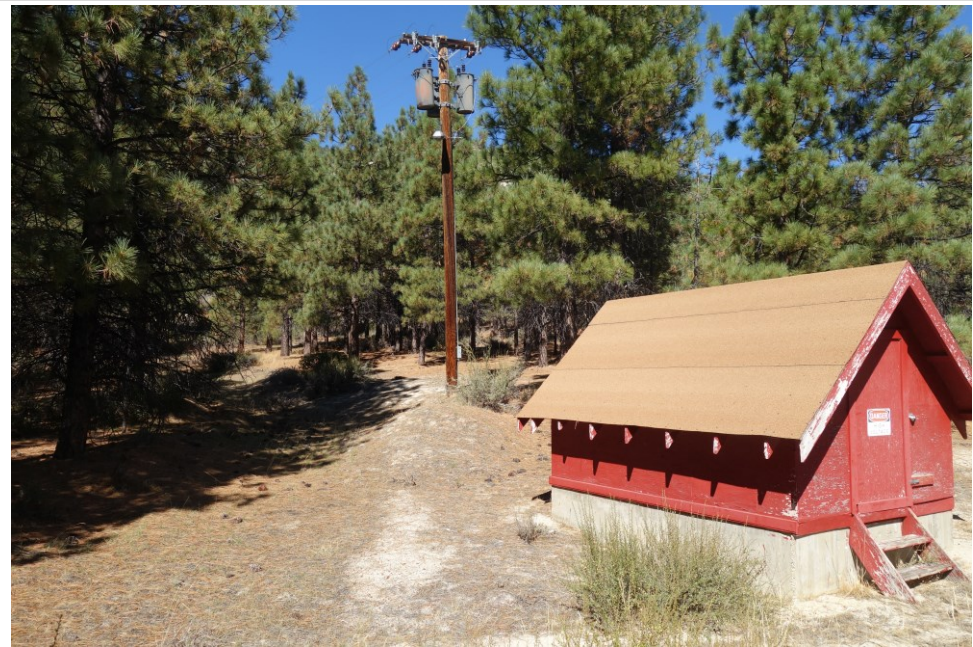
1901 – SEWAGE BUILDING (VACANT) **ARRESTED DECAY**

The building is a wood frame, T-111 sided shed used for storage. No projects will be written for this building due to the lack of building value (both physical value and serves no purpose) compared to the cost to maintain.

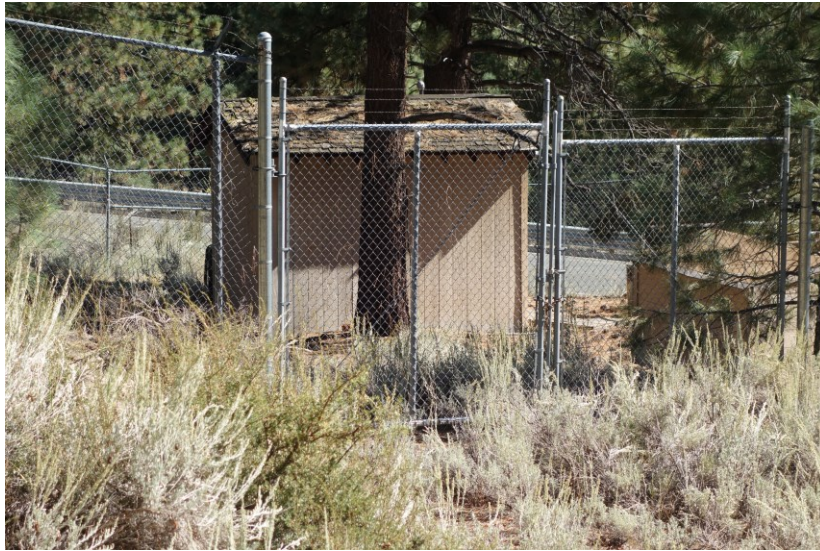
CONSTRUCTION TYPE		
- %	FIRE SUPPRESSED	
EXTERIOR TYPE	100% Painted Wood Siding	-%
OCCUPANCY TYPE	-%	-%

BUILT	1960
AGE	64 yrs
ACQUIRED	1960
HOW ACQUIRED	CONSTRUCTED
SQUARE FEET (SF)	96
FLOORS	-
BASEMENT?	No
LONGITUDE /LATITUDE	39.113732 / -119.839651
REPLACEMENT COST	\$ 2,400.00
COST PER SF	\$ 25.00
FACILITY CONDITION INDEX	0.00
