DEPARTMENT OF ADMINISTRATION  
STATE PUBLIC WORKS DIVISION  
FACILITY CONDITION ASSESSMENT

### PROPERTY PORTFOLIO REVIEW PROJECT ADDENDUM

NORTHWEST REGION  
NORTHERN STATE AND COUNTY GOVERNMENT CAMPUS  
9981 - SIERRA REGIONAL CENTER SITE  
605 S 21ST ST  
SPARKS, NV 89431-8100  
WASHOE COUNTY

SURVEY DATE: 04/16/2025

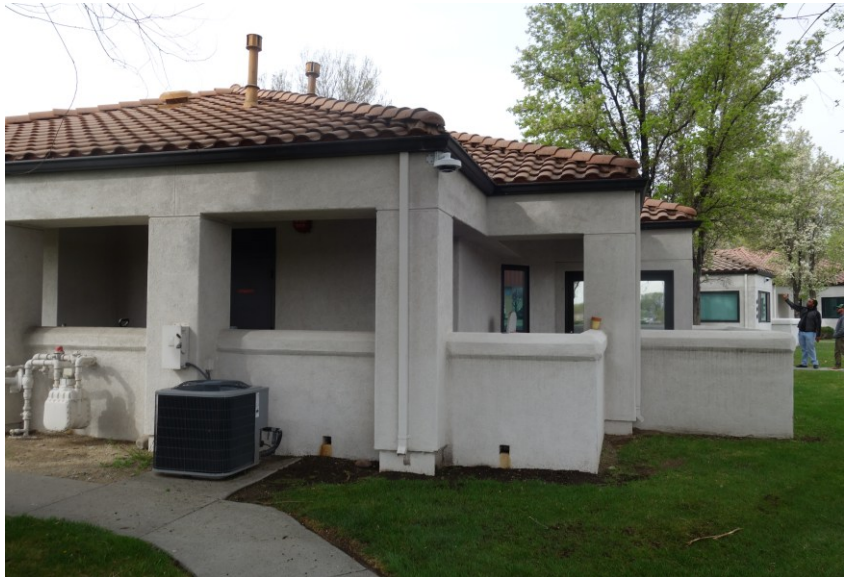
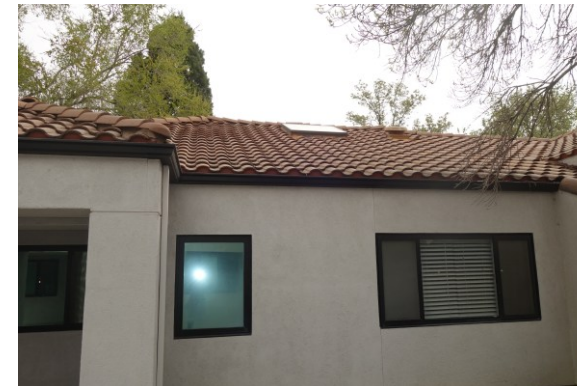
#### 1955-EXT-2: ROOF REPLACEMENT - FULL

The building has a concrete S-tile roof that has experienced repeated issues over several years, including broken and displaced tiles, deterioration of the underlayment, and localized flashing/penetration leaks. Prior repairs have not resolved the underlying moisture intrusion. Replacement of the roof system is recommended.

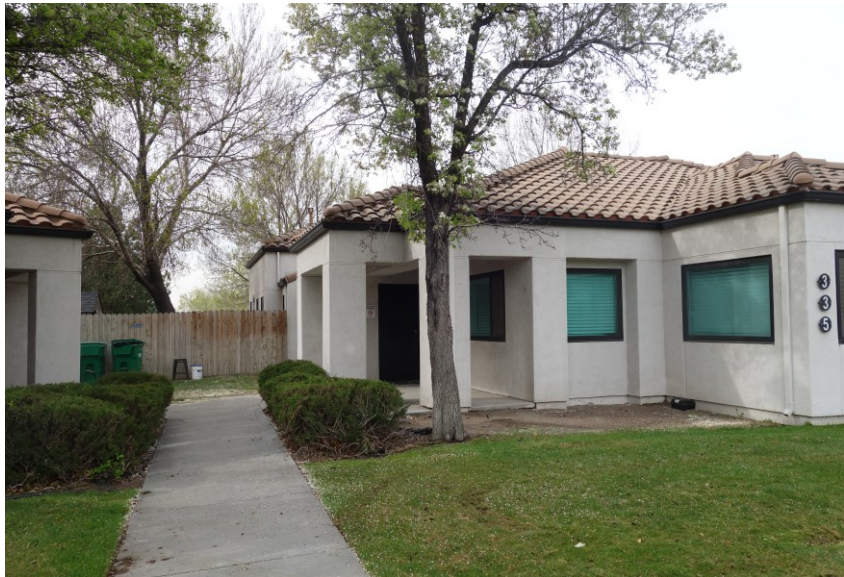
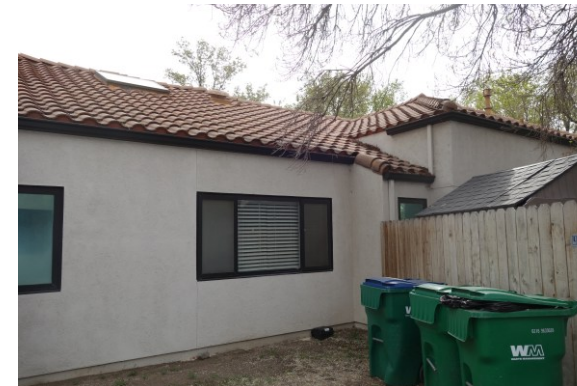
#### 0516-EXT-2: ROOF REPLACEMENT - FULL

The building has a concrete S-tile roof that has experienced repeated issues over several years, including broken and displaced tiles, deterioration of the underlayment, and localized flashing/penetration leaks. Prior repairs have not resolved the underlying moisture intrusion. Replacement of the roof system is recommended.

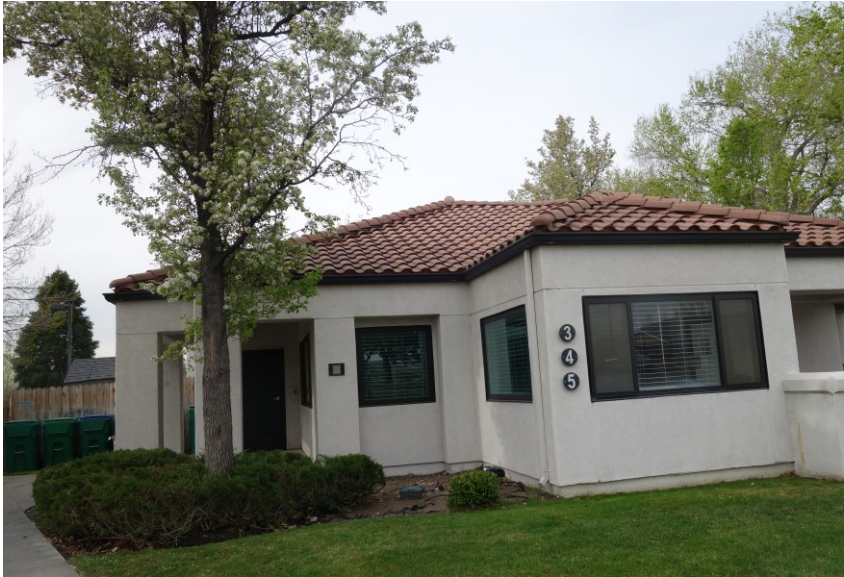
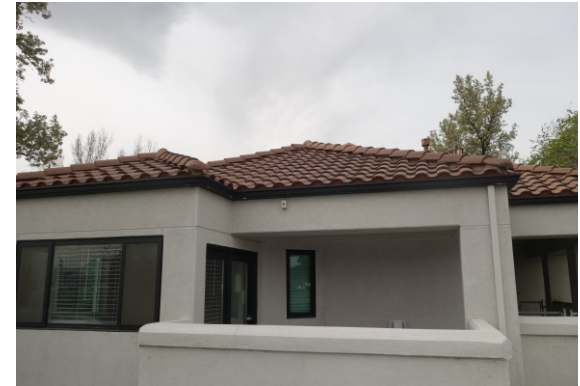
#### 0320-EXT-2: ROOF REPLACEMENT - FULL

The building has a concrete S-tile roof that has experienced repeated issues over several years, including broken and displaced tiles, deterioration of the underlayment, and localized flashing/penetration leaks. Prior repairs have not resolved the underlying moisture intrusion. Replacement of the roof system is recommended.
