Urban Forest  
Management Plan

Stewart Indian School

Prepared by  
John Christopherson  
Forest Protection Specialist  
Nevada Division of Forestry

2001

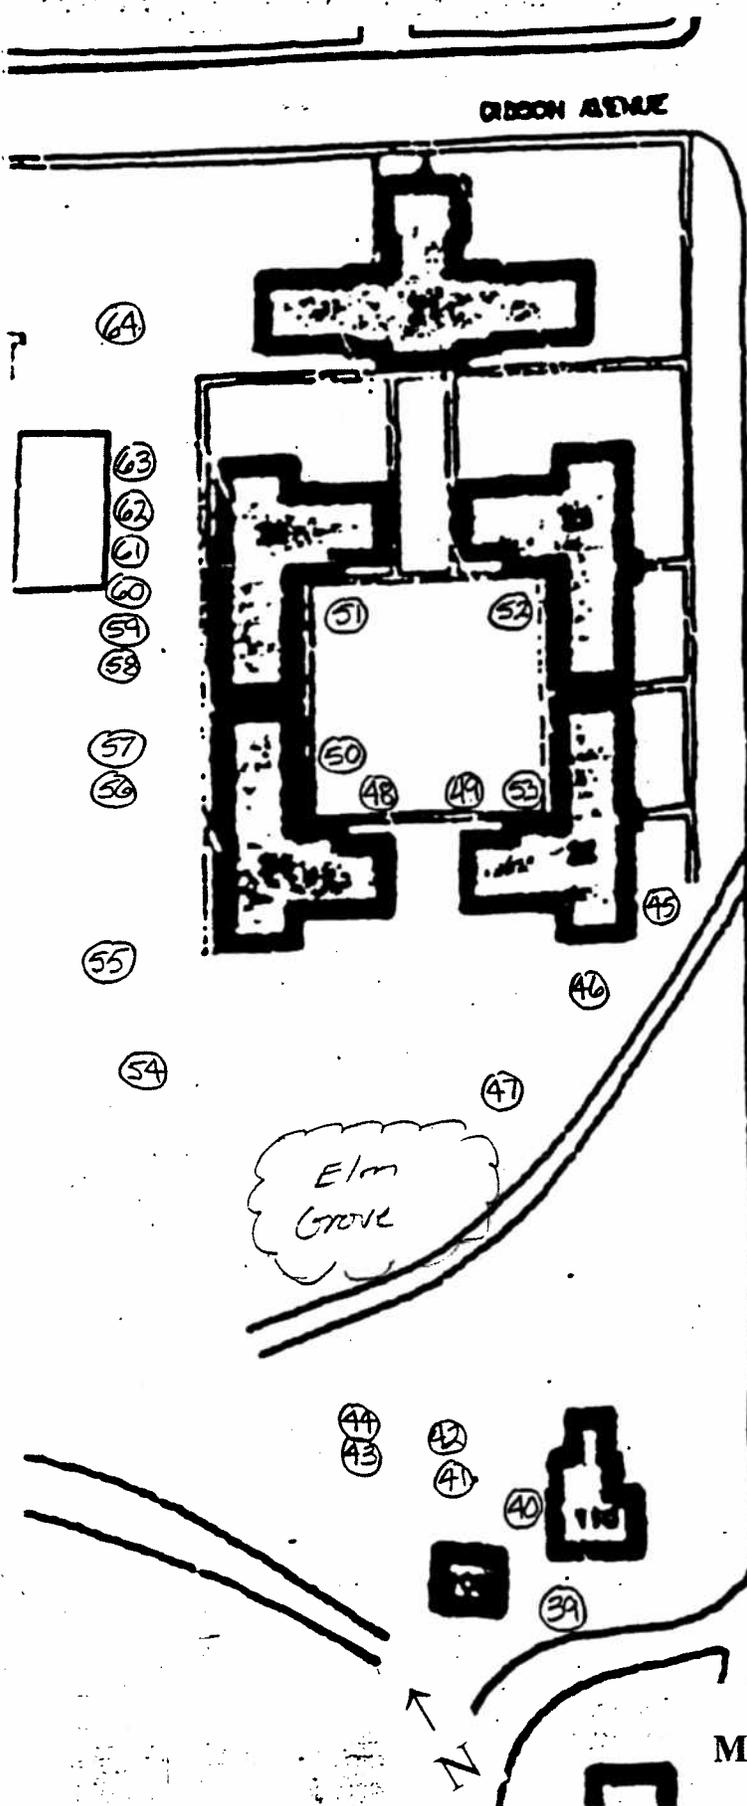
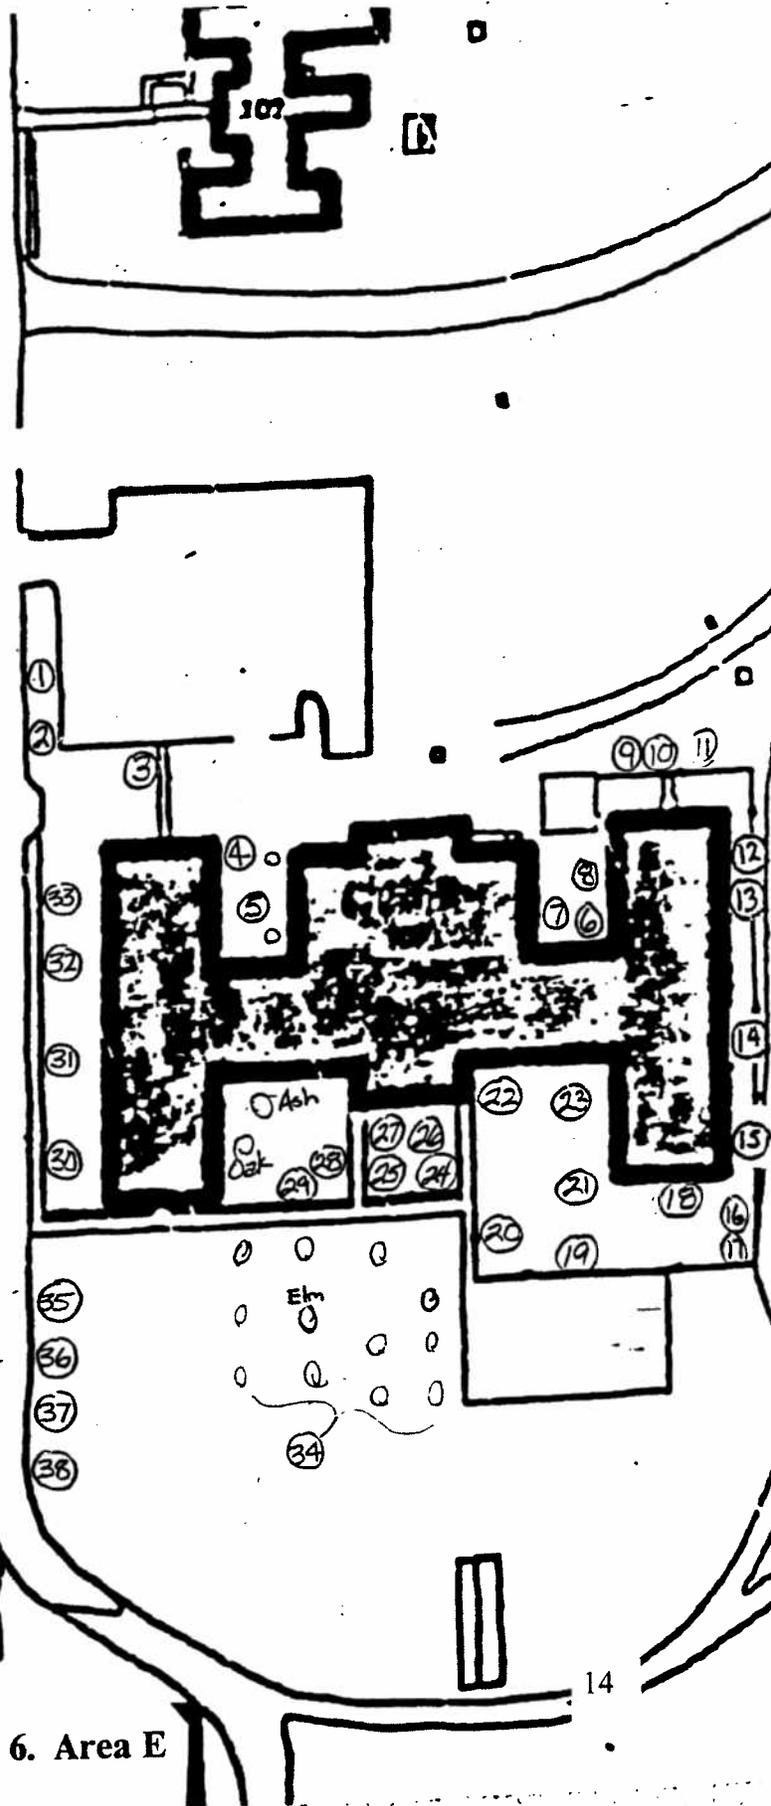
Map 6. Area E

Tree #1, a cottonwood with an old wound running from five feet up to 20' high. Tree has internal decay. Tree has sufficient sound wood (7") at base of scar to compensate for the decay. However, samples should be taken further up the stem along the scarred portion to make sure sufficient sound wood is present higher up. Use a certified arborist to make this evaluation.

Tree #4, a cottonwood with 3 main scaffold branches. The northwest one has a large decay hollow where a branch broke off. Immediately above that is a four inch diameter dead branch. This branch should be removed.

Tree #14, may be the largest cottonwood on the grounds. Past pruning and branch breakage has left several large decay pockets in the upper branches. Future branch failures are likely. However, given the tree's significance (large size) and the unlikely presence of any targets, I recommend the tree be kept.
