State of Nevada
Department of Wildlife
Ely Wildlife Field Office
Facility Condition Analysis

ELY WILDLIFE FIELD OFFICE

1218 North Alpha Street
Ely, Nevada 89301

Site Number: 9825
STATE OF NEVADA PUBLIC WORKS DIVISION
FACILITY CONDITION ANALYSIS

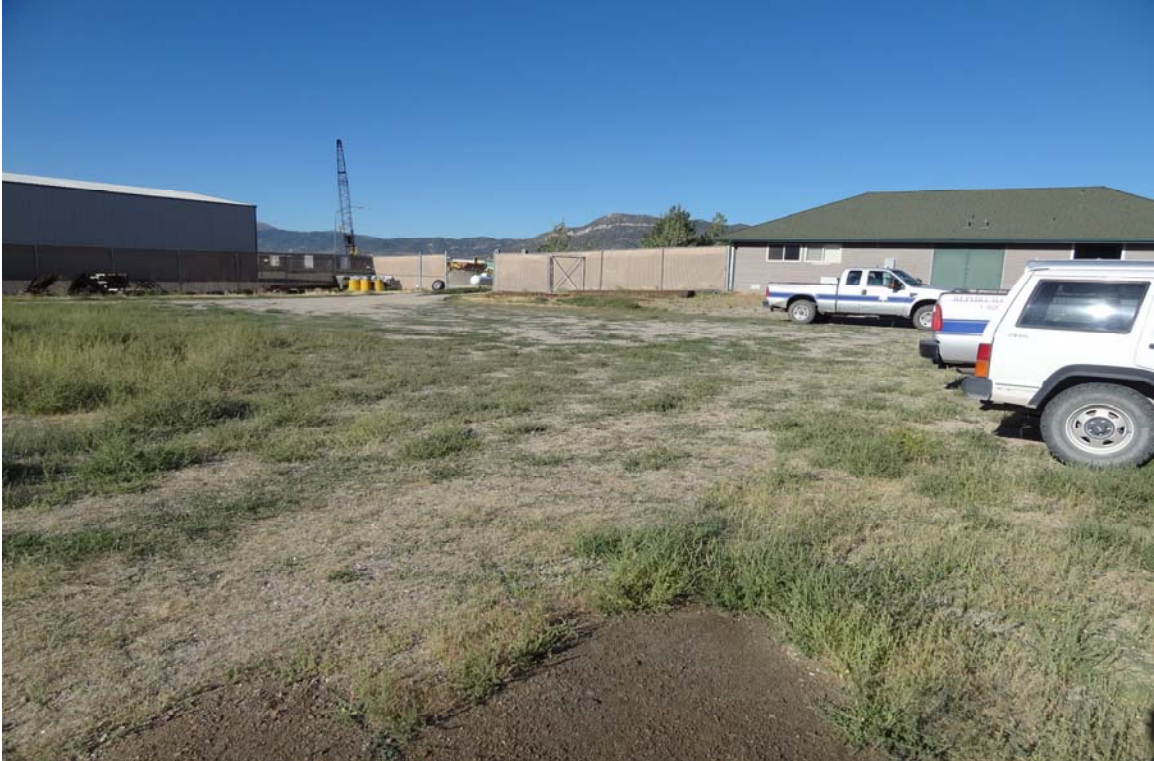
Ely Wildlife Field Office Site - Site #9825
Description: View of equipment yard looking west.

There are approximately 10 state vehicles parked in the rear parking area at any given time including trucks, boats, trailers and quads. Some of these vehicles carry sensitive measuring and testing equipment which can deteriorate quickly due to exposure to the elements. This project would provide a steel carport capable of protecting 10 vehicles to be built on the east side of the site.

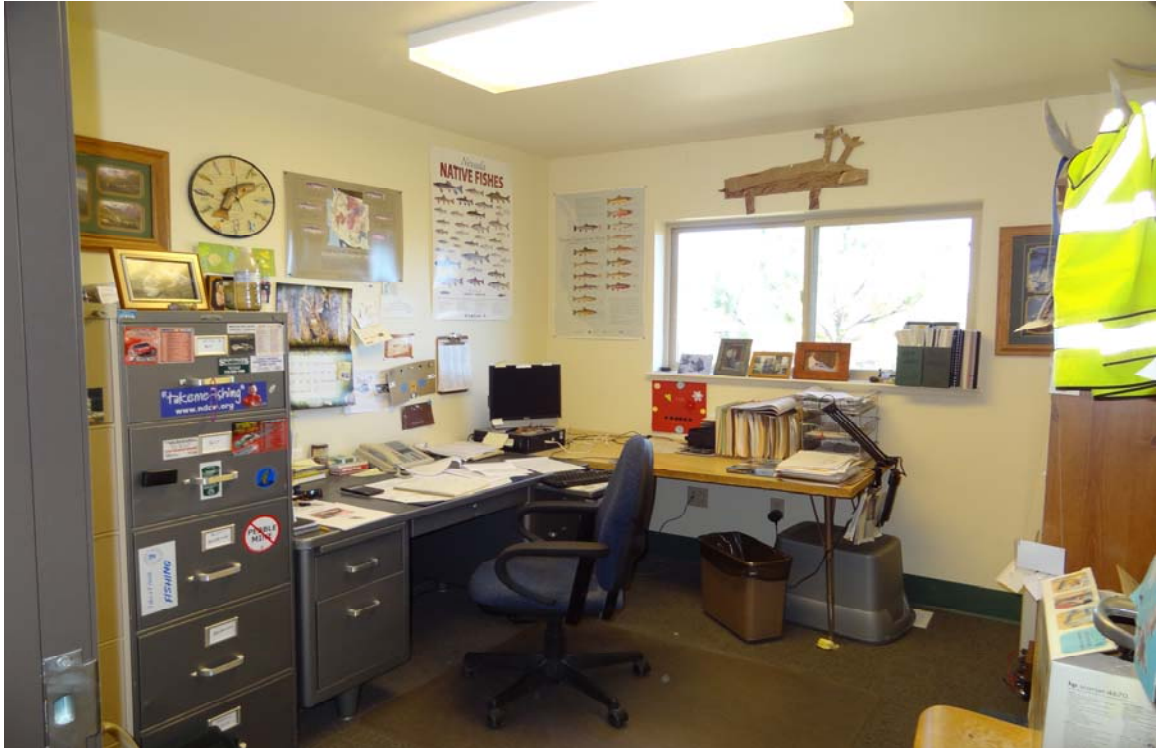
Ely Wildlife Field Office - Building #2127
Description: Typical interior office.
