# DPS TRAINING FACILITY

2101 Snyder Avenue  
Carson City, Nevada 89701

**Site Number: 9851**  
**STATE OF NEVADA PUBLIC WORKS DIVISION**  
**FACILITY CONDITION ANALYSIS**

Report Printed in December 2011

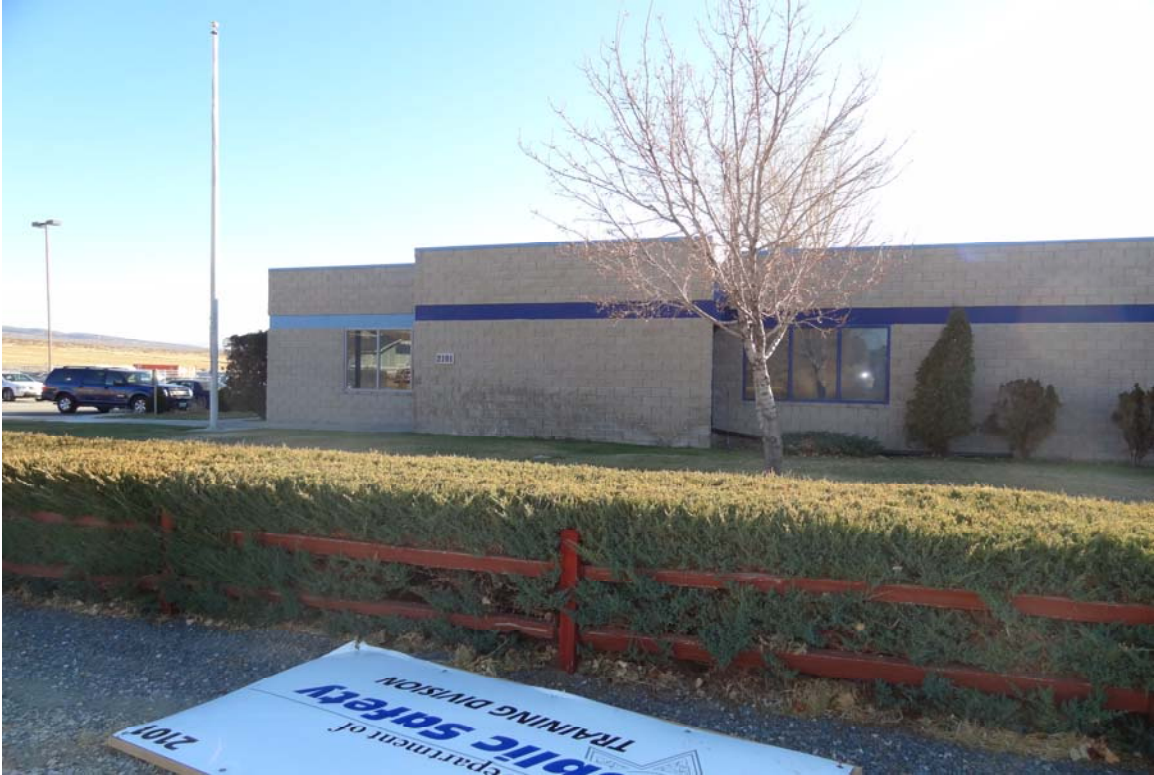
DPS Training Facility Site - Site #9851

There is a large tree on the south side of the building which has shallow roots that may cause damage to the foundation of the building as it continues to grow.

Description: Tree recommended for removal, south side of building.

This project would provide for the removal of the tree to prevent damage to the building's foundation.

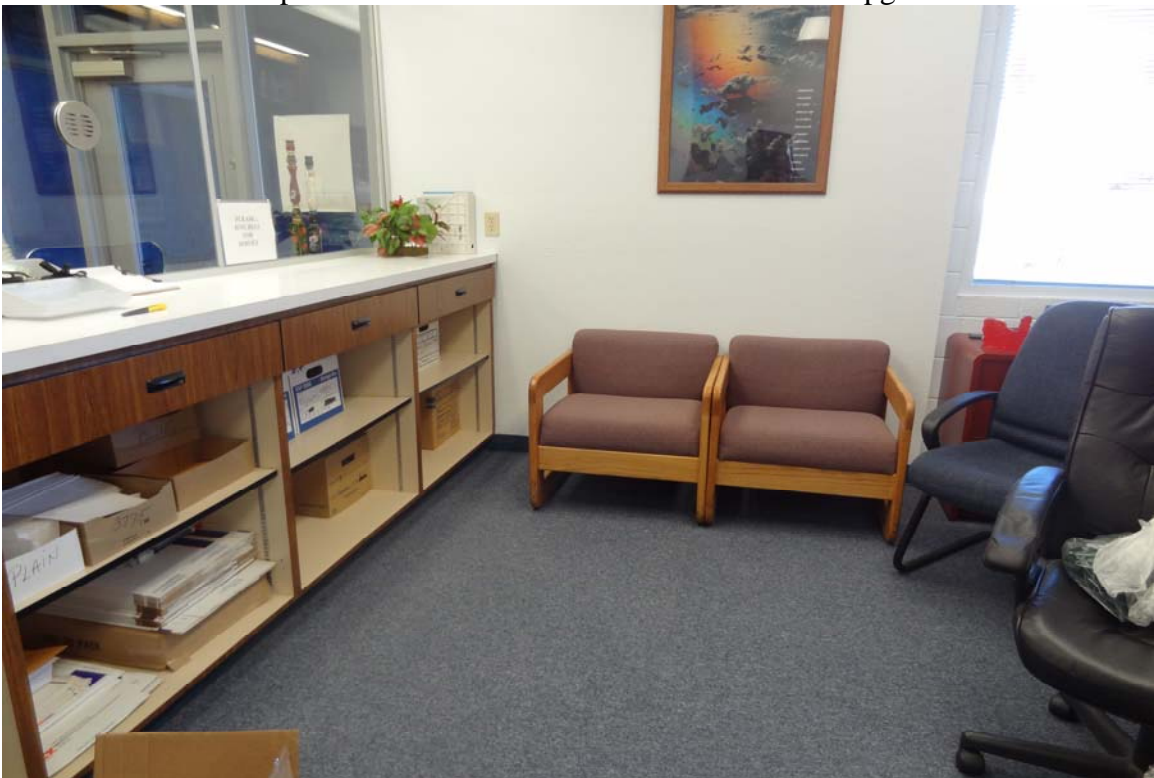
DPS Training Facility - Building #0898  
Description: Interior of window / frame in need of upgrade.
