Department of Conservation and Natural Resources
Division of State Parks
Wild Horse State Recreation Area
Facility Condition Analysis

WILD HORSE STATE RECREATION AREA

Site Number: 9935 STATE OF NEVADA PUBLIC WORKS DIVISION FACILITY CONDITION ANALYSIS

Survey Date: 7/23/2014

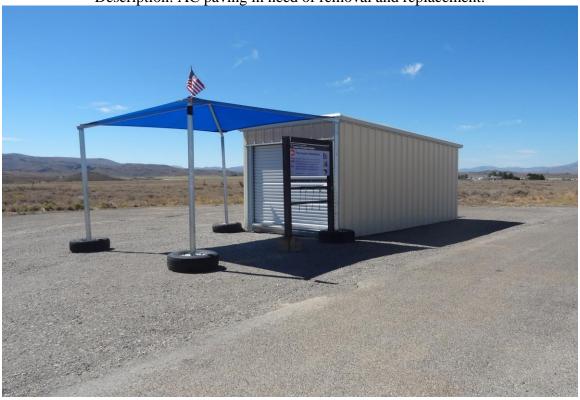
Wild Horse State Recreation Area Site – FCA Site #9935 Description: AC paving in need of removal and replacement.

The AC paying behind the visitors center has failed and is in need of replacement. This project would provide for the removal of the damaged paving and installation of new 3" thick AC paving over a compacted base. It may be possible to grind in place the damaged paving and use for base which could reduce project cost.
