State of Nevada
Department of Corrections

SOUTHERN DESERT CORRECTIONAL CENTER

Site Number: 9970
STATE OF NEVADA PUBLIC WORKS DIVISION
FACILITY CONDITION ANALYSIS

Report distributed in December 2021

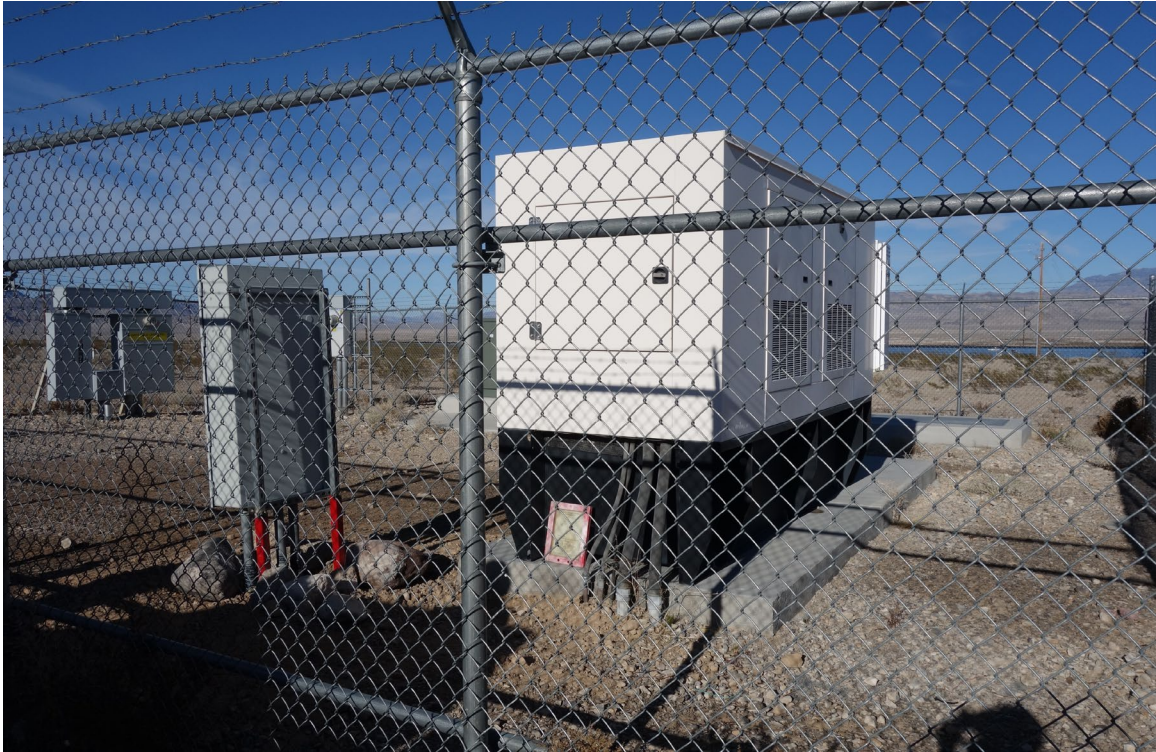
Southern Desert Correctional Center Site – FCA Site #9970

Description: Backup Power for Dorm Units 11 & 12 located outside East perimeter fence.

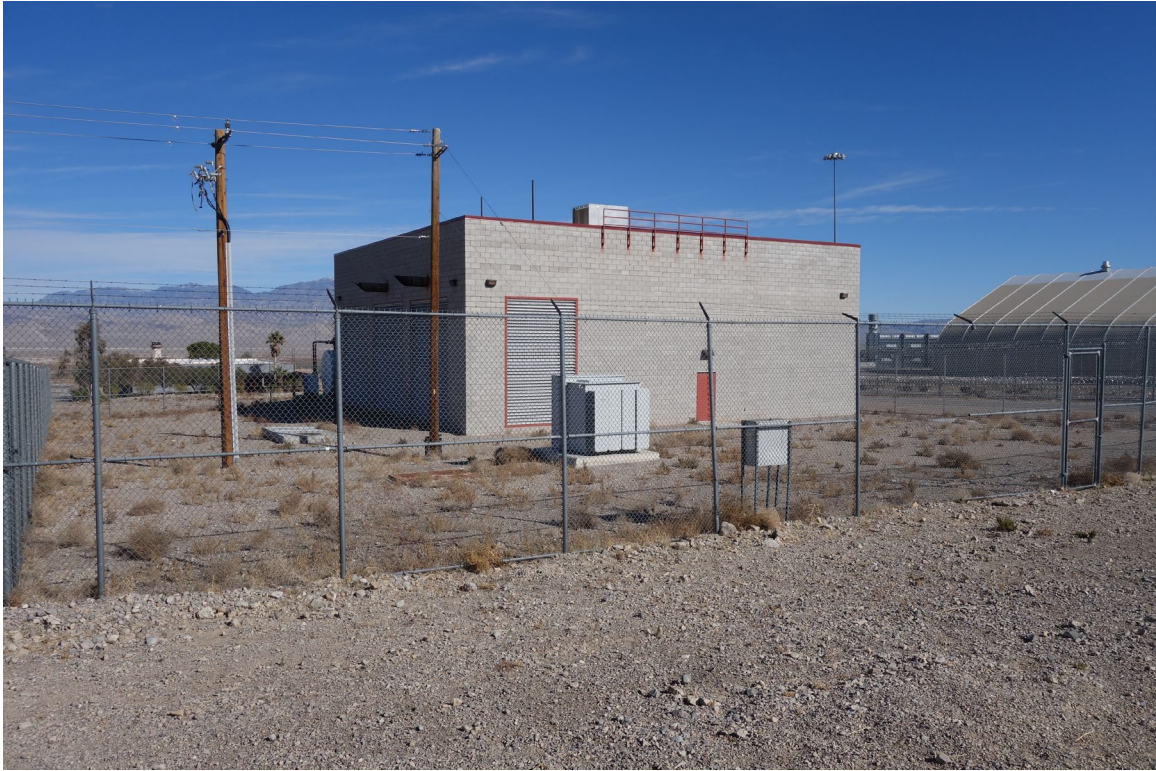
SDCC Power/Generator Building – FCA Building #3097
Description: Exterior of the building.

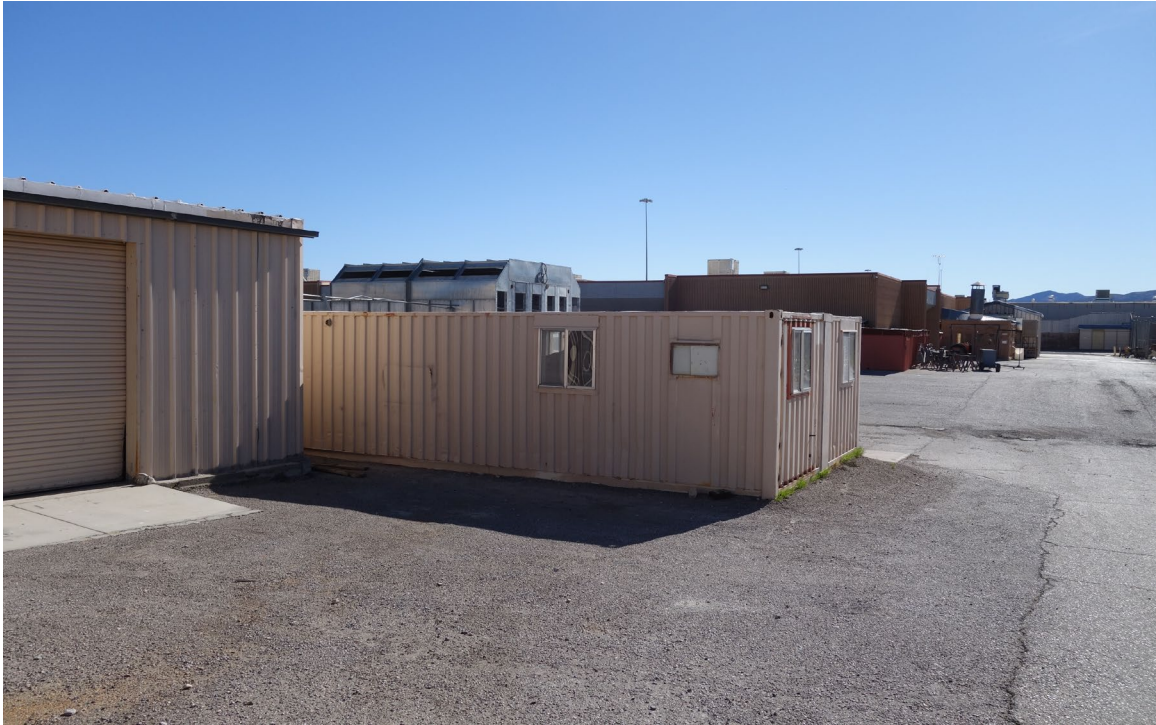
SDCC P.I. Lunch Room – FCA Building #2181
Description: Exterior of the building.

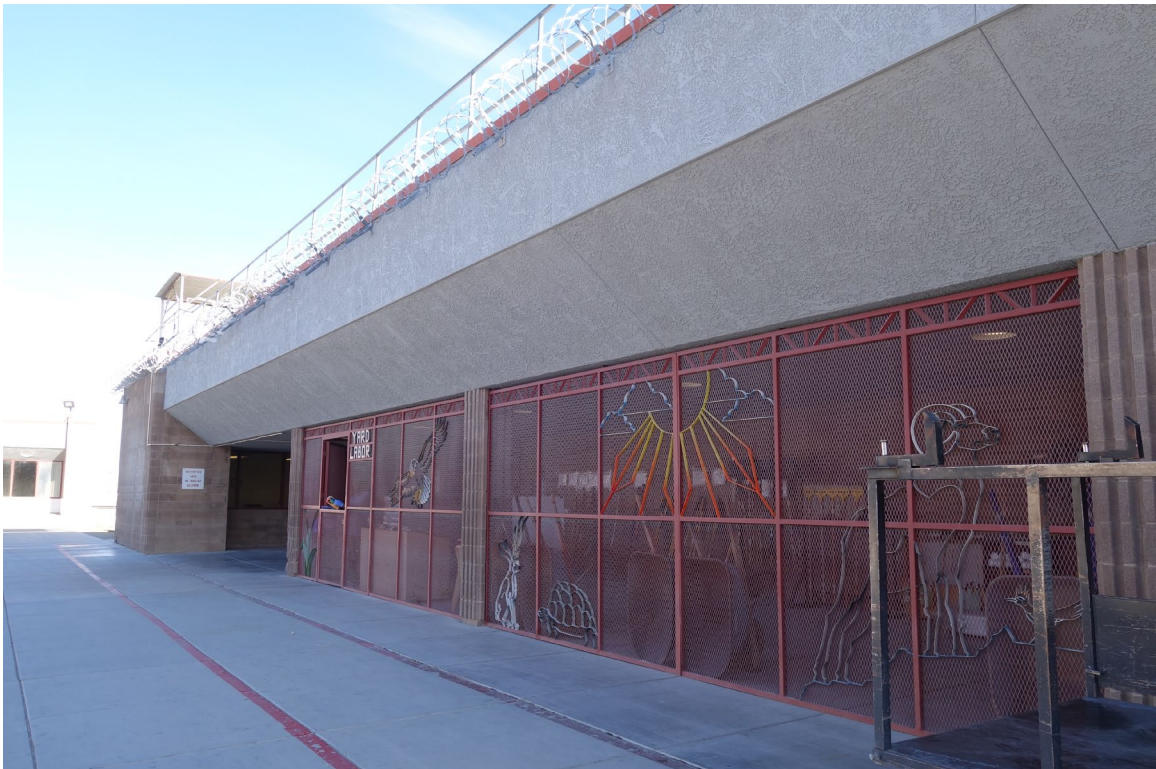
Recent heavy rains exposed drainage problems around the site. The grade does not slope away from the buildings effectively which allowed water to infiltrate several of the housing units. This project would create positive flow away from the buildings by regrading, paving and/ or installing additional drainage swales as needed. This is particularly troublesome on the north side of the Gym Building #0166.

SDCC Gym/Recreation Building – FCA Building #0166
Description: Exterior of the building.
